SAFETY COMPLIANCE TESTING FOR FMVSS NO. 138 TIRE PRESSURE MONITORING SYSTEMS

TOYOTA MOTOR MANUFACTURING
2007 CAMRY FOUR-DOOR
PASSENGER CAR
NHTSA NO. C75100

FINAL REPORT

1. Report No. 138-STF-06-007	2. Government Accession No.	3. Recipient's Catalog No.
4. Title and Subtitle Final Report of FMVSS 138 Compliance Testing of 2007 Toyota Camry Four-door Passenger Car, NHTSA No. C75100		5. Report Date May 9, 2007

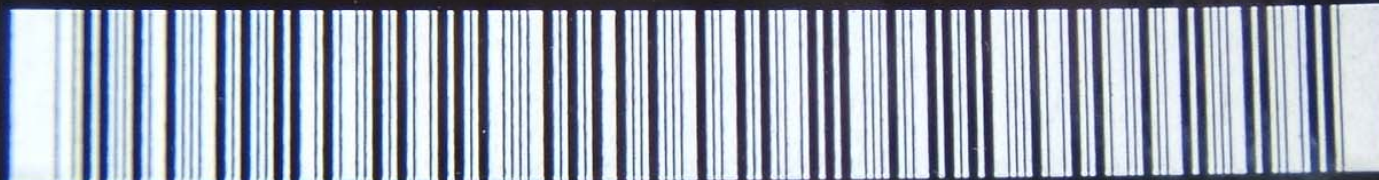
GVWR 4345LB GAWR FR 2668LB RR 2359LB
THIS VEHICLE CONFORMS TO ALL APPLICABLE
FEDERAL MOTOR VEHICLE SAFETY, BUMPER, AND
THEFT PREVENTION STANDARDS IN EFFECT ON
THE DATE OF MANUFACTURE SHOWN ABOVE.

4T1BE46K47U038100 PASS. CAR

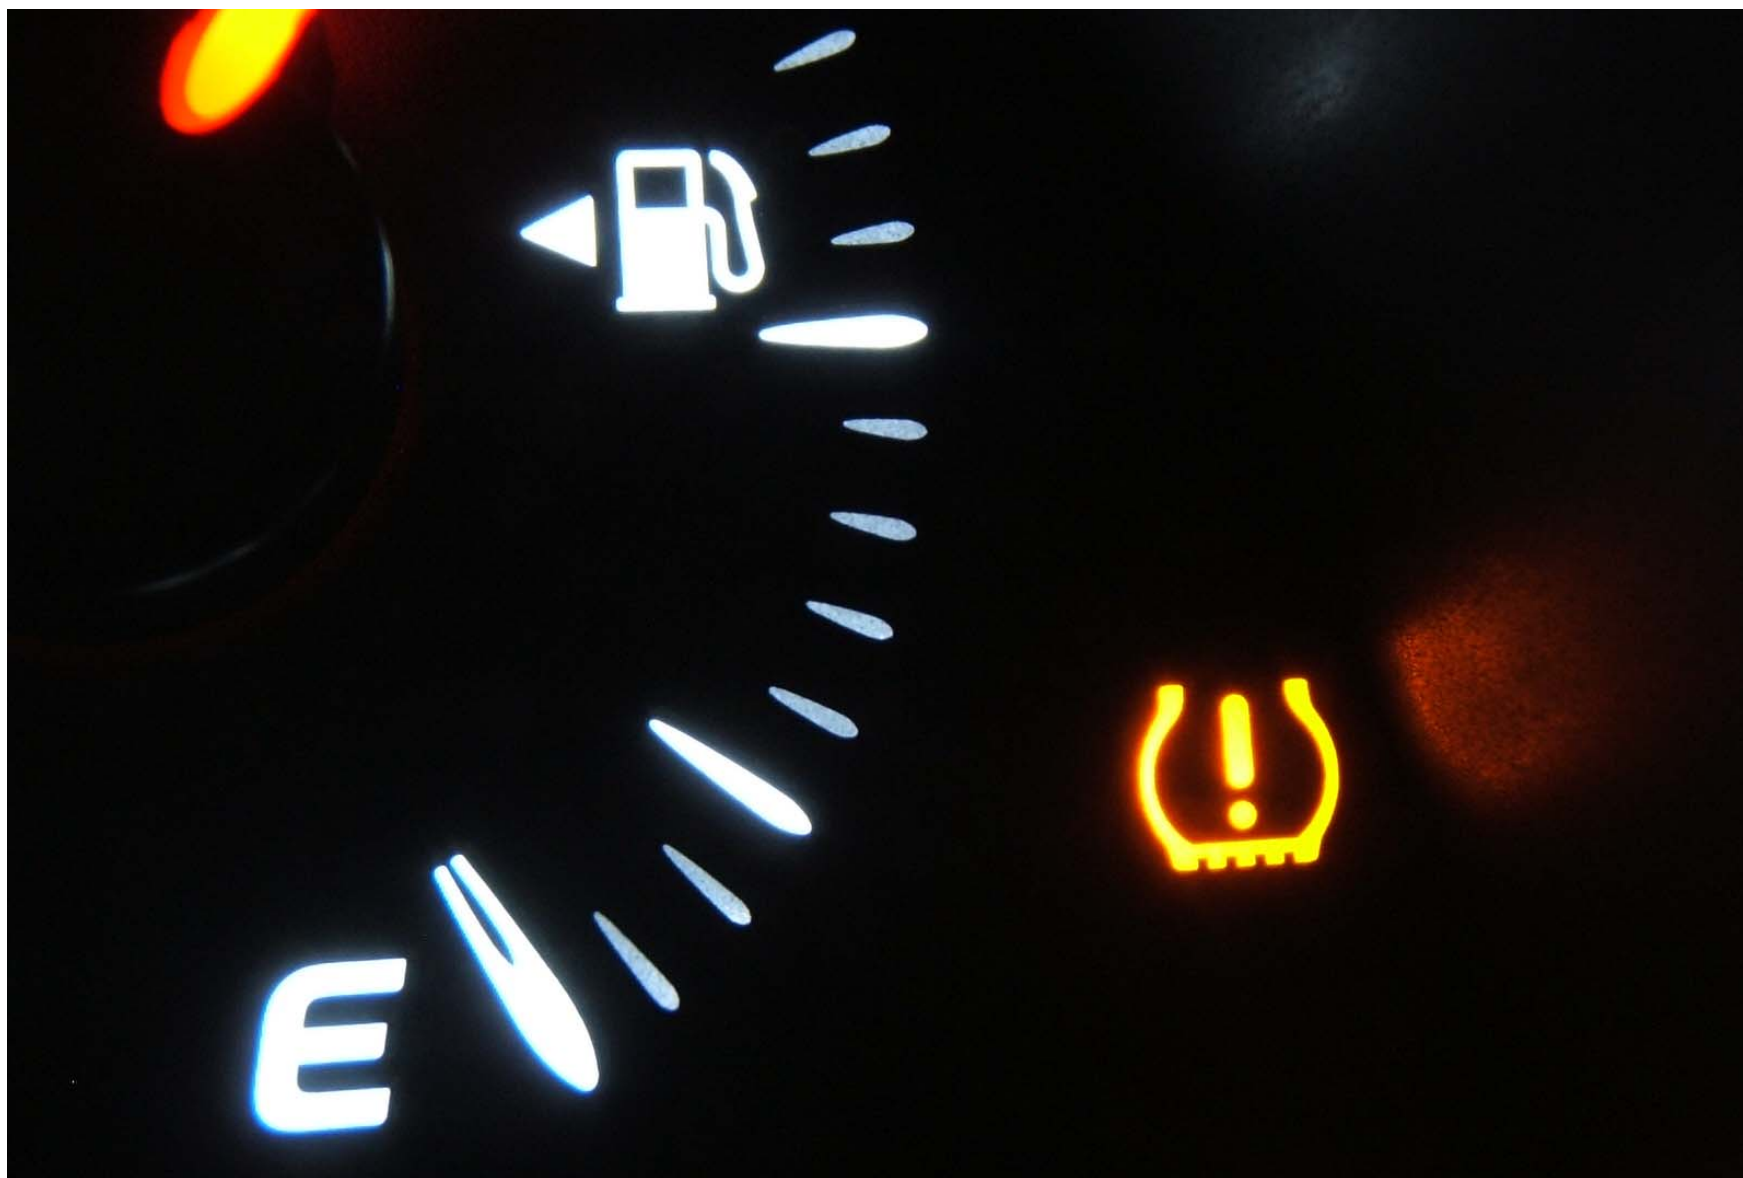
FIGURE 5.11
INSTRUMENT PANEL SHOWING COMBINATION LOW TIRE
PRESSURE WARNING AND MALFUNCTION TELLTALE

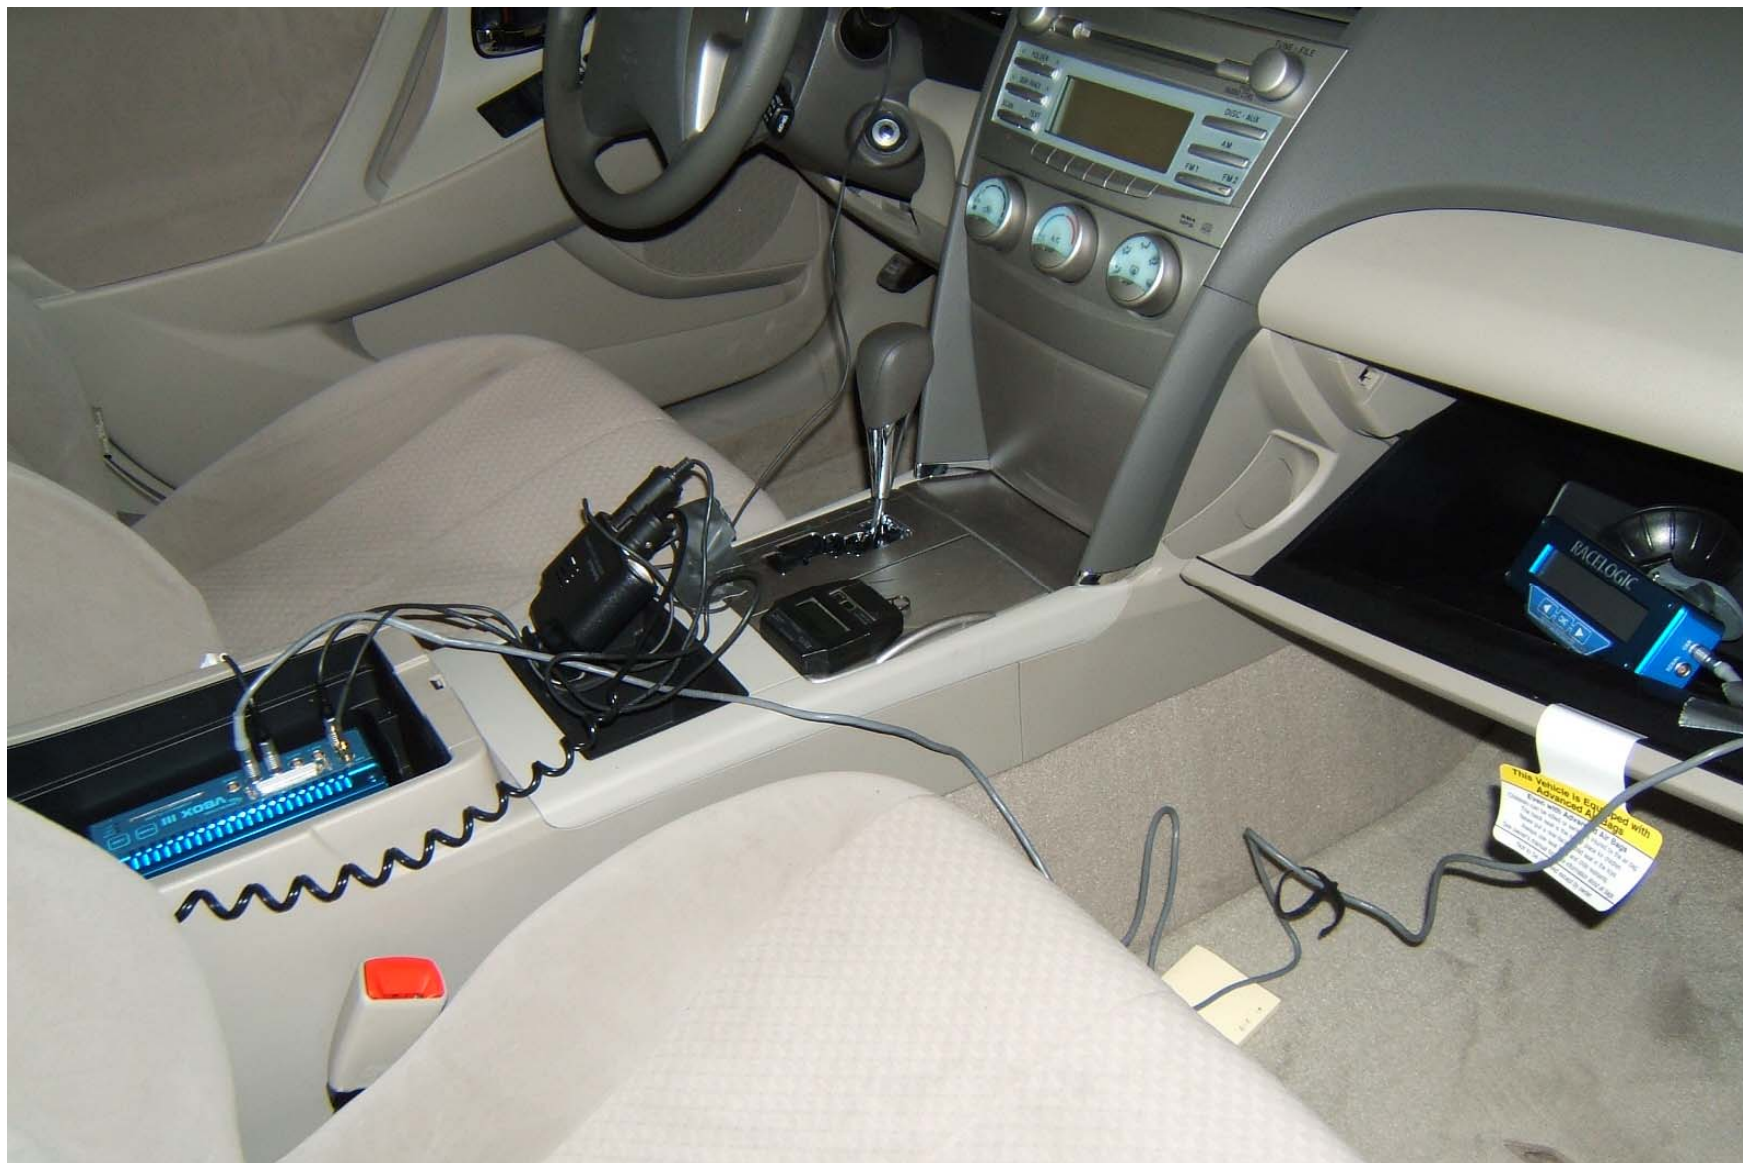
The vehicle was instrumented with a Racelogic VBOX III 100 Hz GPS Data Logger and brake pedal trigger. The VBOX uses GPS to measure vehicle speed, time, and distance. Test data were recorded to a compact flash card. During the test, a stopwatch was used to determine the approximate "cumulative driving time" during each test phase. Cumulative driving time does not include time during the brake application or when the vehicle speed was below 50 km/h or above 100 km/h. Upon completion of a tire deflation test, graph(s) were generated by VBOX software showing vehicle speed versus time during the test procedure calibration phase and detection phase. The graphs furnish a second-by-second analysis of each test phase. The cumulative driving time for each test was calculated by post processing the VBOX graph data and is reported in Section 3 (Test Data) as 'Total Driving Time'.

FIGURE 5.12
TEST INSTRUMENTATION MOUNTED ON VEHICLE

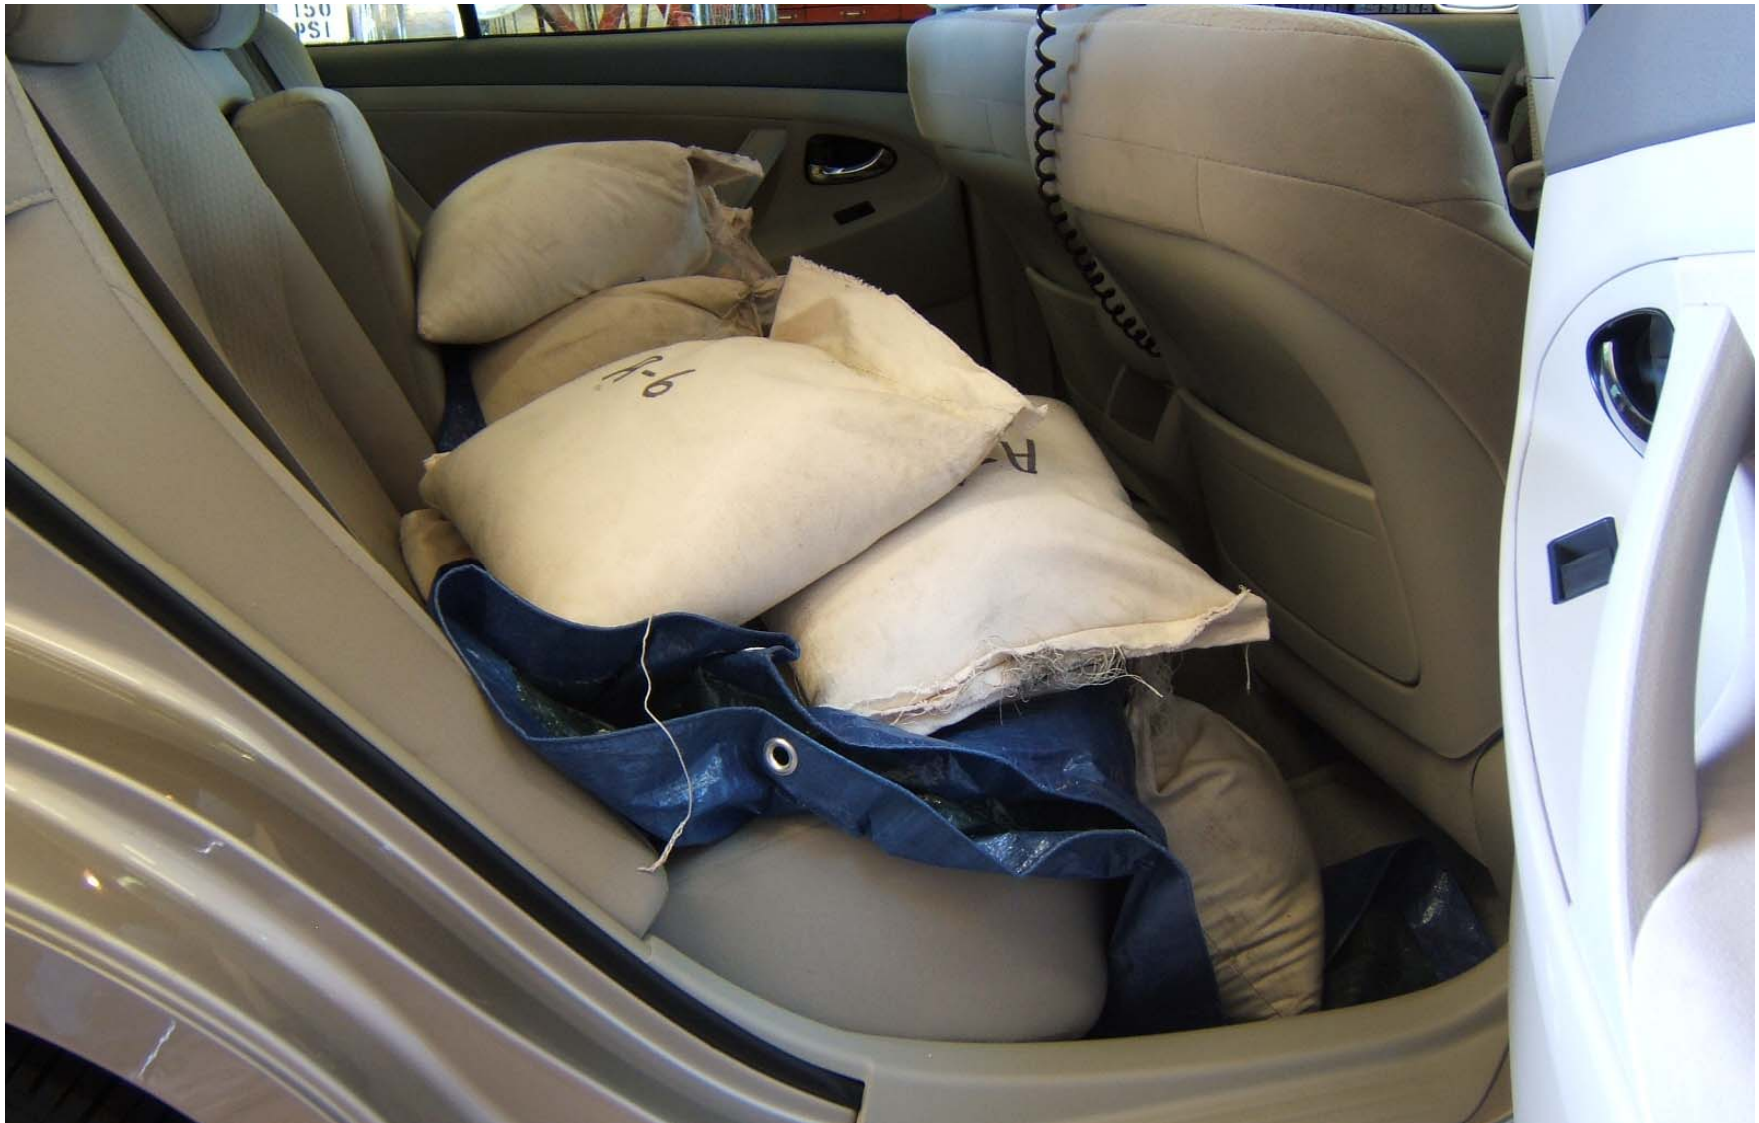
FIGURE 5.13
VEHICLE REAR SEAT BALLAST FOR GVWR LOAD

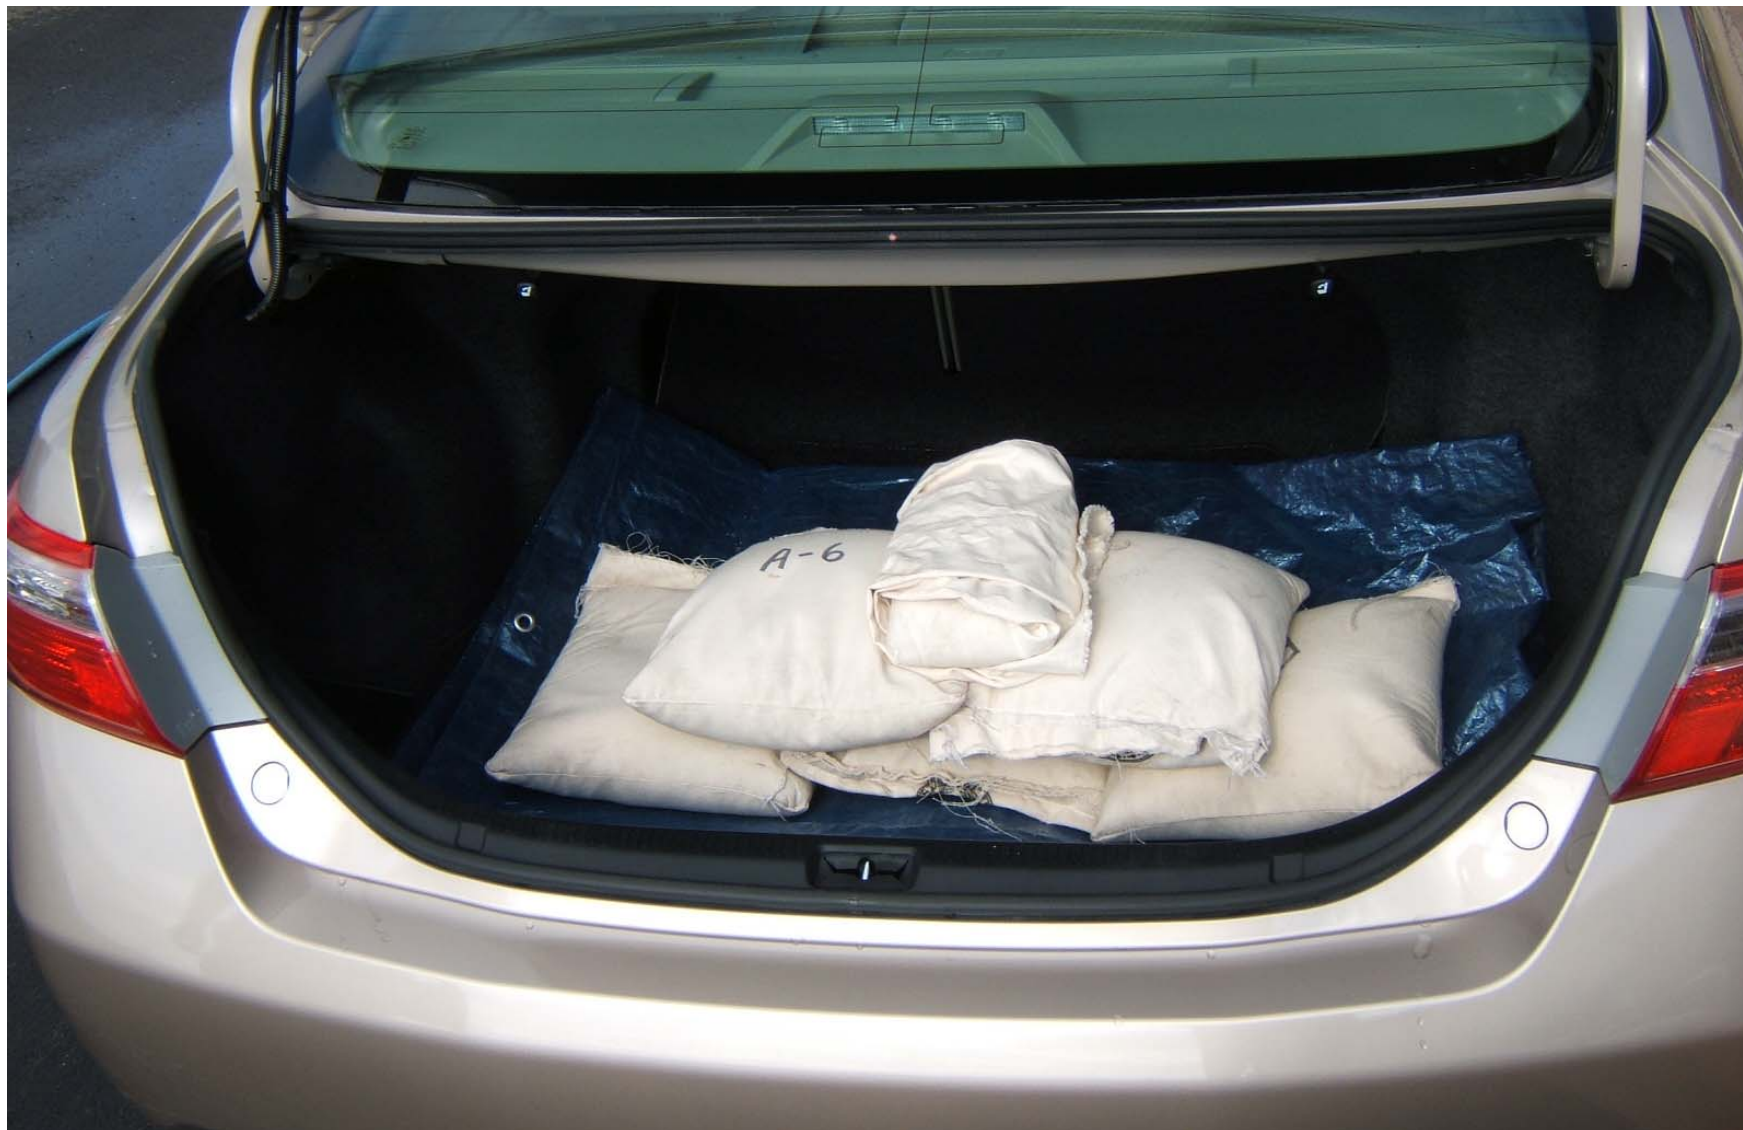
FIGURE 5.14
VEHICLE TRUNK BALLAST FOR GVWR LOAD

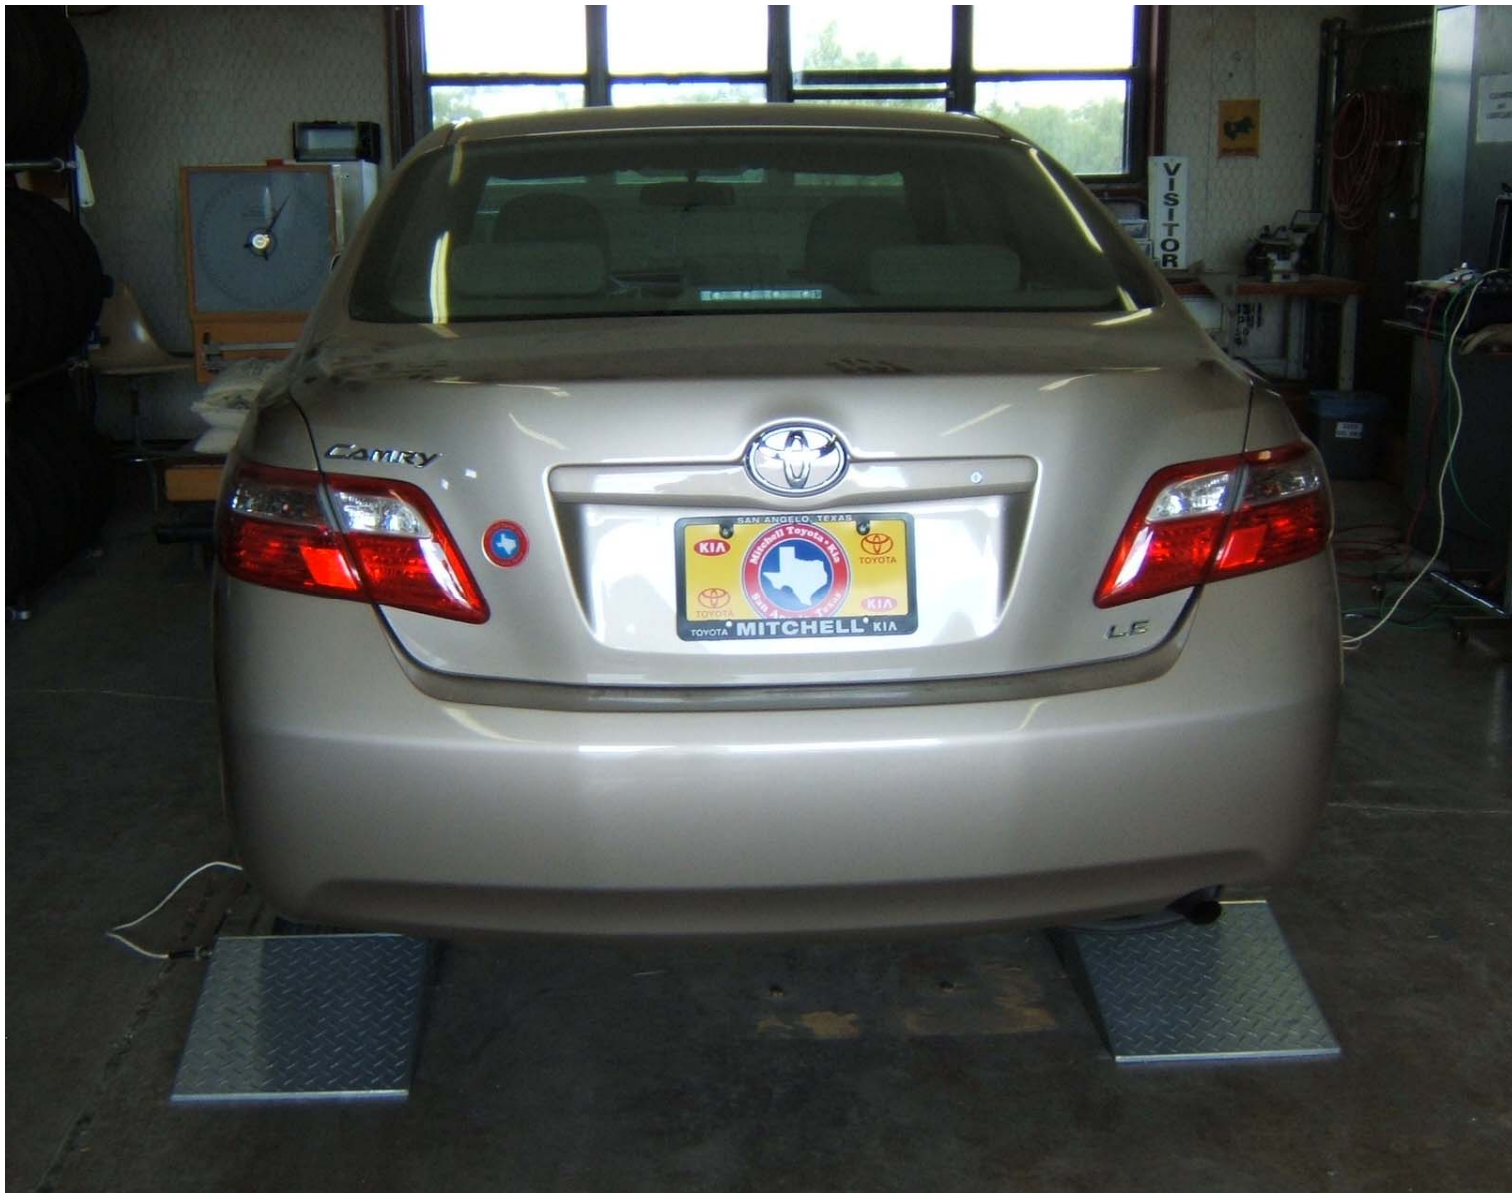
FIGURE 5.15
VEHICLE ON WEIGHT SCALES

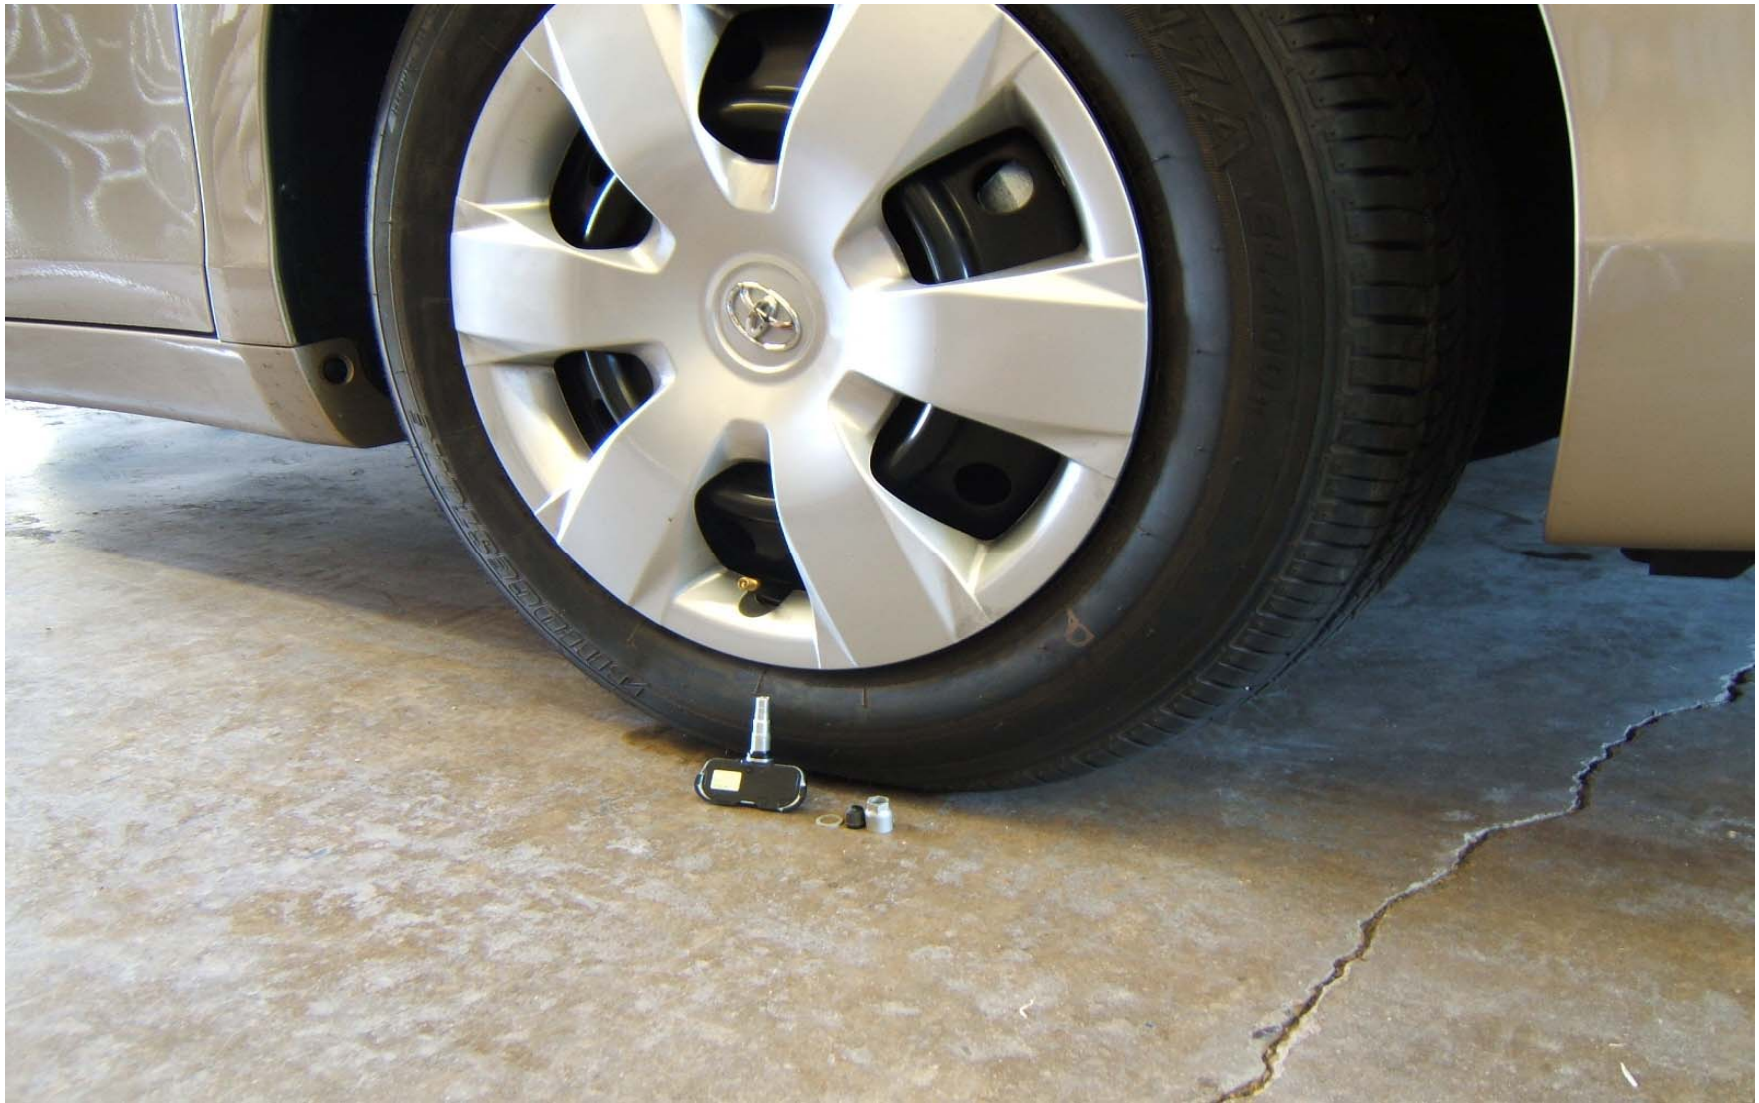
An indicant malfunction detection scenario was performed with the vehicle loaded to its GVWR. A malfunction was simulated by replacing the TPMS sensor in the right front wheel with a regular rubber valve stem. The vehicle was driven until telltale illumination or until a minimum of 20 minutes of cumulative driving time between 50 and 100 km/h was attained.

FIGURE 5.16
RIGHT FRONT WHEEL WITH SENSOR REMOVED
FOR MALFUNCTION DETECTION TEST

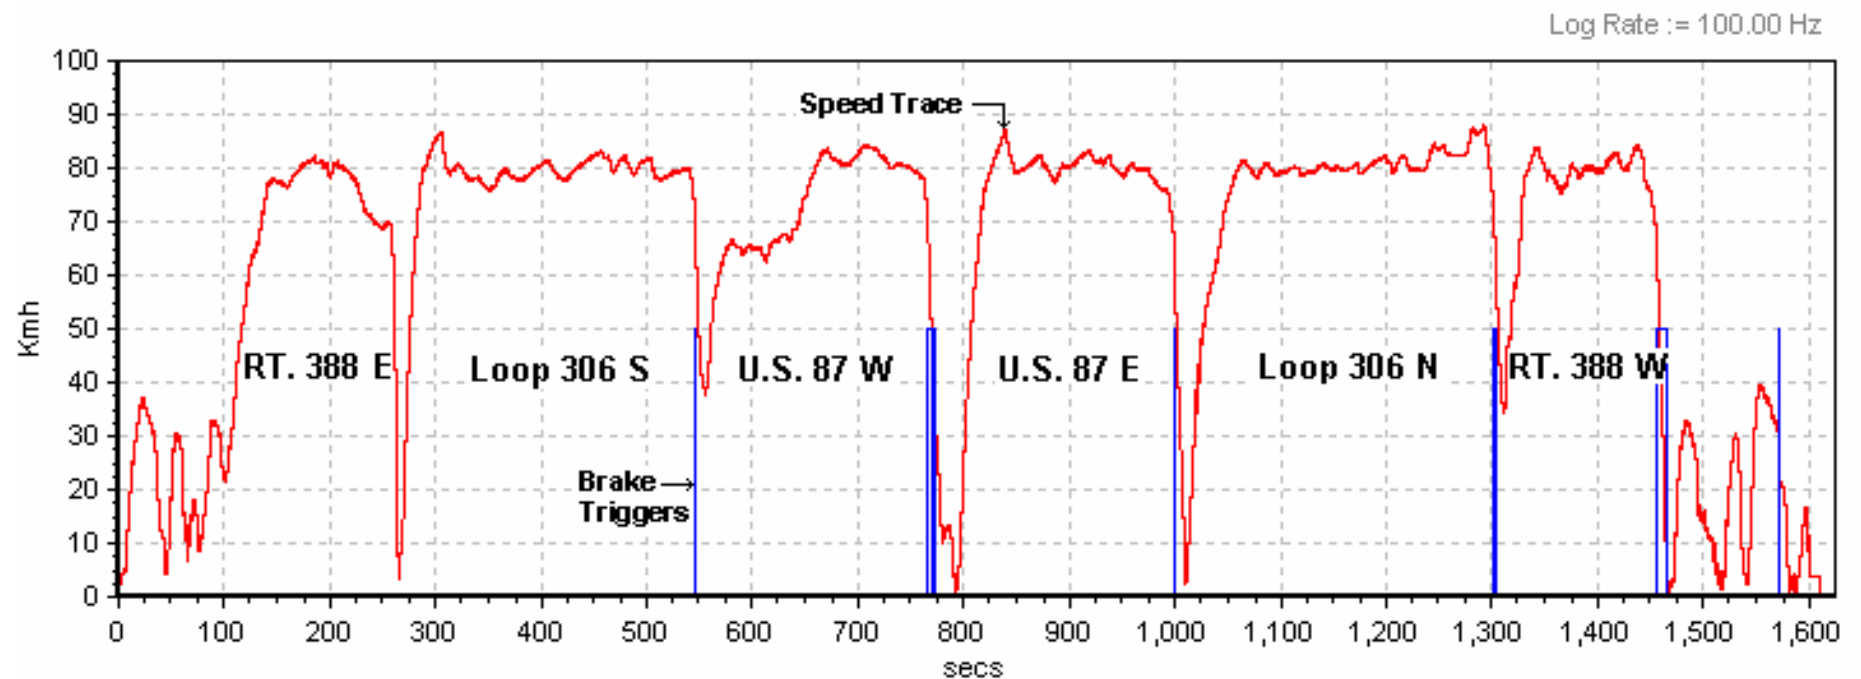
2007 Toyota Camry (C75100) LF Calibration / LLWW

LF Detection Phase: Telltale illuminated upon ignition activation. Driving was not required.

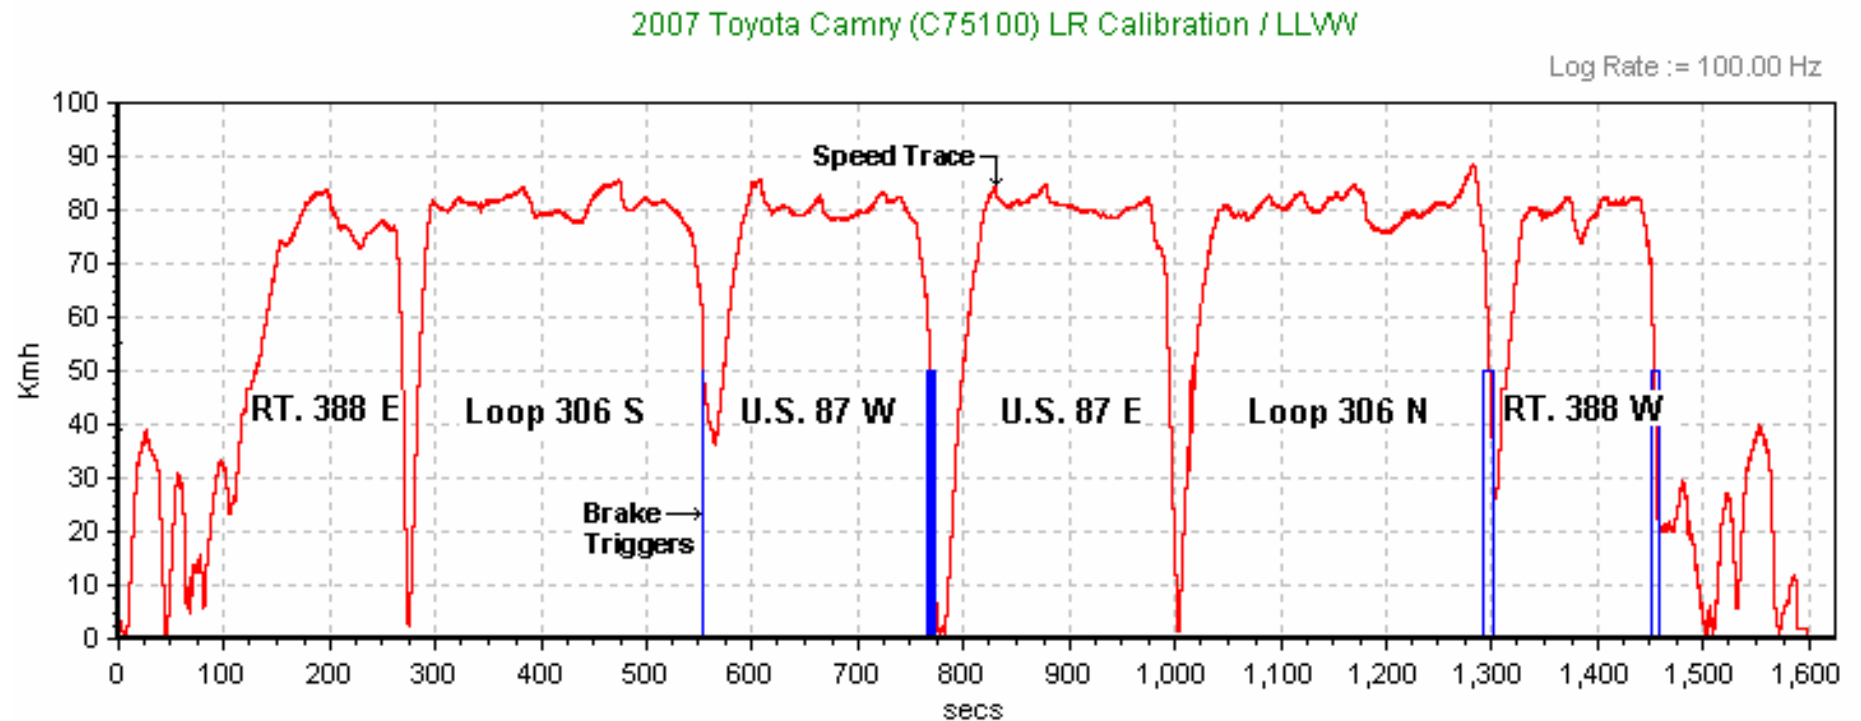
Scenario B: Left Rear Tire
Test Date: 11/16/06
Data File Time: 26:39 minutes
Cumulative Driving Time: 20:04 minutes
Start Point: SATF shop

LR Detection Phase: Telltale illuminated upon ignition activation. Driving was not required.

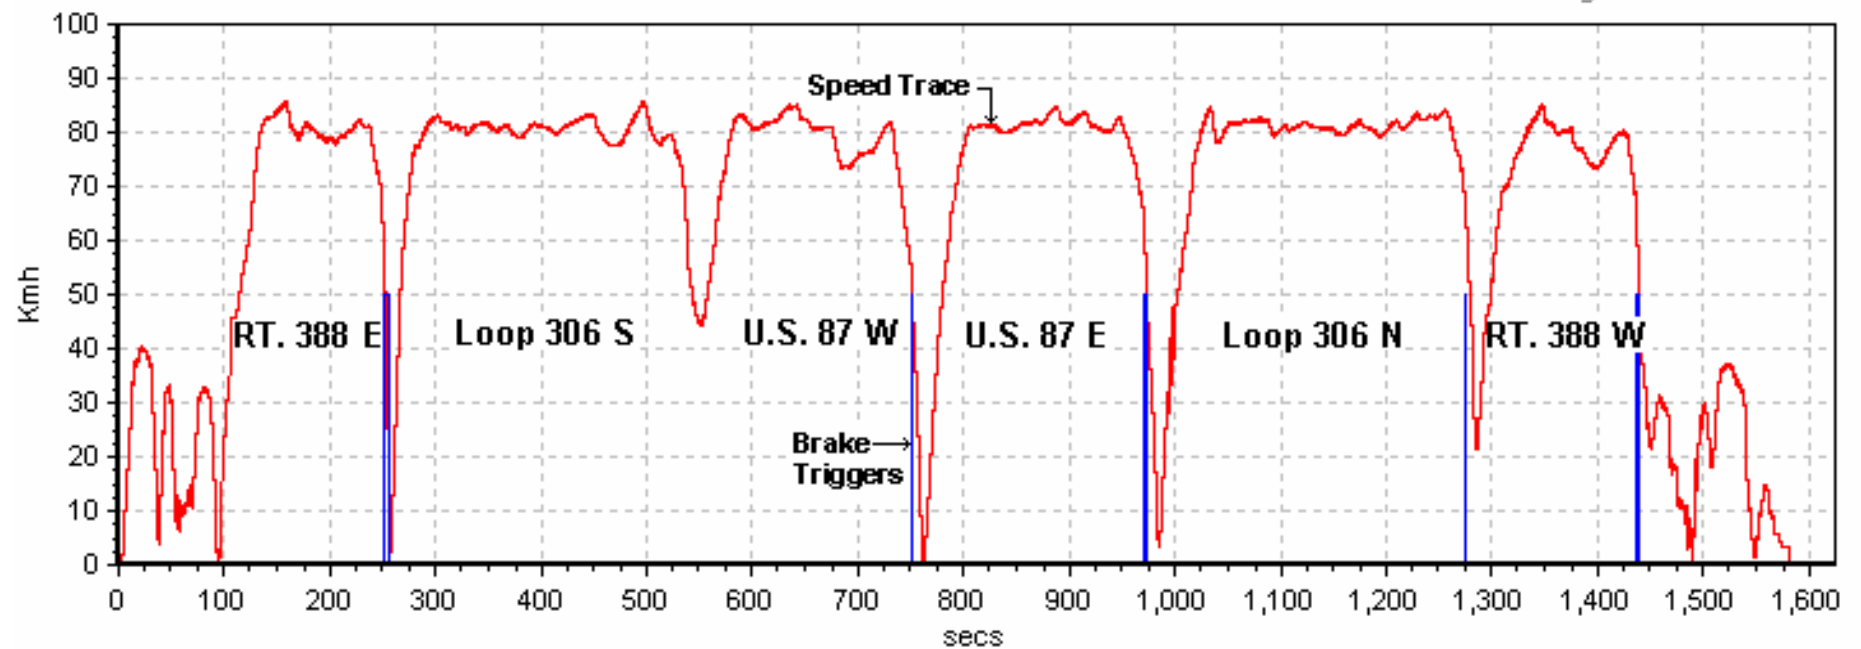
2007 Toyota Camry (C75100) RF Calibration / LLWW

Scenario C: Right Front Tire
Test Date: 11/16/06
Data File Time: 26:22 minutes
Cumulative Driving Time: 20:07 minutes
Start Point: SATF shop

RF Detection Phase: Telltale illuminated upon ignition activation. Driving was not required.

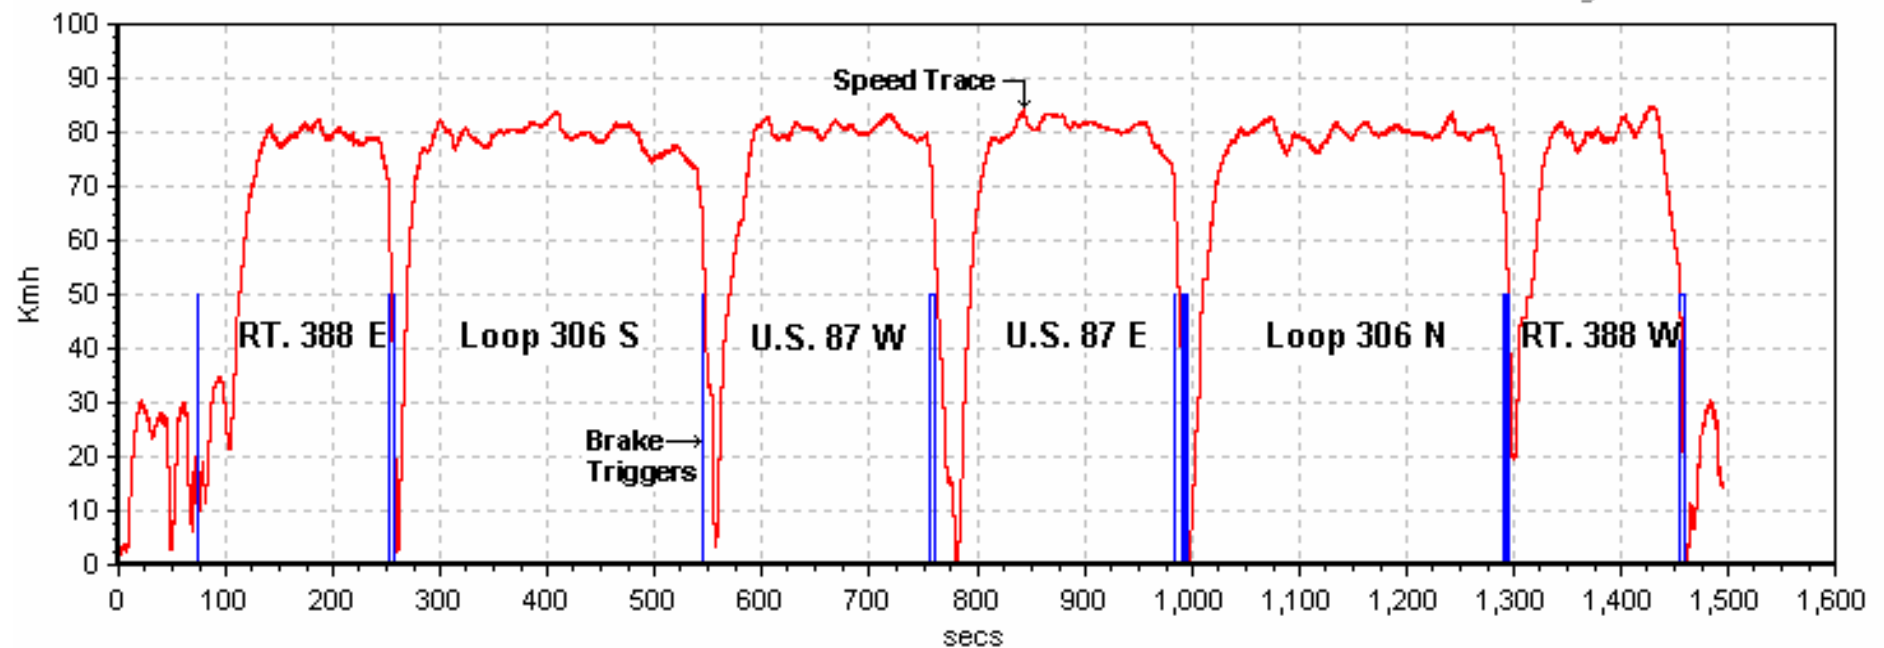
2007 Toyota Camry (C75100) RR Calibration / LLWW

Scenario D: Right Rear Tire
Test Date: 11/17/06
Data File Time: 24:55 minutes
Cumulative Driving Time: 20:18 minutes
Start Point: SATF shop

RR Detection Phase: Telltale illuminated upon ignition activation. Driving was not required.

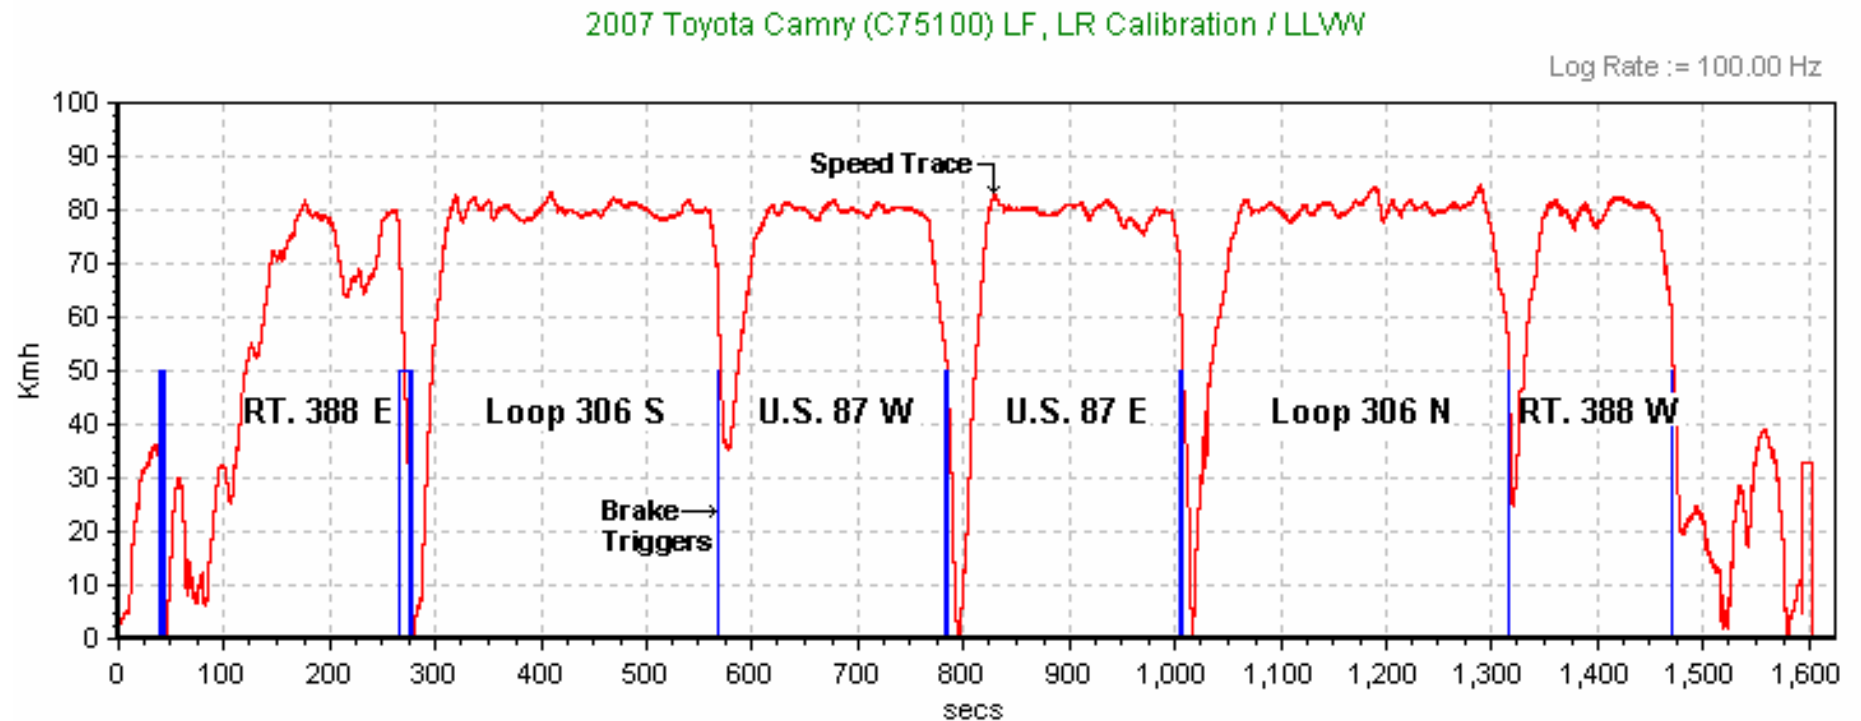
Scenario E: Left Front, Left Rear Tires
Test Date: 11/17/06
Data File Time: 26:44 minutes
Cumulative Driving Time: 20:10 minutes
Start Point: SATF shop

LF, LR Detection Phase: Telltale illuminated upon ignition activation. Driving was not required.

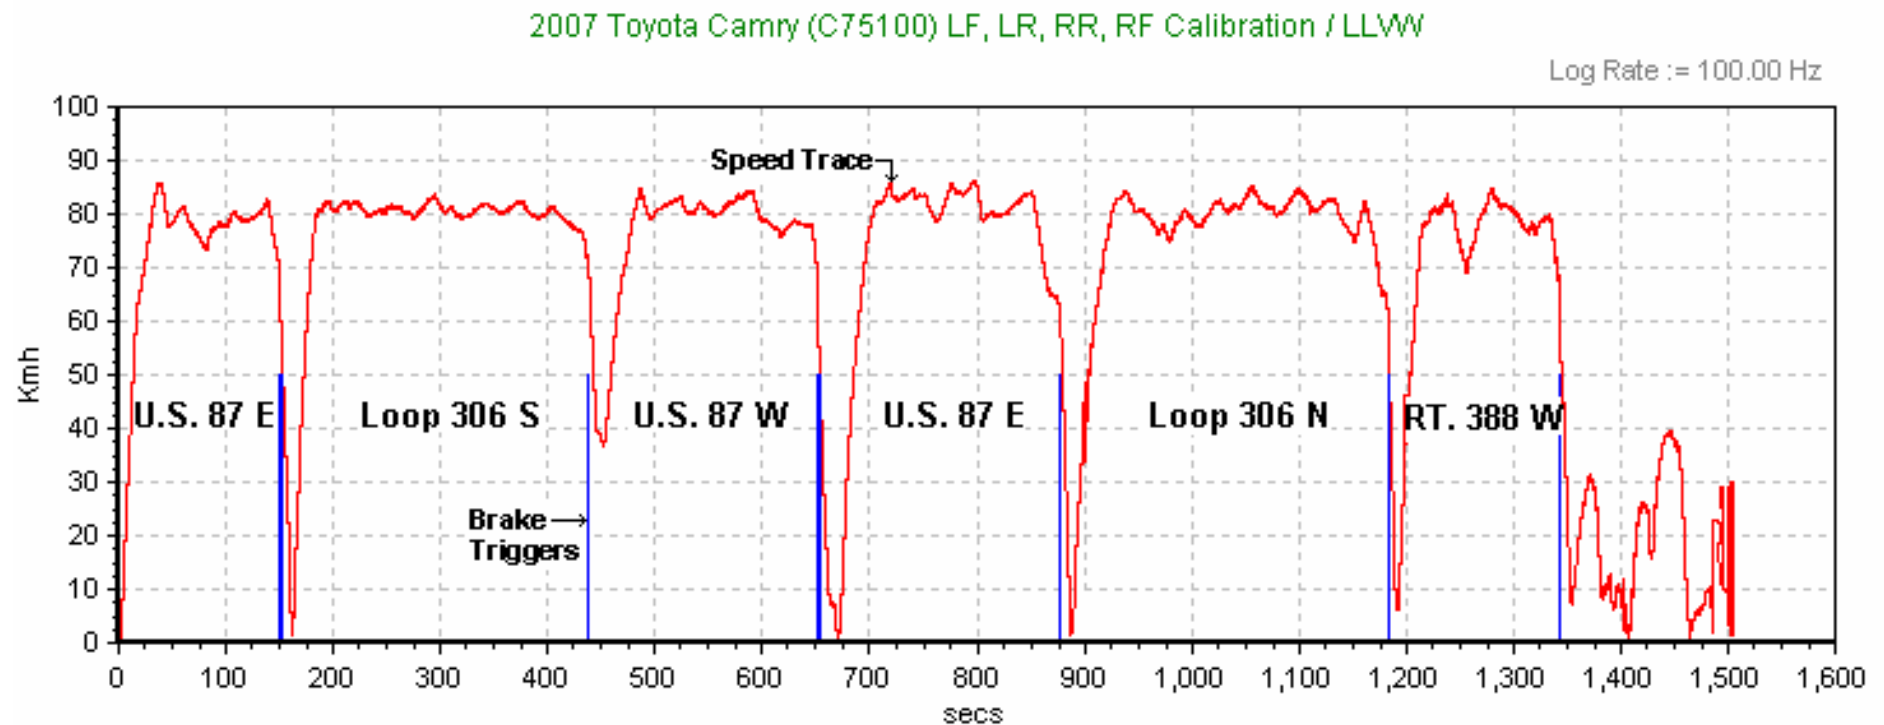
Scenario F: Left Front, Left Rear, Right Rear, Right Front Tires
Test Date: 11/17/06
Data File Time: 25:05 minutes
Cumulative Driving Time: 20:10 minutes
Start Point: SATF shop

LF, LR, RR, RF Detection Phase: Telltale illuminated upon ignition activation. Driving was not required.

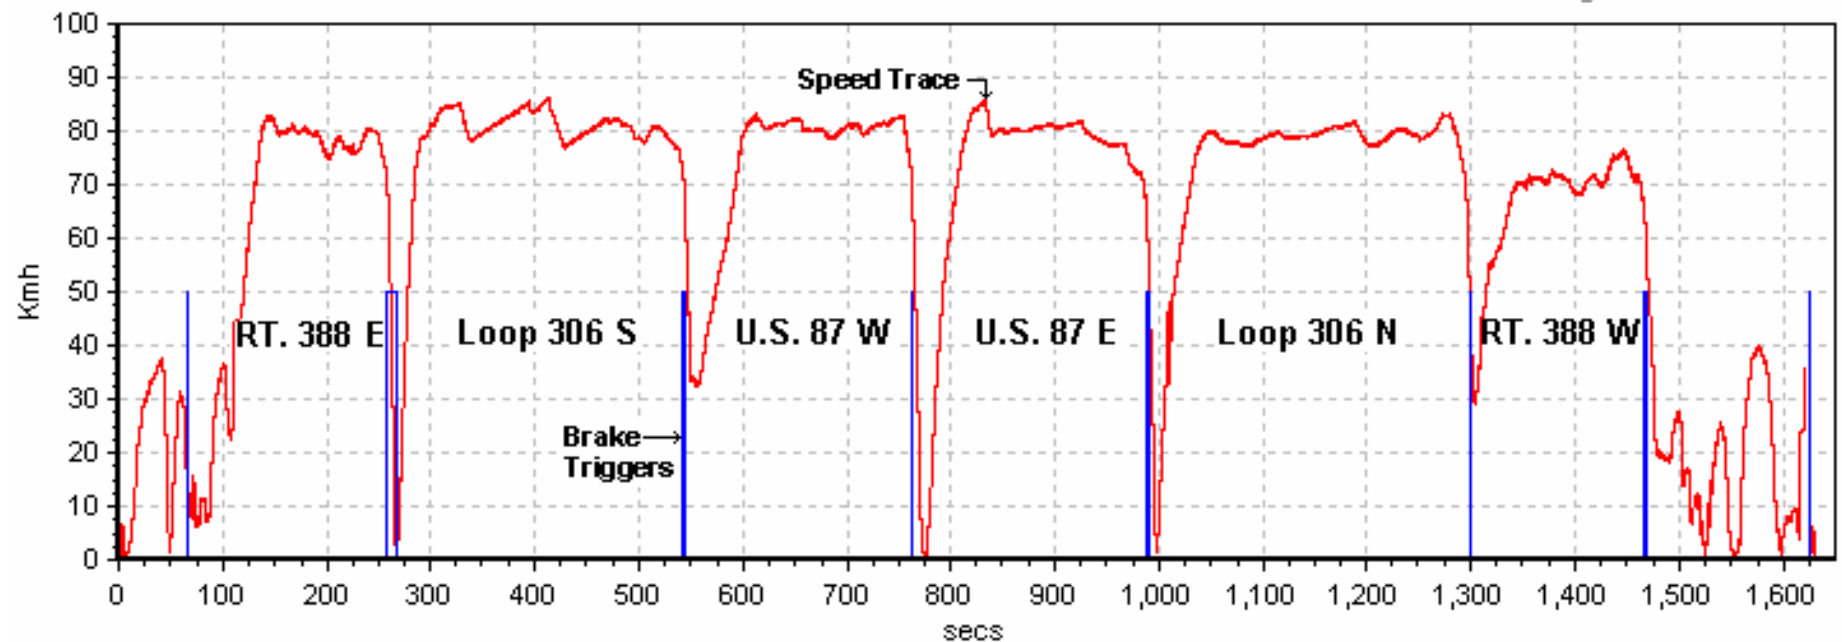
2007 Toyota Camry (C75100) LF Calibration / GVWR

Scenario G: Left Front Tire
Test Date: 11/20/06
Data File Time: 27:12 minutes
Cumulative Driving Time: 20:29 minutes
Start Point: SATF shop

LF Detection Phase: Telltale illuminated upon ignition activation. Driving was not required.
