SAFETY COMPLIANCE TESTING FOR FMVSS NO. 138 TIRE PRESSURE MONITORING SYSTEMS

TOYOTA MOTOR MANUFACTURING
2007 CAMRY FOUR-DOOR
PASSENGER CAR
NHTSA NO. C75100

FINAL REPORT

1. Report No. 138-STF-06-007	2. Government Accession No.	3. Recipient's Catalog No.
4. Title and Subtitle Final Report of FMVSS 138 Compliance Testing of 2007 Toyota Camry Four-door Passenger Car, NHTSA No. C75100		5. Report Date May 9, 2007

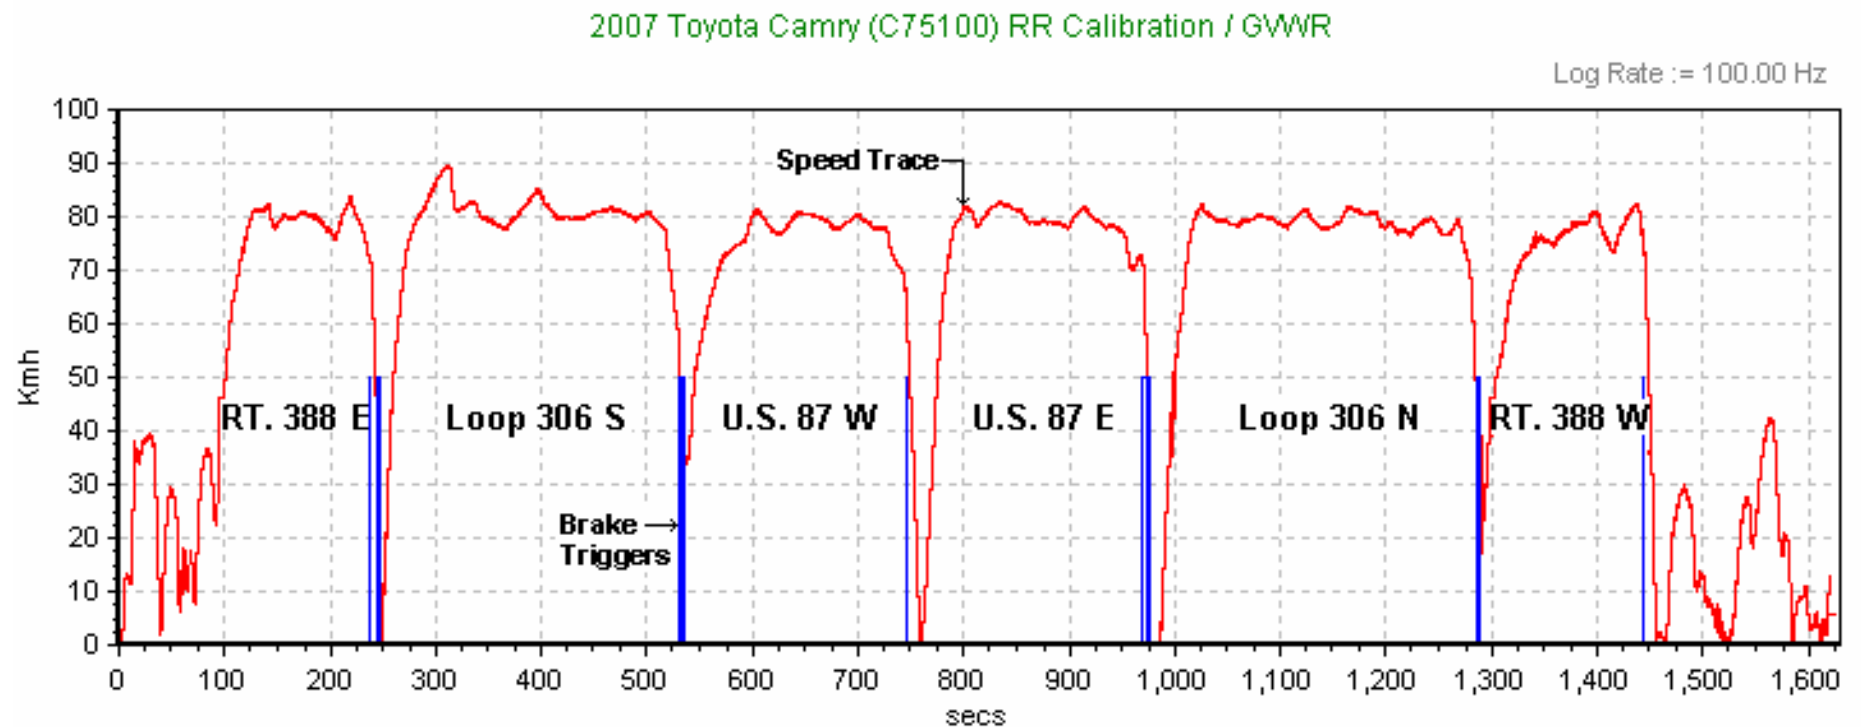
Scenario H: Right Rear Tire
Test Date: 11/21/06
Data File Time: 27:08 minutes
Cumulative Driving Time: 20:36 minutes
Start Point: SATF shop

RR Detection Phase: Telltale illuminated upon ignition activation. Driving was not required.

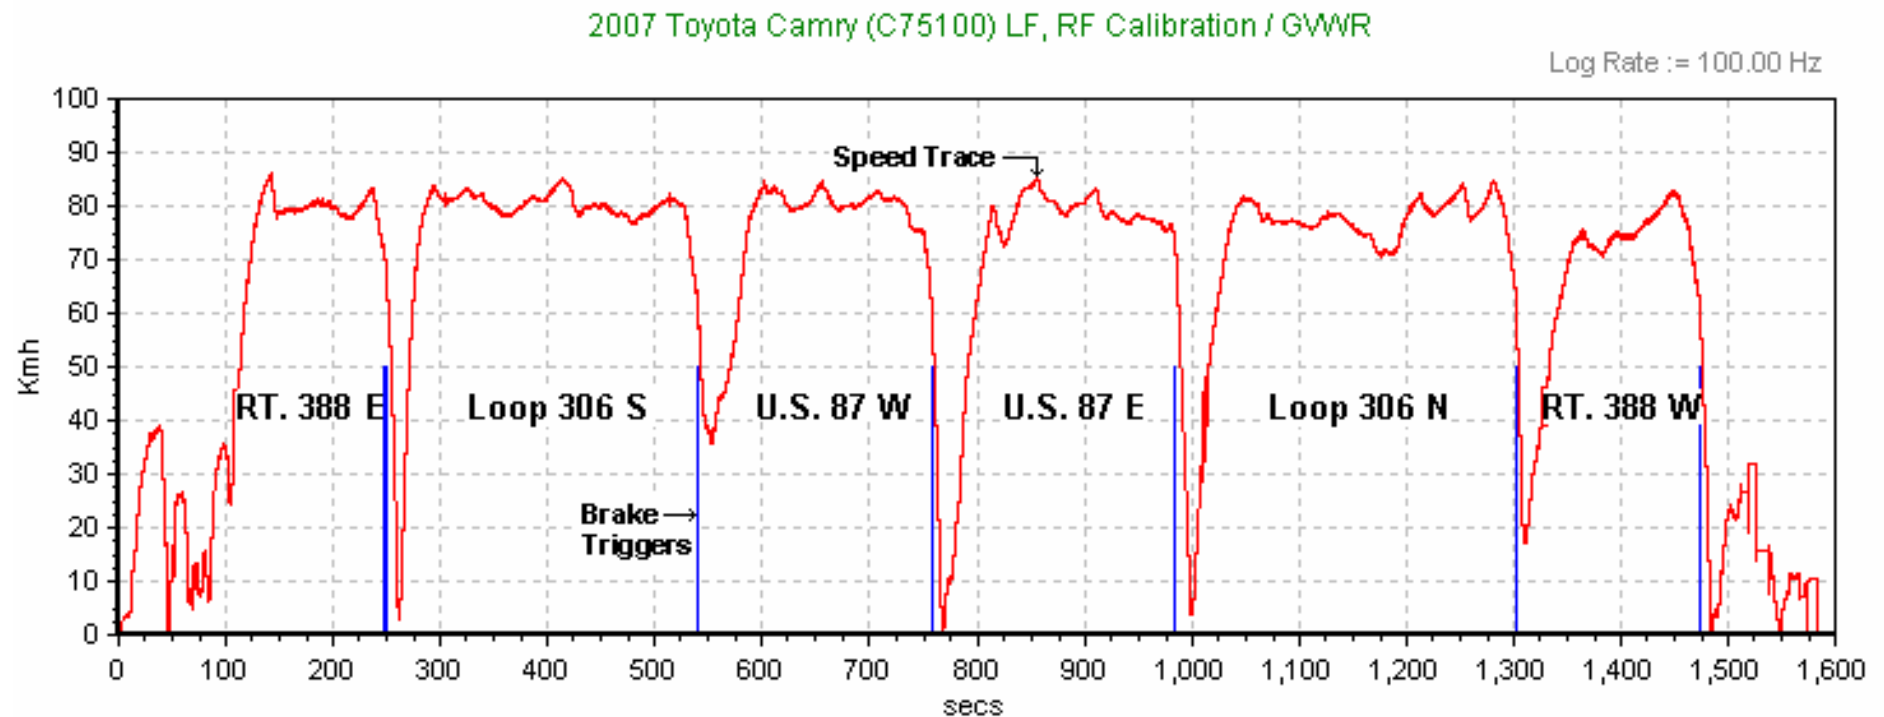
Scenario I: Left Front, Right Front Tires
Test Date: 11/21/06
Data File Time: 26:23 minutes
Cumulative Driving Time: 20:14 minutes
Start Point: SATF shop

LF, RF Detection Phase: Telltale illuminated upon ignition activation. Driving was not required.

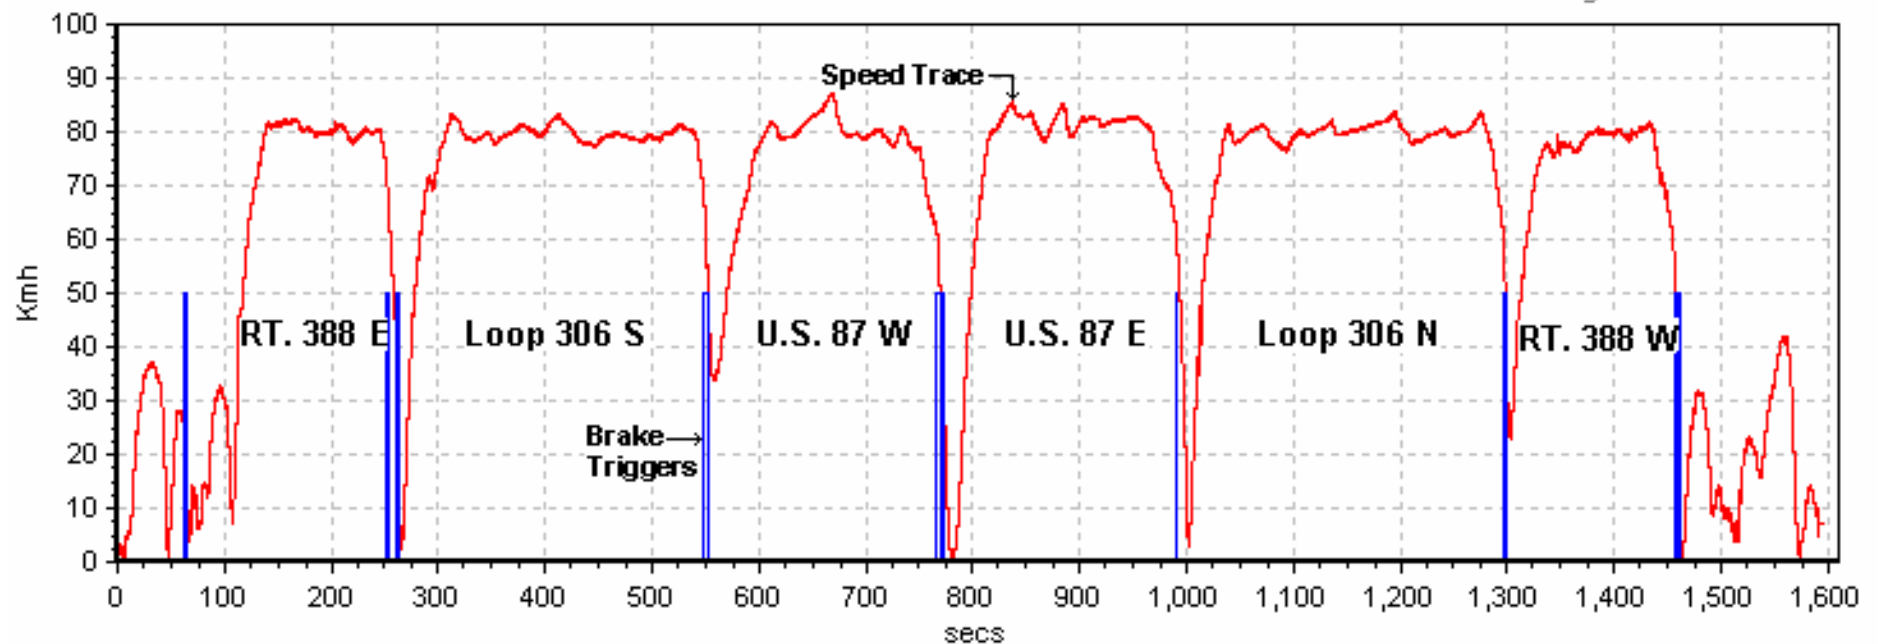
2007 Toyota Camry (C75100) LF, LR, RR, RF Calibration / GWR

Scenario J: Left Front, Left Rear, Right Rear, Right Front Tires
Test Date: 11/27/06
Data File Time: 26:37minutes
Cumulative Driving Time: 20:16 minutes
Start Point: SATF shop

LF, LR, RR, RF Detection Phase: Telltale illuminated upon ignition activation. Driving was not required.

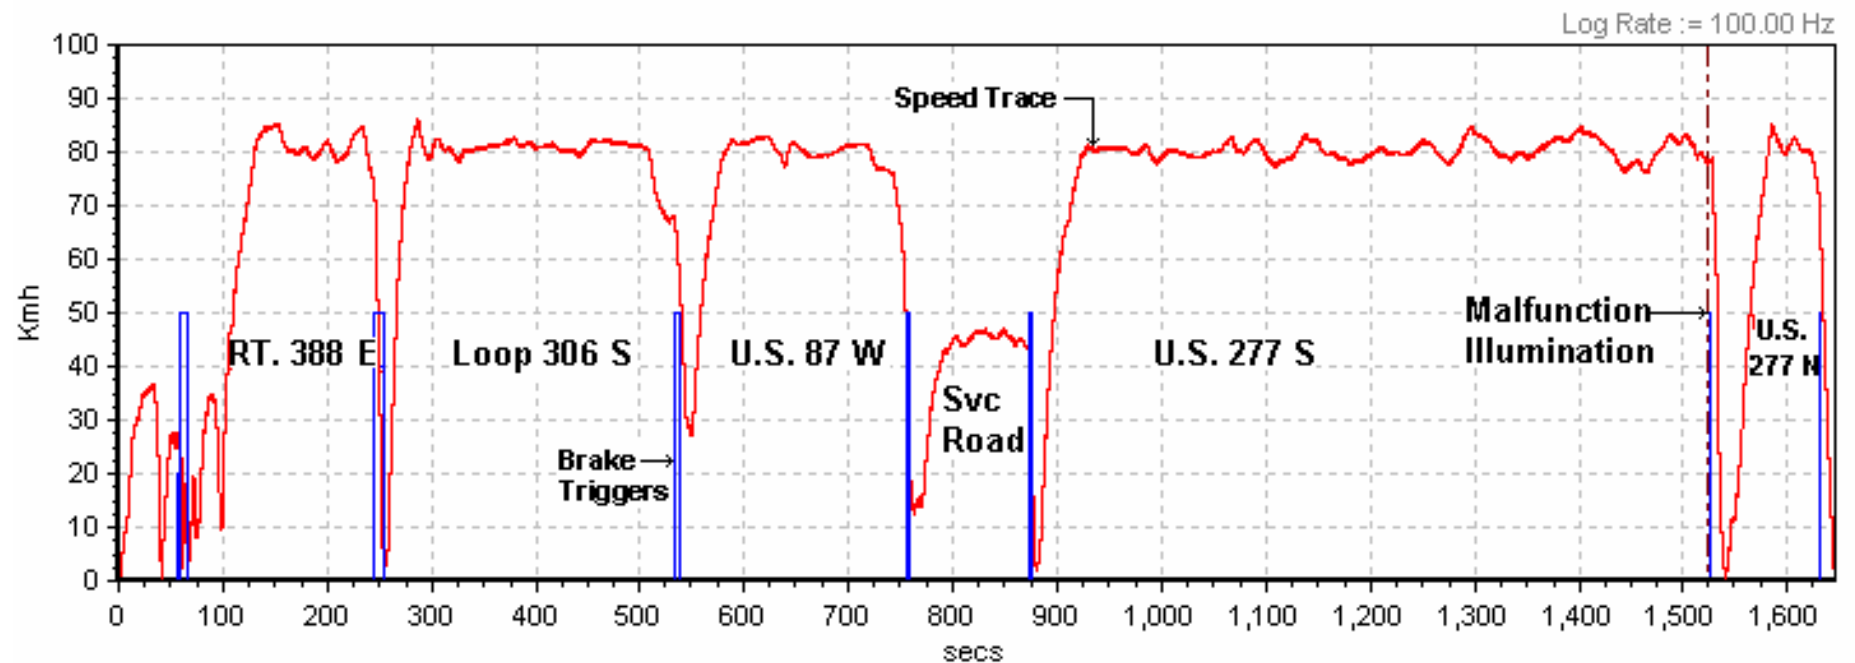
2007 Toyota Camry (C75100) RF Combination Low Tire / Malfunction Telltale Illumination / GVWR

One indicant malfunction detection scenario was performed on the test vehicle at GVWR. The vehicle's combination low tire pressure warning and malfunction telltale indicated a malfunction, but did not flash and illuminate per the standard's requirements effective September 1, 2007.

Scenario K: Sensor from Right Front Wheel Replaced with Non-TPMS Valve Stem
Test Date: 11/28/06
Data File Time: 27:26 minutes
Illumination: 21:41 minutes
Start Point: SATF shop

RF Malfunction Detection Telltale: Indicant test only.
