REPORT NUMBER: 305-CAL-07-03

**SAFETY COMPLIANCE TESTING FOR FMVSS 305  
ELECTRIC POWERED VEHICLES: ELECTROLYTE SPILLAGE  
AND ELECTRICAL SHOCK PROTECTION**

TOYOTA MOTOR CORPORATION  
2007 TOYOTA CAMRY  
4-DOOR SEDAN

NHTSA NUMBER: C75105

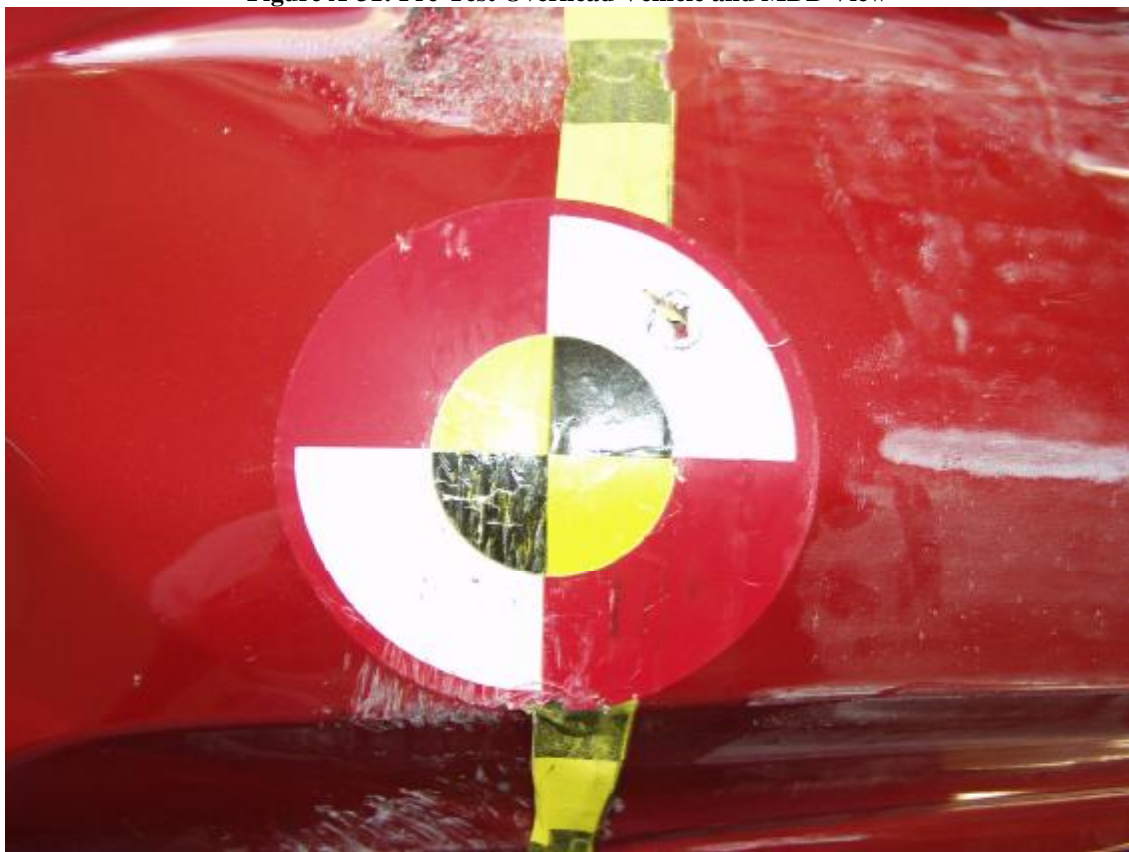
**Figure A-32: Post-Test Impact Target View**

WELDING ROD IMPACT POINT:

-29     Vertical distance from target center (+ is above) Tolerance:  $\pm 40$  mm

-28     Horizontal distance from target center (+ is right) Tolerance:  $\pm 50$  mm

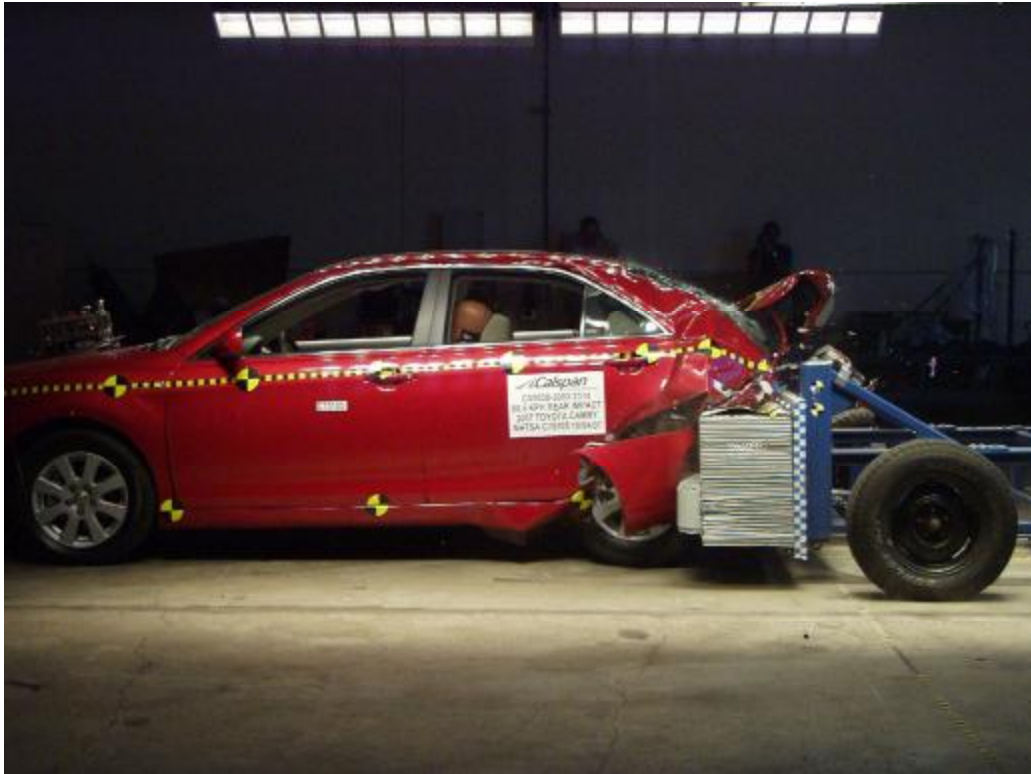
**Figure A-58: Impact View**

A 1849.0 kg 2007 Toyota Camry 4-Door Sedan was impacted from the rear by a 1357.5 kg moving barrier at a velocity of 72.0 kph (49.1 mph). The test was performed by Calspan Corporation on October 4, 2007.

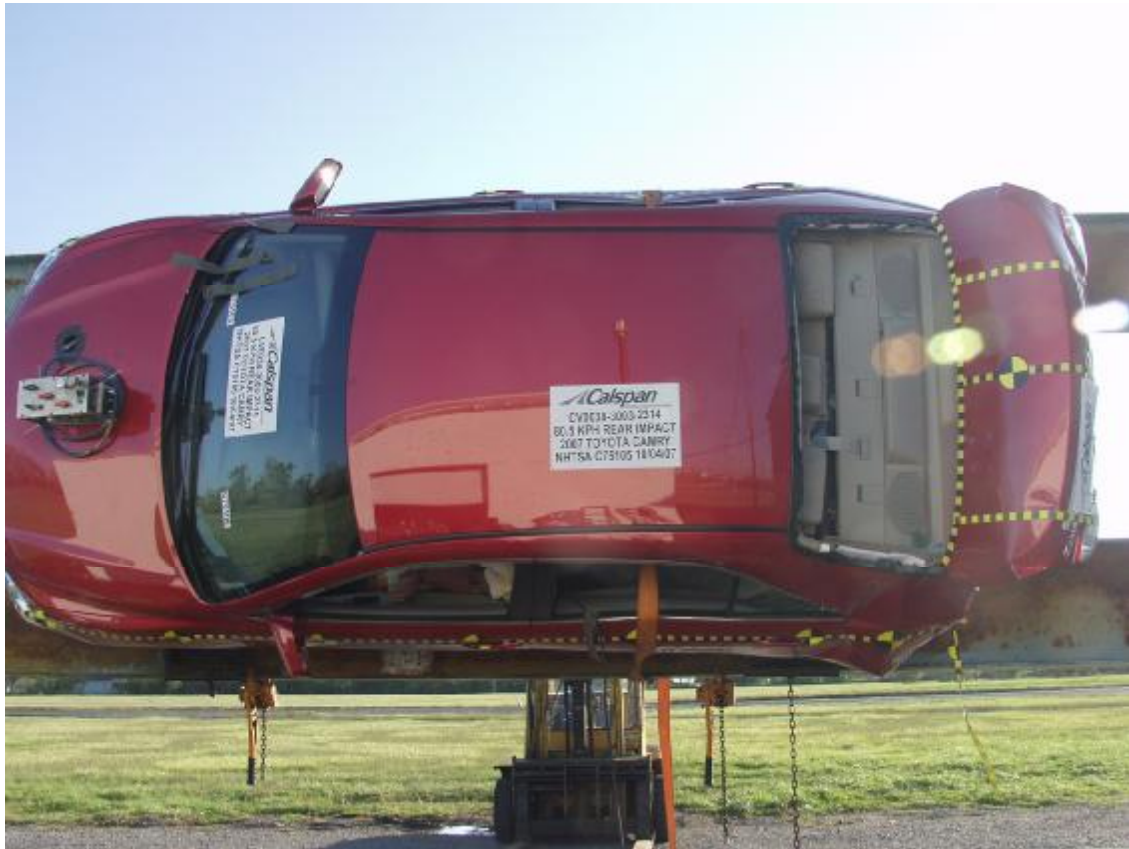
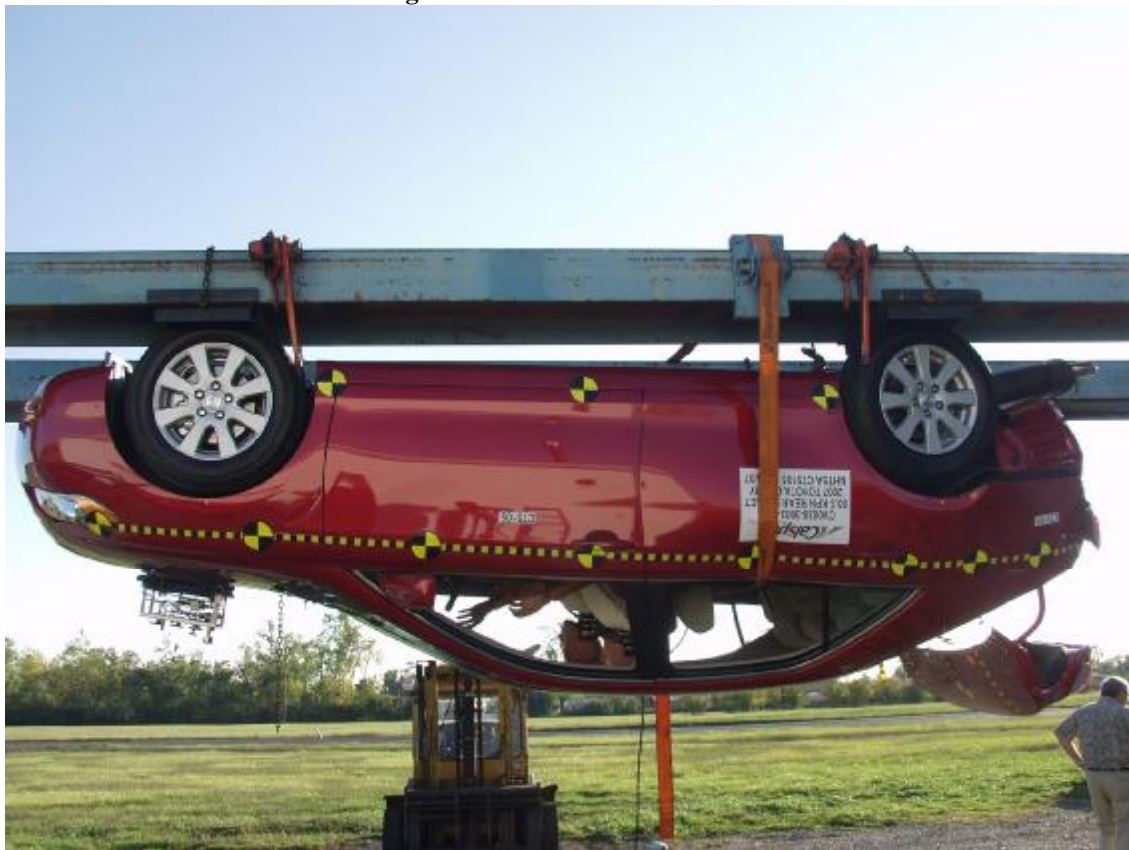
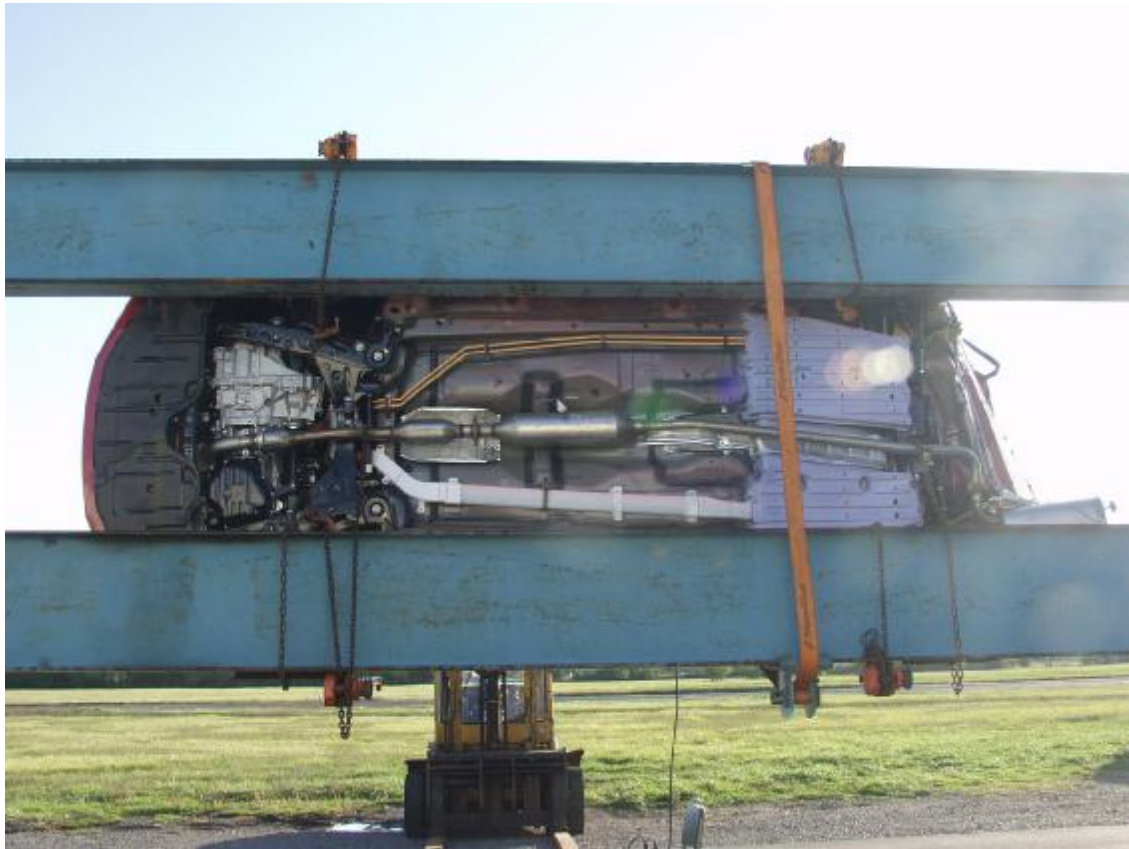
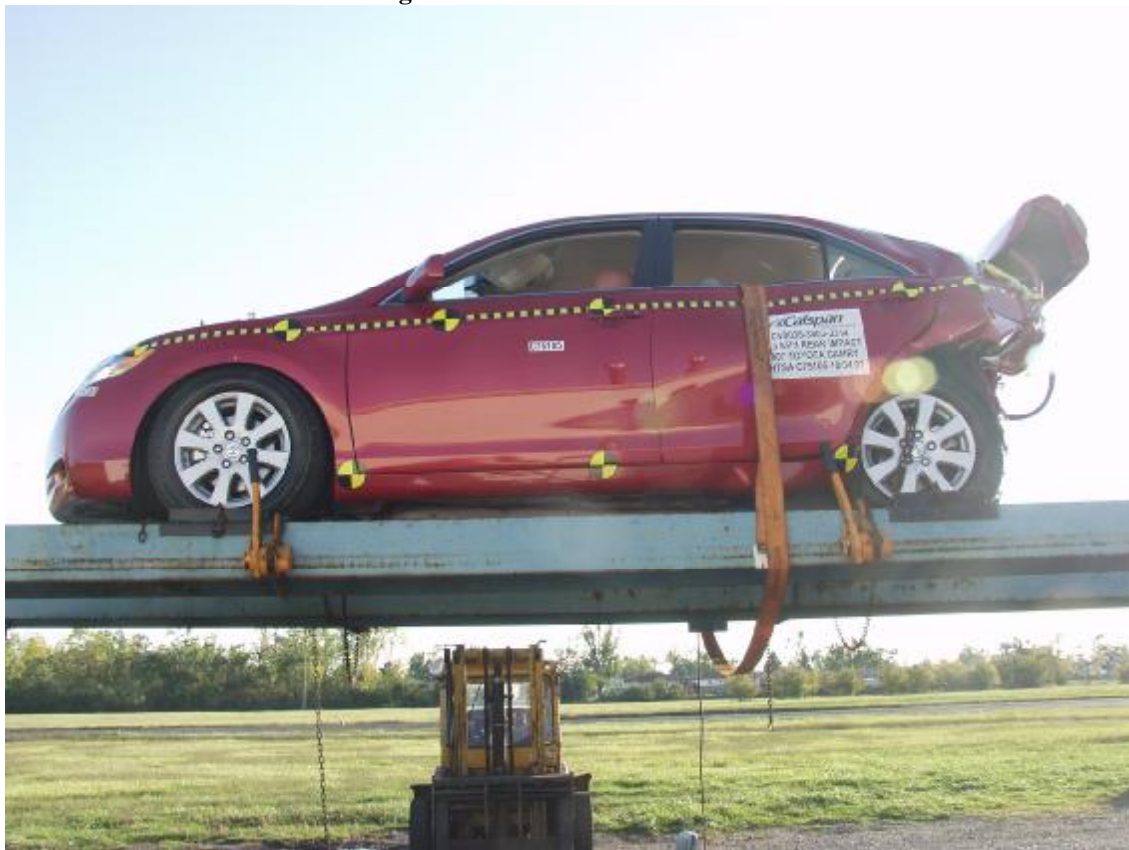
There was no fuel system fluid or propulsion battery electrolyte spillage following the impact or during any portion of the static rollover test. The vehicle appeared to comply with all the requirements of FMVSS 305 "Electric Powered Vehicles: Electrolyte Spillage and Electrical Shock Protection."

Rollover Stage	First 5 minutes from onset of rotation (g)	6th min. (g)	7th min. (g)	8th min. (if required) (g)
0° - 90°	0	0	0	N/A
90° - 180°	0	0	0	N/A
180°-270°	0	0	0	N/A
270°-360°	0	0	0	N/A
