**REPORT NUMBER: 201-MGA-2008-001**

**SAFETY COMPLIANCE TESTING FOR FMVSS 201  
RIGID POLE SIDE IMPACT TEST**

**FUJI HEAVY INDUSTRIES LTD.  
2008 SUBARU IMPREZA 4-DOOR  
NHTSA NUMBER: C85501**

**PREPARED BY:  
MGA RESEARCH CORPORATION  
5000 WARREN ROAD  
BURLINGTON, WI 53105**

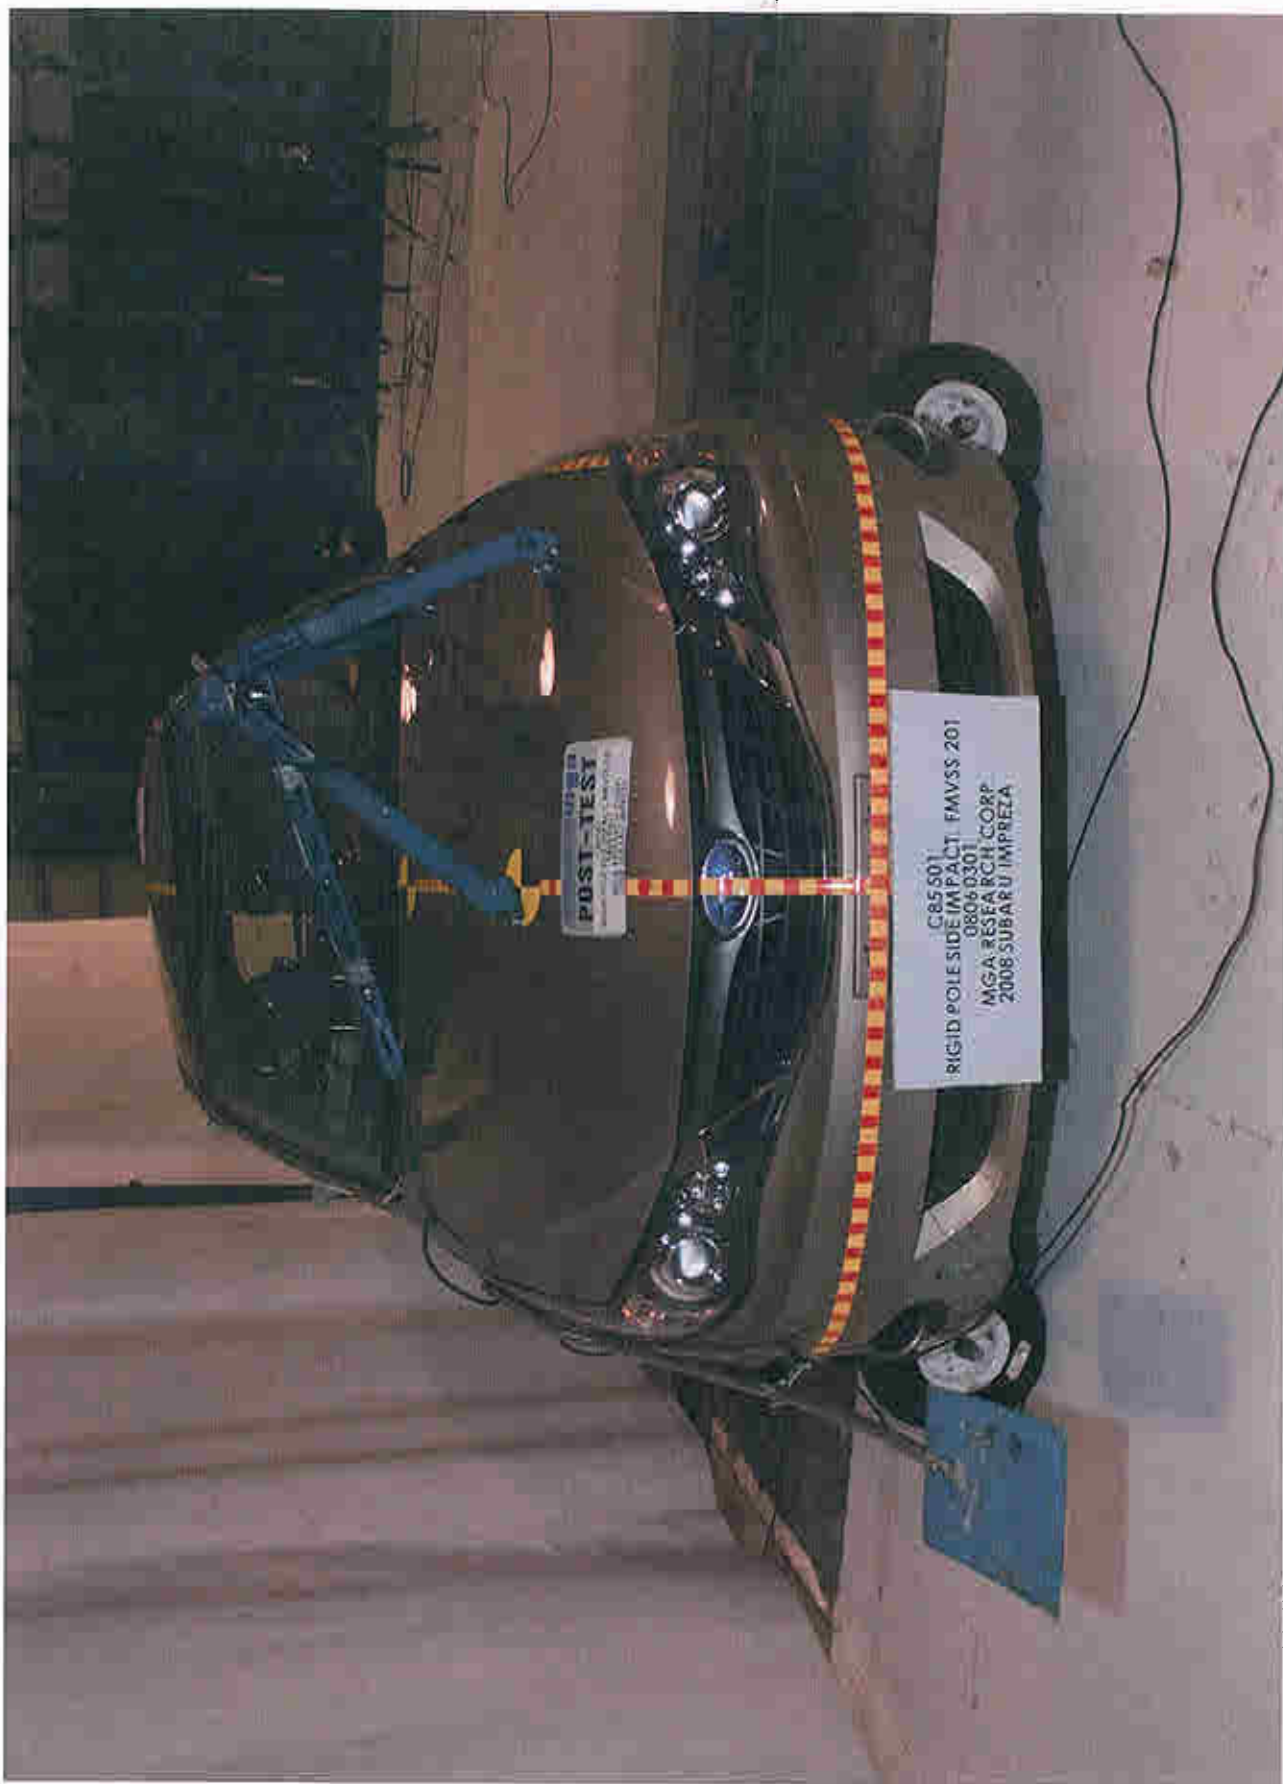
Post-Test Front View of Test Vehicle

| Critical Areas of Performance | Observations and Conclusions |
|---|---|
| Windshield Damage | Cracked |

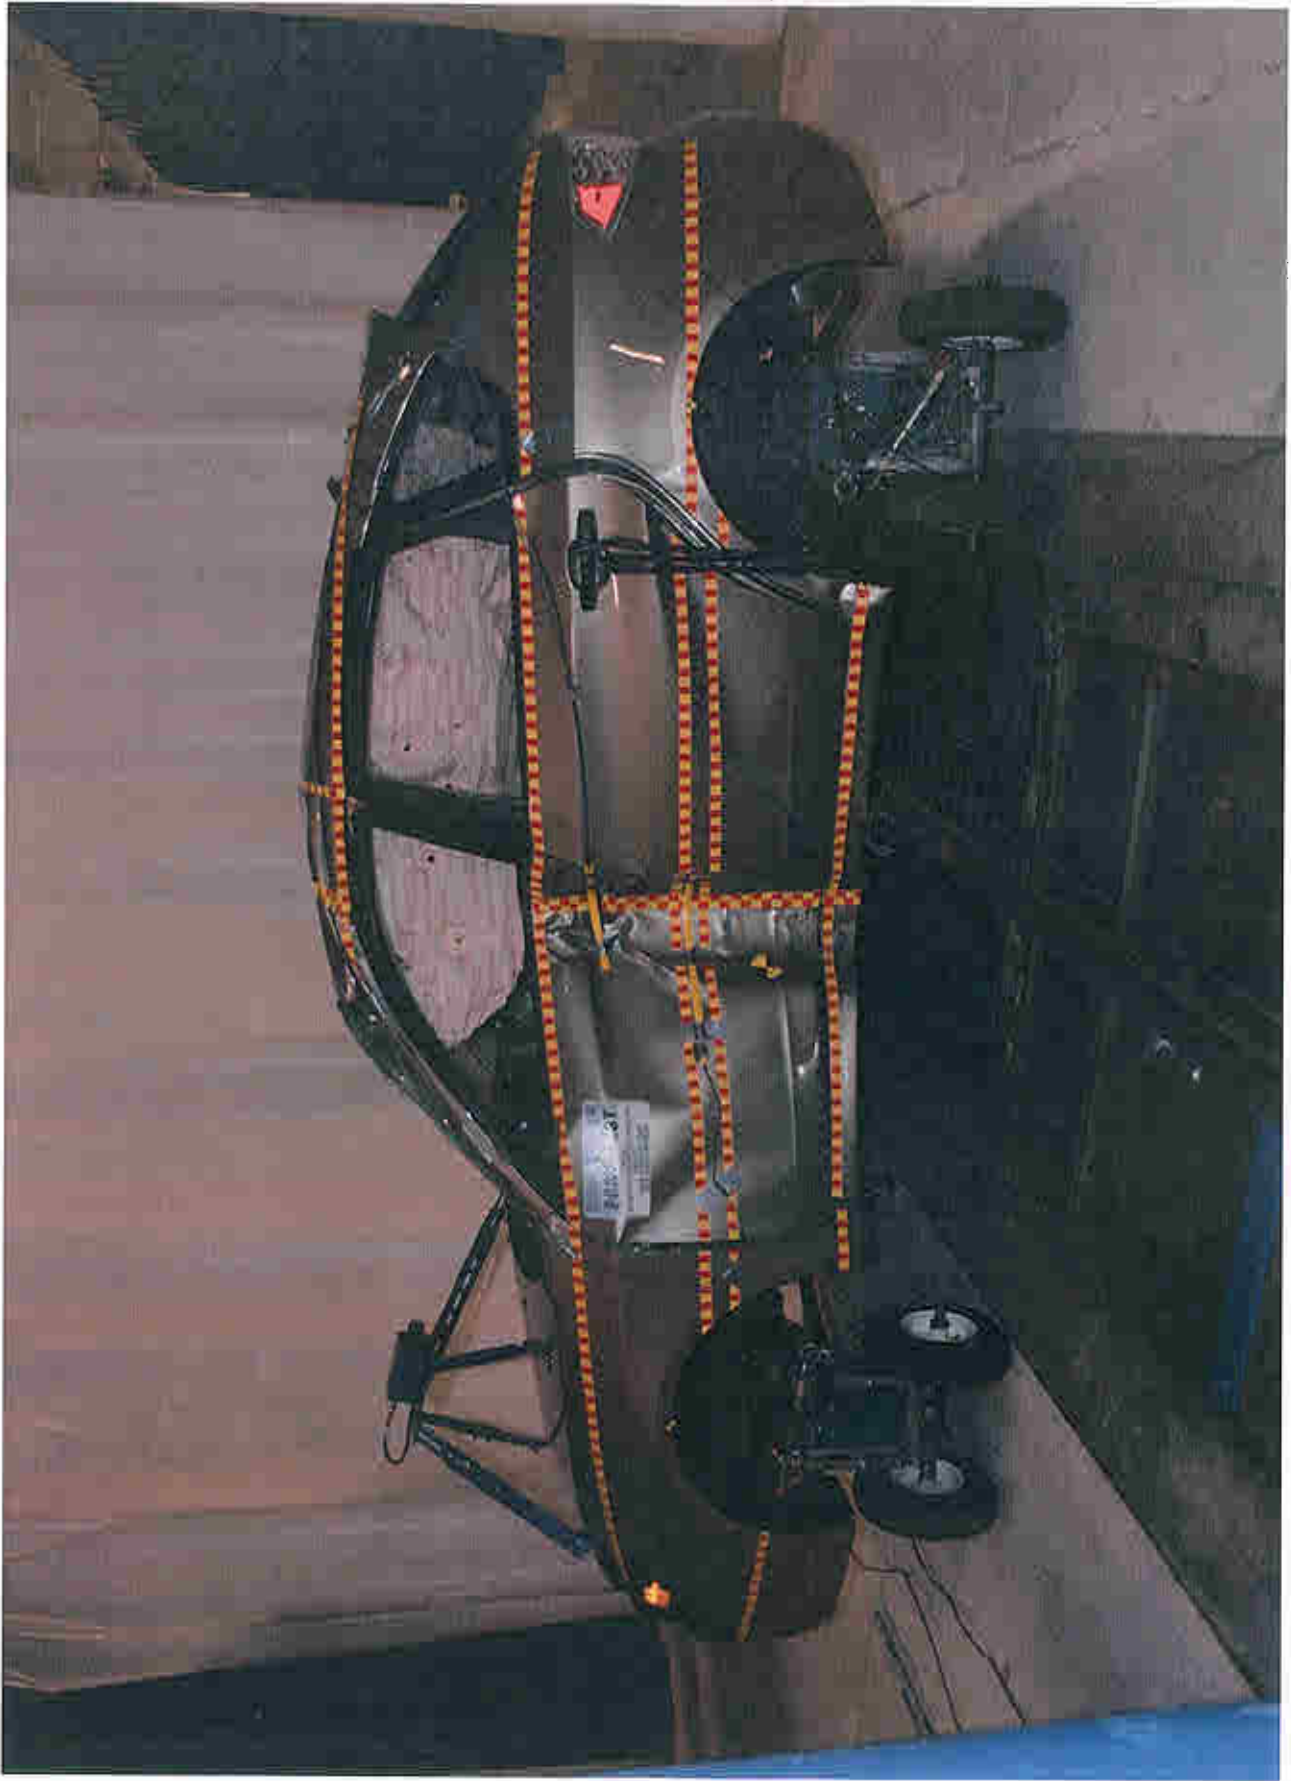
Post-Test Left Side View of Test Vehicle

The test vehicle sustained a maximum static crush of 314 mm at level 3, at the vertical impact line. The driver SID/HIII, Serial No. 036, was calibrated just prior to this test. The SID/HIII's injury criteria are summarized as follows:

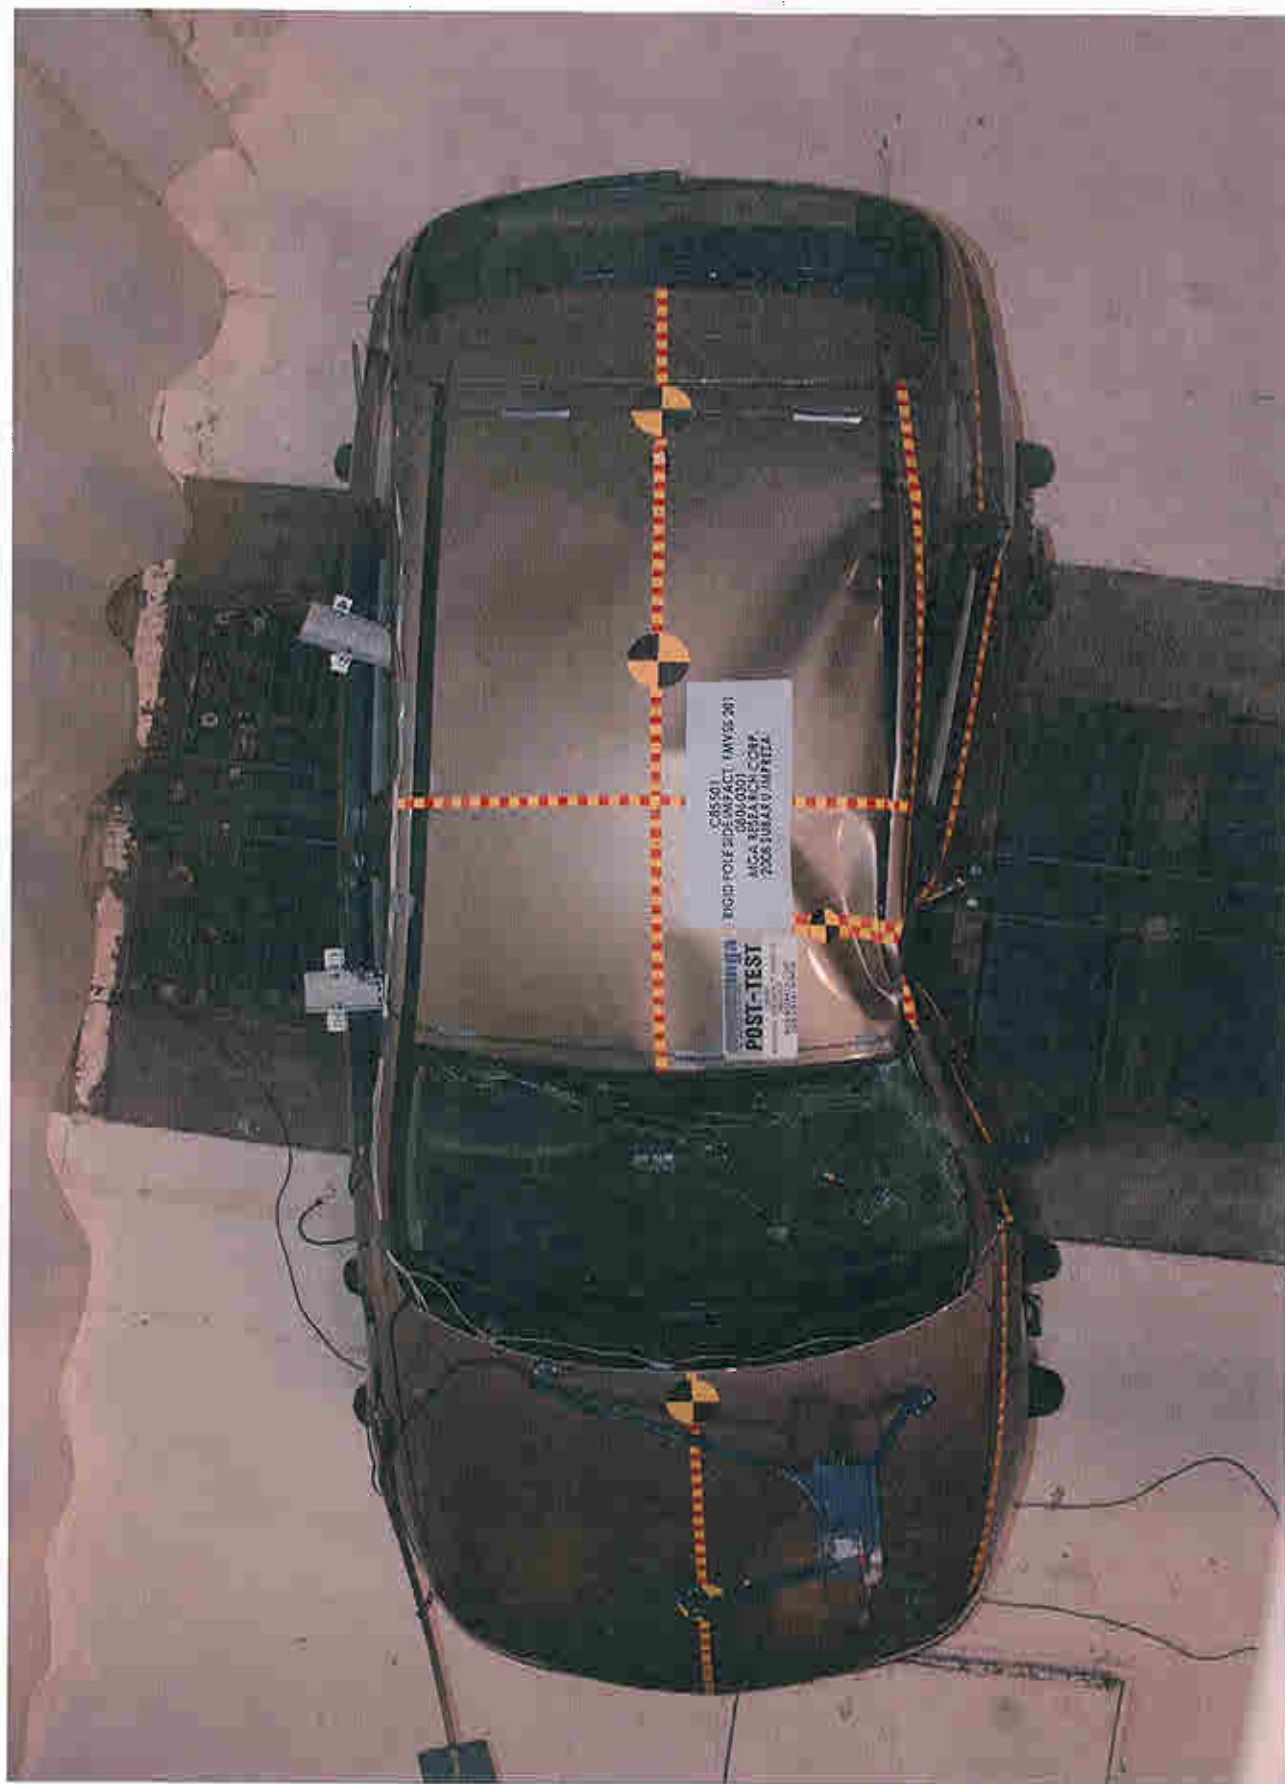
### Post-Test Overhead View of Test Vehicle

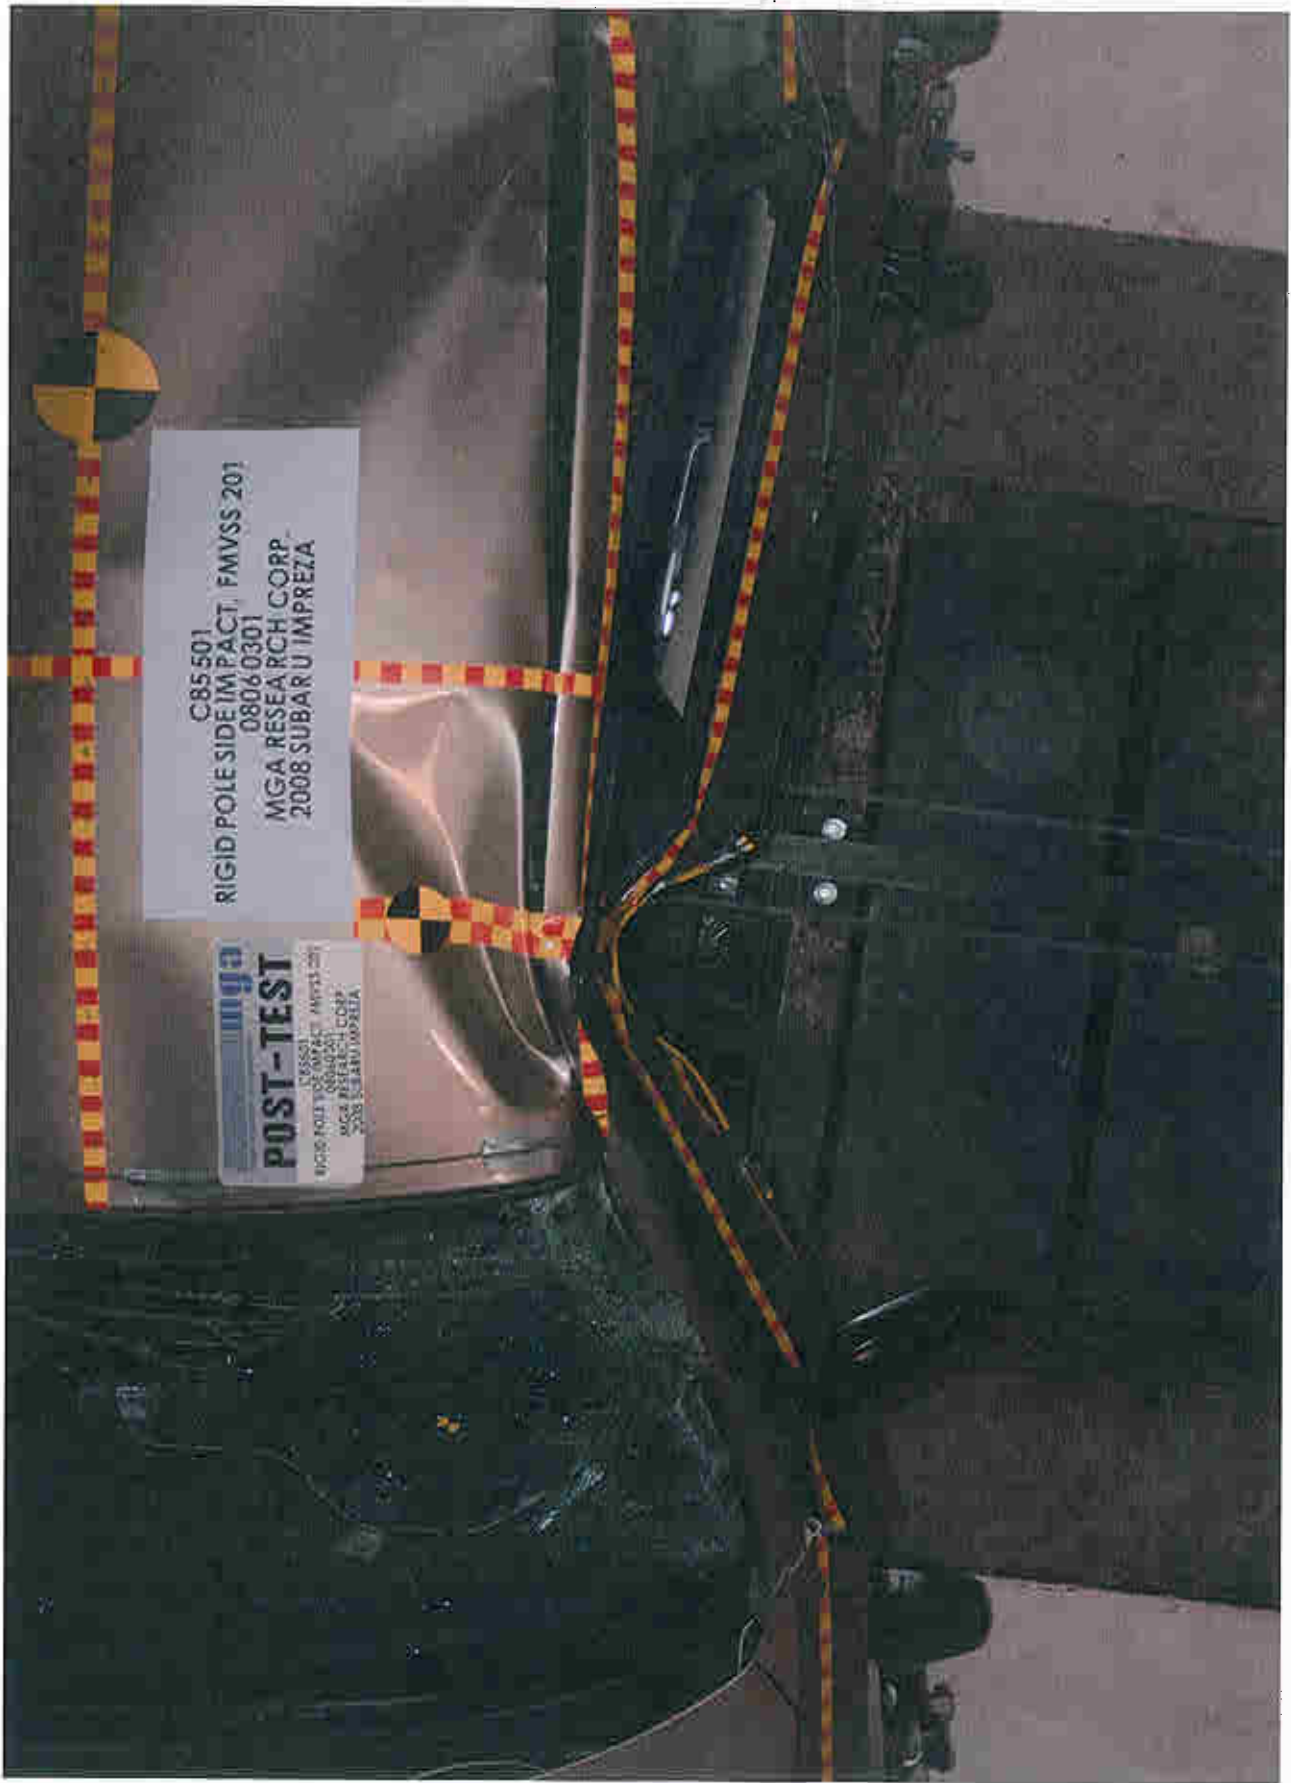
Post-Test Overhead View of Test Vehicle (Closeup)

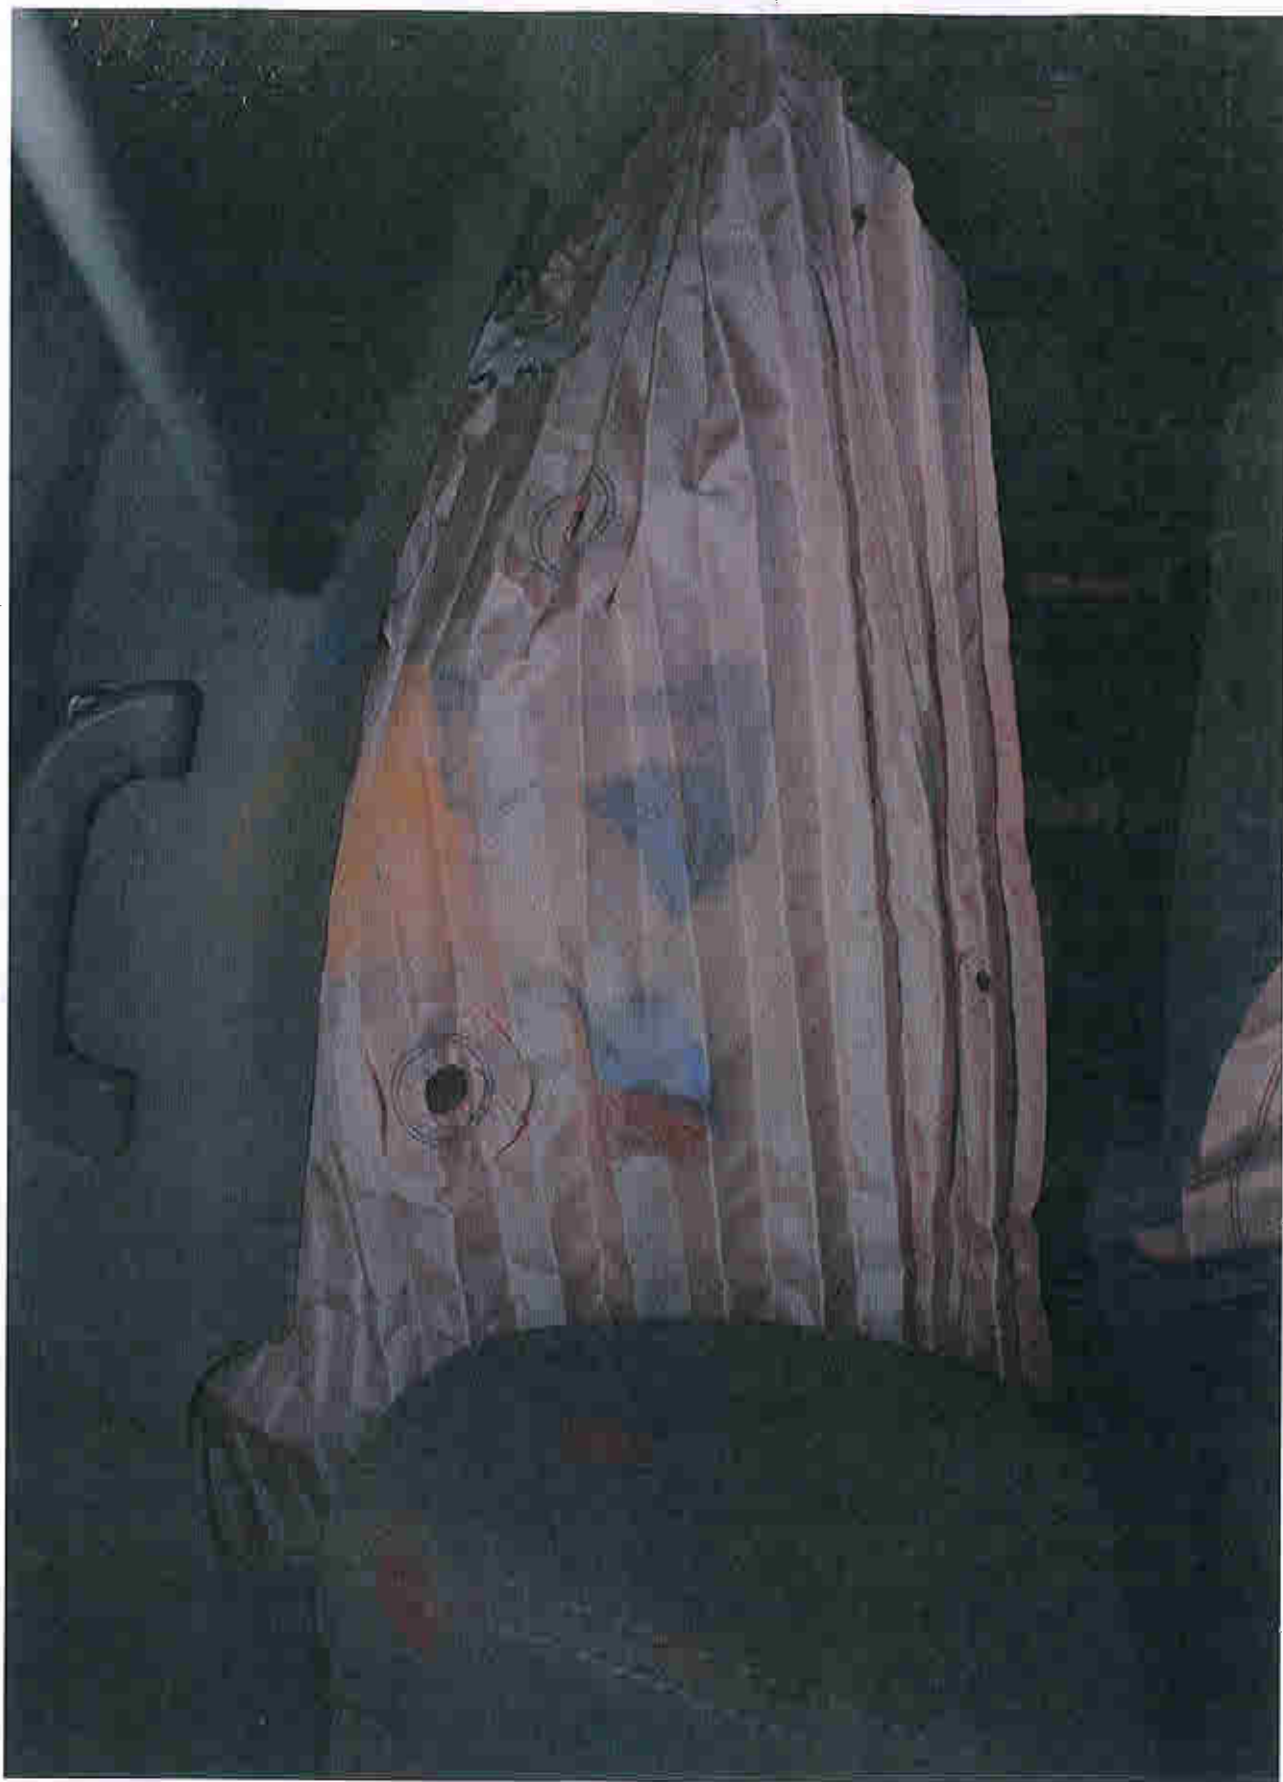
Post-Test Driver Dummy Head Contact CAB & Headrest)

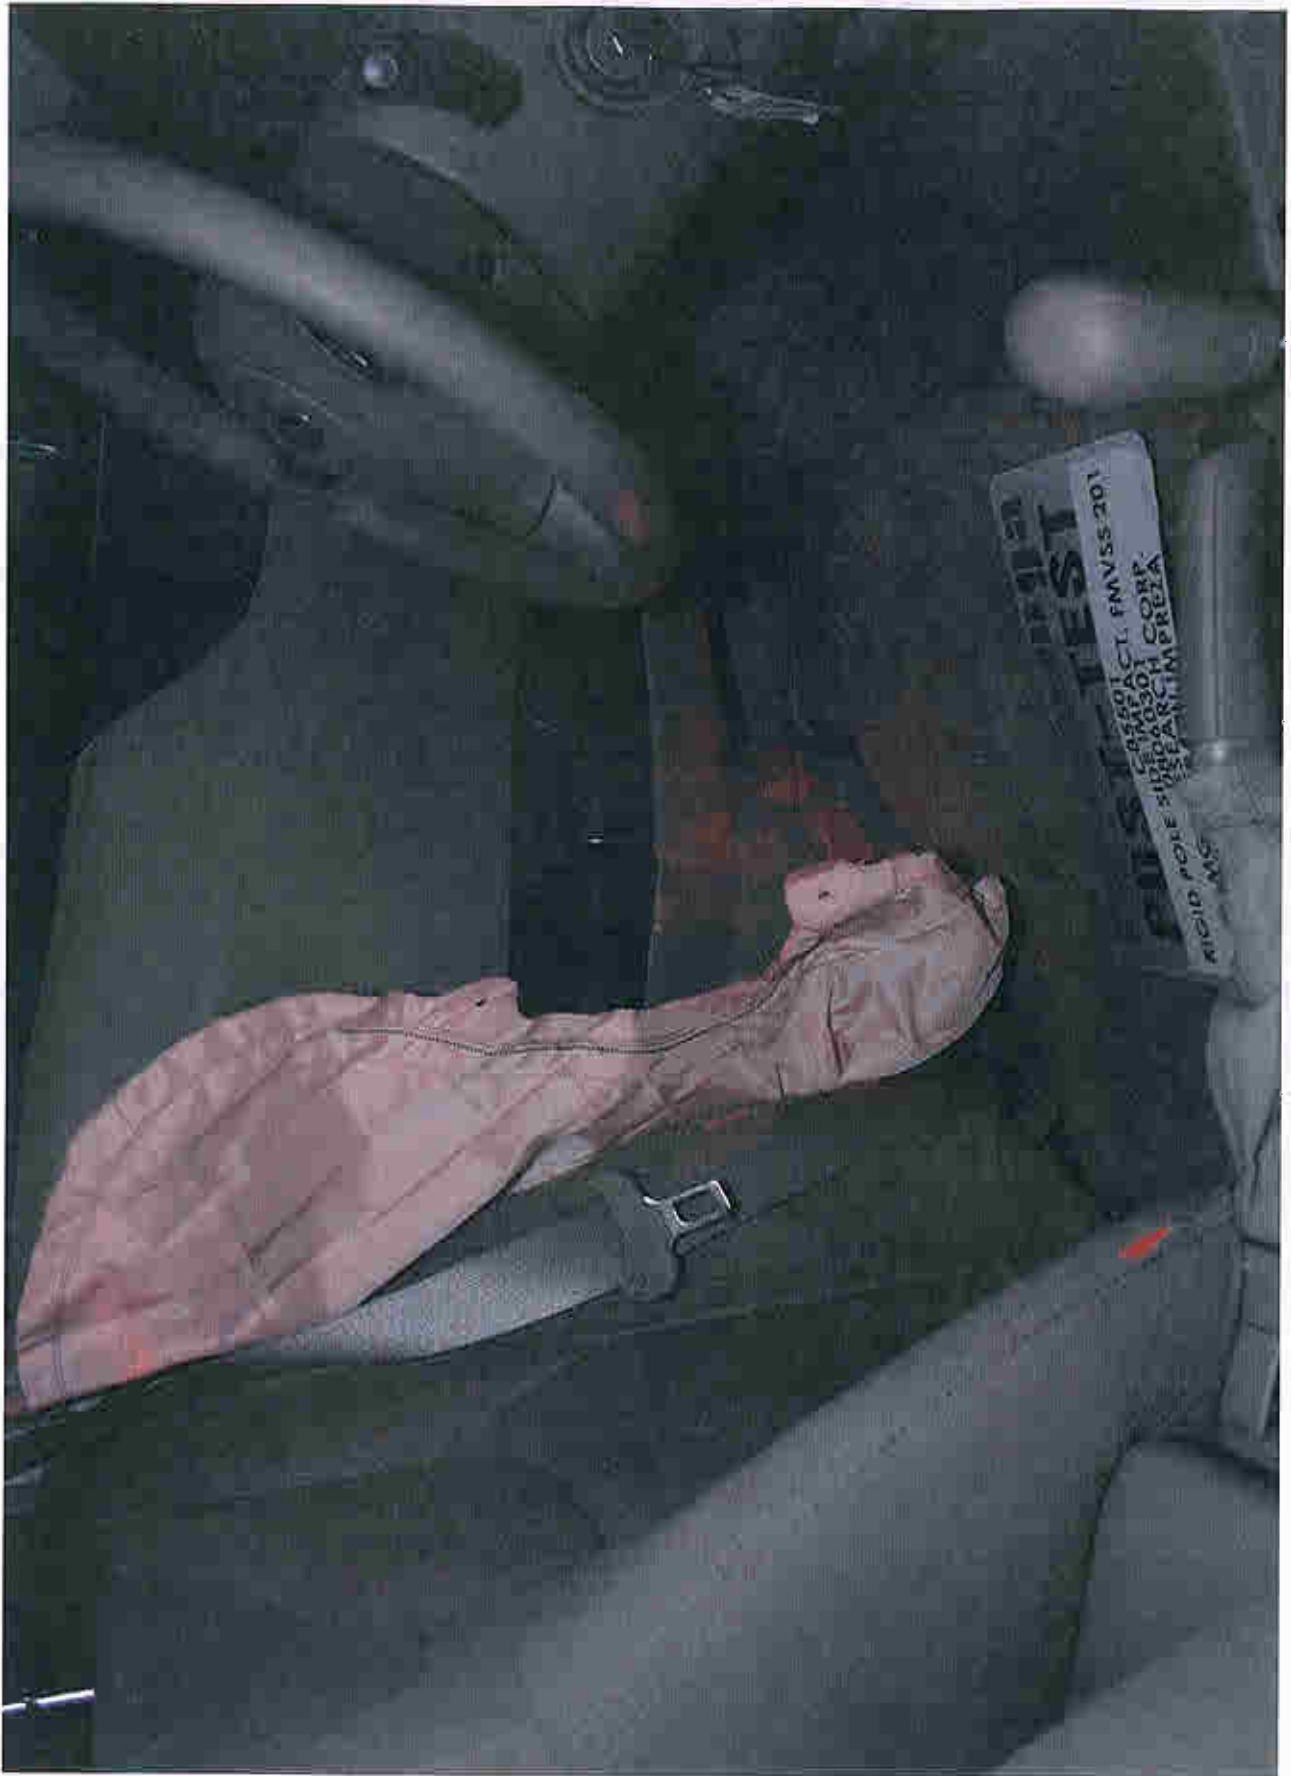
Post-Test Driver Dummy Upper Thorax Contact

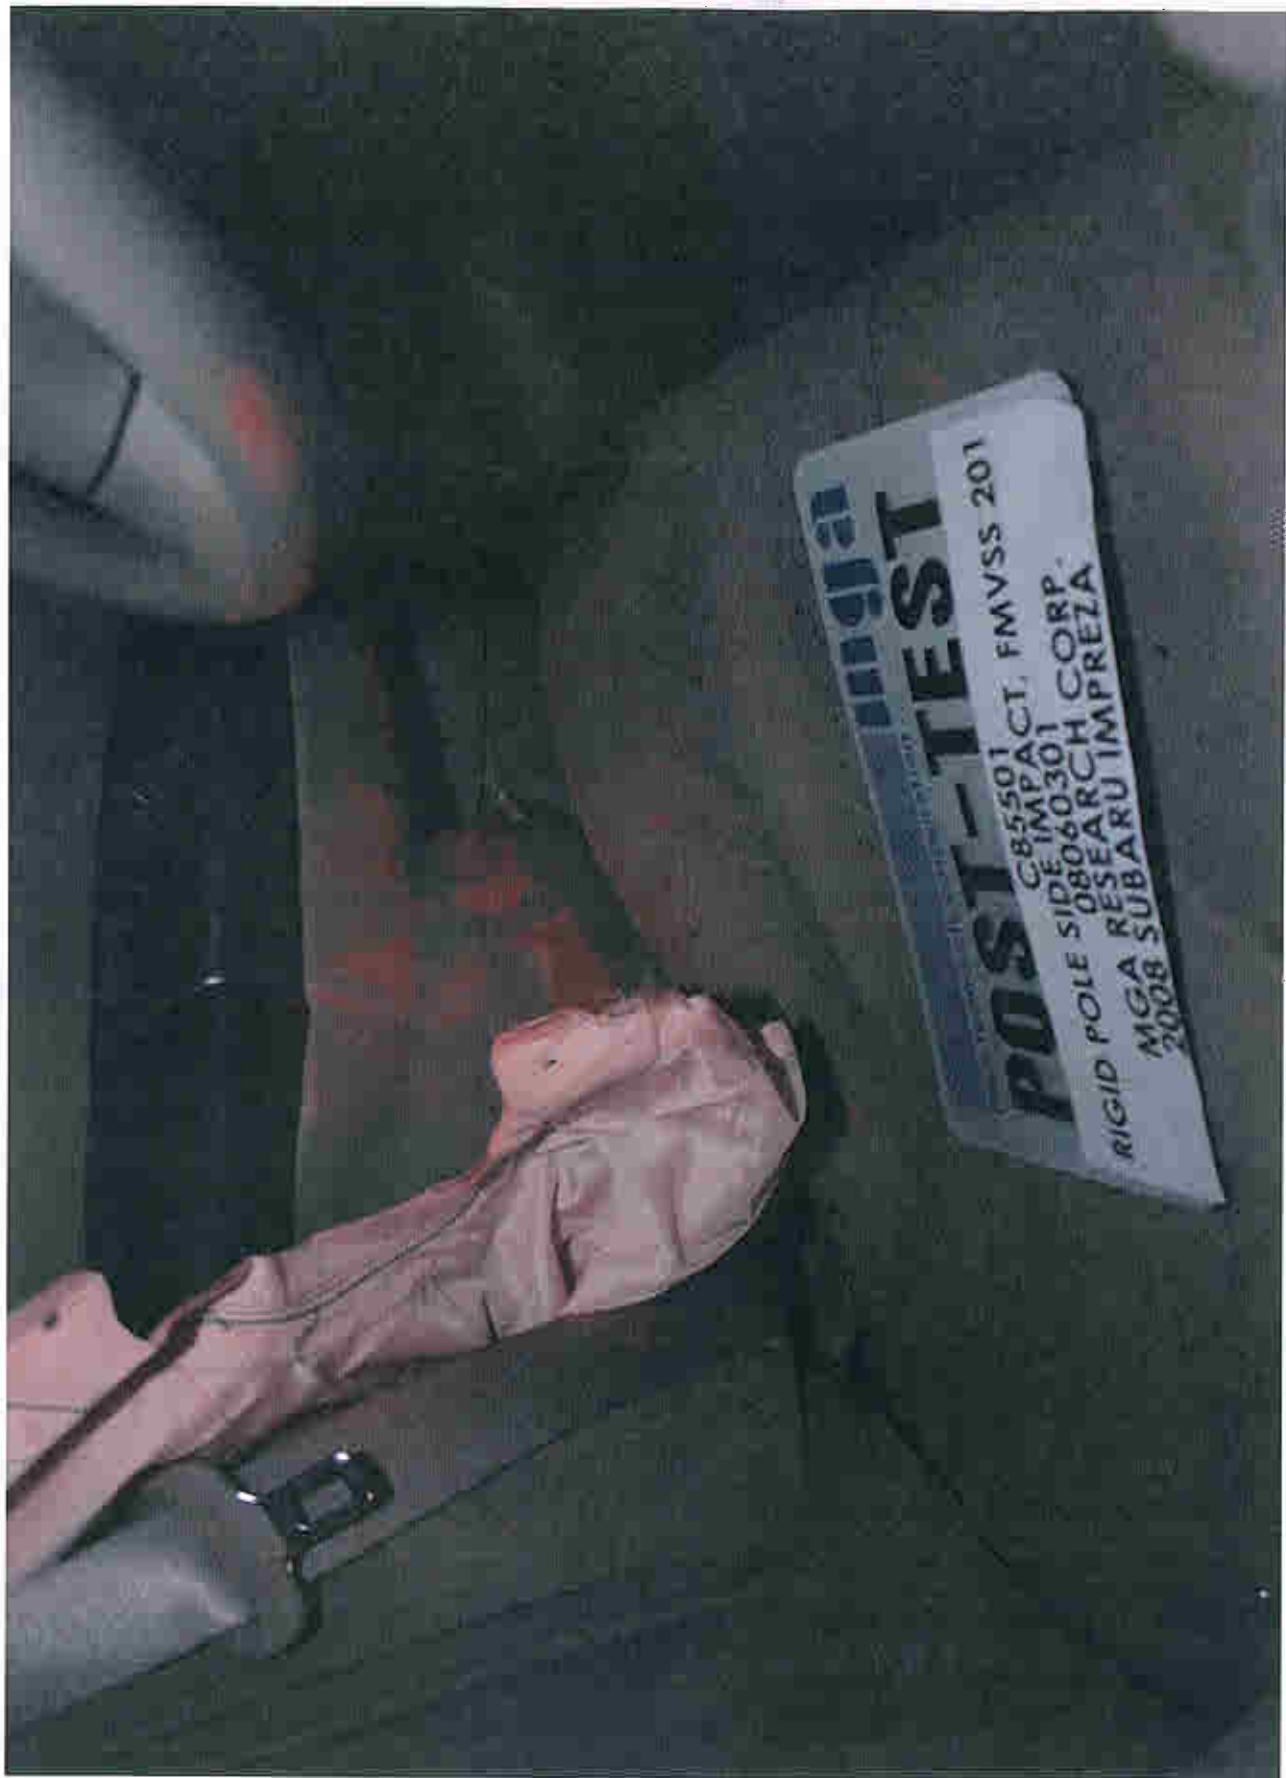
Post-Test Driver Dummy Lower ThoraxContact

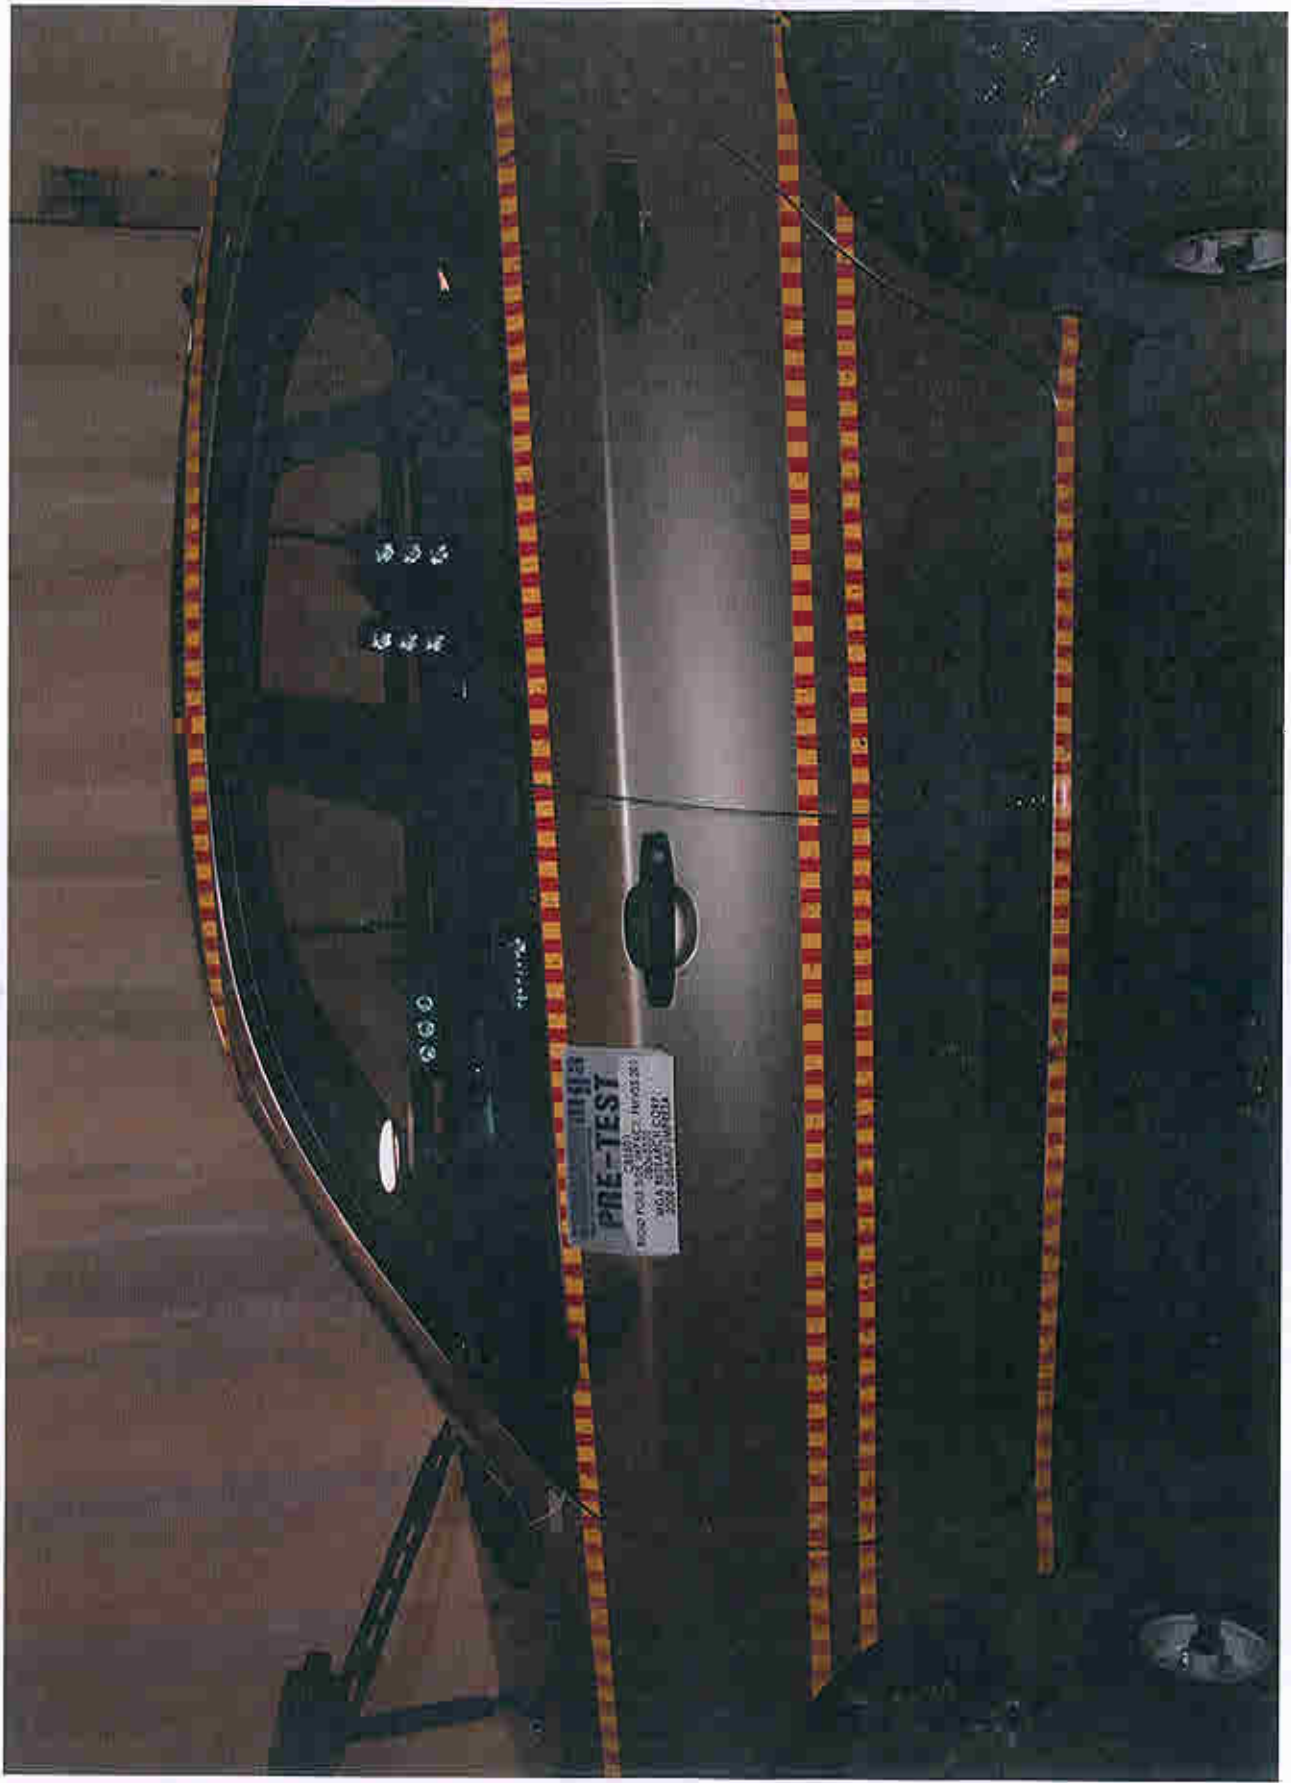
Pre-Test Impact Zone Close-up View
