REPORT NUMBER: 201-MGA-2008-002

**SAFETY COMPLIANCE TESTING FOR FMVSS 201
RIGID POLE SIDE IMPACT TEST**

**FORD MOTOR COMPANY
2008 FORD FOCUS 4-DOOR
NHTSA NUMBER: C80204**

**PREPARED BY:
MGA RESEARCH CORPORATION
5000 WARREN ROAD
BURLINGTON, WI 53105**

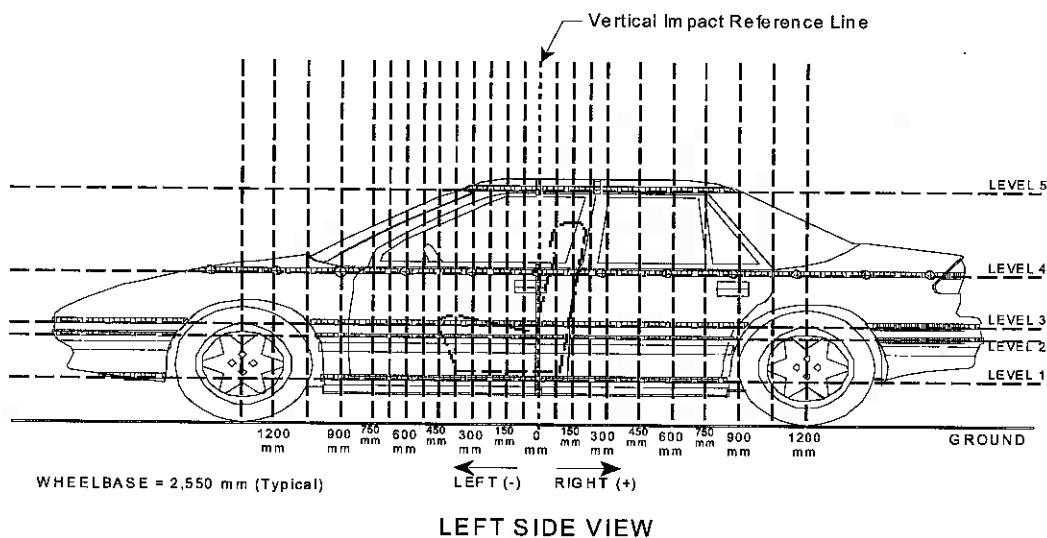
PRETEST AND POST TEST EXTERIOR PROFILE MEASUREMENTS

Measurements are taken with vehicle in the as tested condition.
 Measurements along the vertical 0 mm.

Level	Measurement Description	Units	Height Above Ground
5	Window	mm	1438
4	Window Sill	mm	970
3	Mid Door	mm	662
2	Occupant H-Point	mm	536
1	Sill Top	mm	274

Level	Measured Parameter	Units	Maximum Crush	Above Ground
Level 1	Sill Top Height	mm	344	274
Level 2	Occupant H-Point	mm	370	536
Level 3	Mid Door	mm	380	662
Level 4	Window Sill	mm	335	970
Level 5	Window Top	mm	138	1438
N/A	Maximum Penetration	mm	380	755

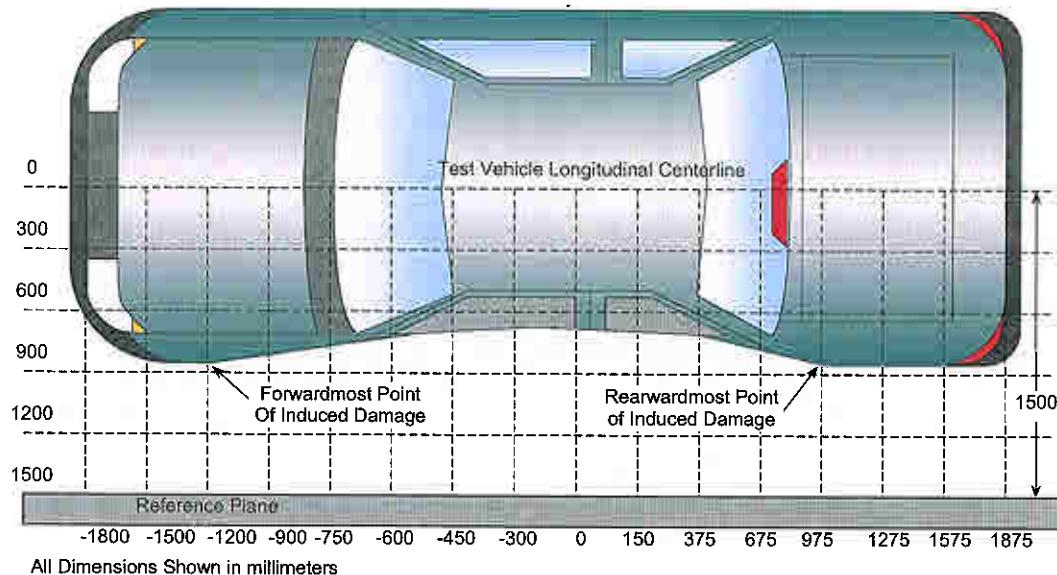
DATA SHEET NO. 11
VEHICLE DAMAGE PROFILE DISTANCES

TOP VIEW

Damage Profile Distances

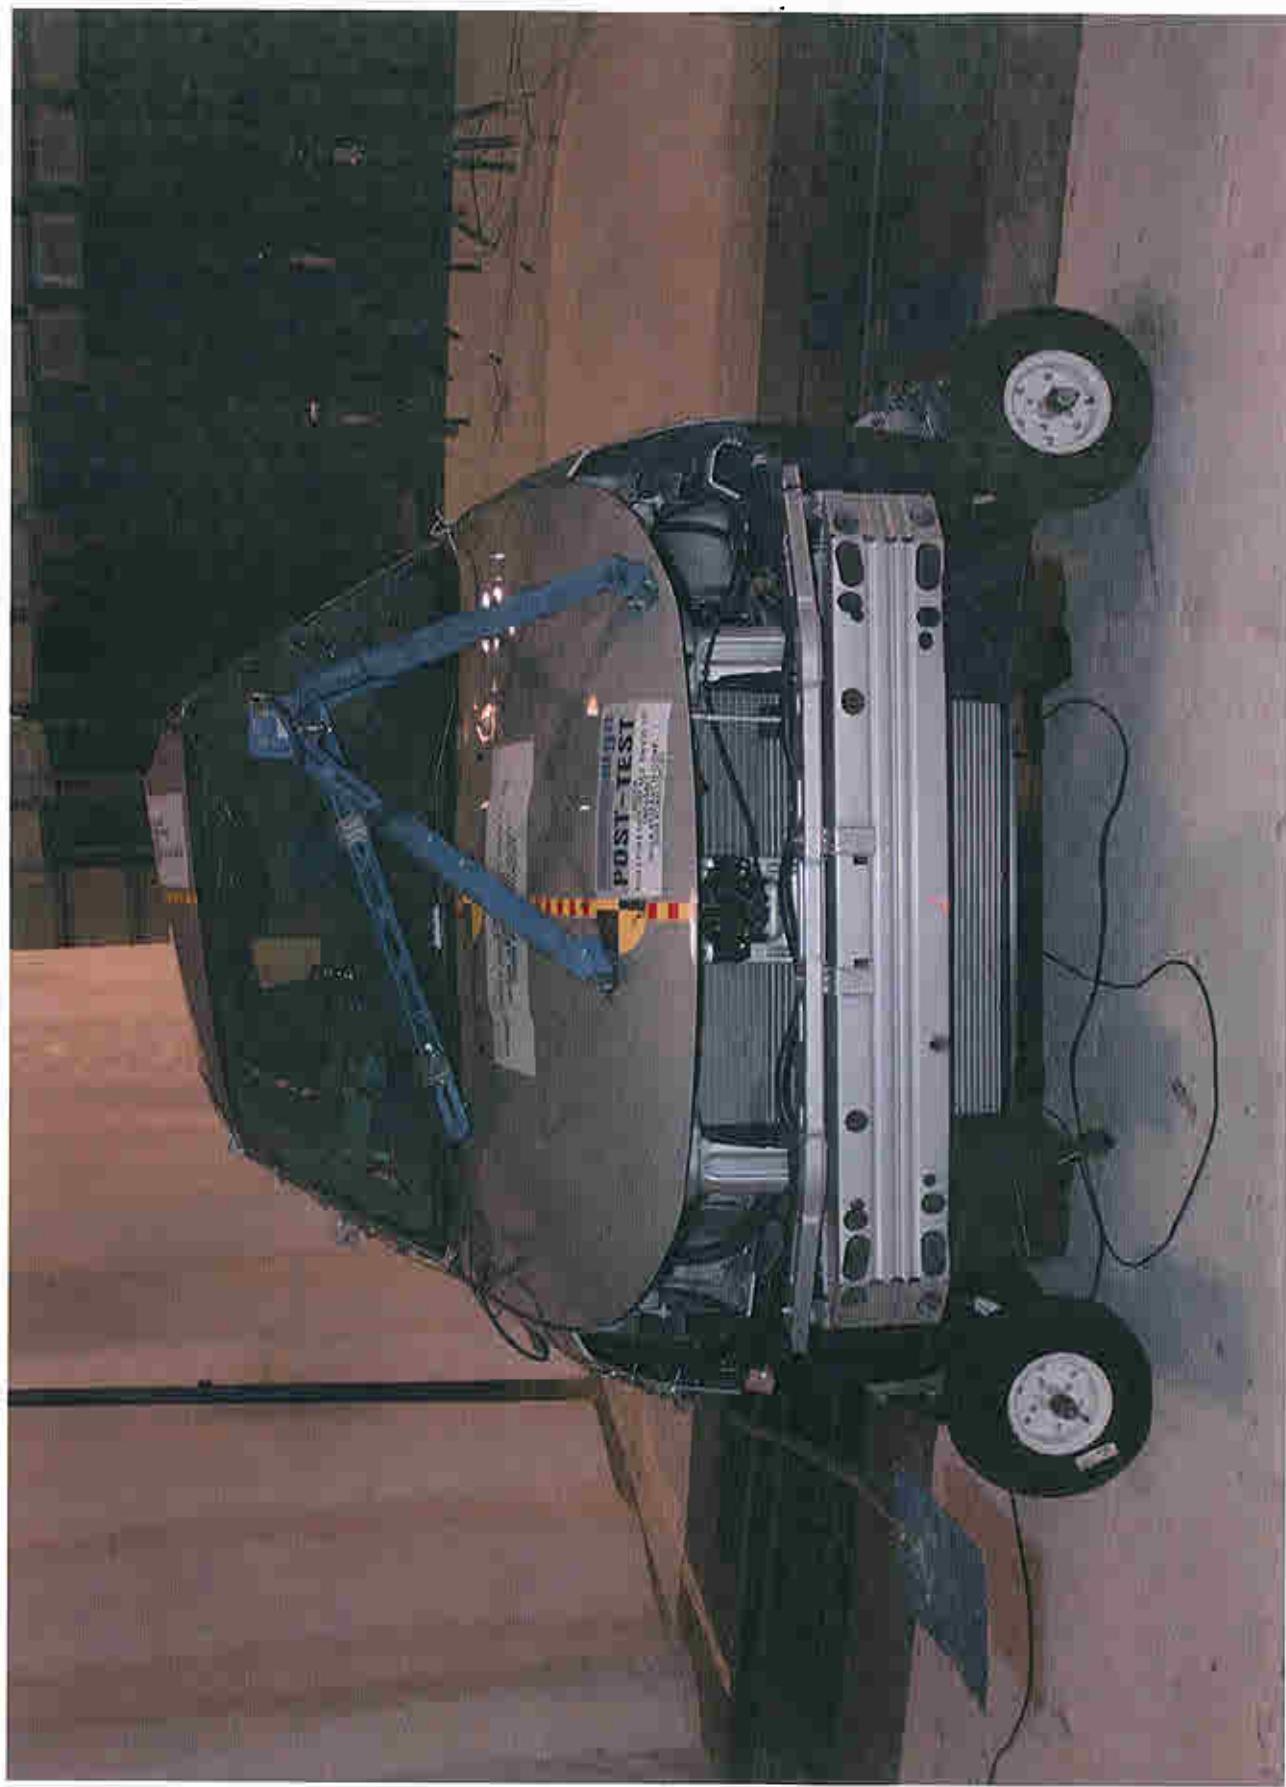
Post-Test Front View of Test Vehicle

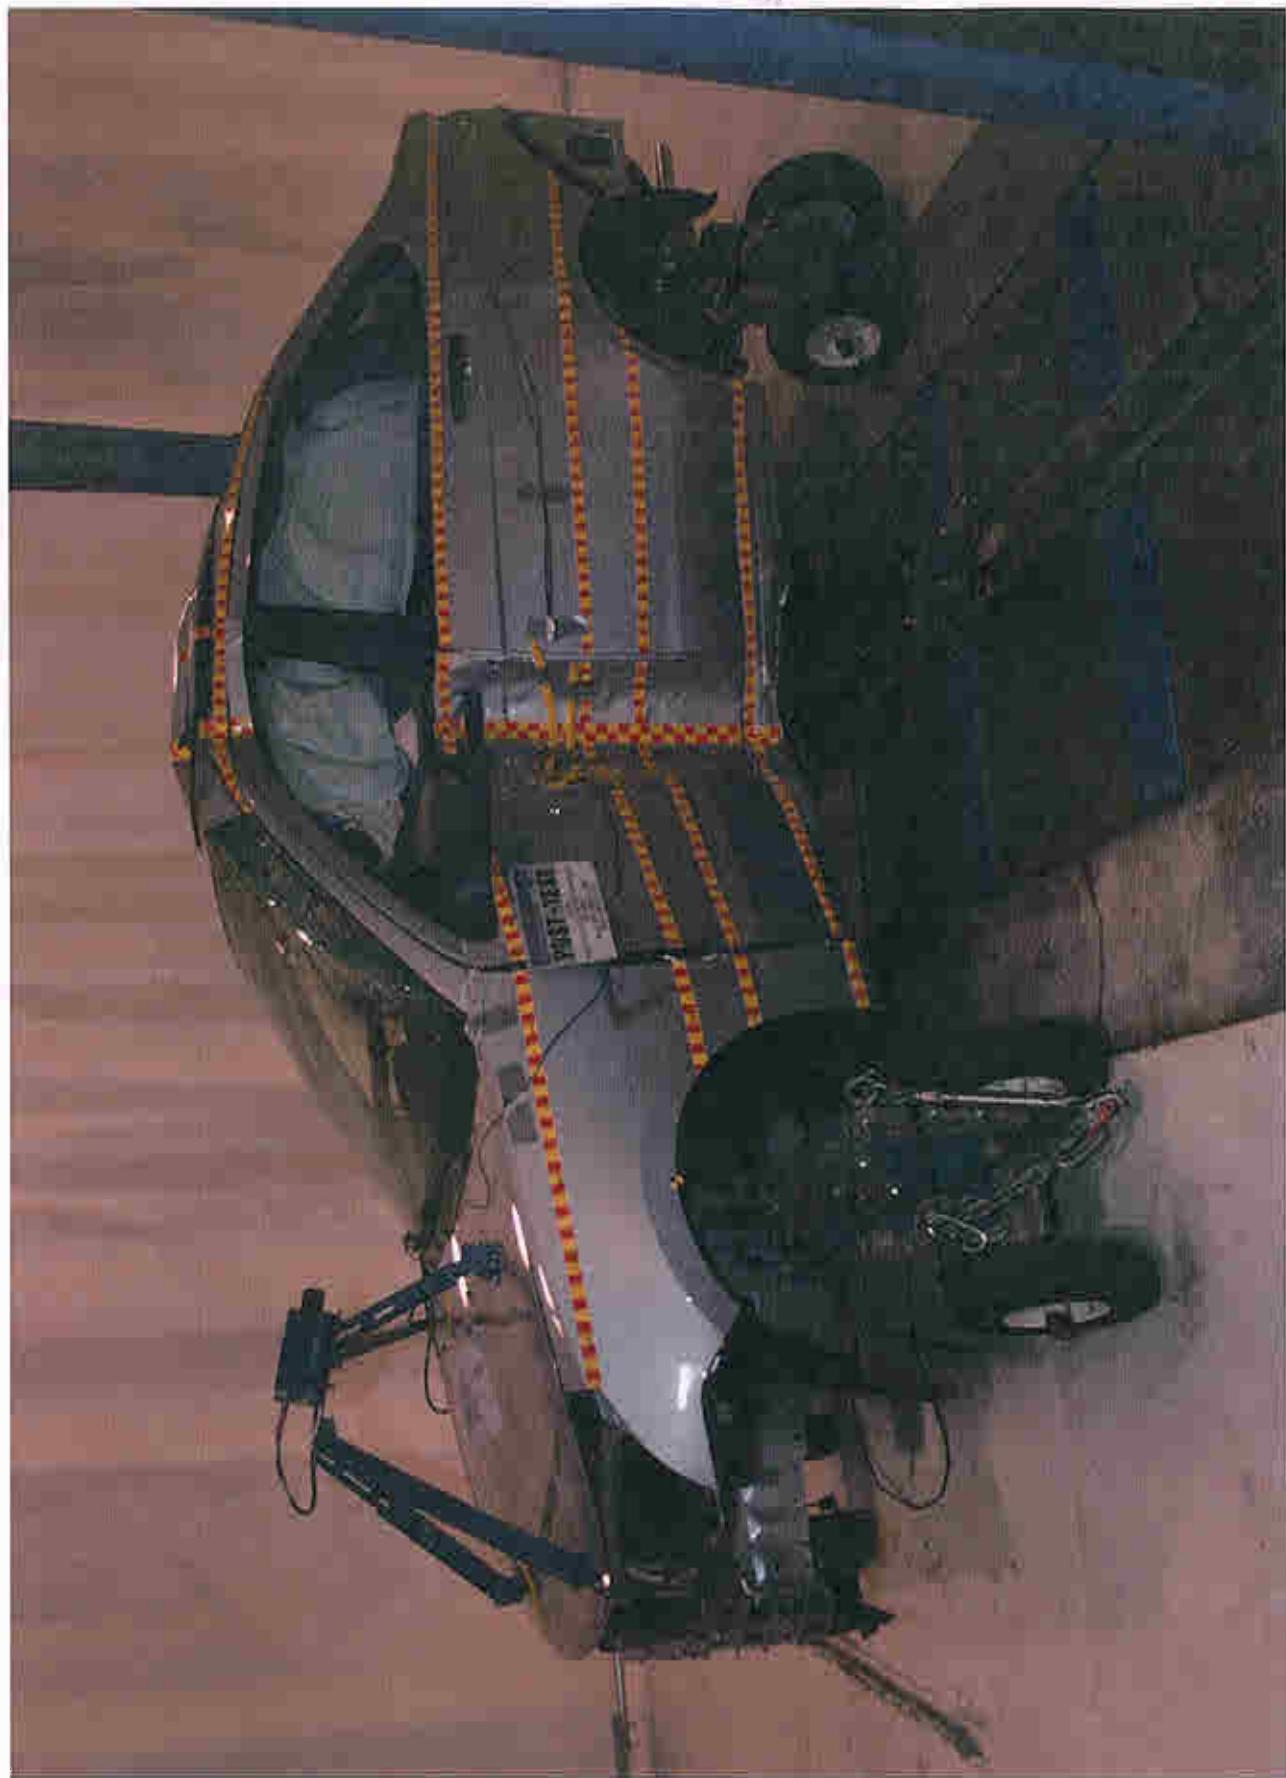
Post-Test Left Side View of Test Vehicle

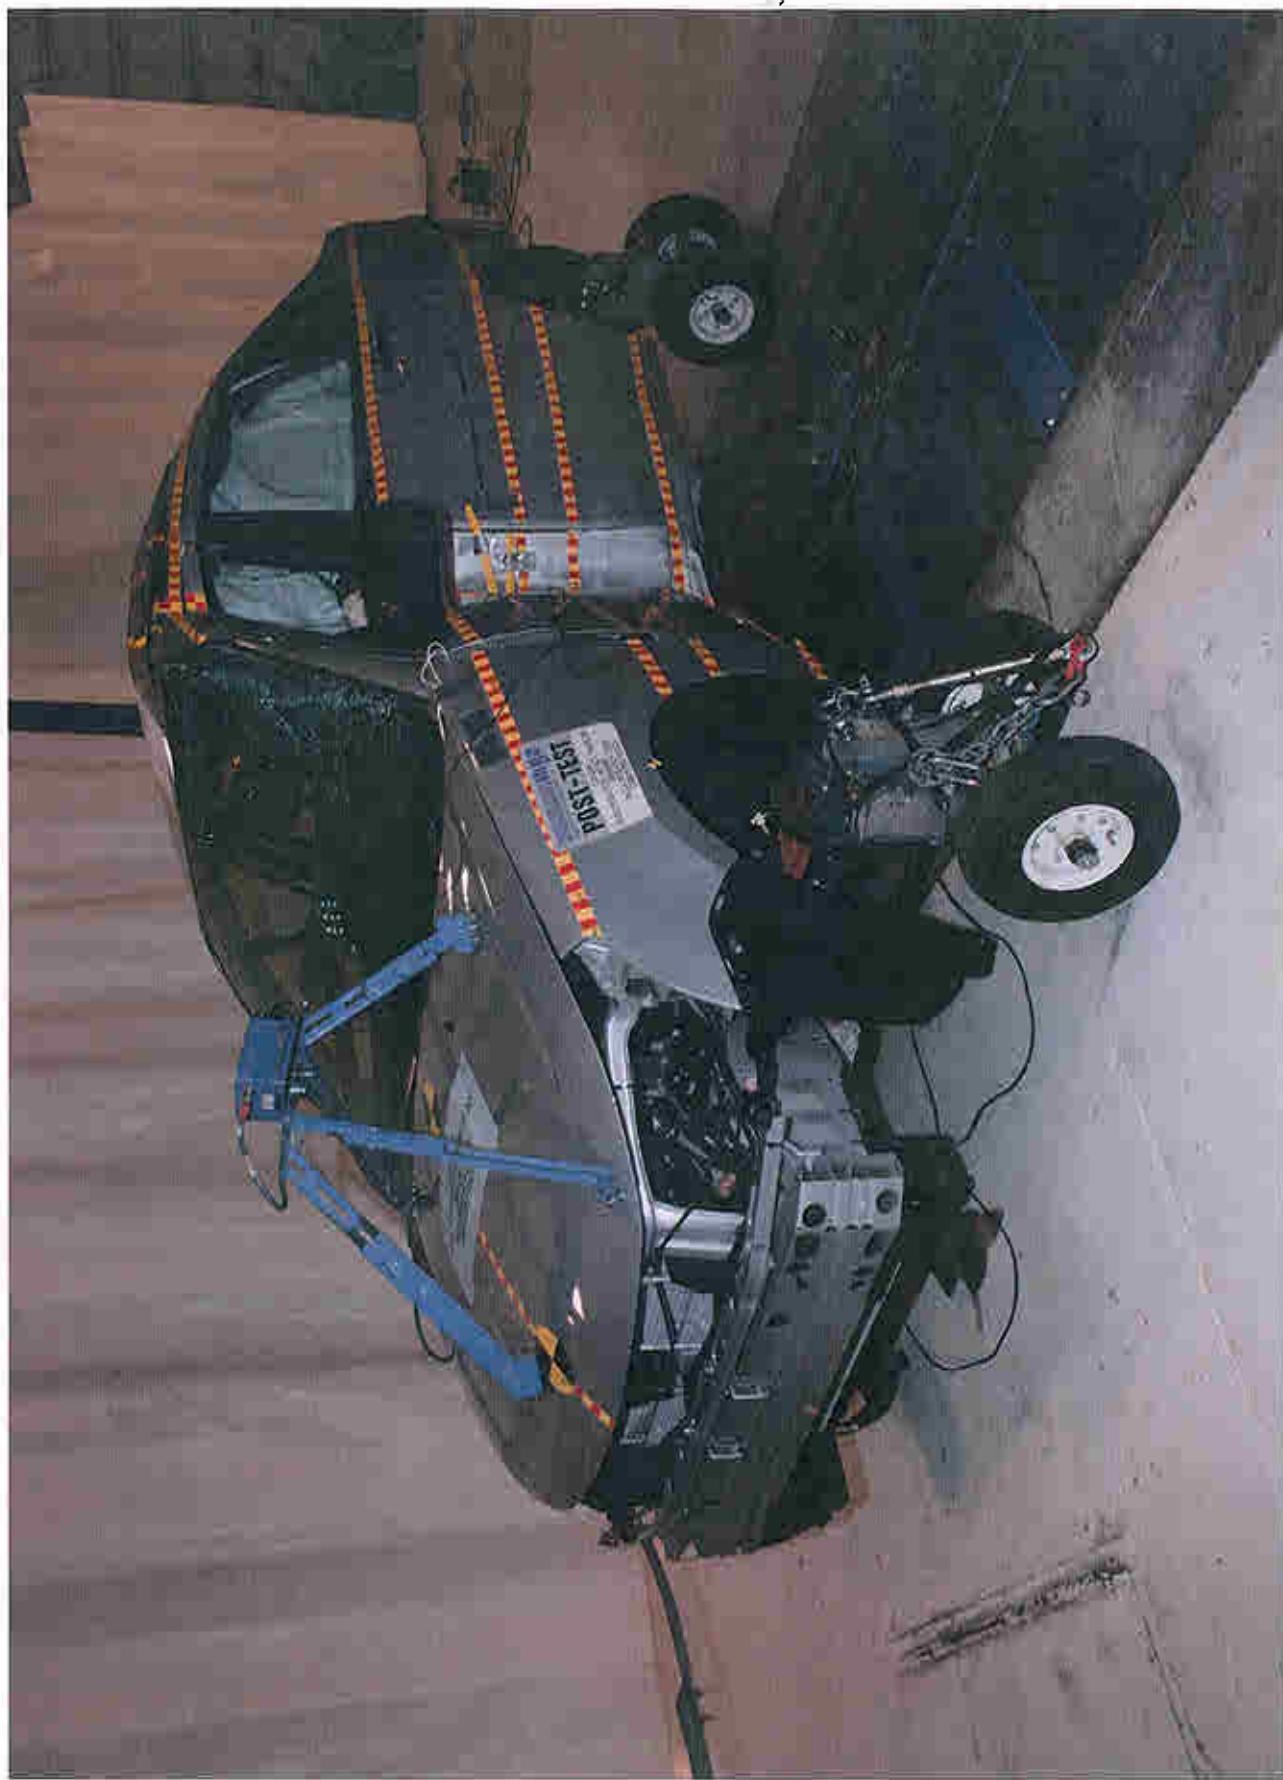
Post-Test Left Front Three-Quarter View

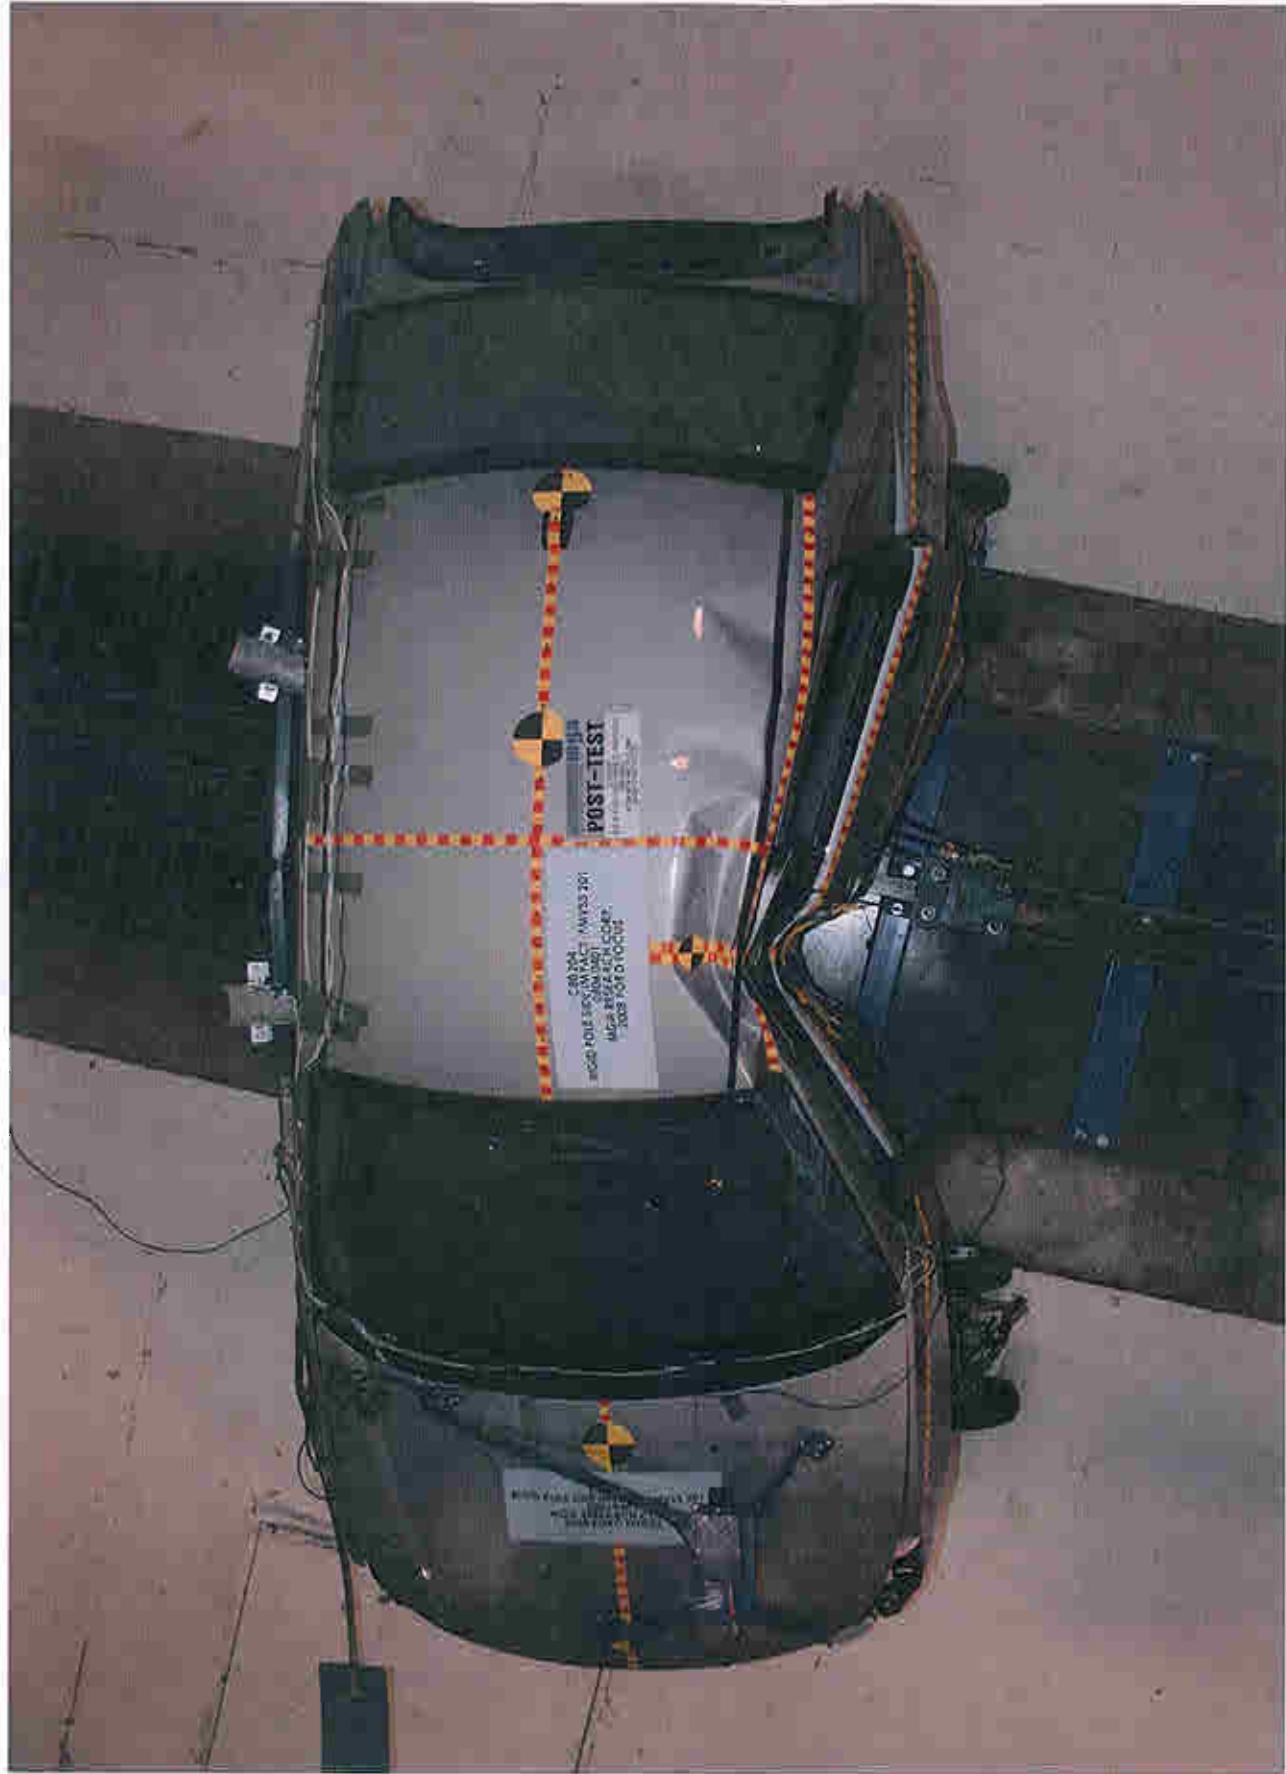
Post-Test Overhead View of Test Vehicle

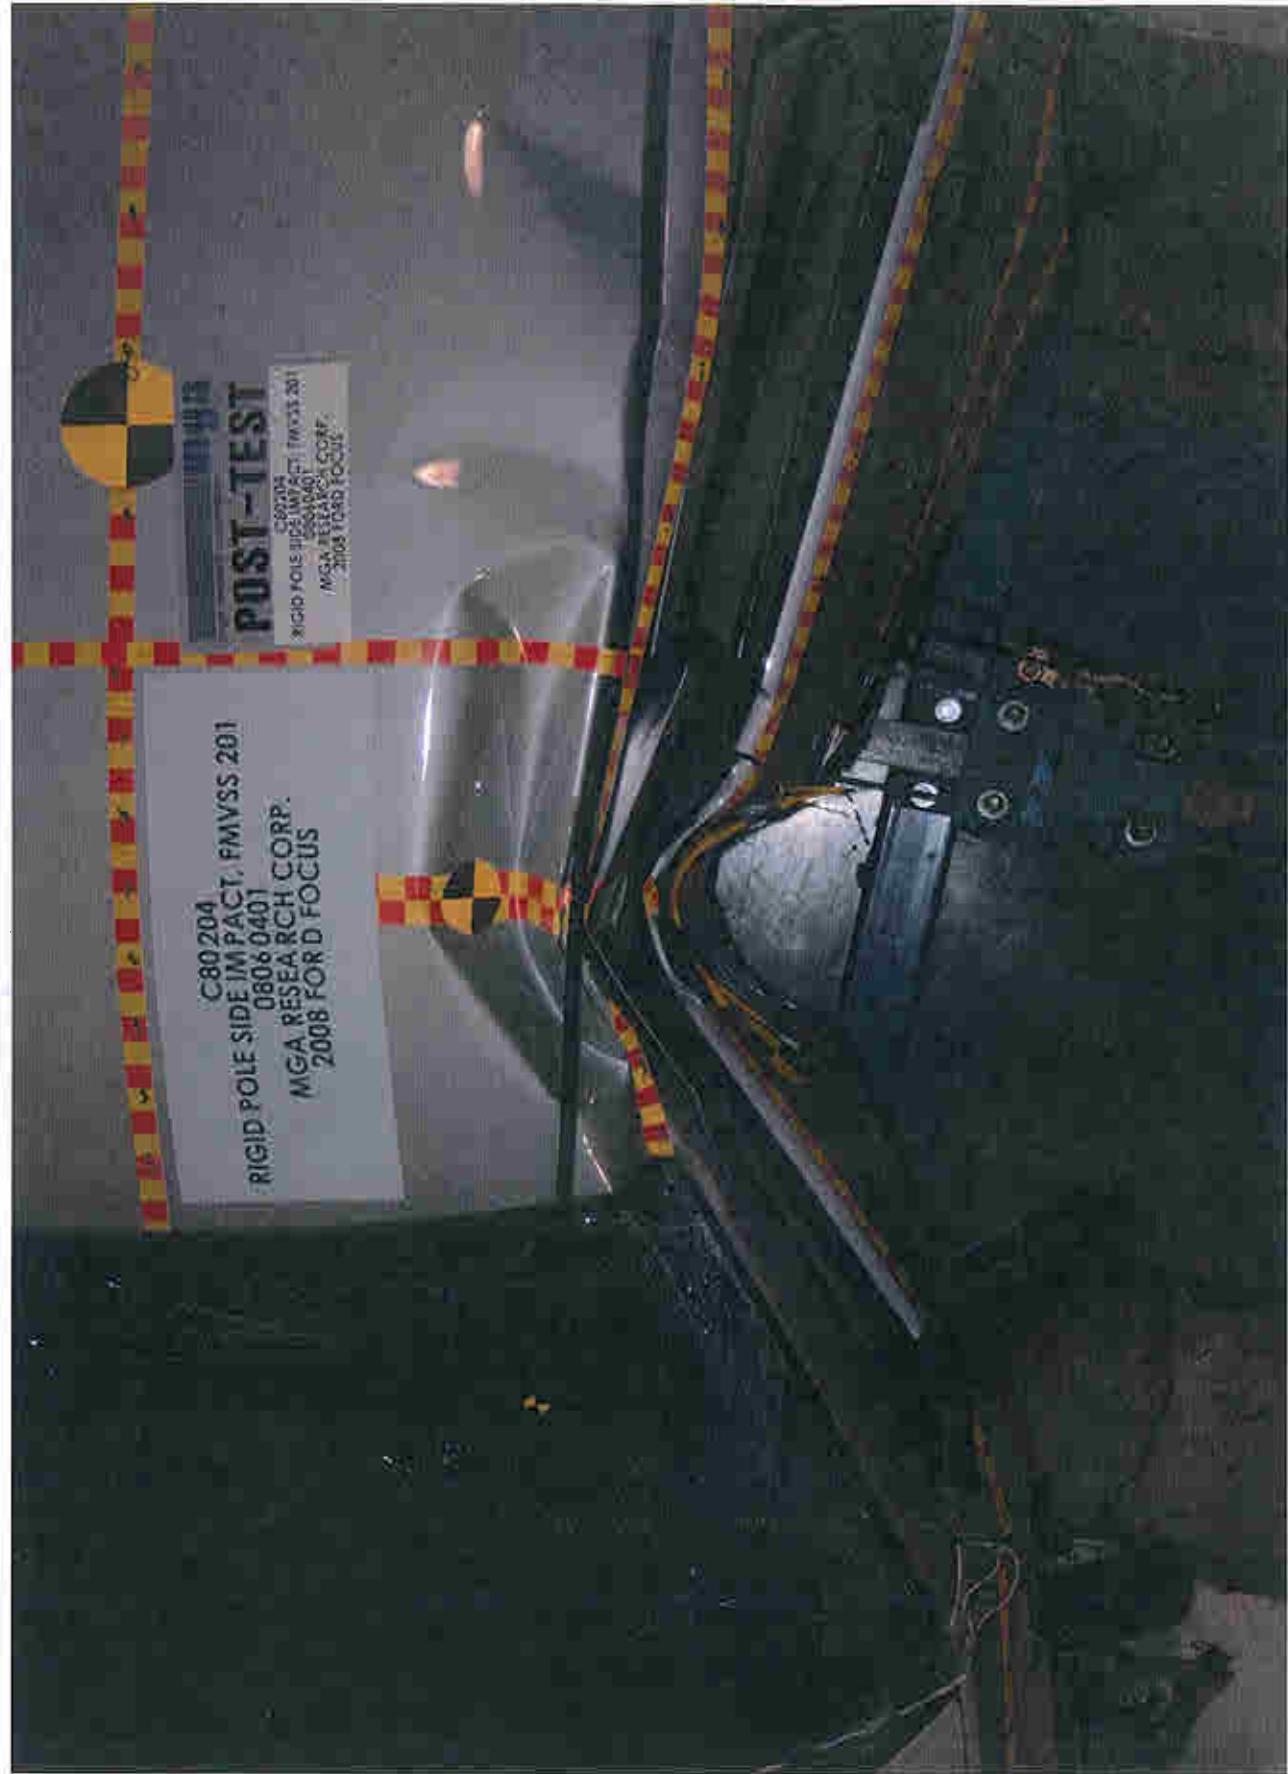
Post-Test Overhead View of Test Vehicle (Closeup)

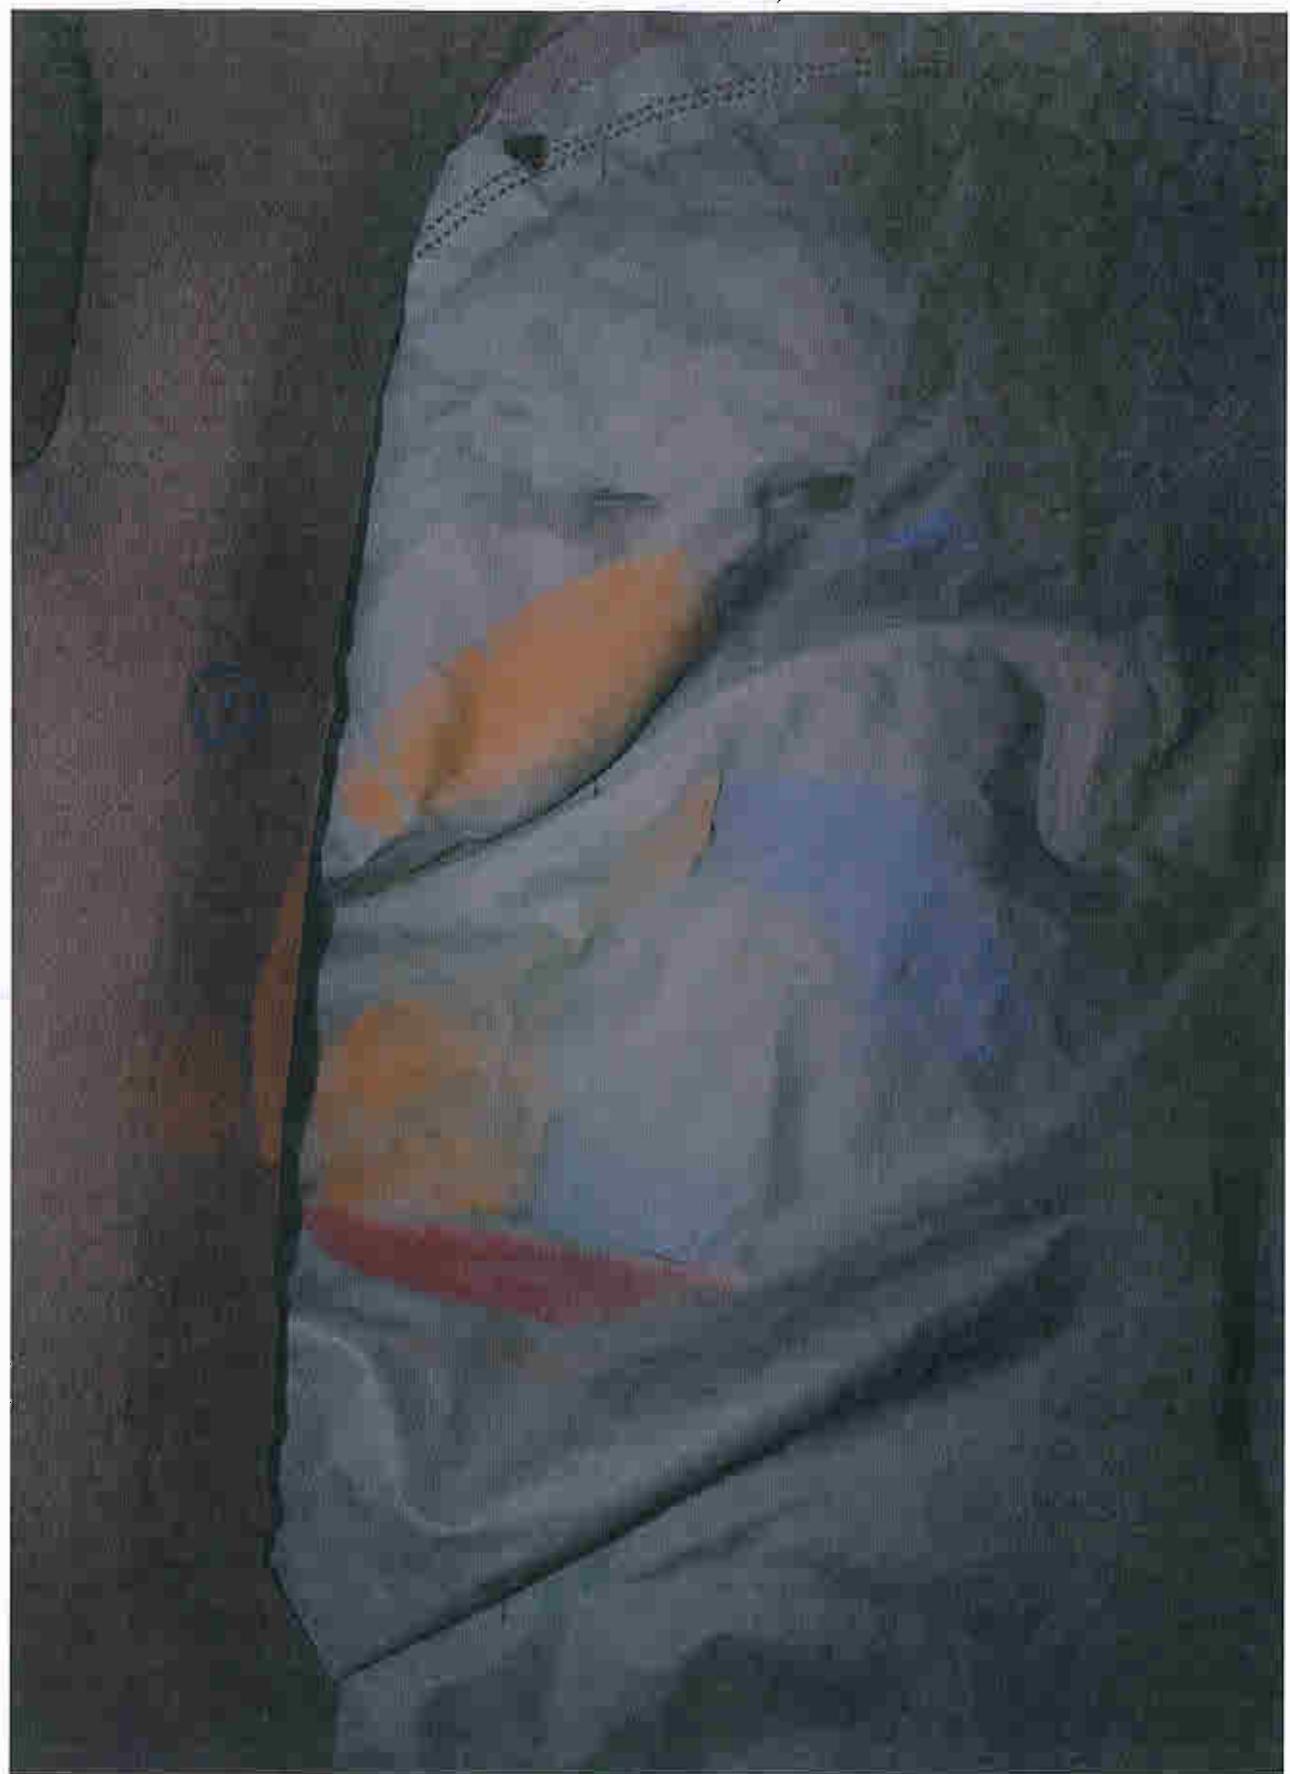
Post-Test Driver Dummy Head Contact (CAB)

Description	Left Front Seating Position
Dummy Type / Serial No.	SID/HIII / 037
Head Contact	Curtain Airbag, Headrest
Upper Torso Contact	Side Airbag
Lower Torso Contact	Door Panel
Left Knee Contact	Door Panel
Right Knee Contact	Left Knee

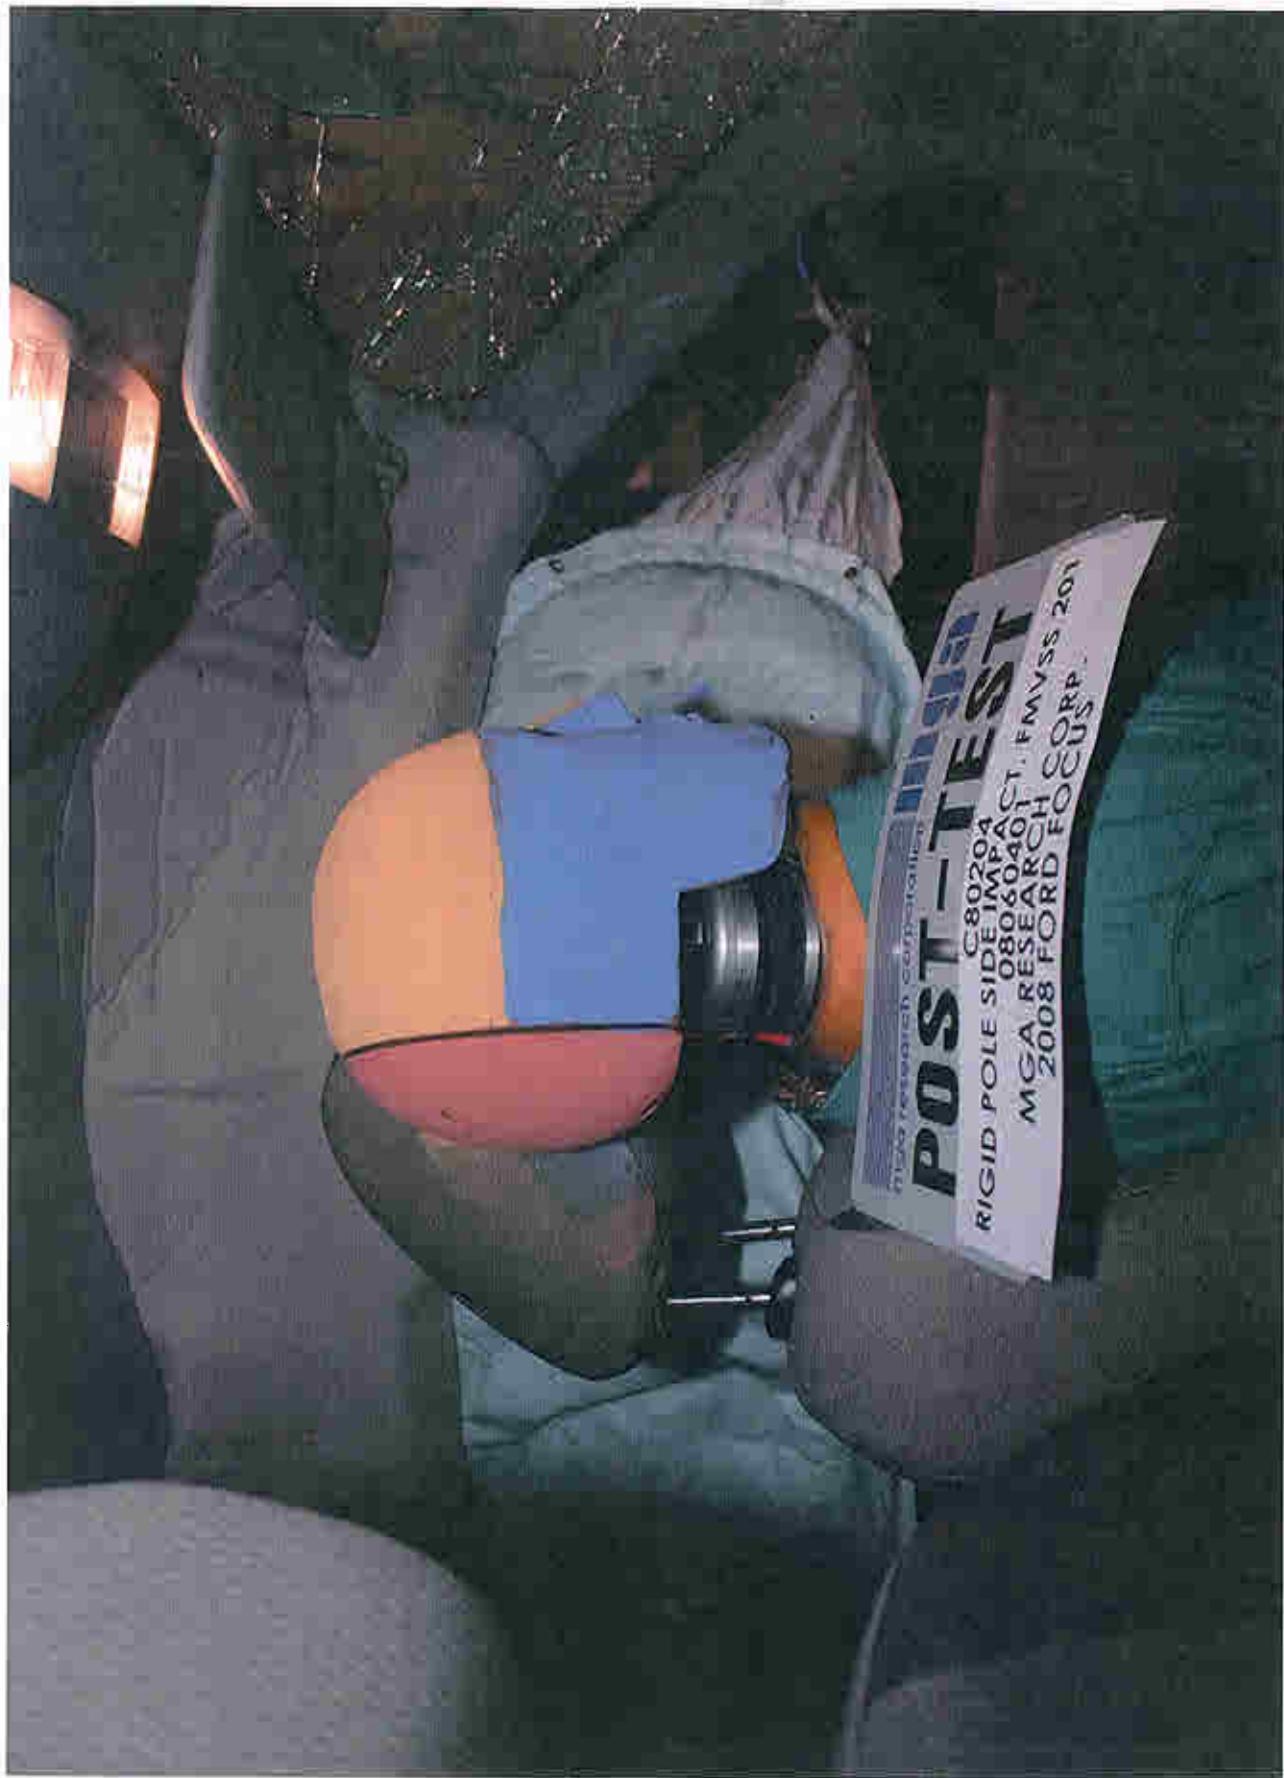
Post-Test Driver Dummy Head Contact (Headrest)

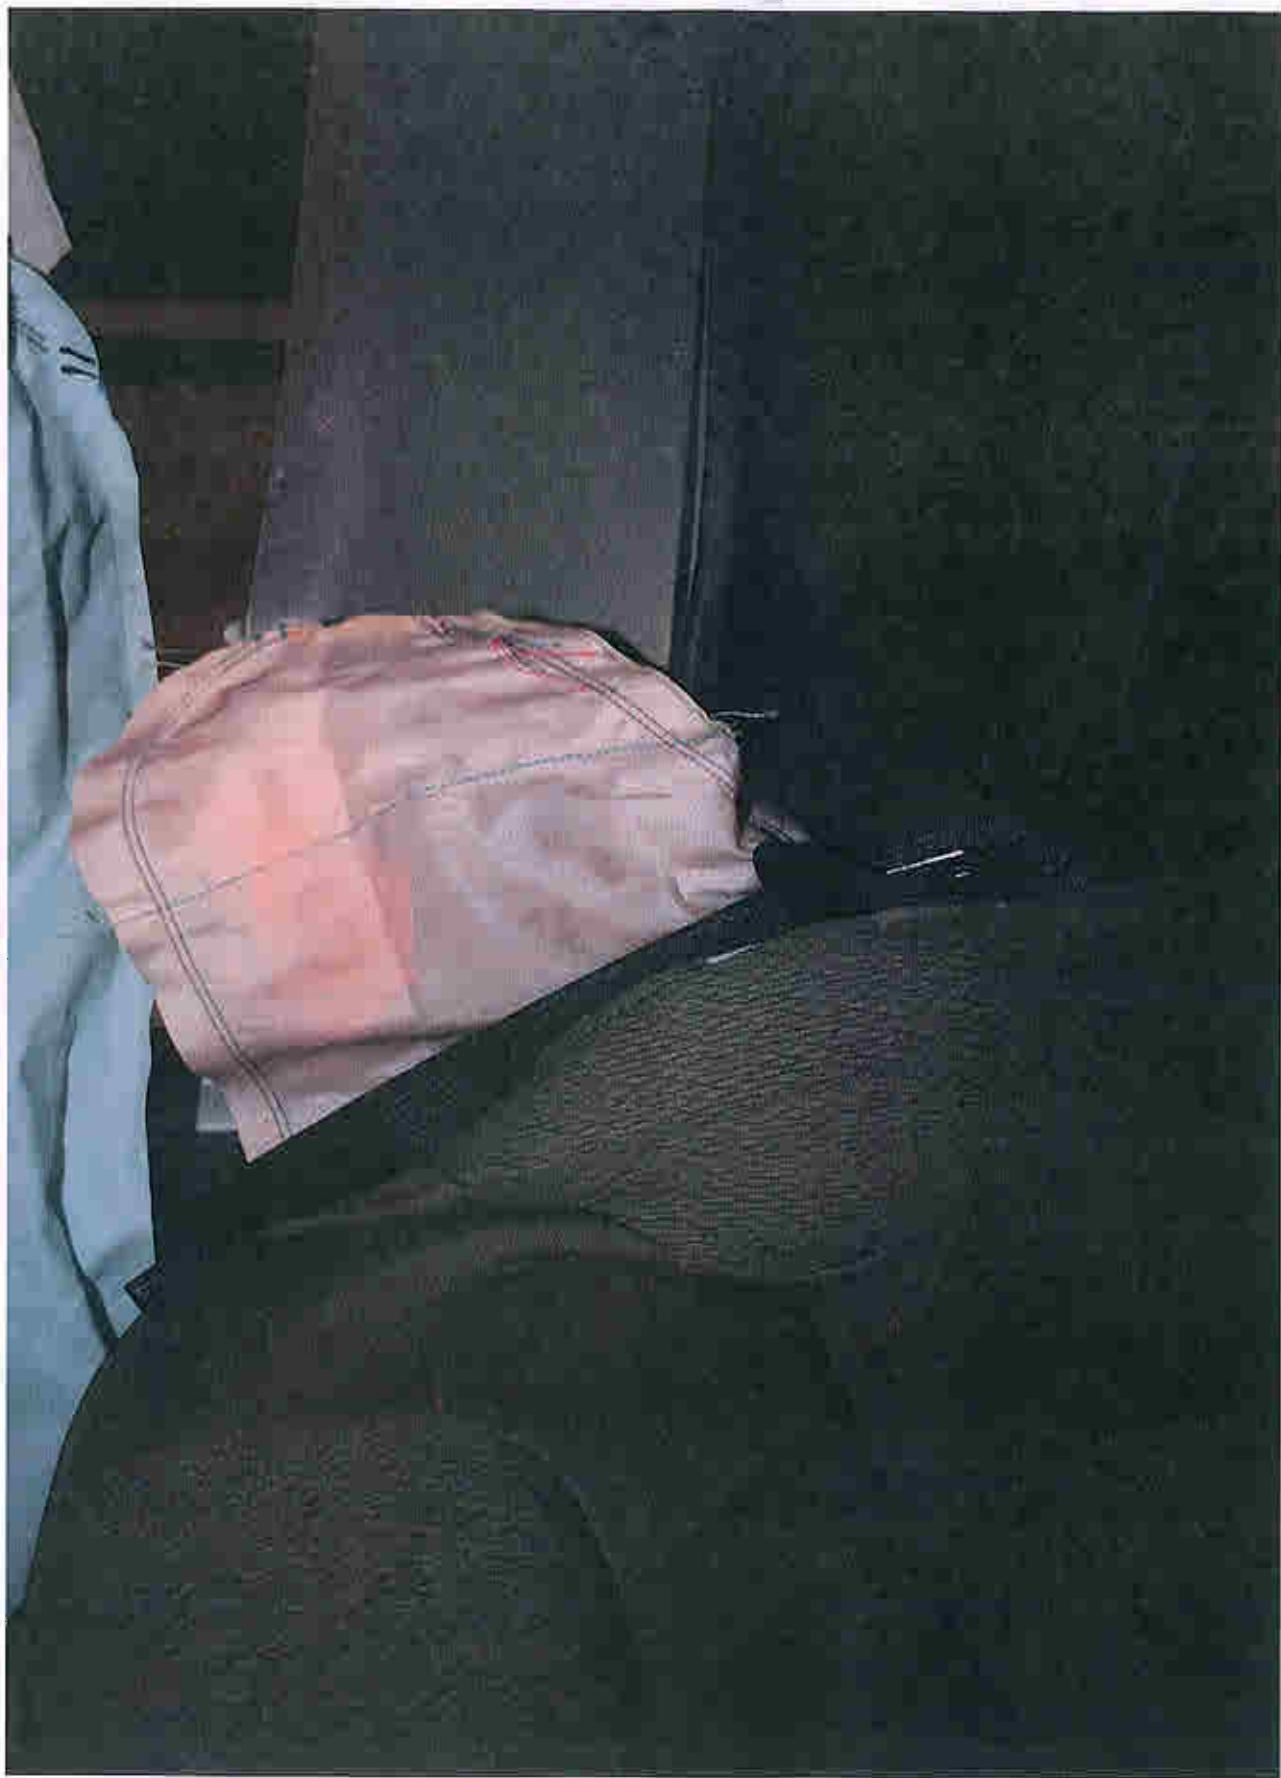
Post-Test Driver Dummy Upper Thorax Contact

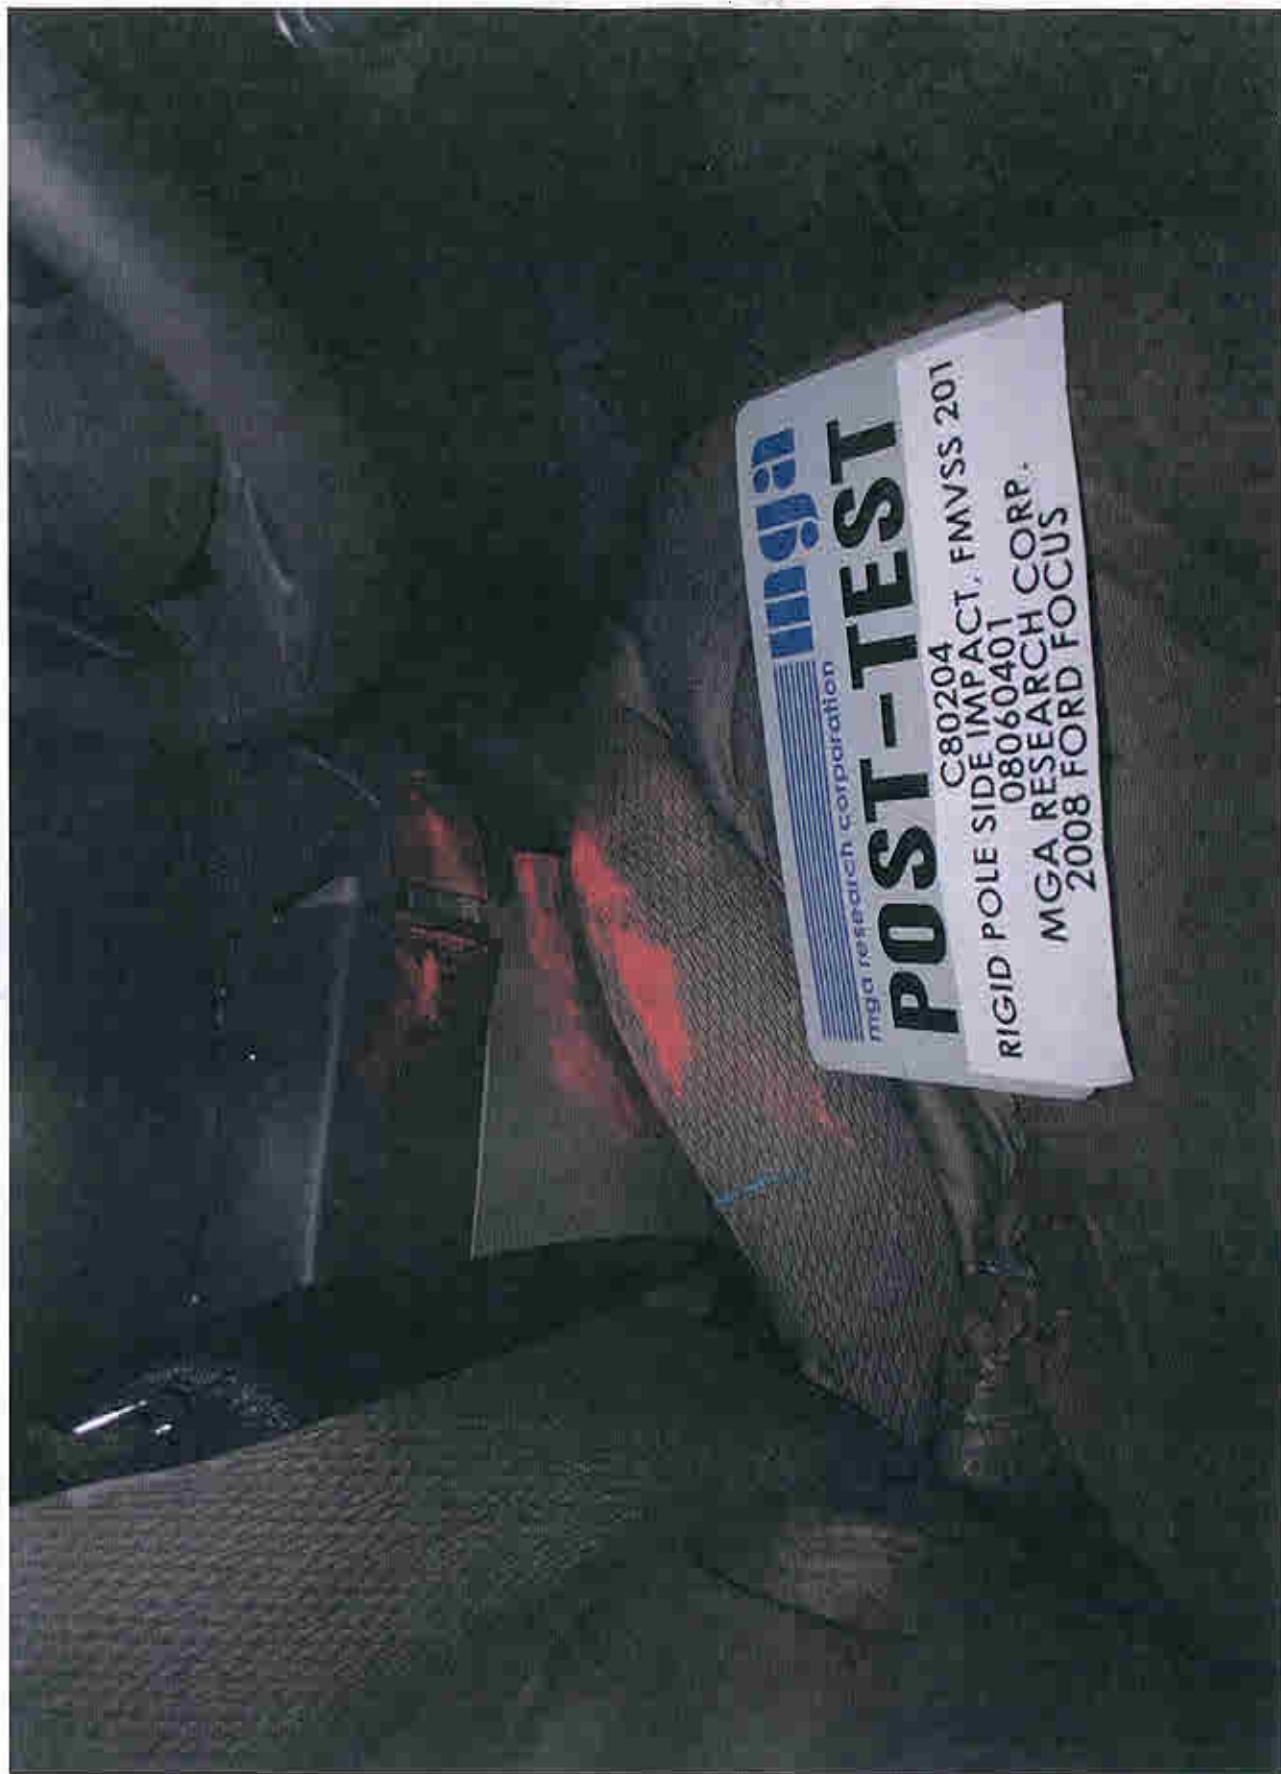
Post-Test Driver Dummy Lower Thorax Contact
