REPORT NUMBER: 201-MGA-2008-002

**SAFETY COMPLIANCE TESTING FOR FMVSS 201
RIGID POLE SIDE IMPACT TEST**

**FORD MOTOR COMPANY
2008 FORD FOCUS 4-DOOR
NHTSA NUMBER: C80204**

**PREPARED BY:
MGA RESEARCH CORPORATION
5000 WARREN ROAD
BURLINGTON, WI 53105**

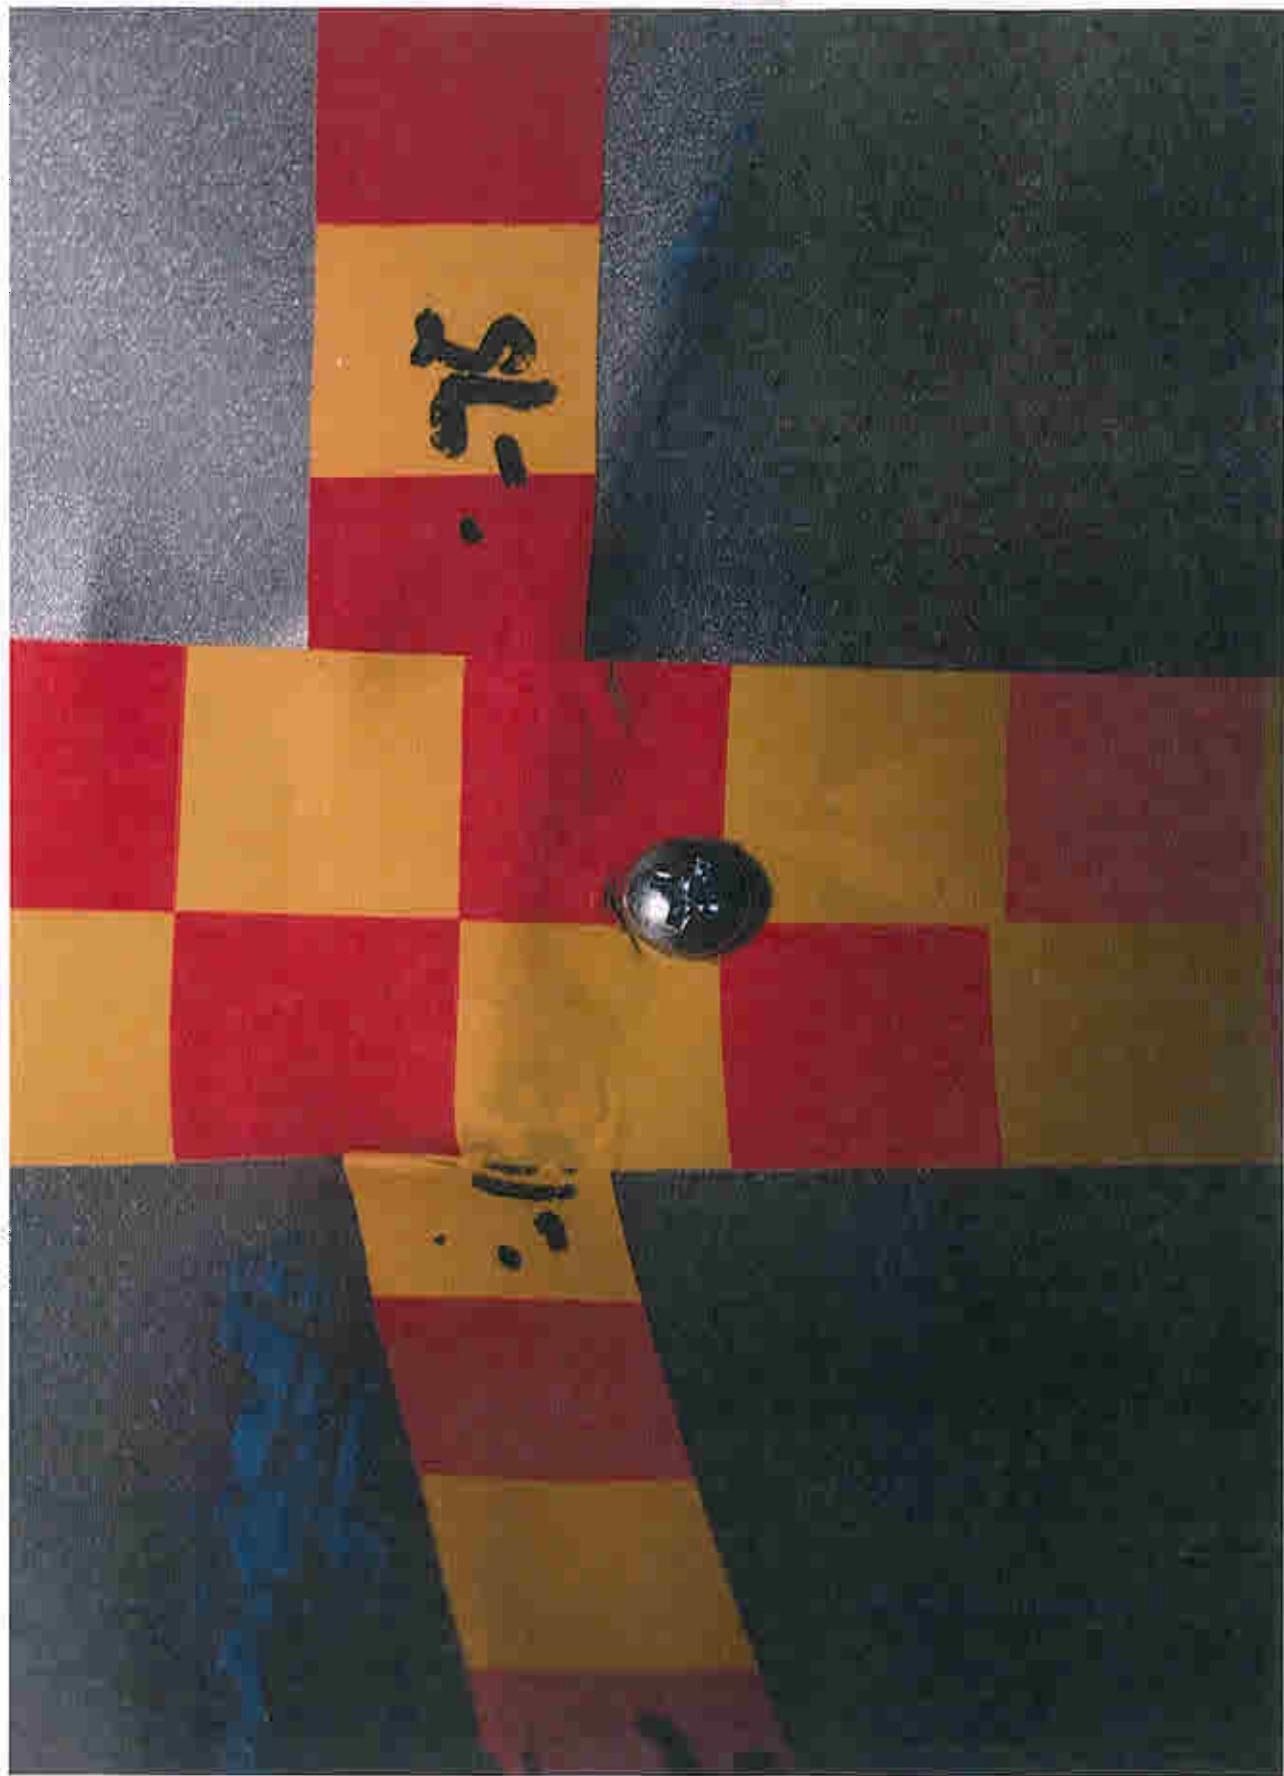
Post-Test Impact Point on Vehicle

Measured Parameter	Units	Requirement	Value
Horizontal Offset	mm	+/- 38	3 rearward

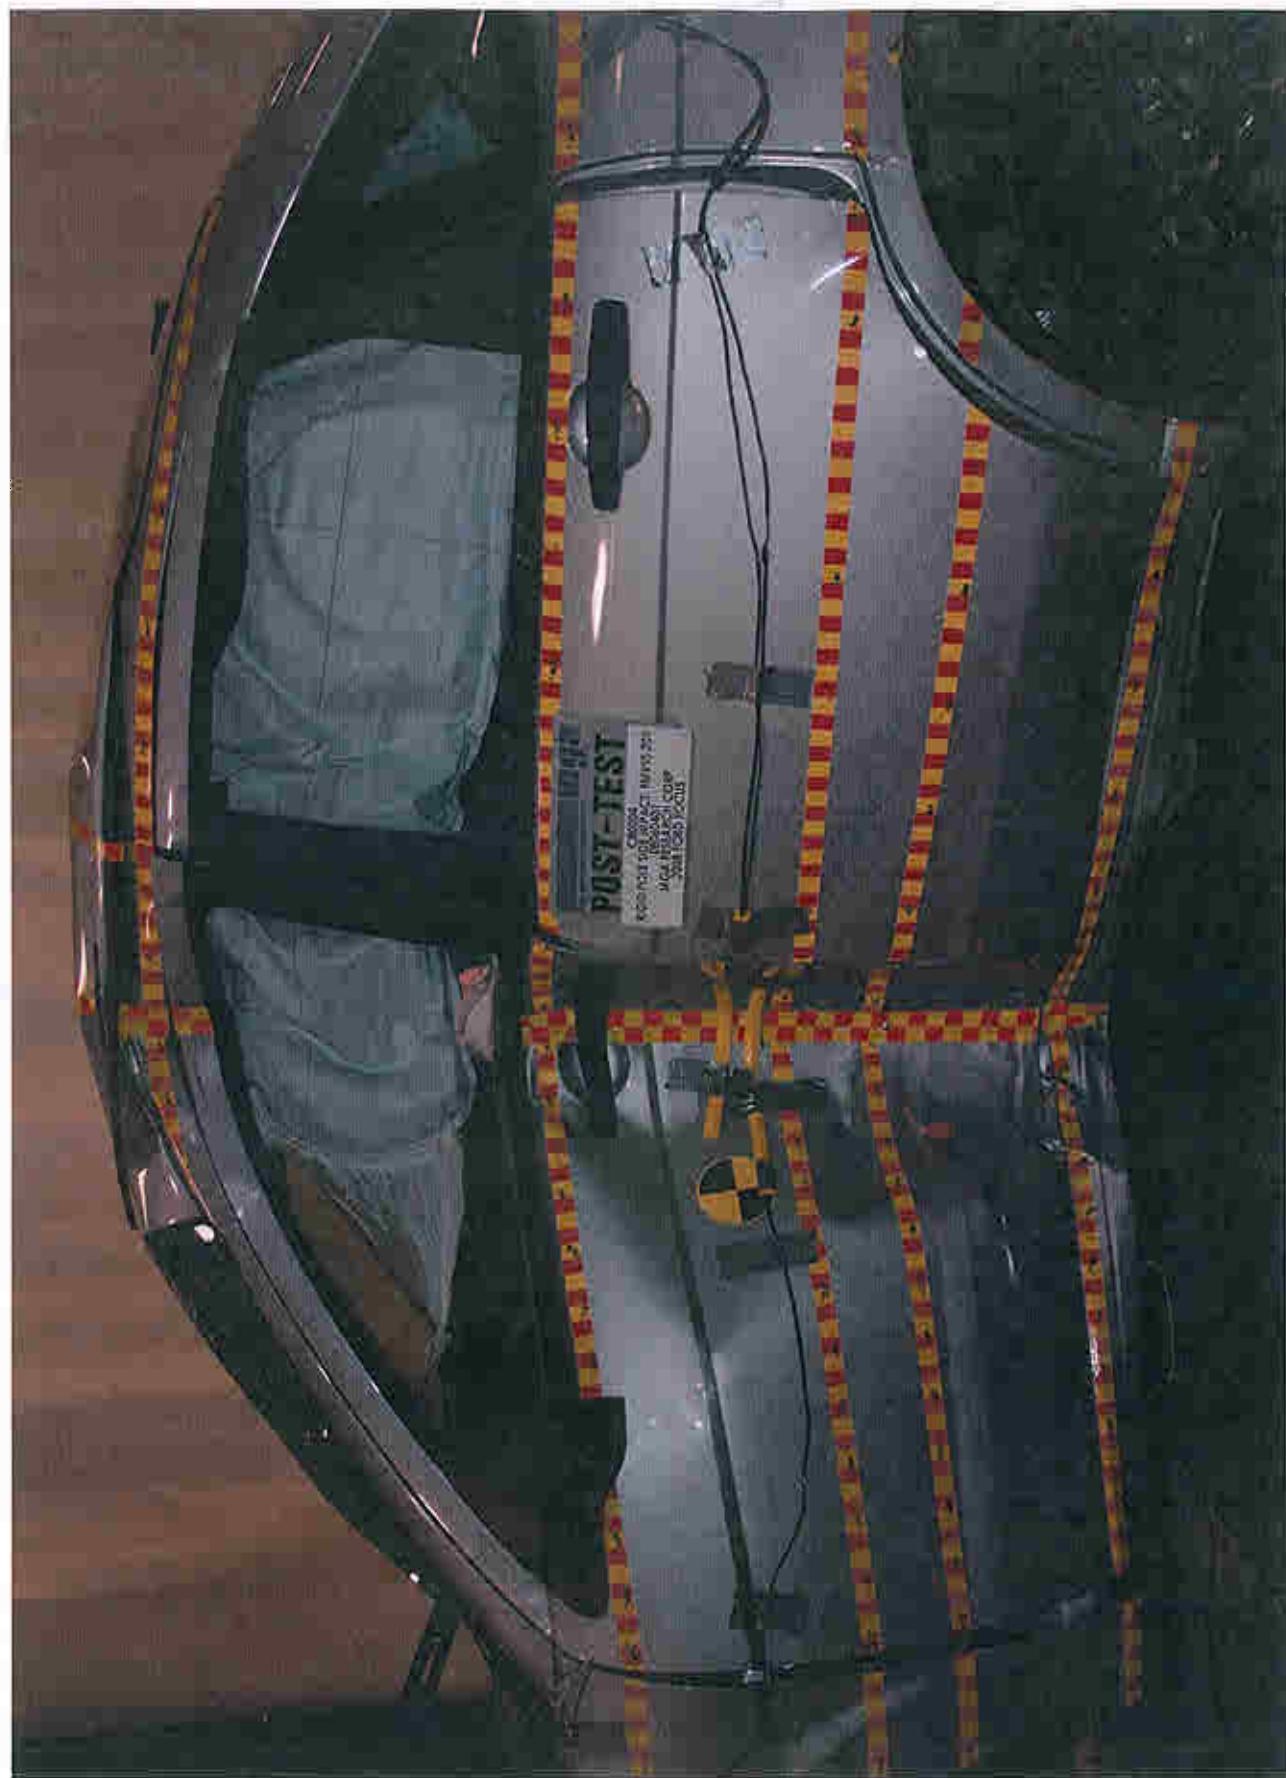
Post-Test Impact Zone Close-up View
