**REPORT NUMBER: 222-MGA-2009-003**

**SAFETY COMPLIANCE TESTING FOR  
FMVSS NO. 222  
SCHOOL BUS PASSENGER SEATING AND CRASH PROTECTION**

**BLUE BIRD BODY COMPANY  
2009 BLUE BIRD MICRO BIRD SCHOOL BUS  
NHTSA NO.: C90902**

**PREPARED BY:  
MGA RESEARCH CORPORATION  
5000 WARREN ROAD  
BURLINGTON, WI 53105**

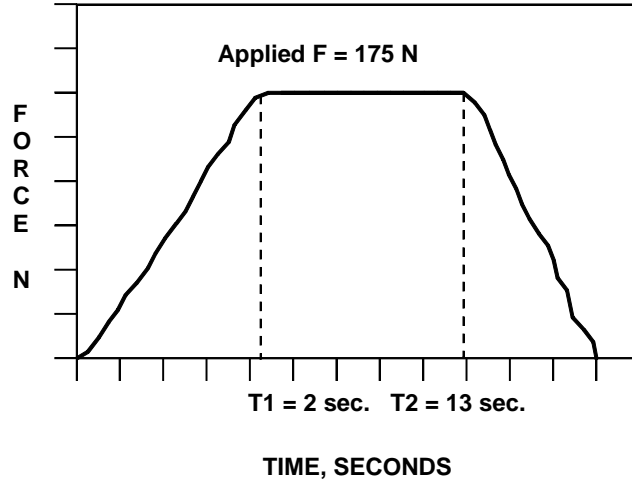
**SEAT NUMBER: S1**

1. Cushion Weight/Mass = 3.2 kg
2. Cushion Weight x 5 = F = 157 N (S5.1.5)
3. Complete the following force/time graph:

F must be 5 x Cushion Weight; t1 and t2 must be according to the following expressions:  
T1 => 1 sec., < 5 sec., t2 = t1 + 5 sec., + 0 sec. and -0.10 sec.

PASS/FAIL
4.	Did seat cushion separate from the seat structure at any attachment point? (S5.1.5) Yes – Fail; No – Pass	<b>PASS</b>

Seat Nos. S1 and S8 were tested in accordance with Section 12.3 of OVSC TP-222-03. Seat cushion weight was 3.2 kg for both cushions S1 and S8. The maximum force reached for S1 was 175 N and 177 N for S8. For S1, the lower time limit boundary ( $t_1$ ) was approximately 3 seconds with approximate load duration of 16 seconds. For S8, the lower time limit boundary ( $t_1$ ) was approximately 4 seconds with approximate load duration of 12 seconds. As shown in Data Sheet No. 3, the seat cushions tested complied with all requirements.

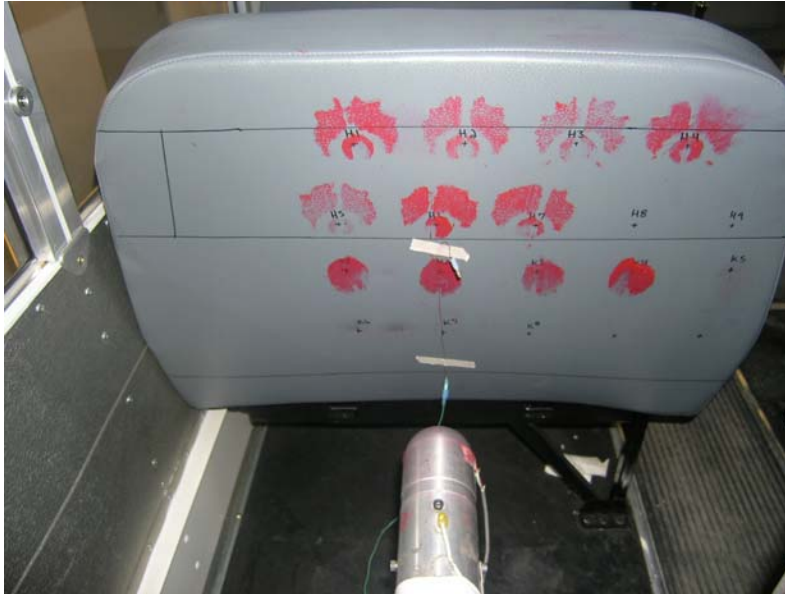
**SEAT NUMBER: S1**

1. Locate x-y reference point on sketch above for head form impact locations. (Label the positive and negative directions, if applicable)
2. Identify head form impact location on sketch by placing H1, H2, H3, H4, H5, H6, and H7 in the appropriate location.
3. Define and mark on graphic above, the plane of reference for head form impact angle:

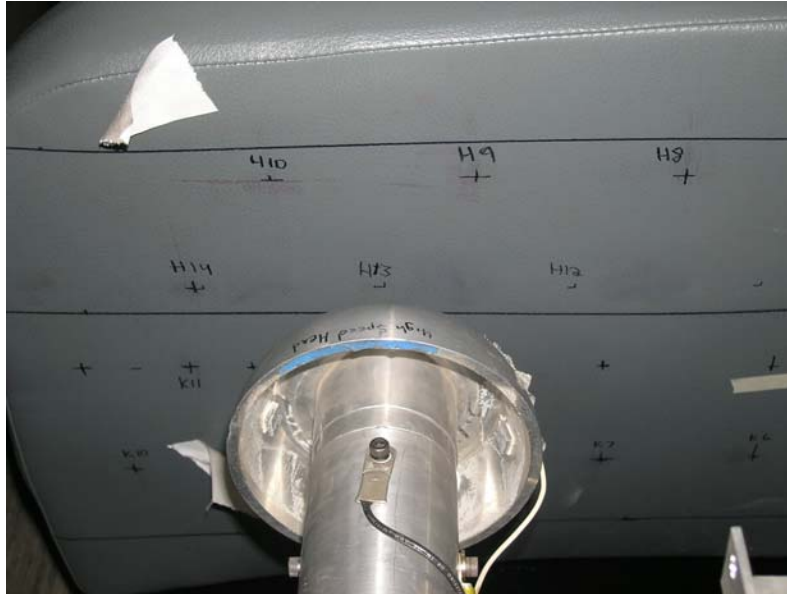
**SEAT NUMBER: S8**

1. Locate x-y reference point on sketch above for head form impact locations. (Label the positive and negative directions, if applicable)
2. Identify head form impact location on sketch by placing H8, H9, H10, H12, H13 and H14 in the appropriate location.
3. Define the plane of reference for knee form impact angle:  
0° = Parallel with Floor, (+) is Up, (-) is Down  
X = From Inboard Edge of the Seat  
Y = Measured Vertically from the SRP

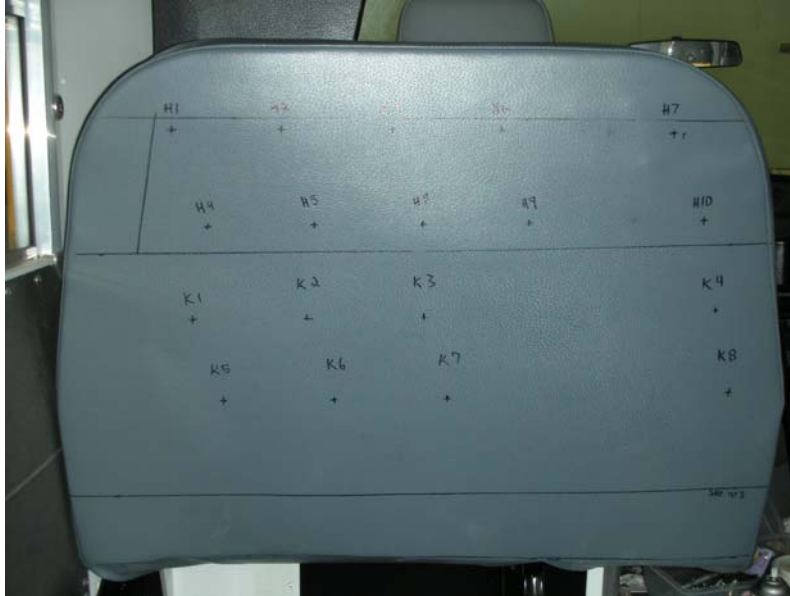
**BARRIER NUMBER: B1**

1. Locate x-y reference point on sketch above for head form impact locations. (Label the positive and negative directions, if applicable)
2. Identify head form impact location on sketch by placing H8 in the appropriate location.
3. Define the plane of reference for knee form impact angle:  
0° = Parallel with Floor, (+) is Up, (-) is Down  
X = From Inboard Edge of the Seat  
Y = Measured Vertically from the SRP

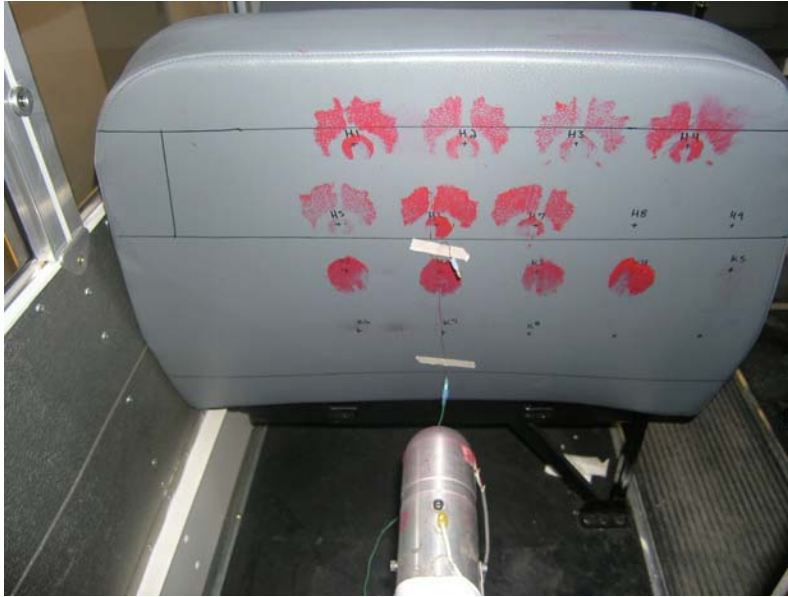
**SEAT NUMBER: S1**

1. Locate x-y reference point on sketch above for knee form impact locations. (Label the positive and negative directions, if applicable)
2. Identify knee form impact location on sketch by placing K1, K2, K3, K4, K5, K6, K7, and K8 in the appropriate location.
3. Define the plane of reference for knee form impact angle:  
0° = Parallel with Floor, (+) is Up, (-) is Down  
X = From Inboard Edge of the Seat  
Y = Measured Vertically from the SRP

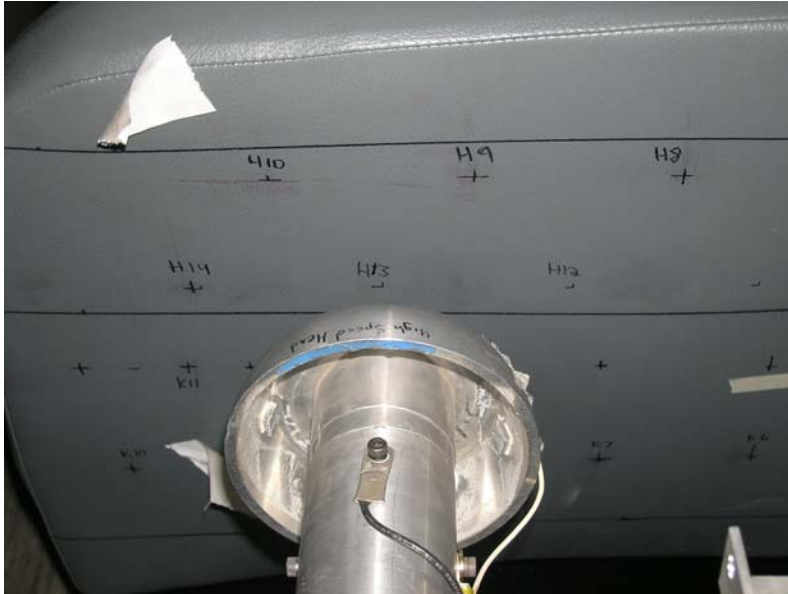
**SEAT NUMBER: S8**

1. Locate x-y reference point on sketch above for knee form impact locations. (Label the positive and negative directions, if applicable)
2. Identify knee form impact location on sketch by placing K9, K10, and K11 in the appropriate location.
3. Define the plane of reference for knee form impact angle:  
0° = Parallel with Floor, (+) is Up, (-) is Down  
X = From Inboard Edge of the Seat  
Y = Measured Vertically from the SRP

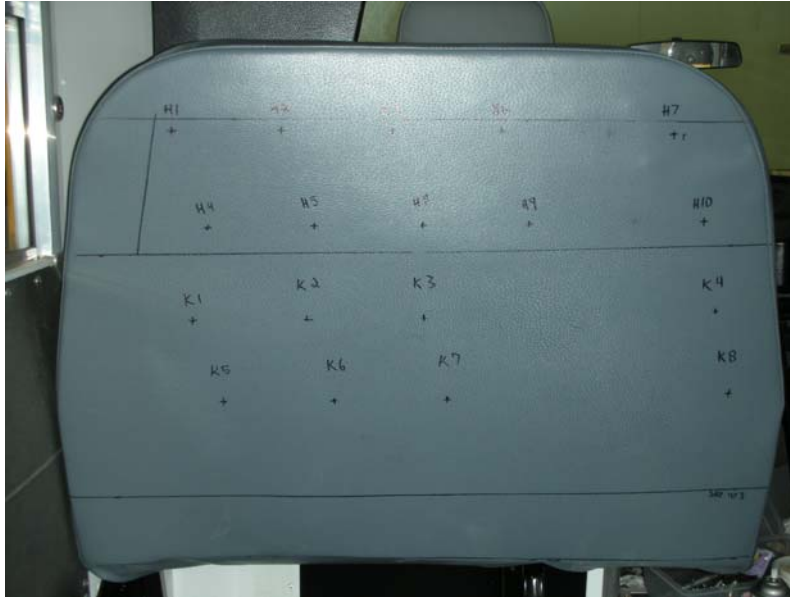
**BARRIER NUMBER: B1**

1. Locate x-y reference point on sketch above for knee form impact locations. (Label the positive and negative directions, if applicable)
2. Identify knee form impact location on sketch by placing K1, K2, K3, K4, K5, and K6 in the appropriate location.
3. Define the plane of reference for knee form impact angle:  
0° = Parallel with Floor, (+) is Up, (-) is Down  
X = From Inboard Edge of the Seat  
Y = Measured Vertically from the SRP

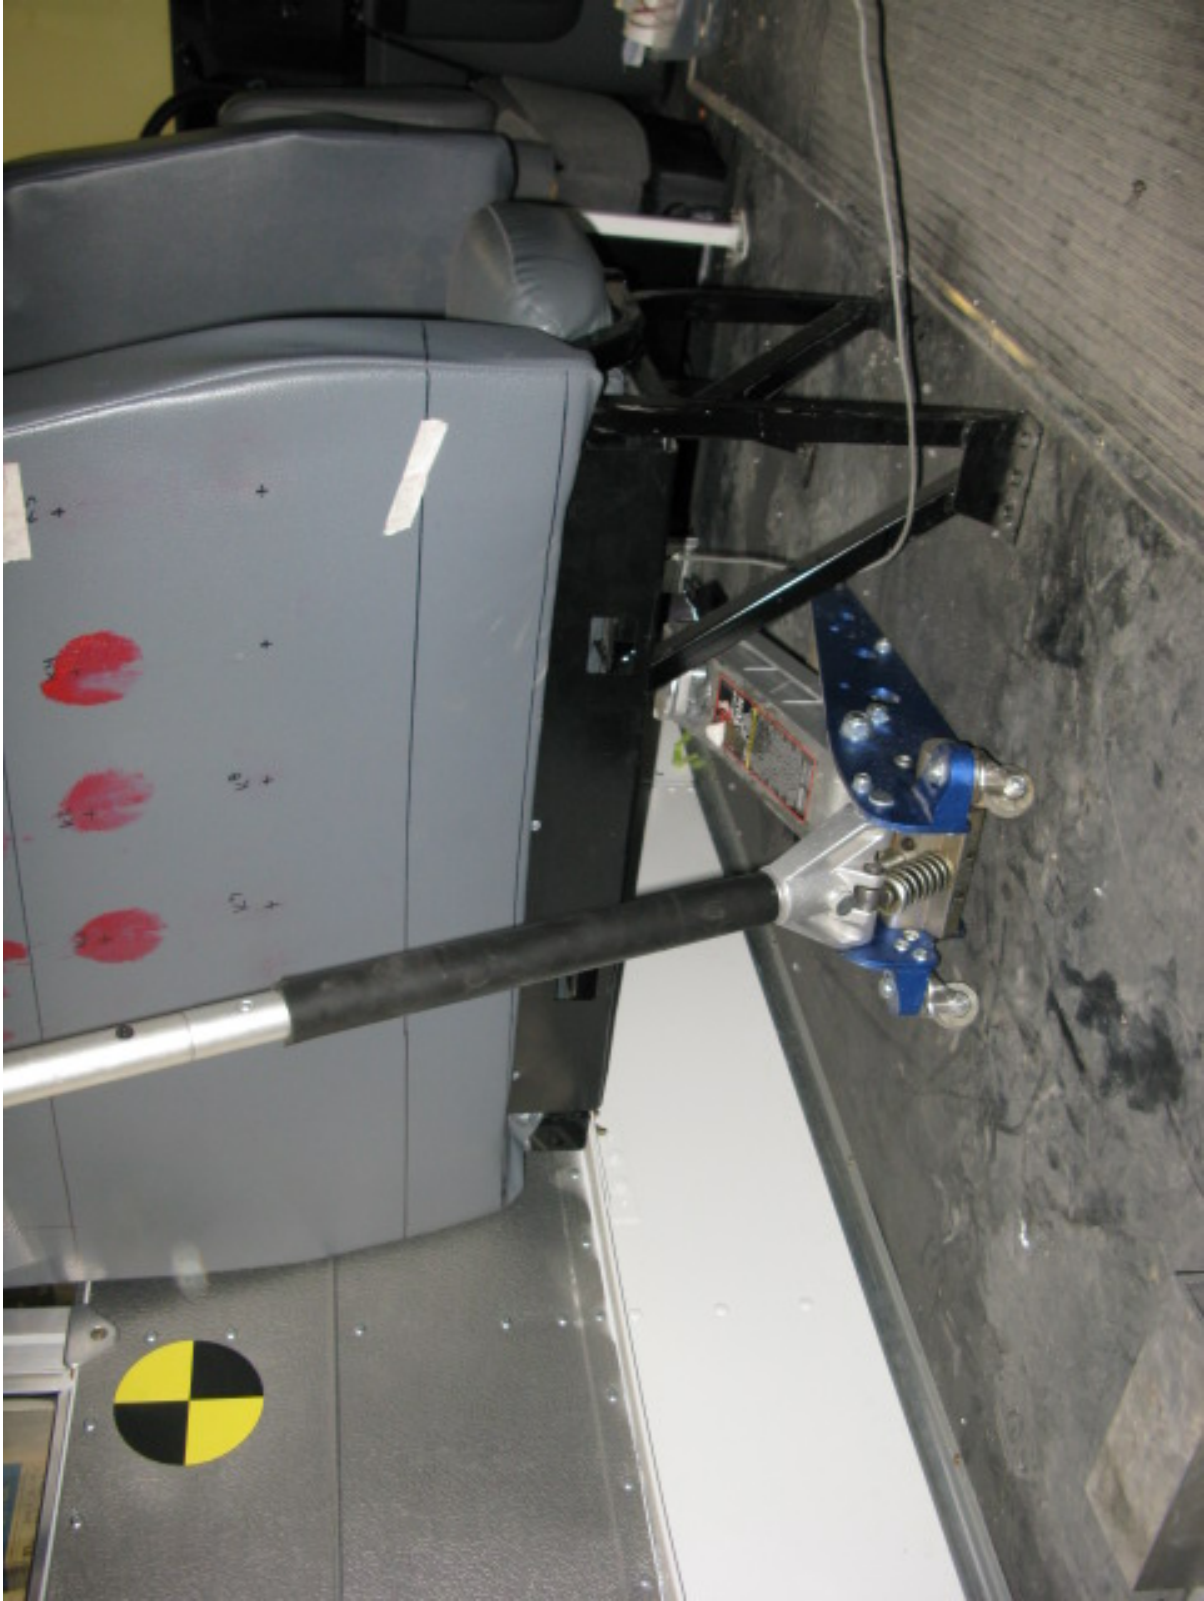
Pre-Test of Seat Cushion Retention Set Up View 1

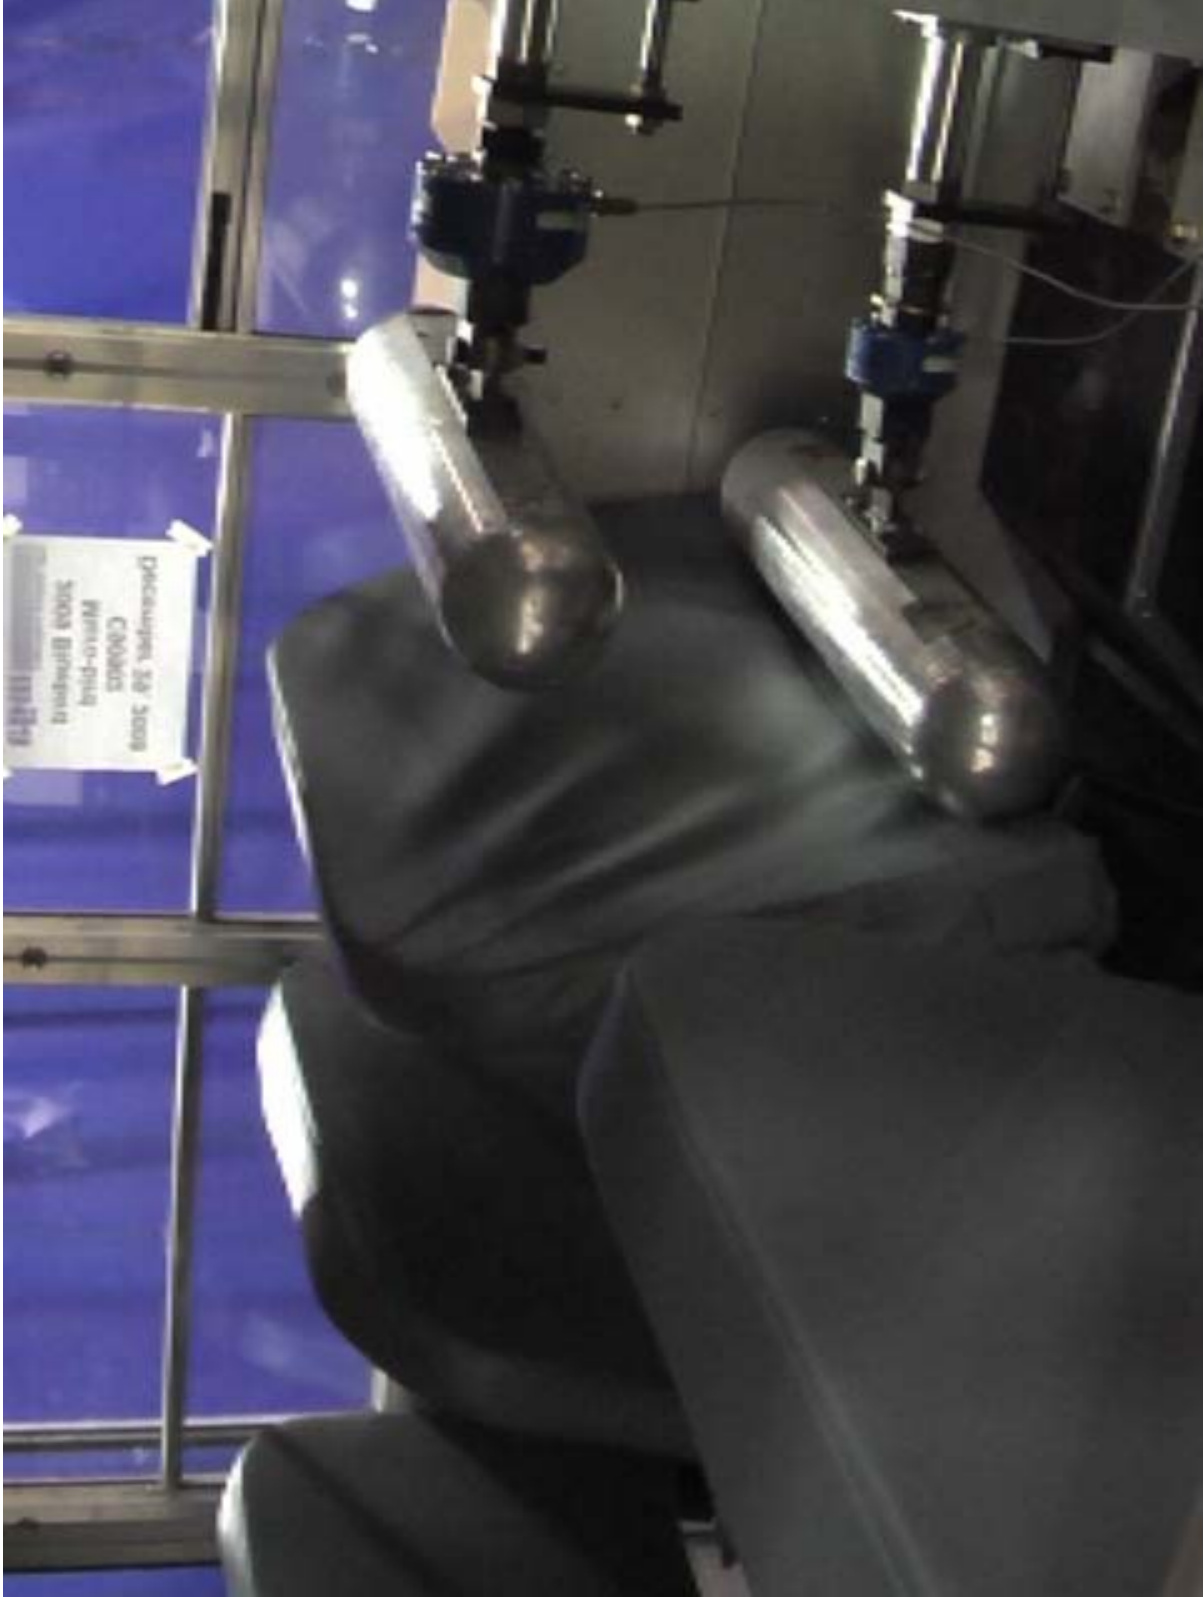
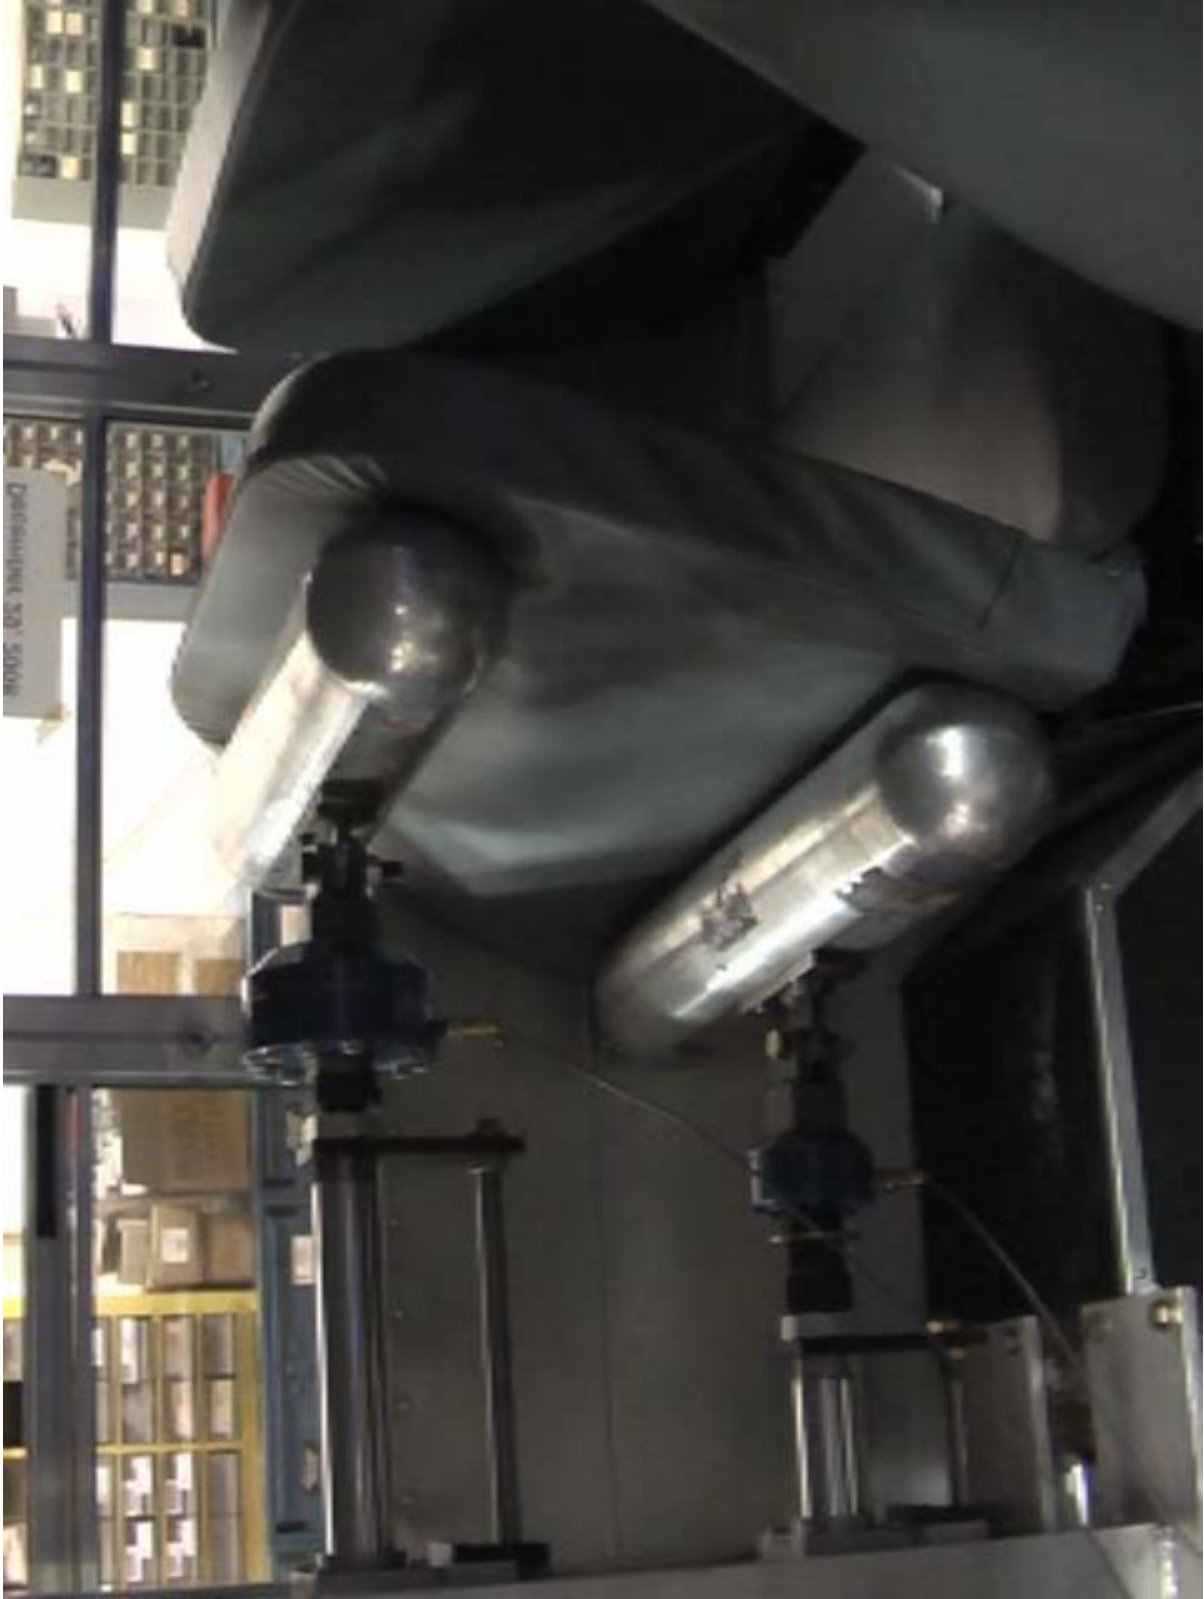
Post-Test of Seat Back S7 Force Deflection Forward Test

Seat No. S7 was tested in accordance with Section 12.4 of OVSC TP-222-03. Seat bench width was determined to be 866 mm. "W" was calculated to be 2.272 and rounded to the nearest whole number (2). The seating reference point (SRP) was 474 mm above the bus floor. The deflection of the seat back at conclusion of lower loading bar loading at 1557 W N load was 60 mm on S7. The allowable maximum deflection without moving the seat back to within 102 mm of another seat or restraining barrier was 356 mm. The stroke rate of the upper loading bar was determined by the test engineer to be 14.4 mm/sec. The location of the upper loading bar was 406 mm above the SRP. The tests were concluded when the maximum deflection of 356 mm was reached in which the seat back absorbed 1568 joules. The minimum required area under the force versus deflection curve of the upper loading bar was 452 W or 904 joules. As shown on Data Sheet No. 4, S7 did meet the force deflection forward requirements.

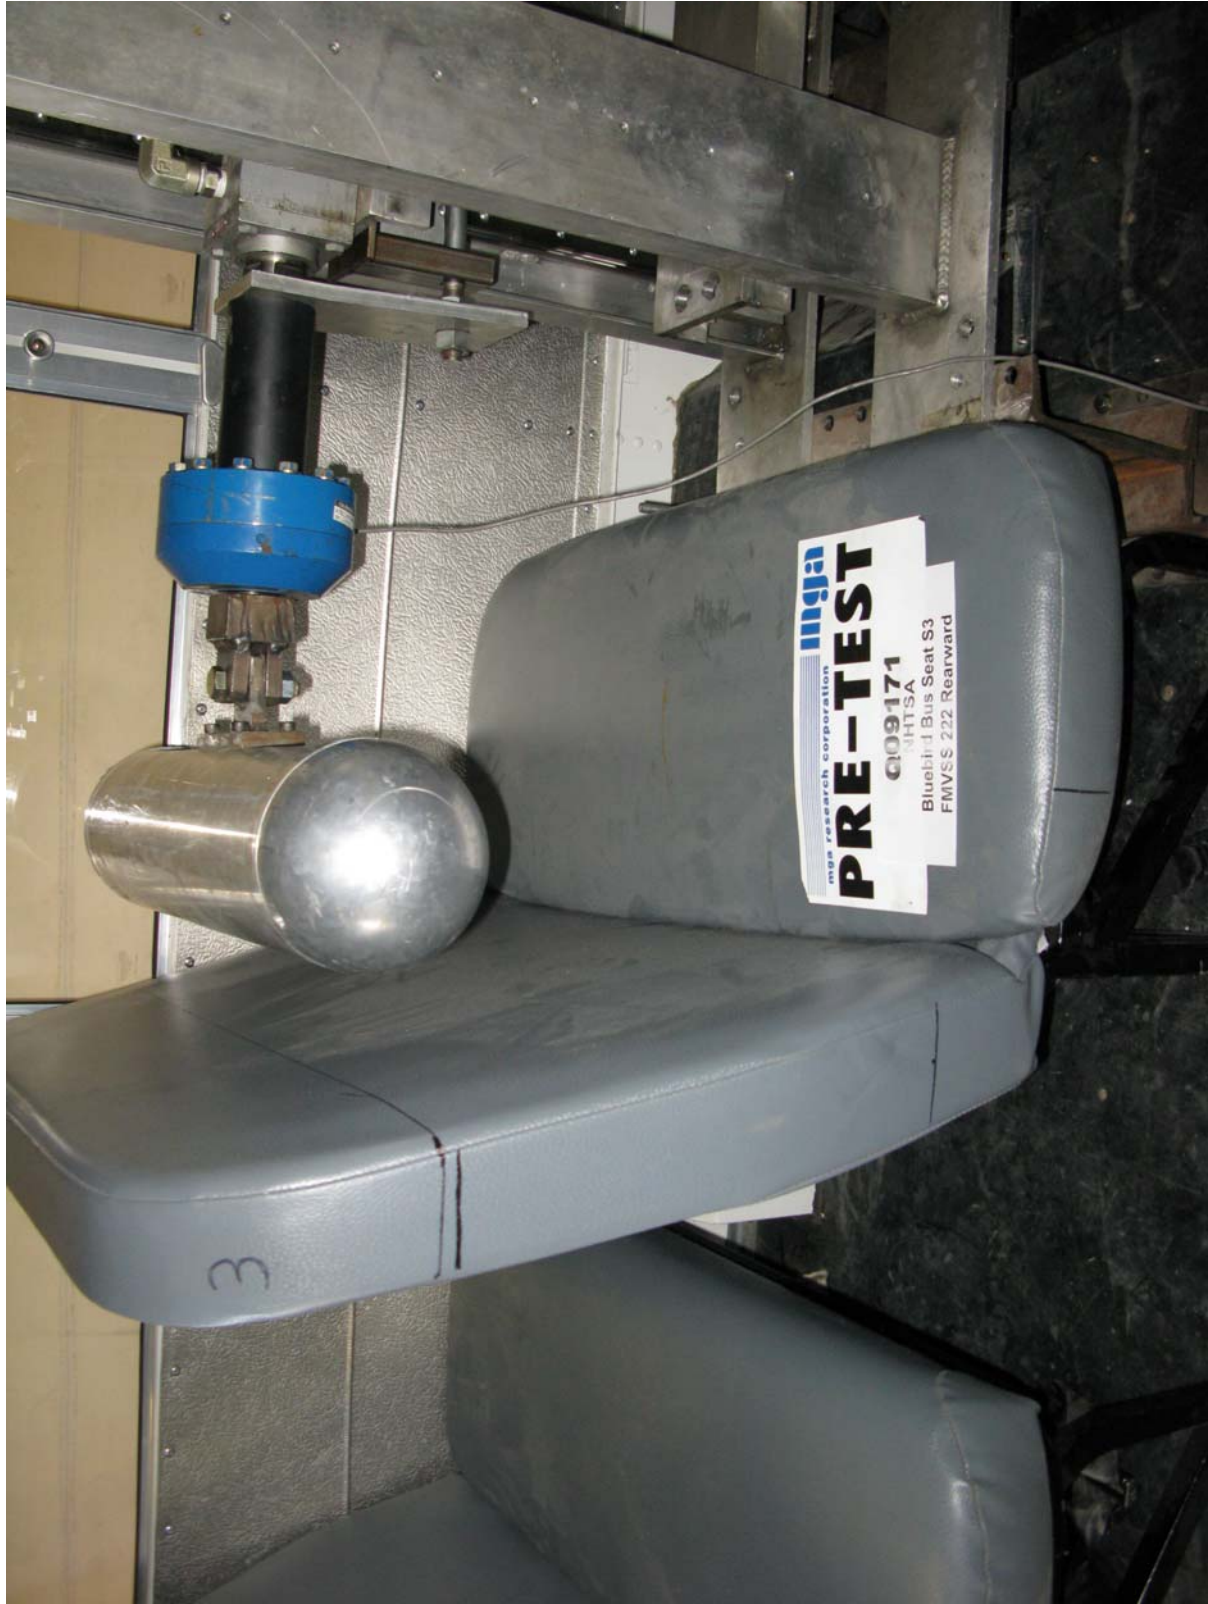
Pre-Test of Seat Back S3 Force Deflection Rearward Test

Seat No. S3 was tested in accordance with Section 12.4 of OVSC TP-222-03. Seat bench width was determined to be 866 mm for S3. "W" was calculated to be 2.272 and rounded to the nearest whole number (2). The seating reference point (SRP) was 474 mm above the bus floor. The allowable maximum deflection without moving the seat back to within 102 mm of another seat or restraining barrier was 254 mm. The stroke rate of the upper loading bar was determined by the test engineer to be 8.76 mm/sec for S3. The location of the loading bar was 343 mm above the SRP. The test was stopped when the maximum deflection of the seat back of 254 mm was achieved. The minimum required area under the force versus deflection curve of the loading bar was 316W or 632 joules. As shown in Data Sheet No. 5, S3 did meet the force deflection rearward requirements.

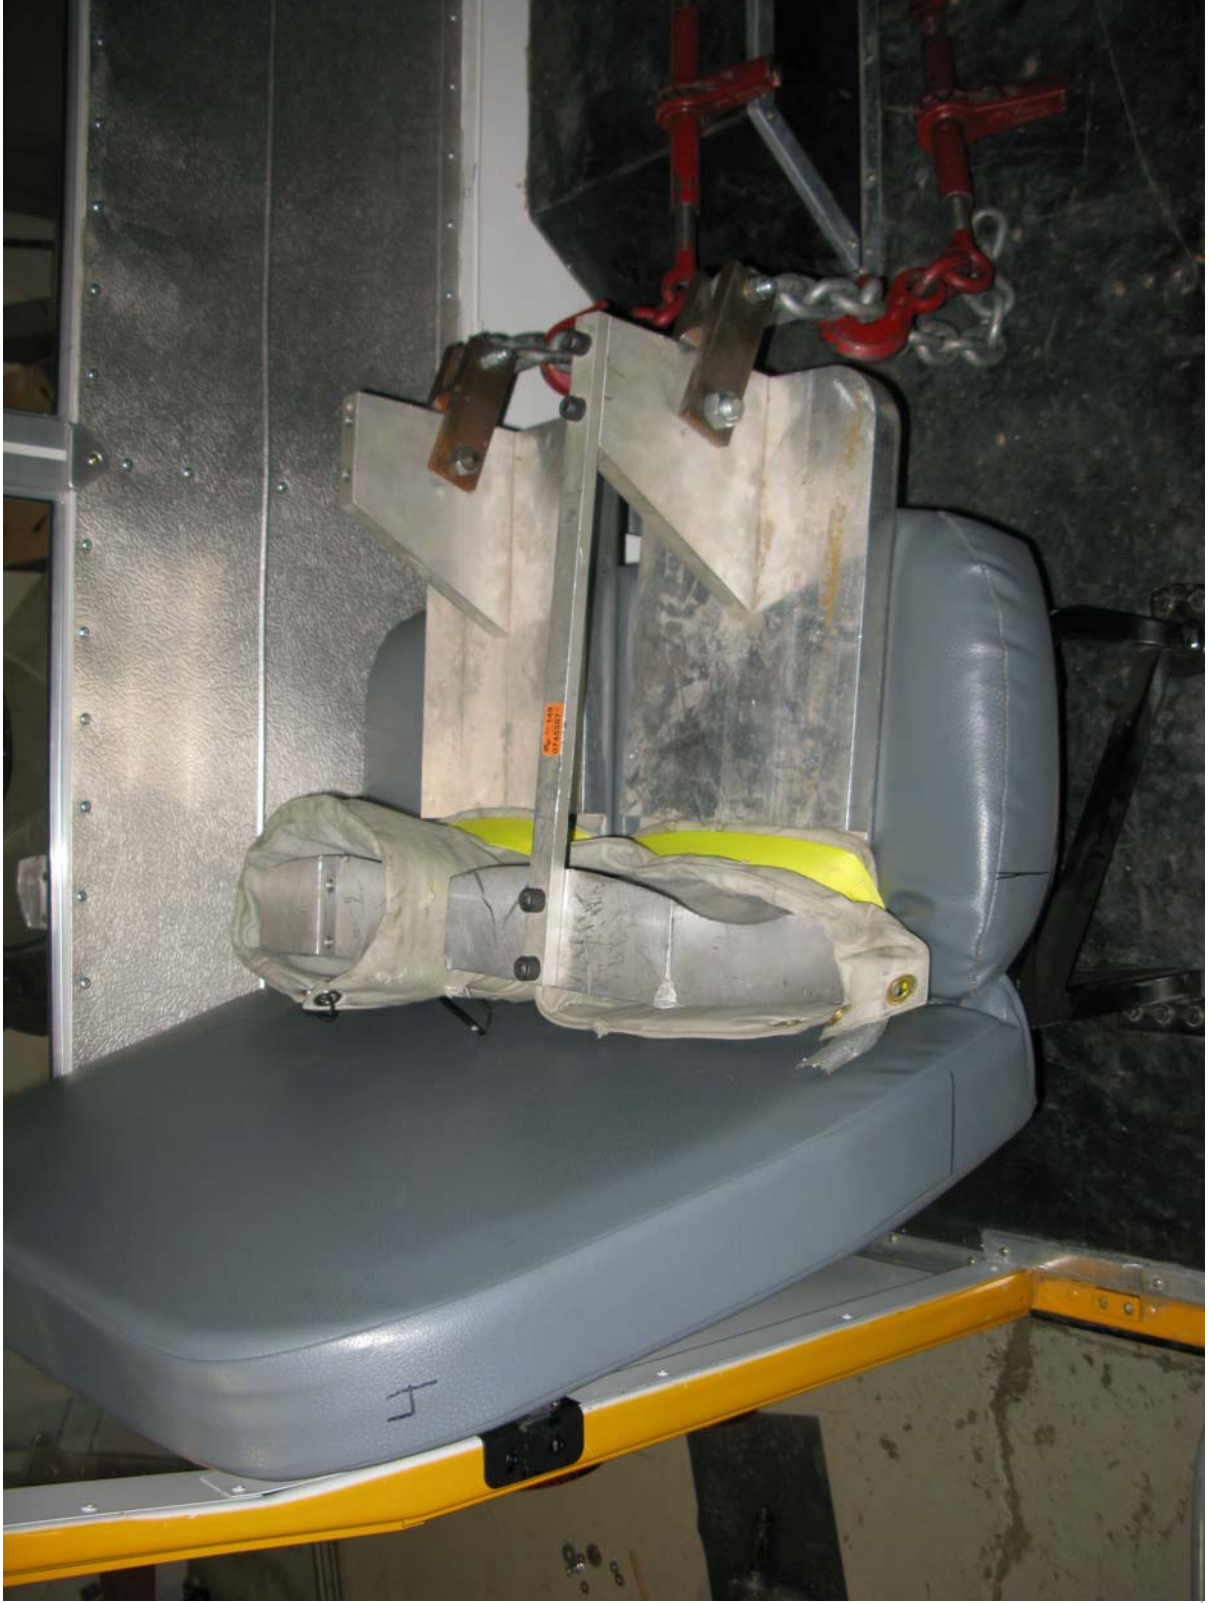
Pre-Test of Seat S4 210 Test

Seat belt anchorages for Seat No. S4 were tested in accordance with Appendix A of OVSC TP-222-03. S4 is located as shown in Section 8, Bus Floor Plan.

Seat belt anchorages and specially made high strength webbing straps were used to conduct the test. The seat belt anchor points met the required load of 22,000 N for each. Data from this test are presented in Data Sheet No. 11.

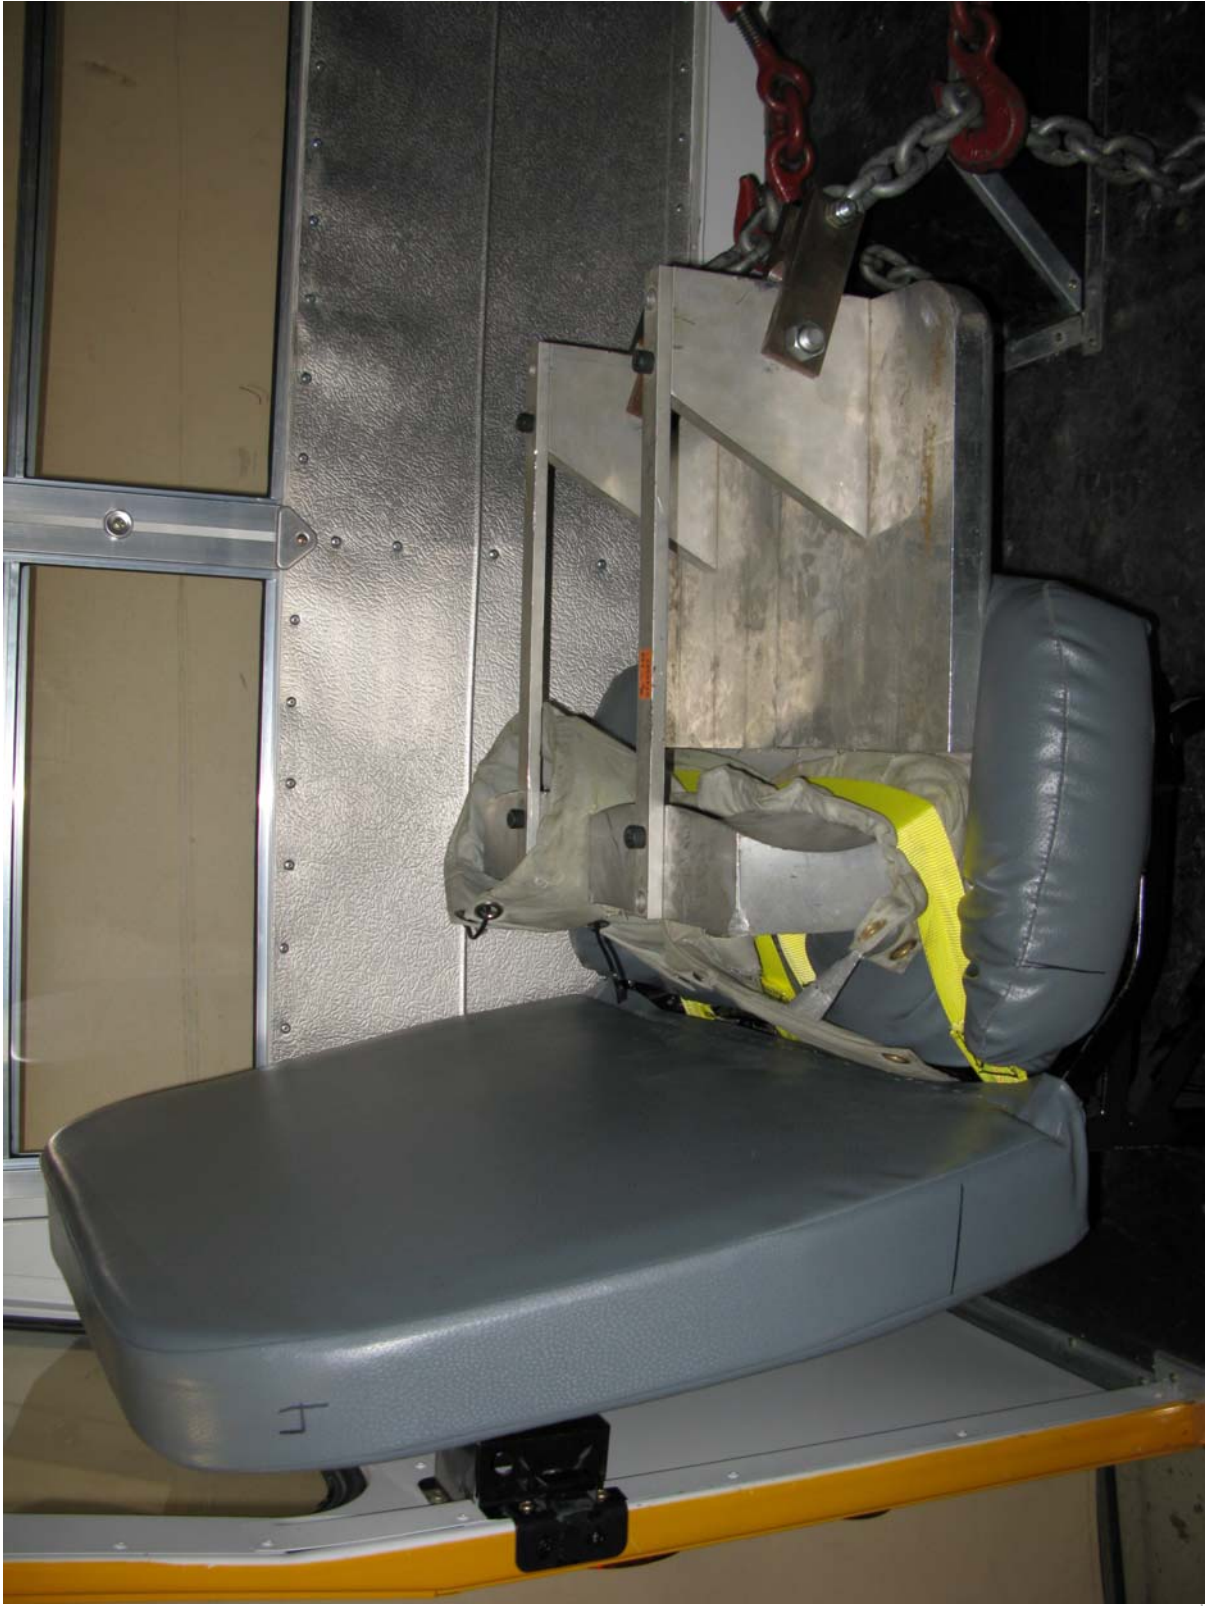
Post-Test of Seat S4 210 Test

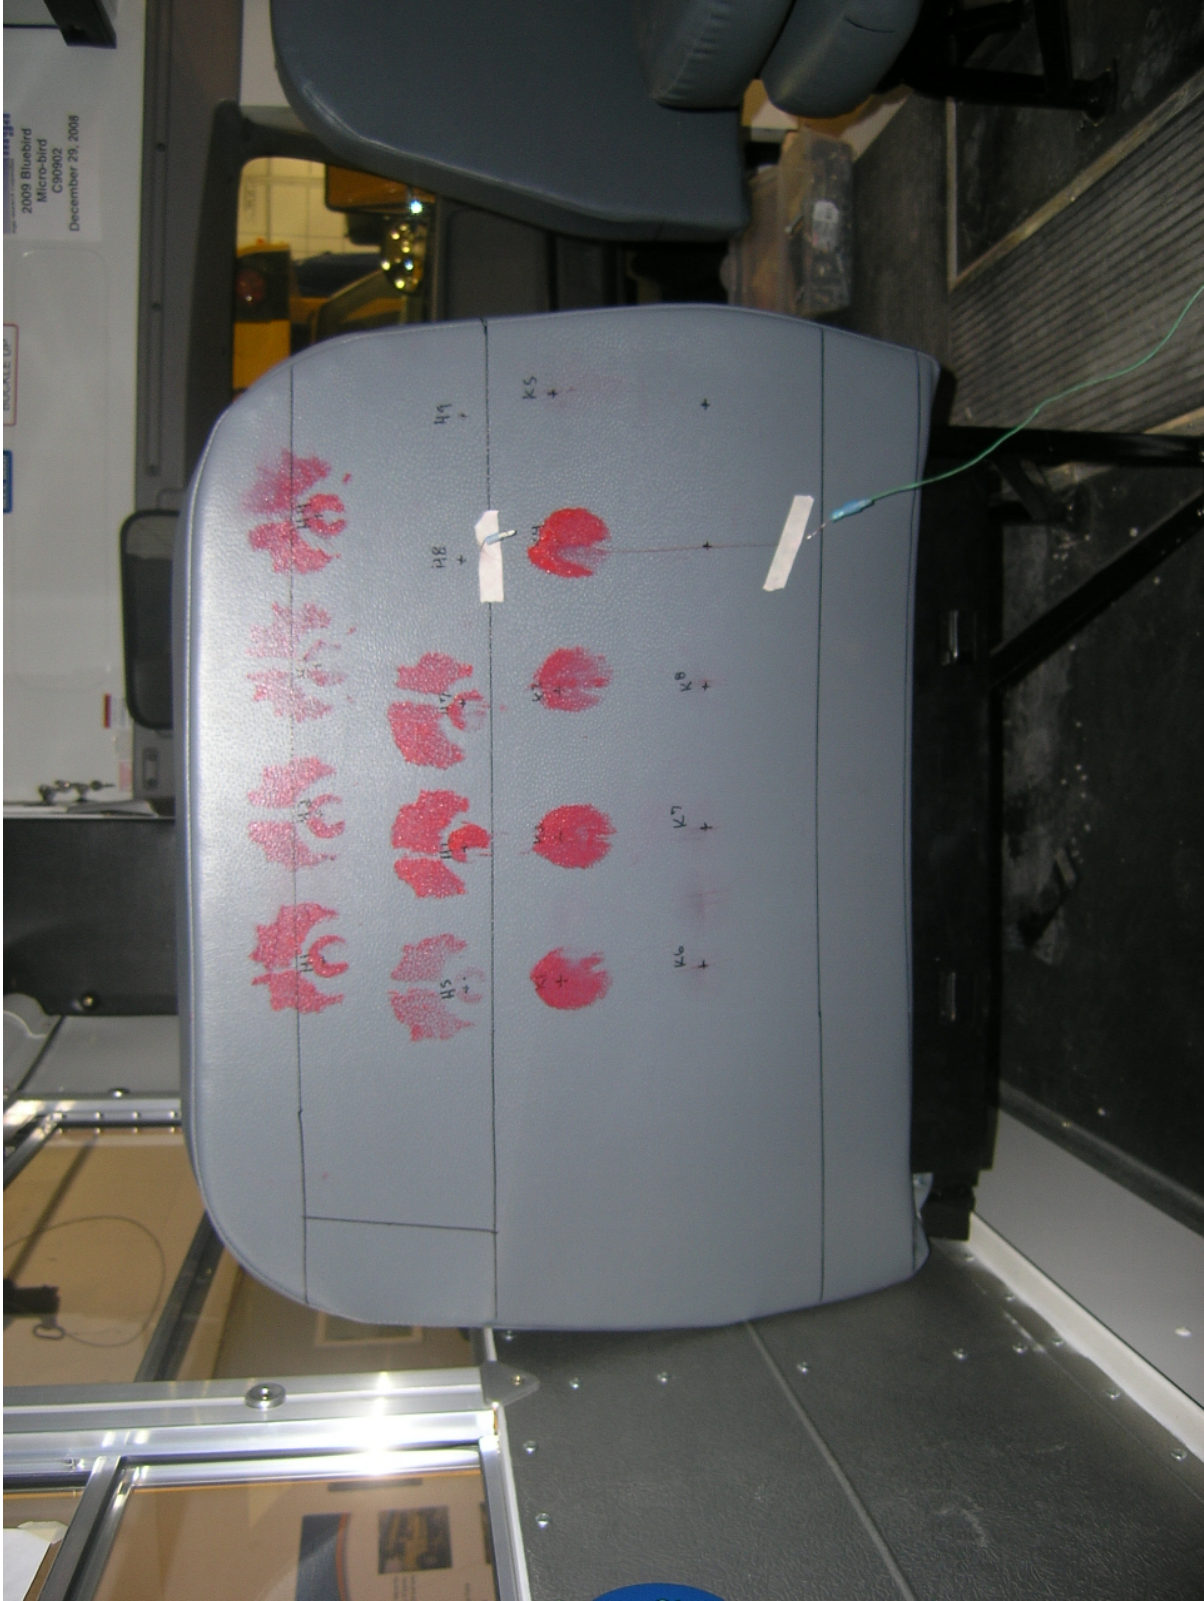
\*\*\* It was concluded through post-test analysis that the knee impact velocities were in excess of that required by FMVSS No. 222, S5.3.2.2. Therefore, the resistive forces recorded for K1 and K4 do not indicate test failures. The velocities indicated by the speed trap were lower than the true velocities due to longitudinal movement of the speed trap. Only knee impact tests on Seat No. S1 were affected.

Post-Test of Head and Knee Impact Locations on Seat S1

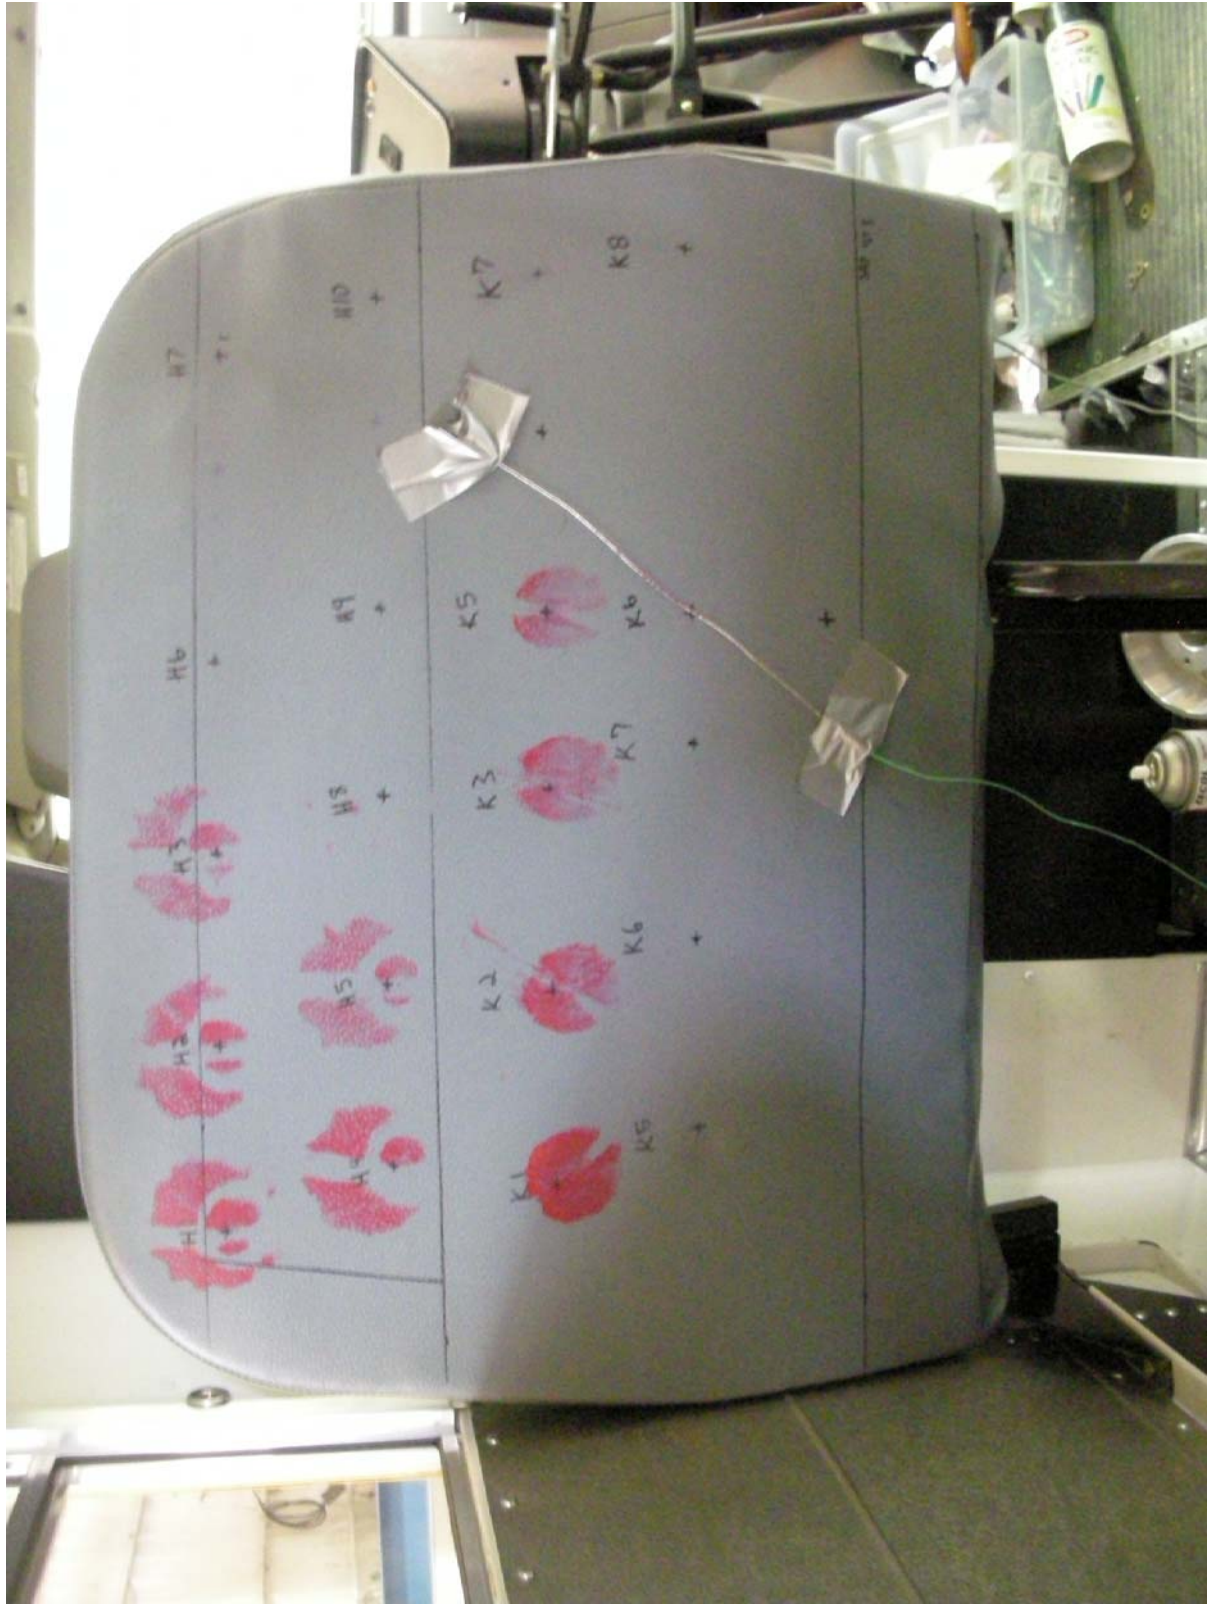
During the dynamic knee impact test on Barrier No. B1, the resistive force exceeded the limit of 2669 N for impact locations B1 K5 and B1 K6.

Post-Test of Head and Knee Impact Locations on Barrier B1

During the Knee Impact test, the B1 barrier failed to provide the minimum resistive force at impact location K5 as required by S5.3.2.2. A repeat test at location K6 was performed with similar results.

Testing of the barrier was discontinued at the request of the COTR due to its failure to meet the knee impact requirements in previous tests. The testing was stopped in an effort to preserve the barrier for post-test inspection.

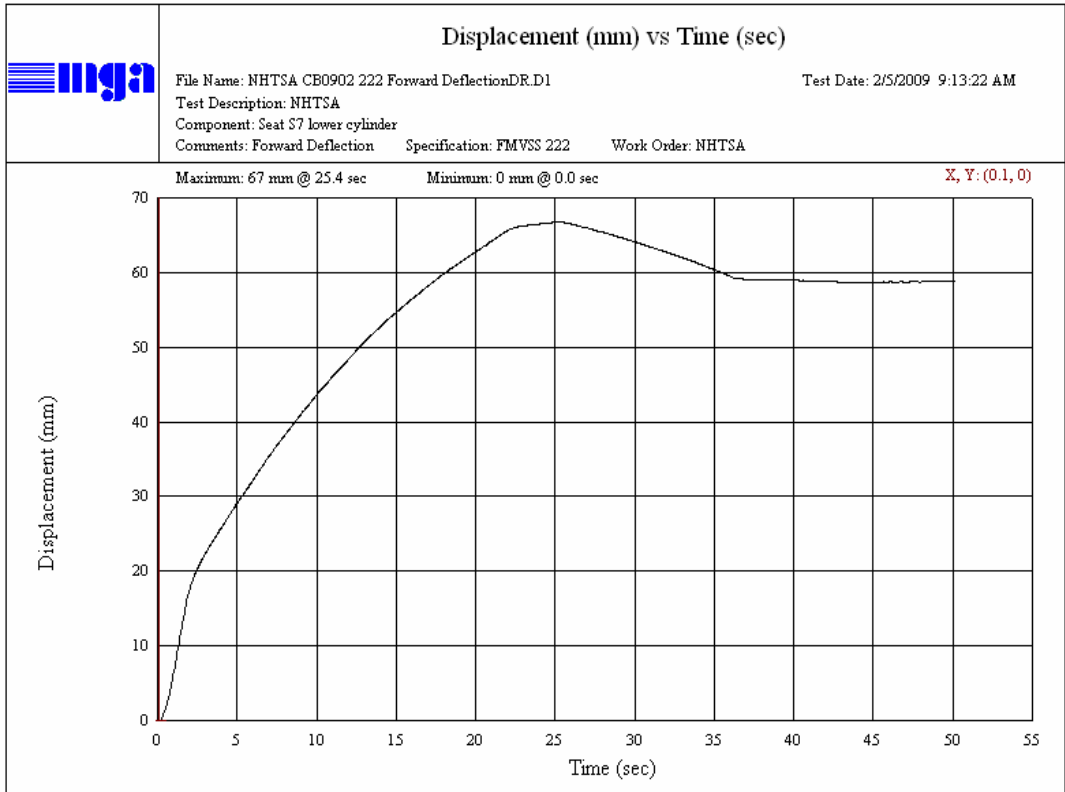
Seat Back Forward Deflection Seat S7 Lower Cylinder

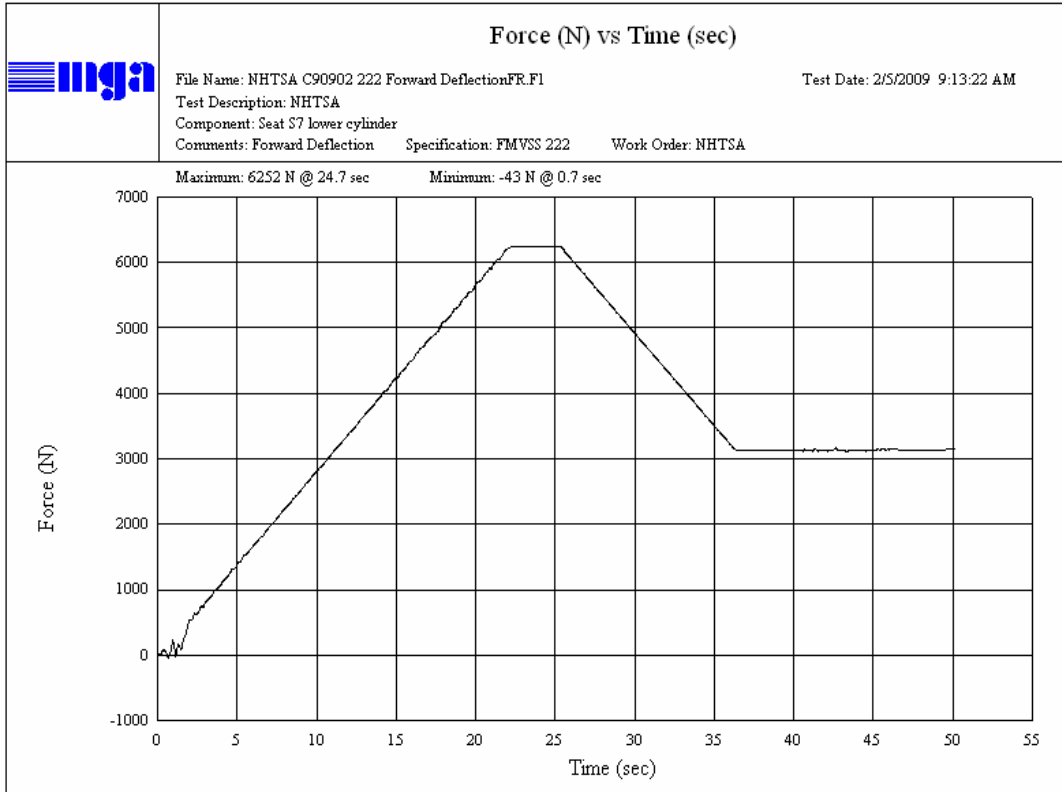
Seat Back Forward Deflection Seat S7 Lower Cylinder

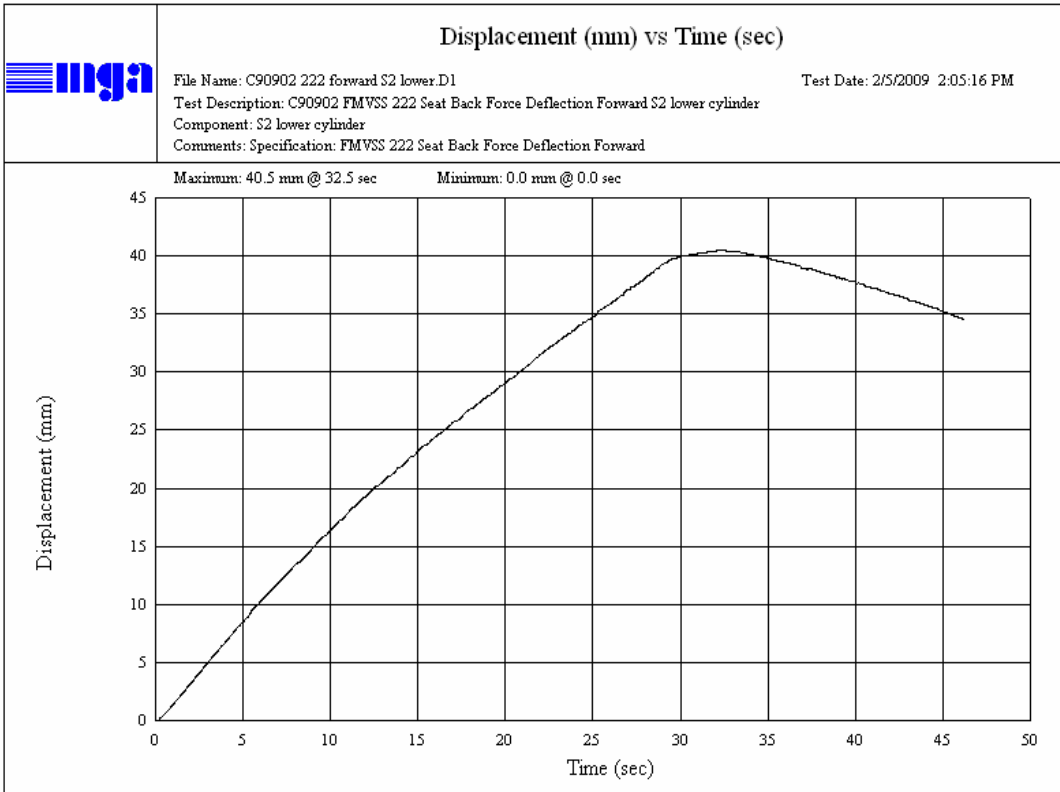
Seat Back Forward Deflection Seat S2 Lower Cylinder
