REPORT NUMBER 138-STF-09-005

# SAFETY COMPLIANCE TESTING FOR FMVSS NO. 138 TIRE PRESSURE MONITORING SYSTEMS

CHRYSLER LLC  
2009 DODGE JOURNEY  
FOUR-DOOR MPV  
NHTSA NO. C90302

FINAL REPORT

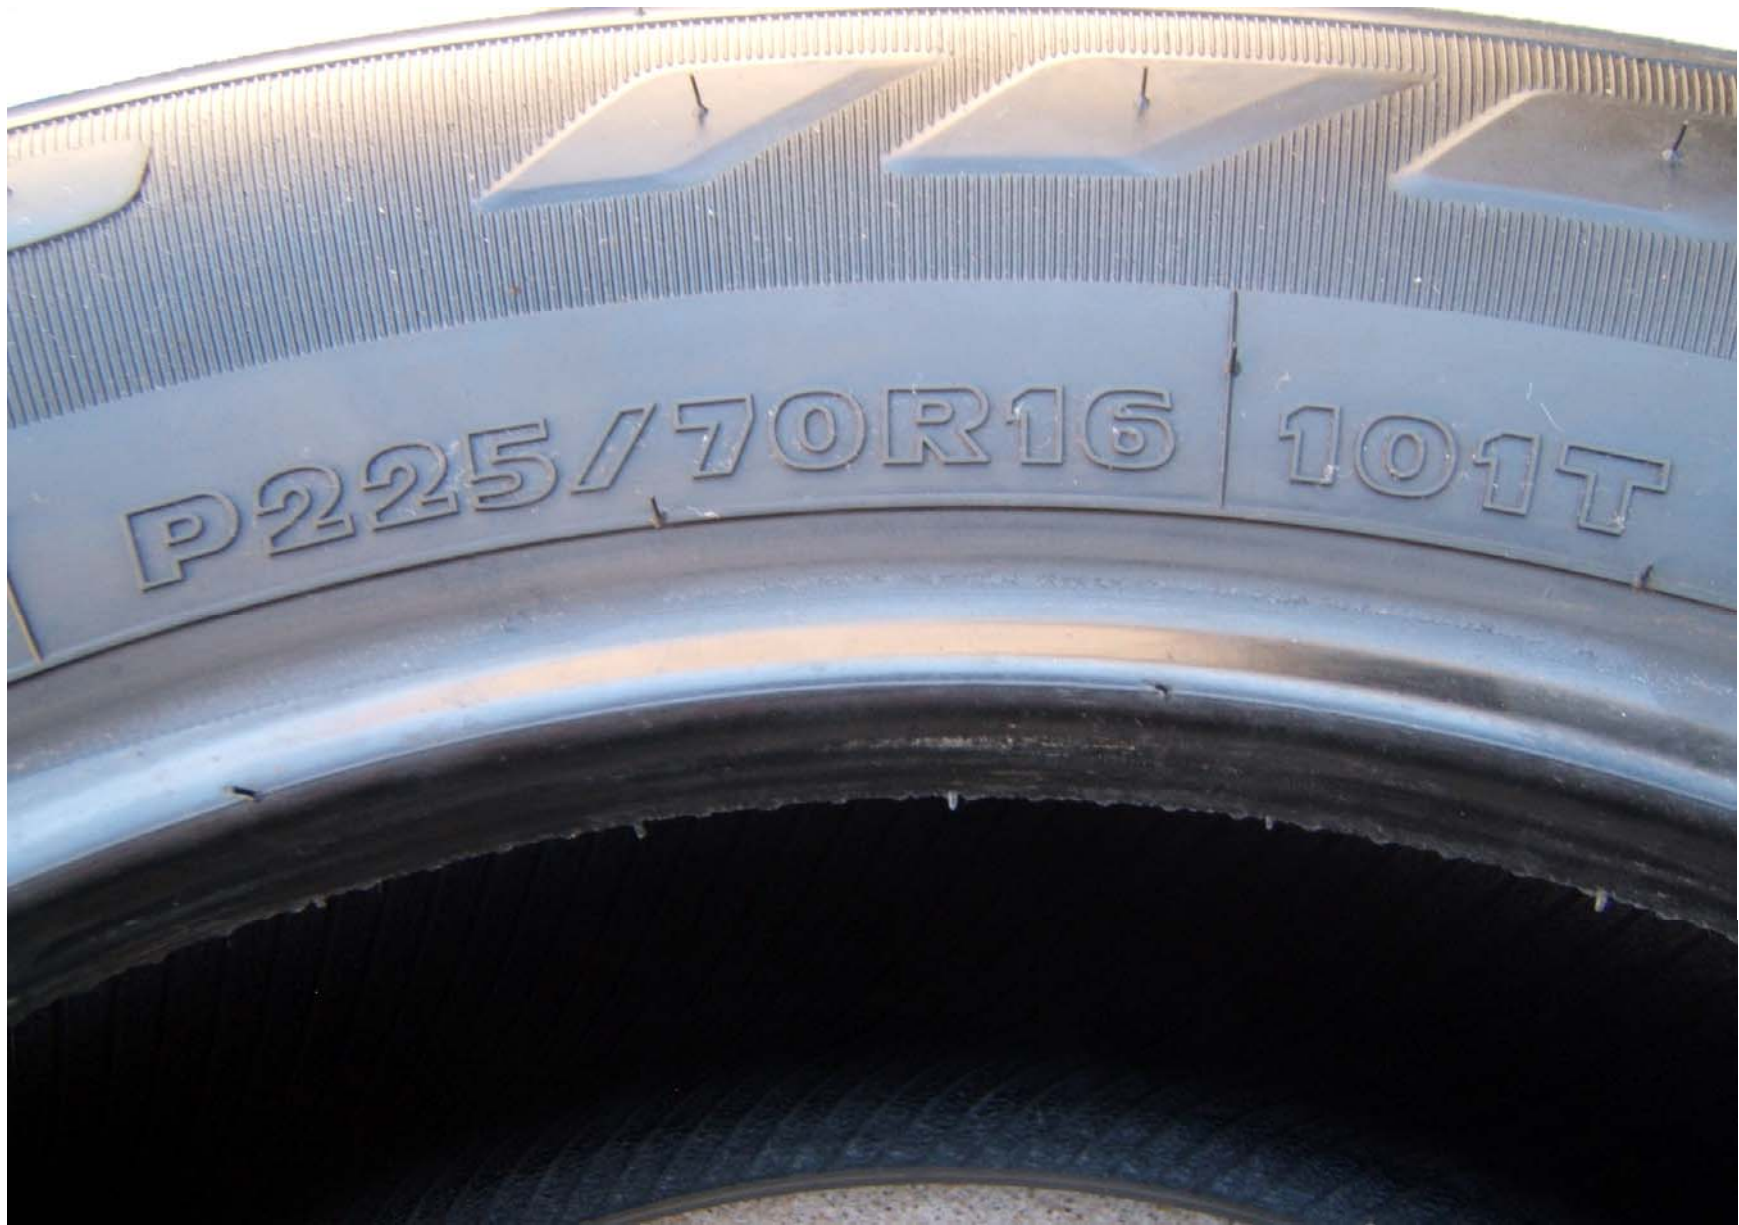
FIGURE 5.6  
TIRE SHOWING SIZE AND LOAD INDEX / SPEED RATING

Tire Size and Load Index / Speed Rating: P225/70R16 101T

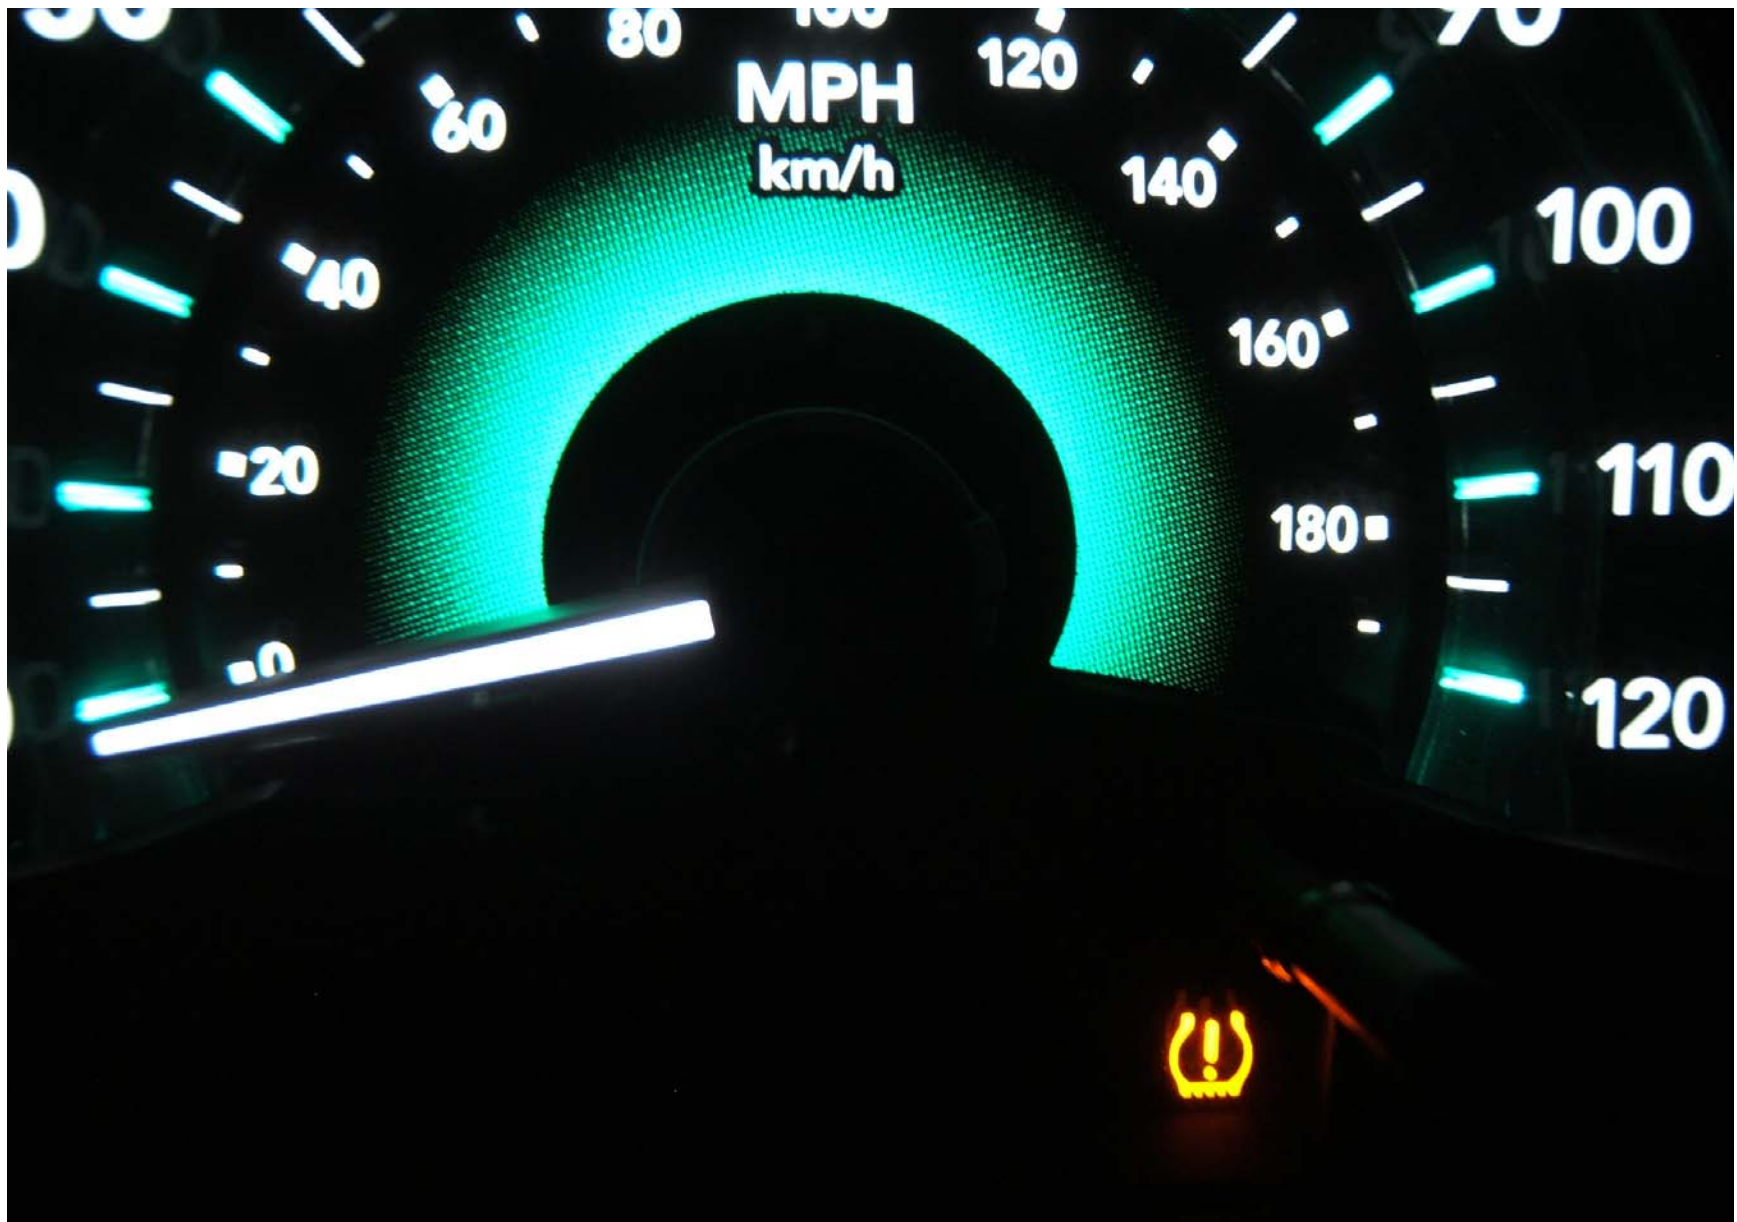
FIGURE 5.12  
DISPLAY SHOWING COMBINATION LOW TIRE PRESSURE  
WARNING / TPMS MALFUNCTION WARNING TELLTALE

REQUIREMENTS	PASS/FAIL
LOW TIRE PRESSURE WARNING TELLTALE S138: S4.3.1 (a), (b); S4.3.3 (a), (b)	
Mounting	<b>PASS</b>
Symbol and color	<b>PASS</b>
Check of lamp function	<b>PASS</b>
MALFUNCTION TELLTALE S138: S4.4 (b) or (c)	
Mounting	<b>PASS</b>
Symbol and color	<b>PASS</b>
Check of lamp function	<b>PASS</b>
LOW TIRE PRESSURE WARNING - OPERATIONAL PERFORMANCE S138: S4.2, S4.3.1 (c), S4.3.2	
Telltale illumination	<b>PASS</b>
MALFUNCTION INDICATOR – OPERATIONAL PERFORMANCE S138: S4.4 (a)	
Telltale illumination	<b>PASS</b>
TPMS WRITTEN INSTRUCTIONS S138: S4.5	
Image of telltales	<b>PASS</b>
Verbatim statements	<b>PASS</b>

Is the telltale yellow in color?      ( X )YES    ( )NO (fail)

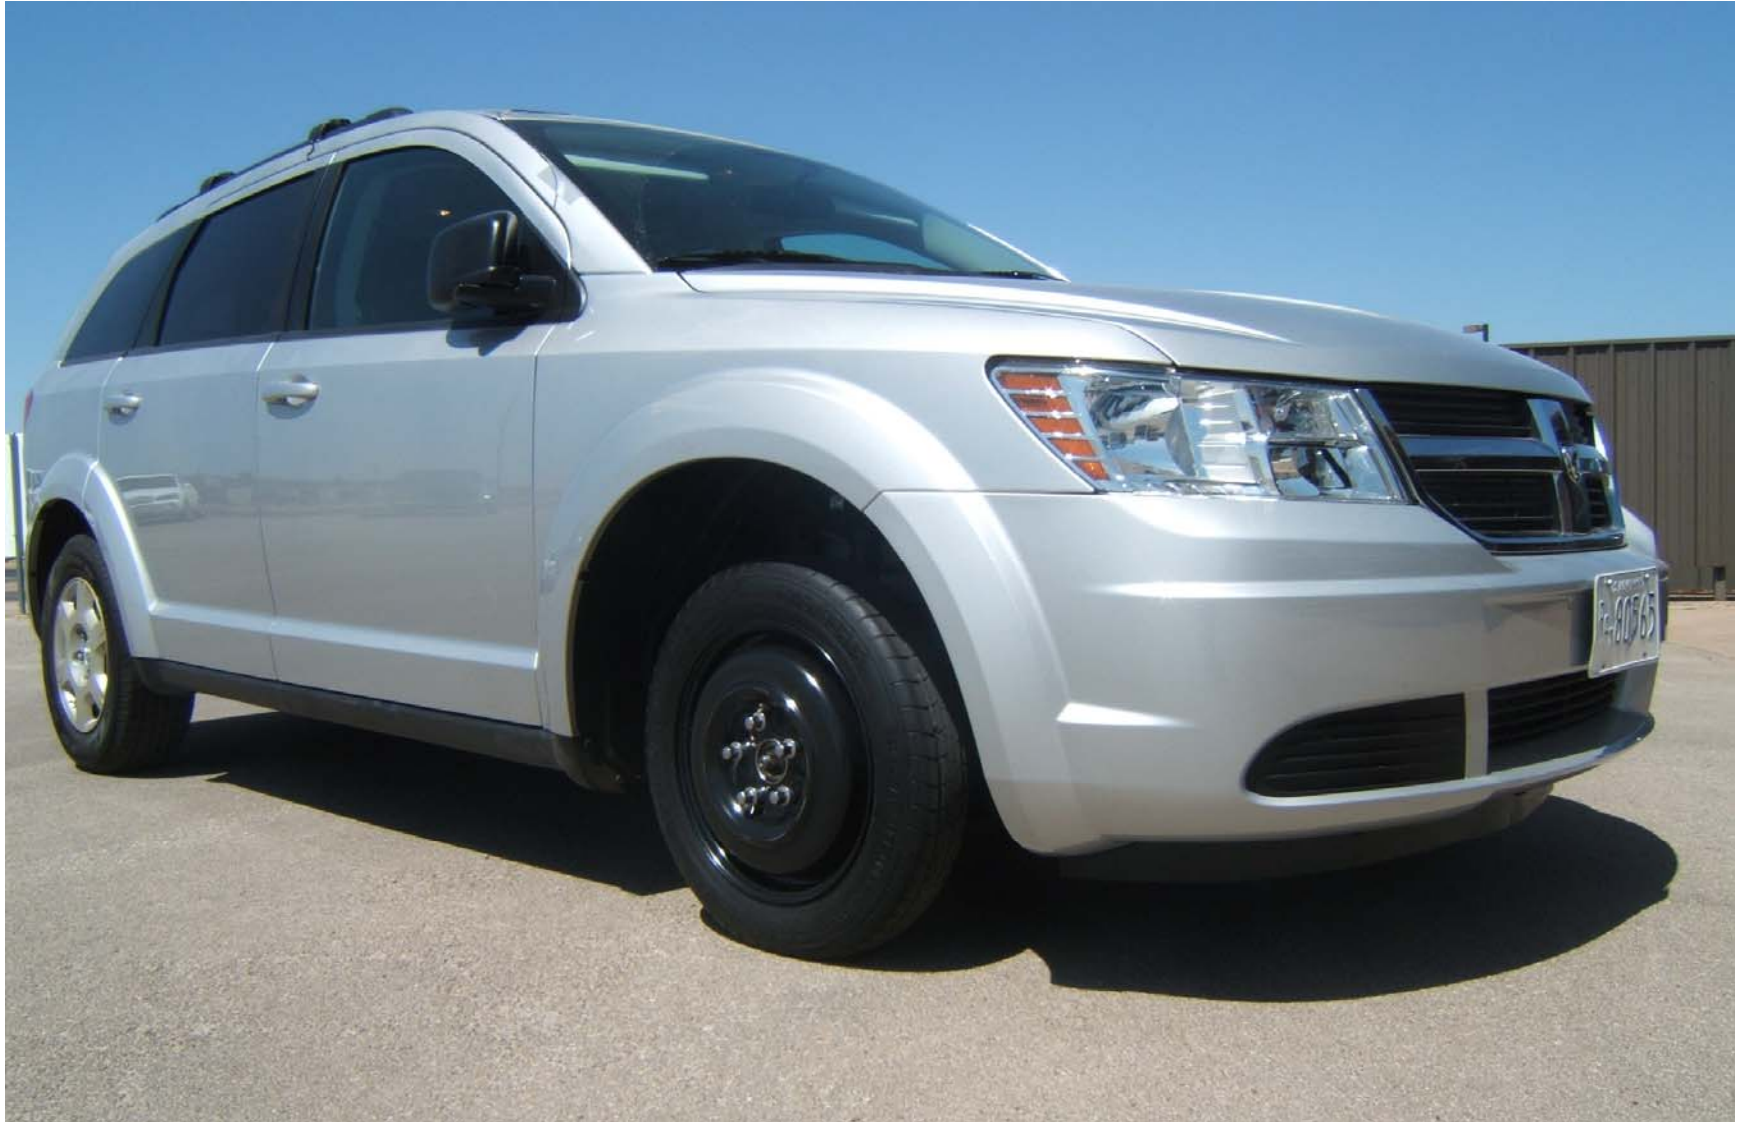
FIGURE 5.17  
SPARE INSTALLED ON RIGHT FRONT  
FOR MALFUNCTION DETECTION TEST

**TPMS MALFUNCTION PERFORMANCE TEST RESULTS (PASS/FAIL)**        PASS    
Spare without TPMS sensor was applied to right front at LLVW.
