**Report Number: 214-TRC-03-003**

**Safety Compliance Testing For FMVSS 214**

**Side Impact Protection**

**Nissan Motor Co., LTD  
2003 Nissan 350Z 2-door Coupe**

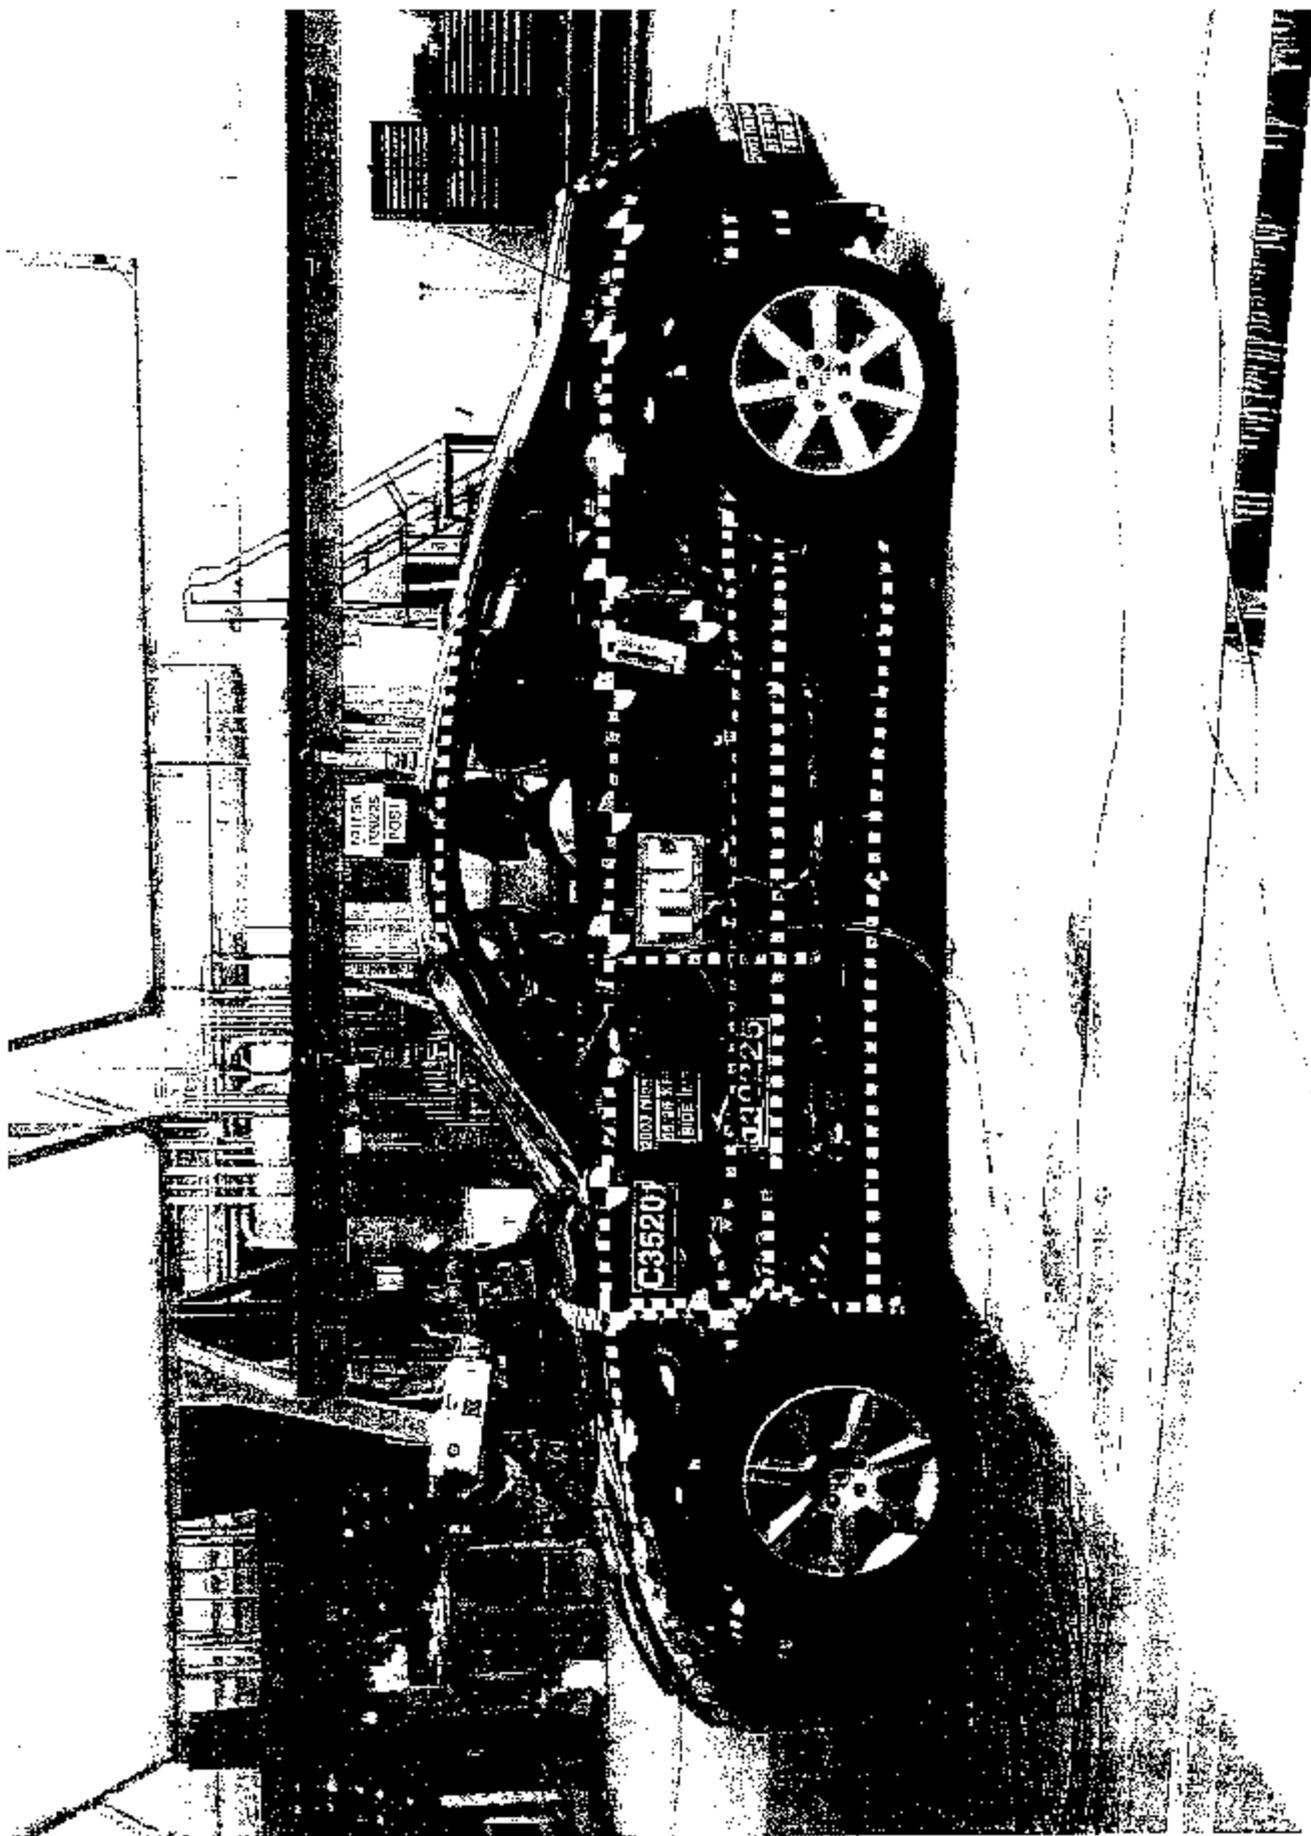
Figure A-4 Post-Test Impacted Side View of Test Vehicle

A 2003 Nissan 350Z 2-door coupe was impacted on the driver's side by a Moving Deformable Barrier (MDB) which was moving forward in a 27° crabbed position to the monorail at a velocity of 62.2 km/h (38.6 mph). The target vehicle was stationary and was positioned at an angle of 63° to the line of forward motion. The side impact test was conducted by Transportation Research Center Inc. in East Liberty, Ohio on February 25, 2003. Pre-test and post-test photographs of the test vehicle, the moving deformable barrier (MDB), and the side impact dummies (SIDs) are included in Appendix A.

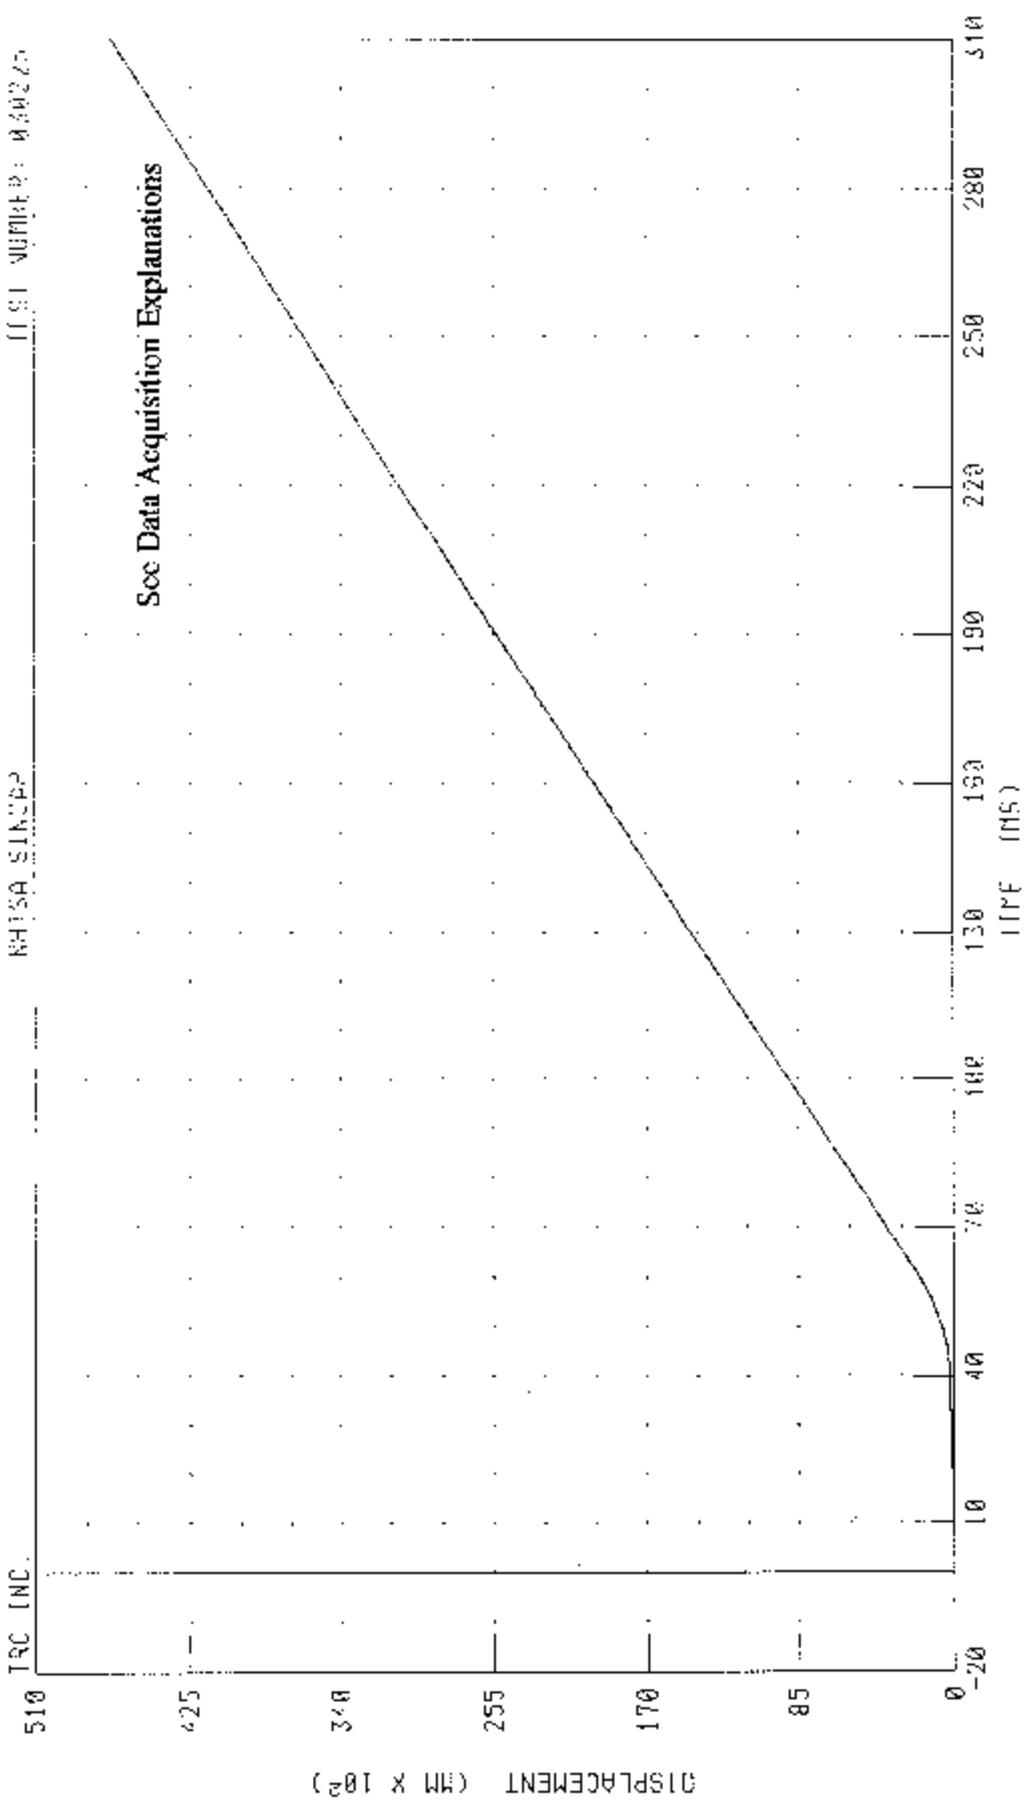
CHANNEL LFMYD1 FILTER CH CLASS 180 PFAK (AREA) 4E9E2 66 MM @ 310 00 MS, -4 KJ @ 11 6 1 78 MS

The left side sill at front Y-axis acceleration data channel, LFSYG1, recorded questionable data after 24 milliseconds and did not return to zero after the impact event. This affected the left side sill at front velocity and displacement calculations.

See Data Acquisition Explanations
