REPORT NUMBER 301L-GTL-03-002

**SAFETY COMPLIANCE TESTING FOR  
FMVSS NO. 301L  
FUEL SYSTEM INTEGRITY**

**FUJI HEAVY INDUSTRIES LTD.  
2003 SUBARU BAJA MPV  
NHTSA NO. C35501**

**FINAL REPORT**

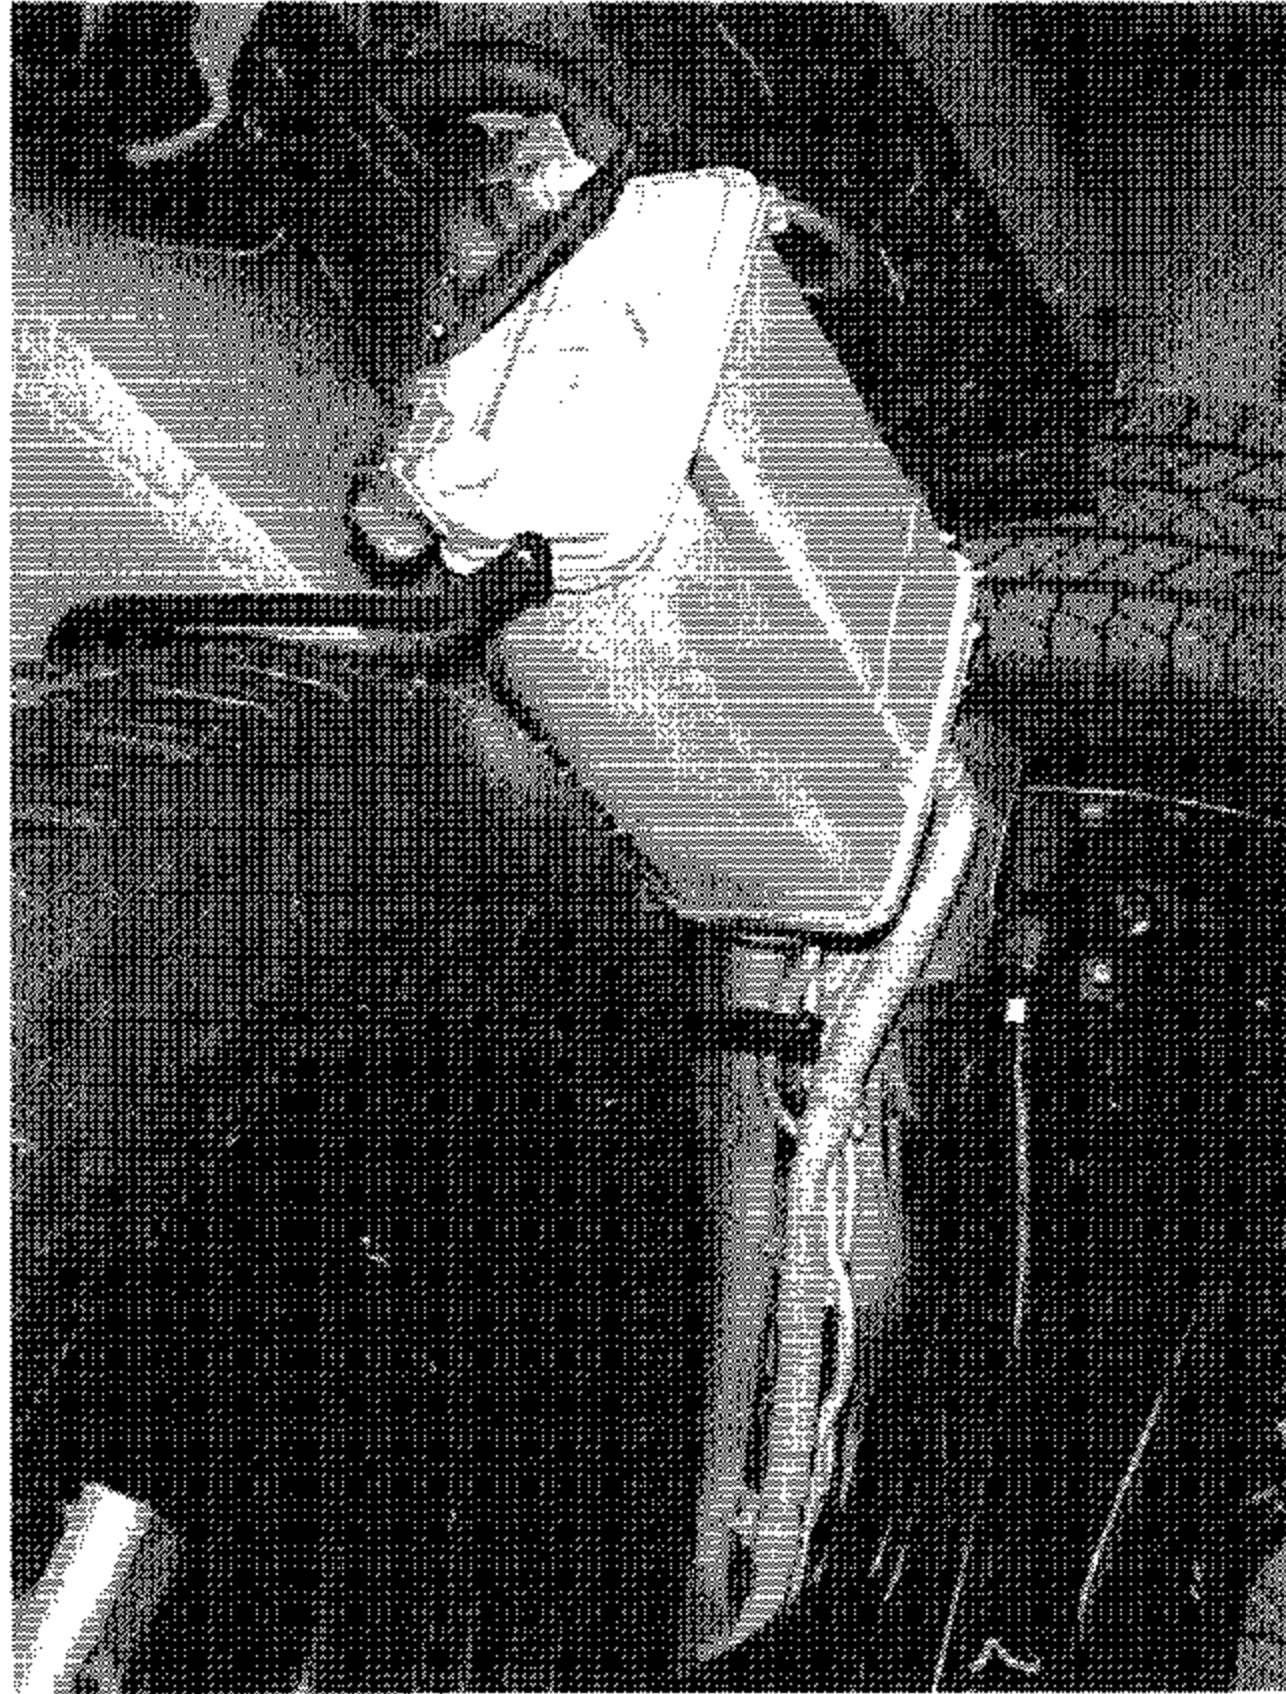
FIGURE 5.24  
UNDERBODY VIEW OF FUEL TANK AND  
VAPOR LINES POST TEST

D. Provide Spillage Details: NONE
