FINAL REPORT NUMBER 225-MGA-09-008

# SAFETY COMPLIANCE TESTING FOR FMVSS 225 "Child Restraint Anchorage Systems"

# SUZUKI MOTOR CORPORATION 2008 Suzuki SX4 Sedan NHTSA No. C80500

# MGA RESEARCH CORPORATION 446 Executive Drive Troy, Michigan 48083

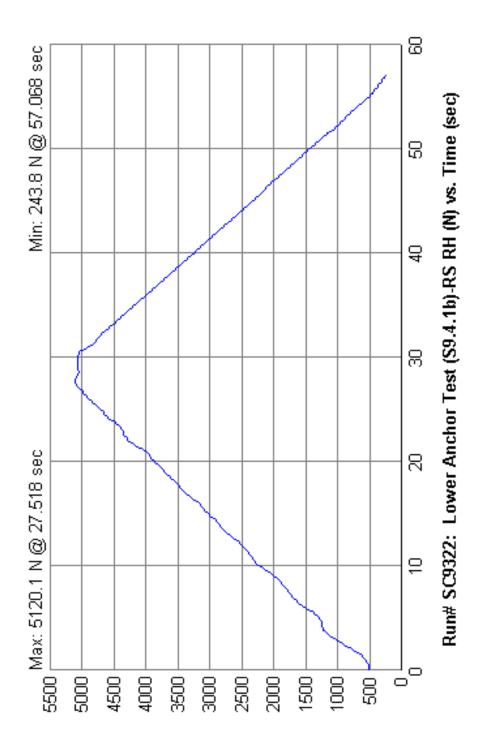
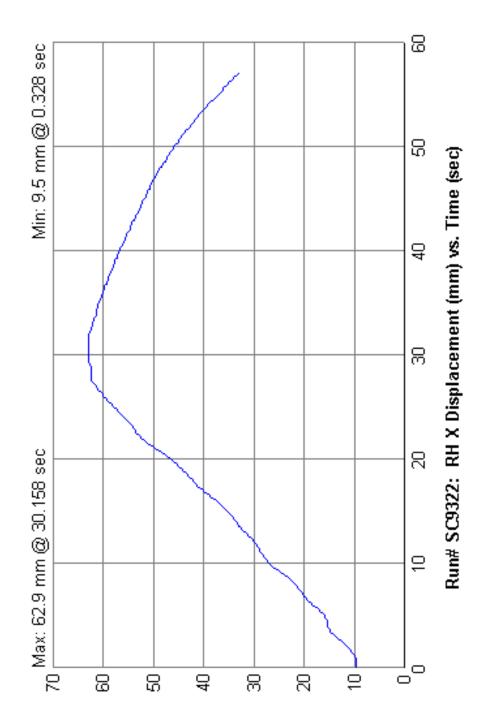
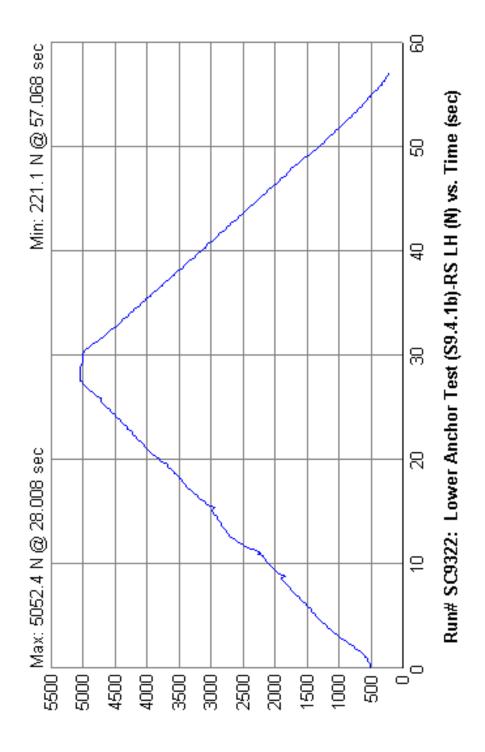
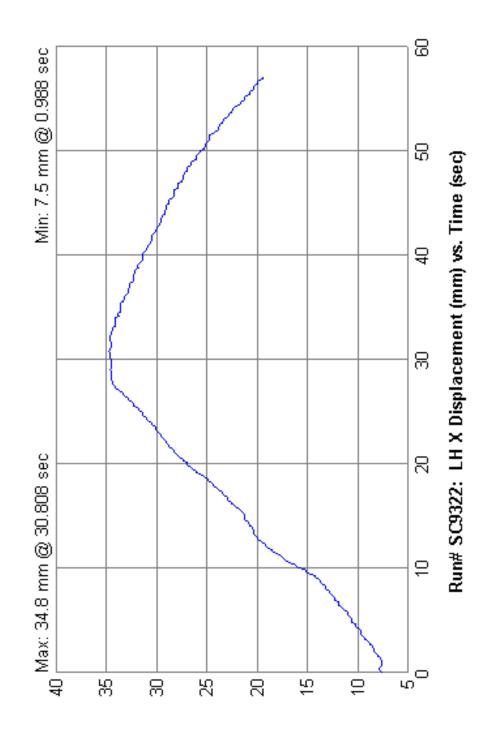
7.0 PLOTS

The SFADII at the  $2^{nd}$  row left seating position sustained a maximum force of 5,052 N and held the required load for 3 seconds and the total displacement was 28 mm. The SFADII at the  $2^{nd}$  row right seating position sustained a maximum force of 5,120 N and held the required load for 3 seconds and the total displacement was 54 mm.
