REPORT NO. 111-KAR-10-002

SAFETY COMPLIANCE TESTING FOR FMVSS 111

2010 CHEVROLET CAMARO

NHTSA NO: CA0106

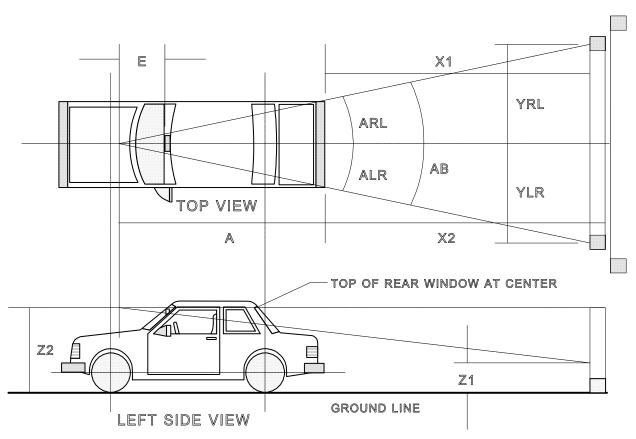
INSIDE REARVIEW MIRROR FIELD OF VIEW TEST GRID AND MARKER SETUP

Е	Distance from center of mirror to projected eye point location =	<u>610mm</u>
А	Distance from rear of vehicle to projected eye point location =	2376mm
X1	Distance from rear of vehicle to field of view grid =	8370mm
Z1	Vertical distance to lowest point of field of view at distance X1	490mm
Z2	Height of center of mirror =	1182mm
Vo

X2 Distance from rear of vehicle where the road surface is first visible $X2 = [(Z2 \times X1) + (Z1 \times A)]/(Z2 - Z1) =$ (S111 REQUIREMENT = 61m maximum) 15.979m

ANGLE AB = <u>**26.5**°</u> (S111 REQUIREMENT = 20 degrees minimum)

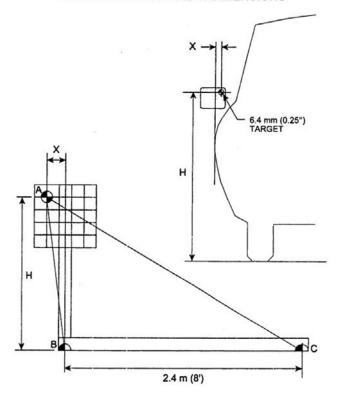
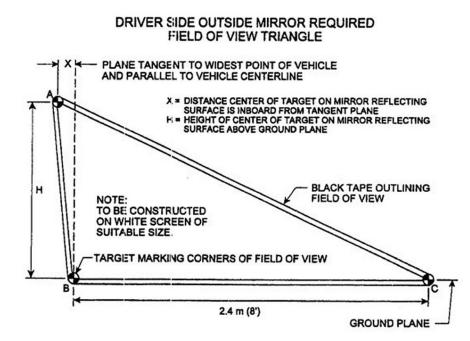
DRIVER SIDE OUTSIDE MIRROR TARGET DISC LOCATION WITH X AND H DIMENSIONS

MIRROR OBSCURED BY UNWIPED PORTION OF WINDSHIELD	YES NO _X
HEIGHT OF TARGET DISC ON MIRROR	1044mm
DISTANCE OF TARGET DISC ON MIRROR FROM VEHICLE TANGENT PLANE	79mm
TARGET DISC LOCATION RELATIVE TO VEHICLE TANGENT PLANE	Inboard (Inboard or Outboard)
ENTIRE TRIANGULAR TEST TARGET AREA ON SCREEN VISIBLE	YES <u>X</u> NO
MIRROR PROTRUDES BEYOND VEHICLE TANGENT PLANE	YES <u>X</u> NO
PROTRUSION REQUIRED TO MEET FIELD OF VIEW REQUIREMENT	YES <u>X</u> NO

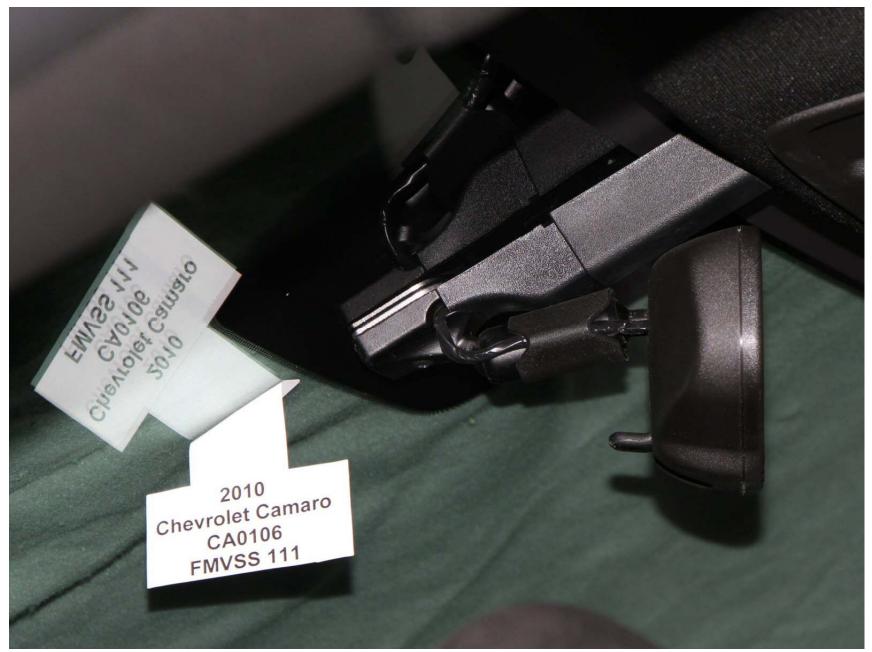
FIGURE 9: INSIDE REARVIEW MIRROR AND MOUNTING

MOUNTING OF MIRROR (INSIDE) DESCRIPTION: TAB GLUED TO WINDSHIELD. MIRROR BASE SLIPS OVER BASE AND HELD IN PLACE WITH SPRING CLIP.

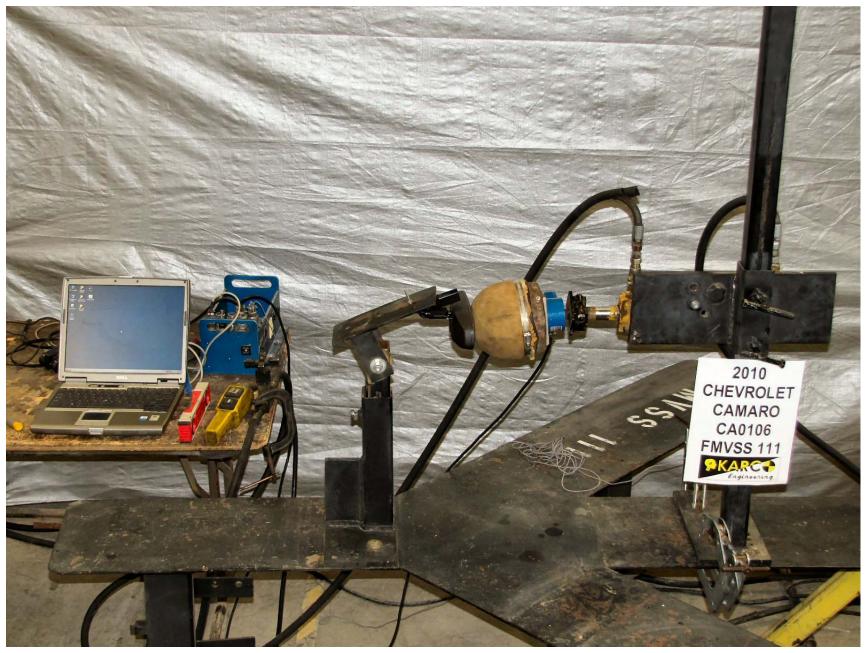
2010 CHEVROLET CAMARO FIGURE 12: OVERALL SET-UP AND INSTRUMENTATION FOR MIRROR BREAK- AWAY TEST NHTSA NO. CA0106 FMVSS NO. 111

TEST NO.	LOAD DIRECTION VERTICAL/HORIZONTAL		DISPLACEMENT	PASS	FAIL
NO.		FORCE (N)	(MM)	V	
1	0-90 DEGREES	277.9	10.0	Х	
2	+45/90 DEGREES	137.7	22.1	Х	
3	-45/90 DEGREES	241.7	10.0	X	
4	-45/+45 DEGREES	177.8	15.8	X	
5	+45/+45 DEGREES	47.7	36.0	X	
6	+45/-45 DEGREES	116.8	18.7	X	
7	-45/-45 DEGREES	99.7	9.2	Х

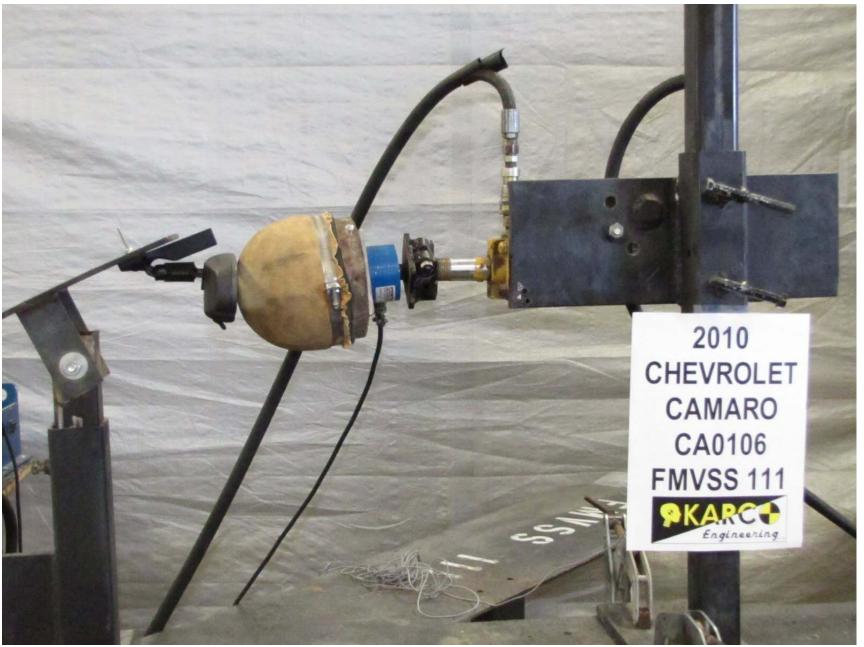
FIGURE 13:CLOSE-UP OF MIRROR BREAK- AWAY TEST

NONE

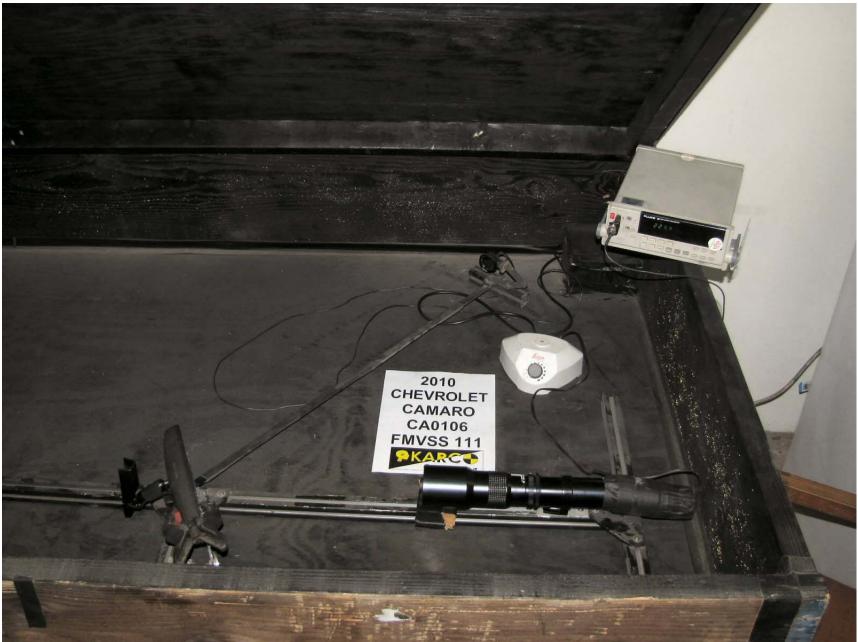
2010 CHEVROLET CAMARO NHTSA NO. CA0106 FMVSS NO. 111 FIGURE 14:REFLECTION TEST SET-UP

DESCRIPTION OF TEST APPARATUS: THE APPARATUS CONSISTS OF AN INCANDESCENT TUNGSTEN FILAMENT LAMP OPERATING AT A NOMINAL COLOR TEMPERATURE OF 2,856 K, COLLIMATING OPTICS, A SAMPLE HOLDER POSITIONED AT 25°, A SILICON PHOTOCELL, AND A FLUKE 45 DUAL DISPLAY MULTIMETER (CALIBRATION DUE DATE 3-26-08). REFLECTANCE TESTS ARE CONDUCTED IN A 4'X6' WOODEN CABINET PAINTED FLAT BLACK. FOR CONVEX MIRROR A 6" INTEGRATING SPHERE WAS INCORPORATED INTO THE RECEIVER.

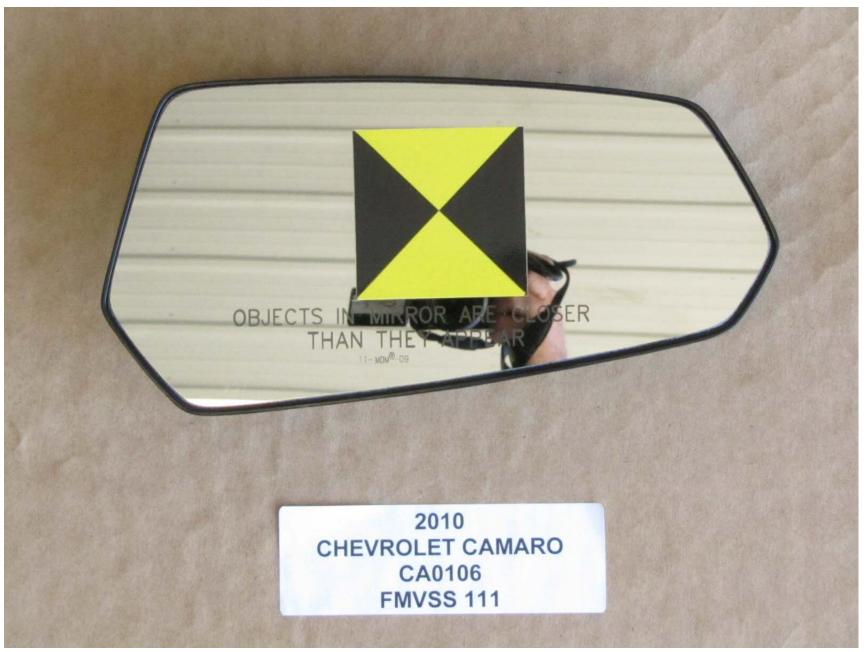
FIGURE 15: MIRROR SET-UP FOR AREA MEASUREMENT

MIRRORS	AREA (cm ²)	REQUIREMENT		RESI	JLTS
		GVWR <u><</u> 4536 kg	GVWR <u>></u> 4536 kg	PASS	FAIL
Outside Driver's Side	184	126 cm ²	323cm ²	х	
Outside Passenger Side	182	126 cm ²	323 cm ²	x

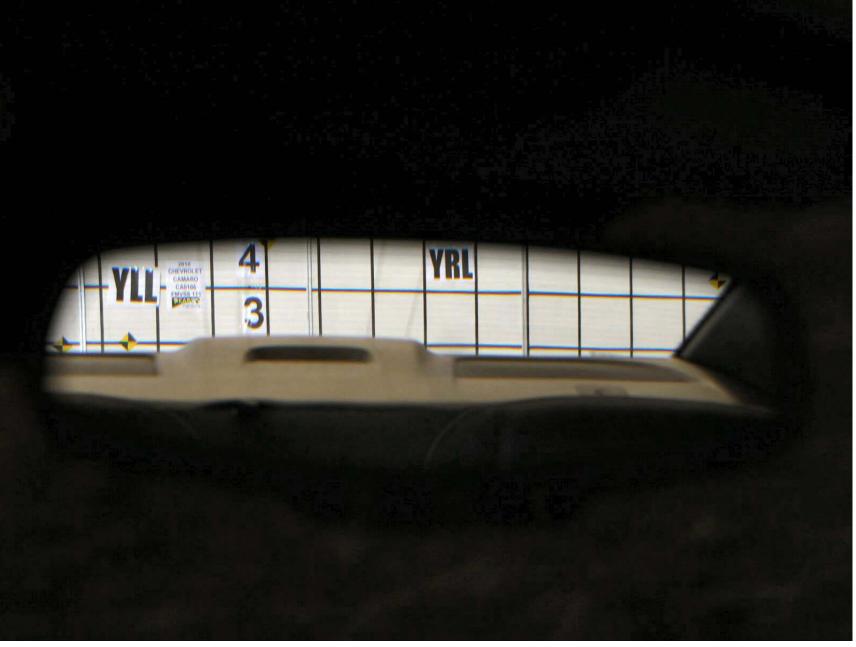
2010 CHEVROLET CAMARO NHTSA NO. CA0106 FMVSS NO. 111 FIGURE 16:LEFT EYE FIELD OF VIEW TEST (INSIDE MIRROR)

EYE LOCATION	MONOCULAR DATA (ALR & ARL ARE ANGLES)				
	YL (mm)	YR (mm)	ALR (°)	ARL (°)	
LEFT EYE POINT	YLL =1189	YRL =2673		14.1	
RIGHT EYE POINT	YLR =2335	YRR =2222	12.4

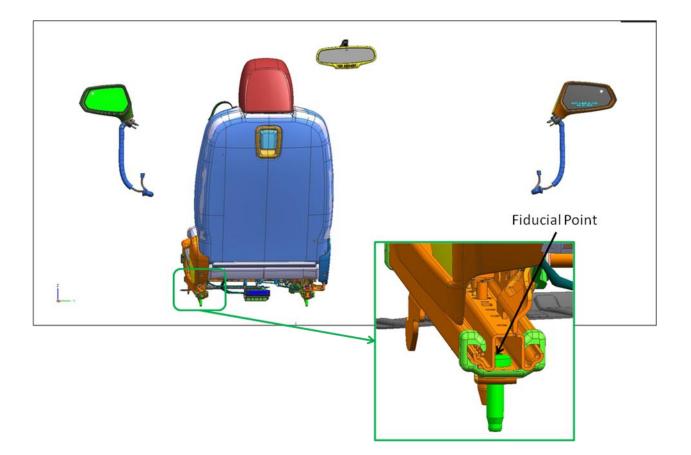
Driver's Seat Rear Outboard Mounting Bolt (see attached sketch)_

COORDINATES	LEFT SIDE MIRROR		INSIDE MIRROR		RIGHT SIDE MIRROR	
	LE1 (left eye)	RE1 (right eye)	LE2	RE2	LE3	RE3
х	-55	-33	-40	-56	-21	-62
Y	-185	-246	-195	-258	-223	-273
Z	855	855	856	856	854	854
Mirror Mfr.,	Magna		Gentex		Magna	
Model	Electric 92247439		Auto-Dim, no OnStar 13503047		Electric 92247440	
Part No.
