REPORT NUMBER: 301-CAL-10-3

SAFETY COMPLIANCE TESTING FOR FMVSS 301 FUEL SYSTEM INTEGRITY – REAR IMPACT

Toyota Motor Corporation 2010 Lexus HS250h Sedan

NHTSA NUMBER: CA5102

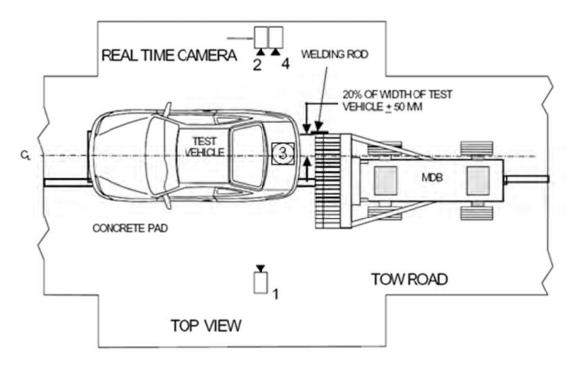
HIGH SPEED CAMERA LOCATIONS AND DATA SUMMARY

| Camera No. | View | Coordinates (millimeters) | | | Angle (deg.) | Lens (mm) | Film Speed (fps) |
| 1 | Left Side View | 8010 | 1880 | 975 | -0.5 | 24 | 1000 |
| 2 | Real-Time Camera | - | - | - | - | - | 30 |
| 3 | Overhead View | 0 | 775 | 4900 | -90 | 20 | 1000 |
| 4 | Right Side View | 8705 | 1680 | 1010 | -1.5 | 24 | 1000 |

^{*} Reference (from point of impact); all measurements accurate to within ±6 mm.

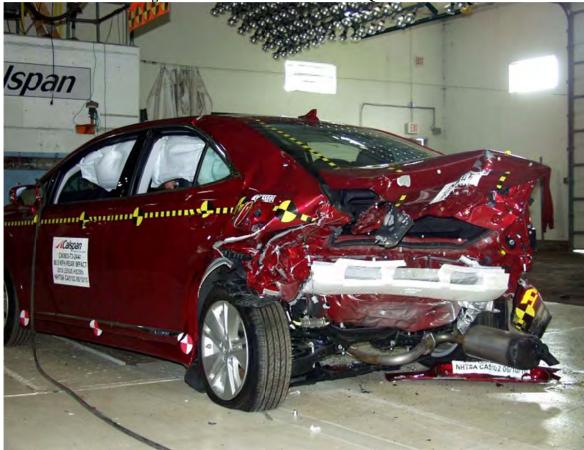
Figure A-14: Post-Test Left Rear Three-Quarter View

| | Left Side | Centerline | Right Side |
|---|---|---|---|
| Crush | 754 | 595 | 449 |

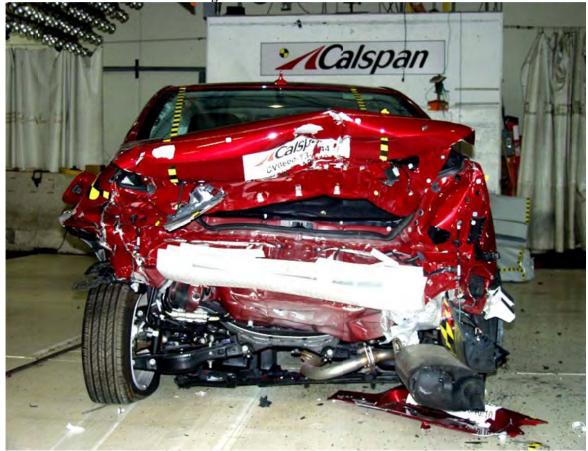
Figure A-18: Post-Test Rear View

The left side curtain airbag and left rear seat airbag deployed during the impact event. Both the left and right side doors were closed and operable after the impact. The rear hatch was closed but not operable.

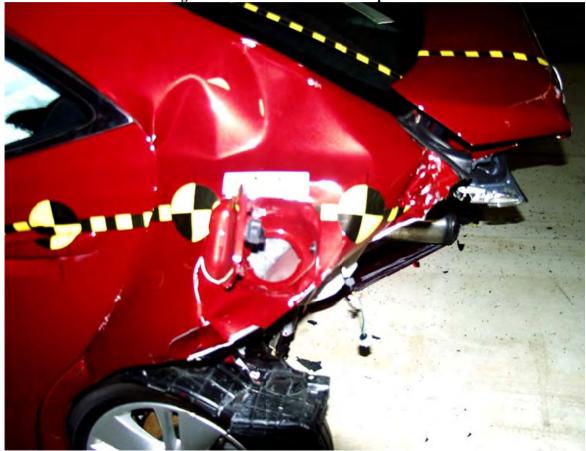
Figure A-36: Post-Test Fuel Filler Cap View

| Rollover Stage | Spillage Location |
|---|--|
| 0° - 90° | Stoddard appeared to leak from the fuel filler neck area that was pulled from the left rear fender area during the impact. |

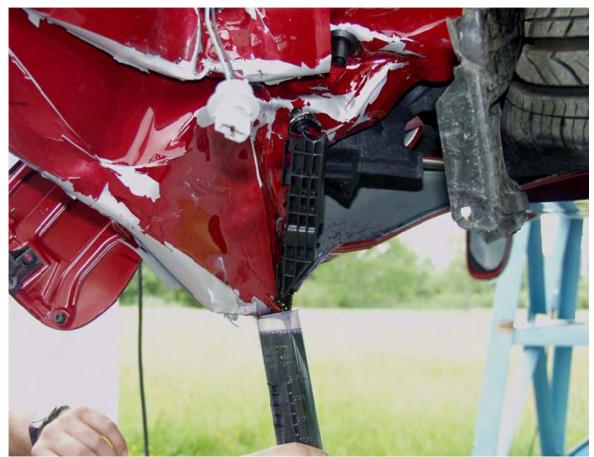
Figure A-42: leak collection at 90°

Post-impact, 1463 grams of fuel leakage was collected during the first 5 minutes of the 0 to 90 degree static roll performed after the impact. The FMVSS 301 standard allows a maximum or 142 grams to leak during this time period. The fuel leakage rate was also exceeded during the 6th and 7th minute of the collection period. Based on this data, the vehicle does not appear to comply with all the requirements of FMVSS No. 301 "Fuel System Integrity." The average vehicle longitudinal crush was 599 millimeters.

| Rollover Stage | First 5 minutes from onset of rotation (g) | 6th min. (g) | 7th min. (g) | 8th min. (if required) (g) |
|---|---|---|---|---|
| 0° - 90° | 1463 | 340 | 335 | N/A |
