**NOT-IN-TRAFFIC SURVEILLANCE
CALSPAN ON-SITE BACKOVER CRASH INVESTIGATION**

SCI CASE NO: CA12008

VEHICLE: 2002 FORD F150 PICKUP

CRASH DATE: MARCH 2012

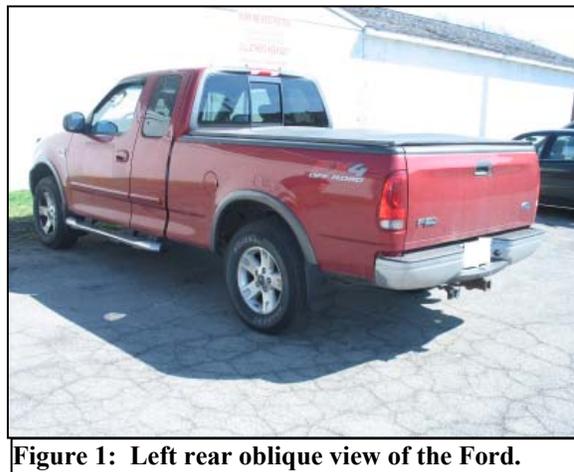
This on-site investigation focused on the circumstances, injury sources, and rear visibility of a 2002 Ford F150 extended-cab pickup (**Figure 1**) driven by a 40-year-old female that was involved in a Not-In-Traffic backover crash with a 70-year-old female non-motorist. The crash occurred in the curb-side parking lane of a two-lane road that was located in an urban commercial setting. Notification of the crash was forwarded to the Crash Investigation Division (CID) of the National Highway Traffic Safety Administration (NHTSA) by the Calspan Special Crash Investigations (SCI) team on March 14, 2012. The CID assigned an on-site investigation on March 15, 2012 to support the Not-In-Traffic Surveillance research that is being conducted by the Agency. The Calspan SCI team immediately contacted and obtained cooperation with the investigating police officer. The officer supplied the Police Crash Report, a Reconstruction Report and on-scene images of the crash. The SCI team also obtained cooperation with the vehicle owner to inspect and measure the rear visibility of the Ford. The vehicle owner would not allow the driver to be interviewed. A witness was interviewed by telephone and detailed the events of the crash.

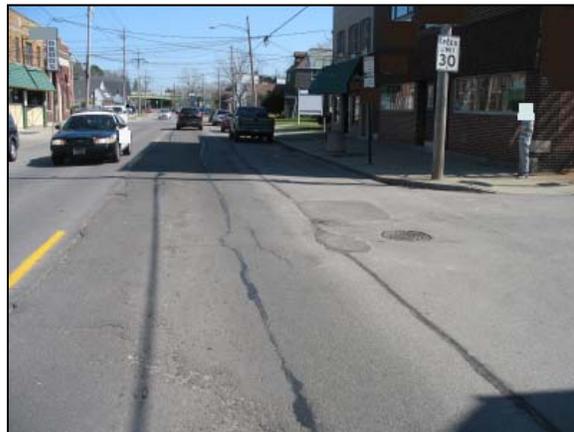
This backover crash occurred within the curb-side parking lane of a two lane east/west road. The parking lane of interest was located on the south side of the road. **Figure 2** is an eastbound approach view of the crash site. The travel lanes measured 5.9 m (19.4 ft) in width and were separated by a broken yellow centerline. Each travel lane was of sufficient width to accommodate through-traffic and curb-side parking. The roadway was bordered by concrete curbs and 3.9 m (12.8 ft) wide sidewalks. Commercial businesses were located on both sides of the road. A two-lane north/south road intersected the primary road from the south. This three-leg intersection was located immediately west of the crash location. The posted speed limit was 48 km/h (30 mph).

Figure 2: Eastward view approaching the crash site.

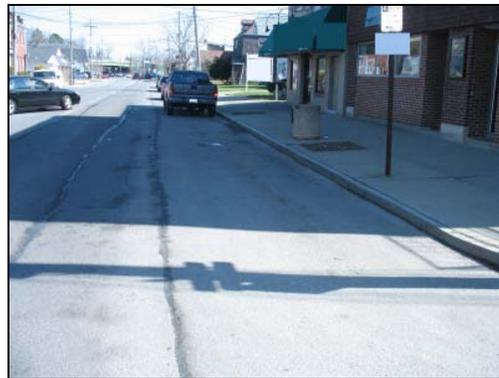
The Ford was traveling east as it the approached the crash site (**Figure 3**). A non-contact vehicle was already parked at the south curb and the driver maneuvered the Ford into the parking lane directly behind this vehicle. The driver applied the brakes and the Ford came to a controlled stop. During her interview with the investigating police officer, she stated that she shifted the transmission into reverse, looked over her right shoulder and began to back up. The non-motorist was reported to have been walking east on the sidewalk. She had crossed the

Figure 3: East view of the crash site.

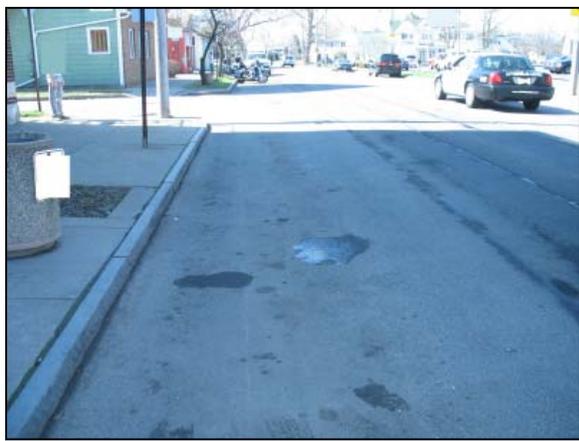
The witness stated to the investigating officer that as the Ford was backing up, he observed the non-motorist standing in the parking lane intending to cross the street. The non-motorist was attempting to cross the street at mid-block, not at the corner. He recalled that the non-motorist was standing between the Ford's centerline and its left rear corner and that she was observing traffic in order to cross the street. He could not recall how or when the non-motorist became positioned behind the Ford. **Figure 4** is a west view along the Ford's backing trajectory.

Figure 4: West view along the backing trajectory.

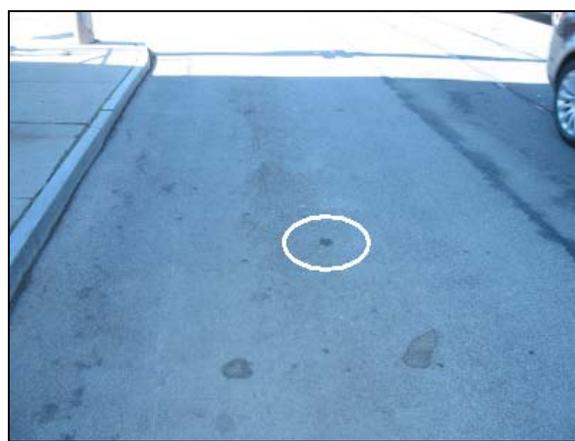
Figure 5: Close-up view of the crash site and the location of the non-motorist's head contact with the ground.

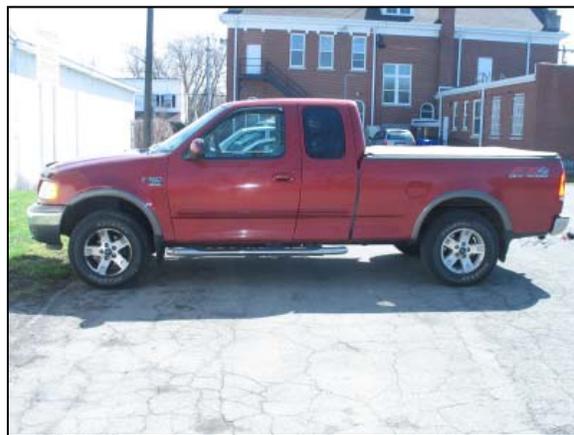
The 2002 Ford F150 pickup (**Figure 6**) was identified by the Vehicle Identification Number (VIN): 2FTRX18L82Cxxxxxx. The extended cab, four-wheel drive, ½ ton, short box pickup was configured on a 353 cm (139 in) wheelbase. The powertrain consisted of a 5.4 liter/V8 engine linked to a 4-speed automatic transmission. The service brakes were a four-wheel disc system with ABS. The cloth-upholstered interior was configured with two front row bucket seats and a second row folding bench seat. The two front head restraints were

Figure 6: Left side view of the 2002 Ford F150.

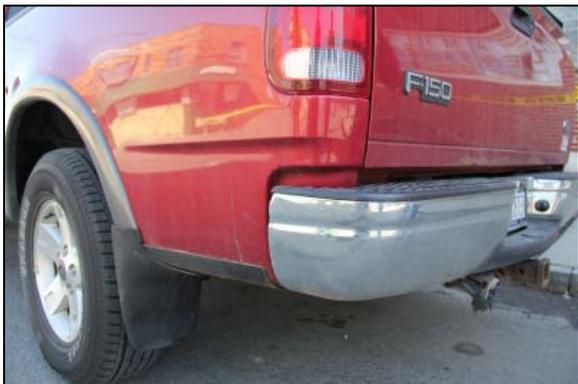
The subject vehicle was not physically damaged in the crash. The police investigation did determine that there was an area of contact to the left corner of the rear bumper and to the left rear mud flap. Dust was removed from these two components and was considered contact areas by the police investigator. **Figures 7 and 8** are on-scene police images of the contact area. Due to the passage of time between the crash date and the SCI investigation, these areas of contact were not apparent during the SCI inspection.

Figure 7: On-scene police image of the left rear bumper corner of the Ford.

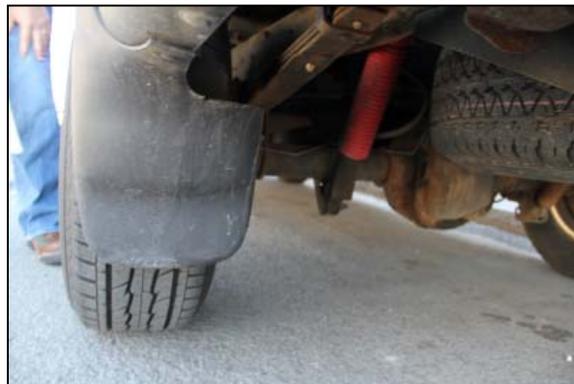
Figure 8: On-scene police image of the Ford's rear mud flap.

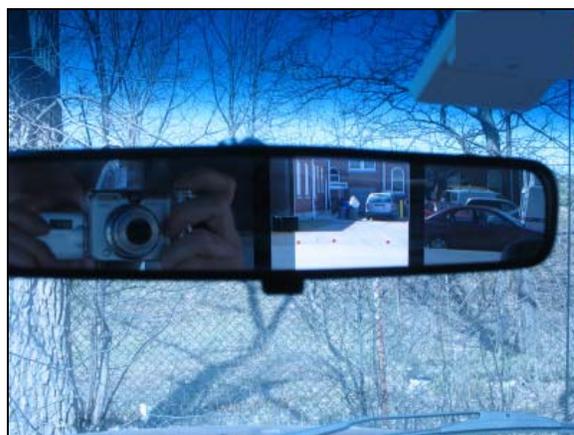
A 71 cm (28 in) tall red reflective target was placed on the vehicle's centerline and moved rearward to a location where the surrogate driver could first see the red target by looking through the rear view mirror (**Figure 9**). The centerline distance measured from the rear bumper to the reflector was 11.8 m (38.7 ft). The driver's line of sight through the rear view mirror projected to the ground was an additional 12.2 m (40.0 ft) for a total distance of 24 m (78.7 ft). **Figures 10 and 11** depict the location of the targets relative to the parked Ford.

Figure 9: Image through the center mirror to the reference targets positioned aft of the Ford.

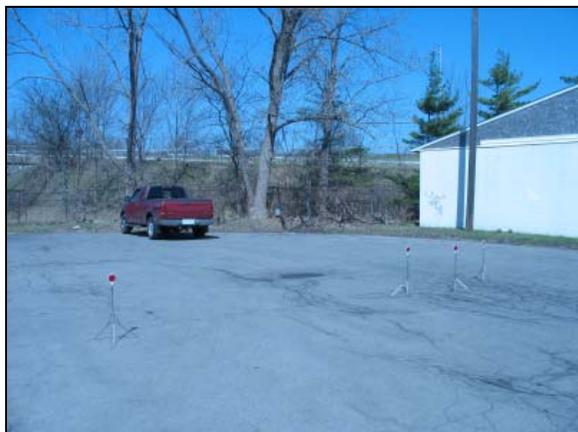
Figure 10: Oblique view depicting the distance from the Ford's rear bumper to the reference targets.

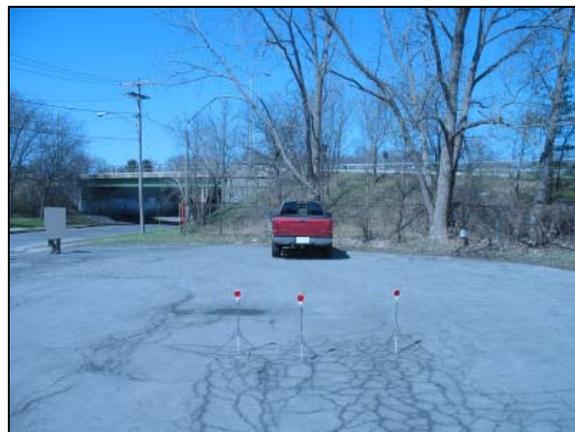
Figure 11: View along the extended centerline of the Ford depicting the reference target locations.

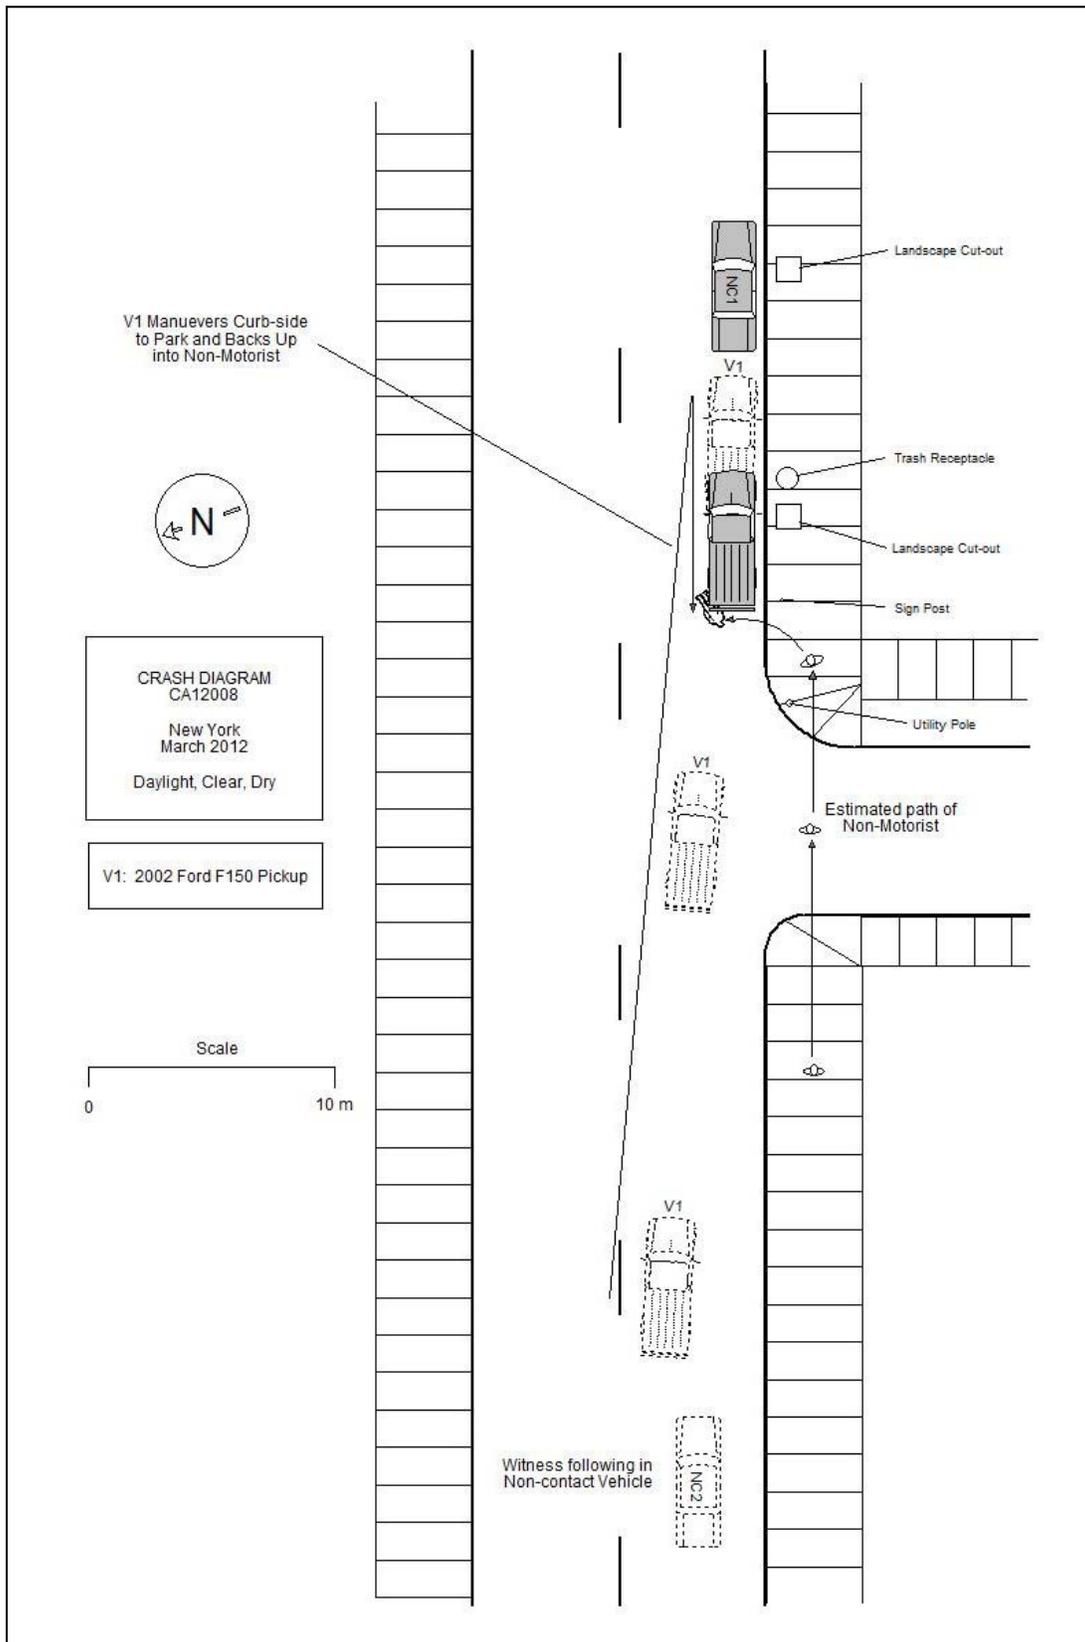
CRASH DIAGRAM

intersecting north/south roadway and was adjacent to the corner as the Ford was parking. A Crash Diagram is included on Page 8 of this report.

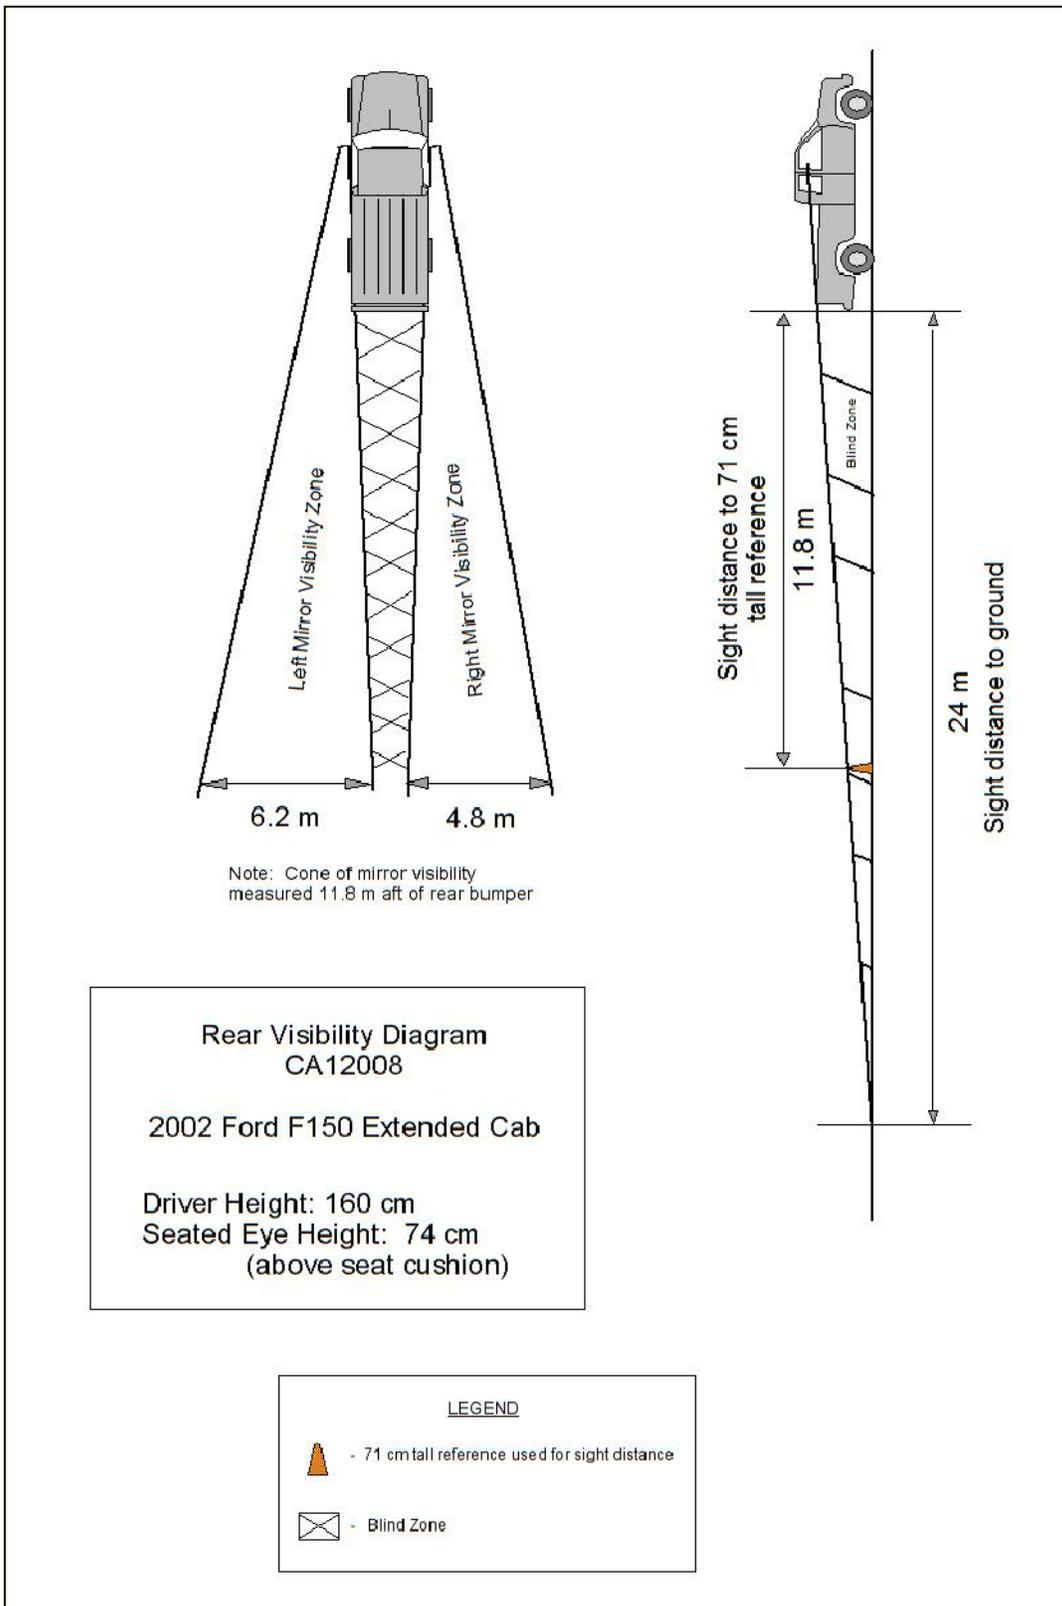
REAR VISIBILITY DIAGRAM

Cones of visibility were also established using the outside mirrors. These lateral visibility measurements were established at the centerline reference distance of 11.8 m (38.7 ft). By using the mirrors, the surrogate driver located the 71 cm (28 in) targets that were placed laterally relative to the centerline from a normal seated position. The visibility for the left mirror began 0.7 m (2.3 ft) left of center and ended 5.5 m (18.0 ft) left of center. The cone for the right mirror began 1.2 m (3.8 ft) right of center and ended 7.4 m (24.3 ft) right of center. These visibility measurements are depicted graphically in a Rear Visibility Diagram on Page 9 of this report.
