REPORT NUMBER 138-STF-08-001

SAFETY COMPLIANCE TESTING FOR FMVSS NO. 138 TIRE PRESSURE MONITORING SYSTEMS

HONDA MOTOR COMPANY
2008 HONDA ACURA RDX
FOUR-DOOR MPV
NHTSA NO. C85300

FINAL REPORT

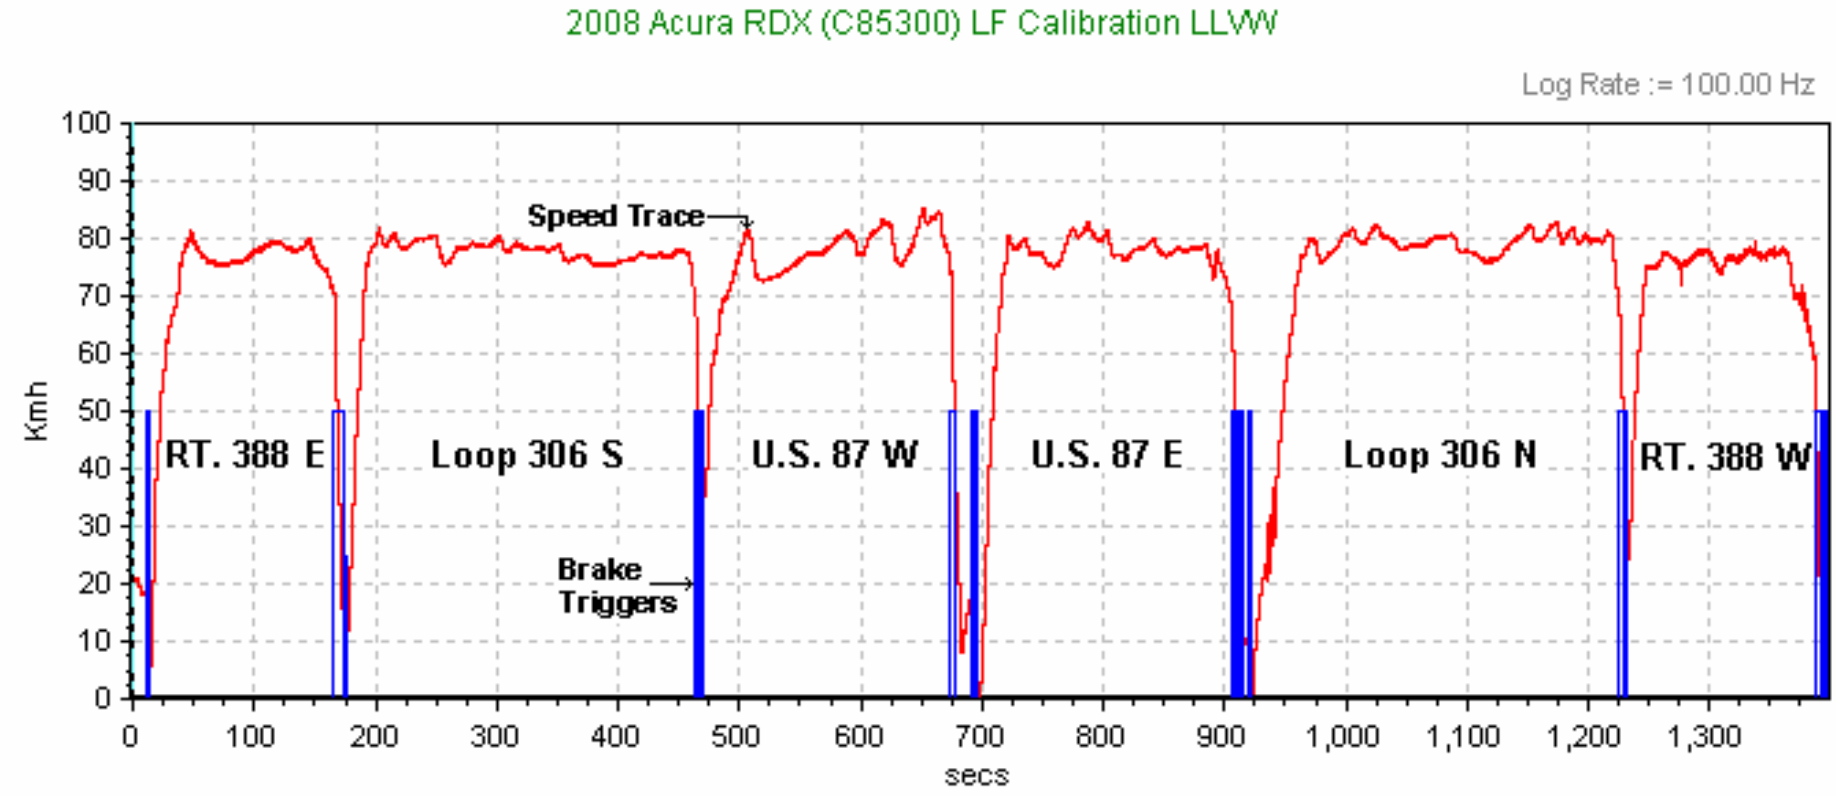
Scenario A:	Left Front Tire
Test Date:	10/23//07
Data File Time:	23:19 minutes
Cumulative Driving Time:	20:42 minutes
Start Point:	GAFB North Gate

LF Detection Phase: Telltale illumination in 5.9 seconds. Driving was not required.

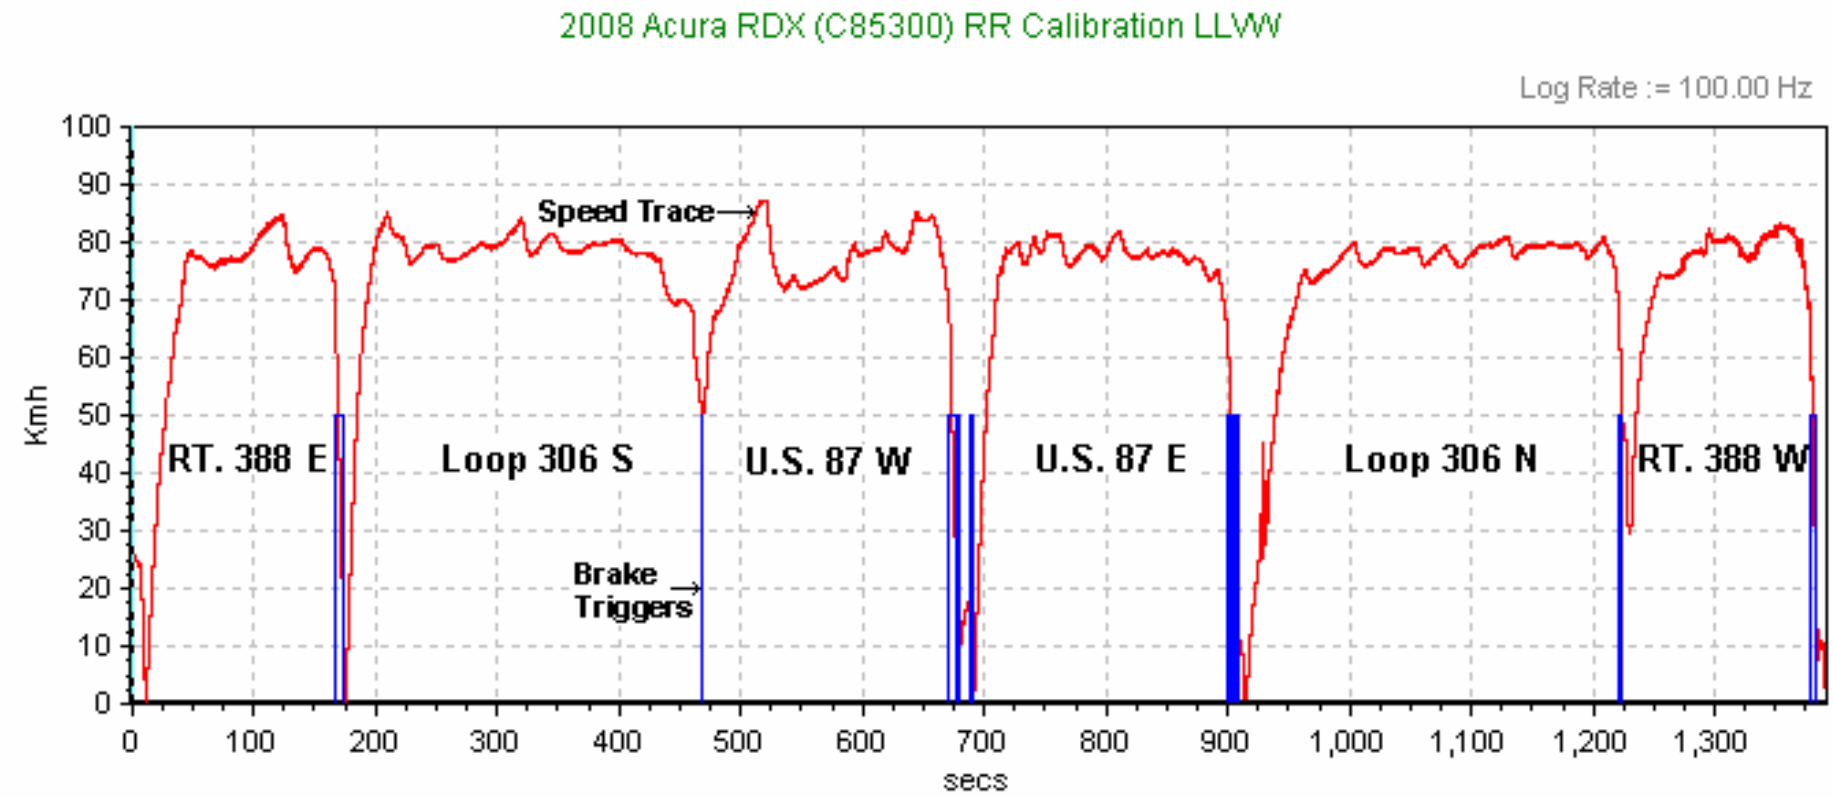
Scenario B: Right Rear Tire
Test Date: 10/24/07
Data File Time: 23:12 minutes
Cumulative Driving Time: 20:48 minutes
Start Point: GAFB North Gate

RR Detection Phase: Illumination in 4.1 seconds. Driving was not required.

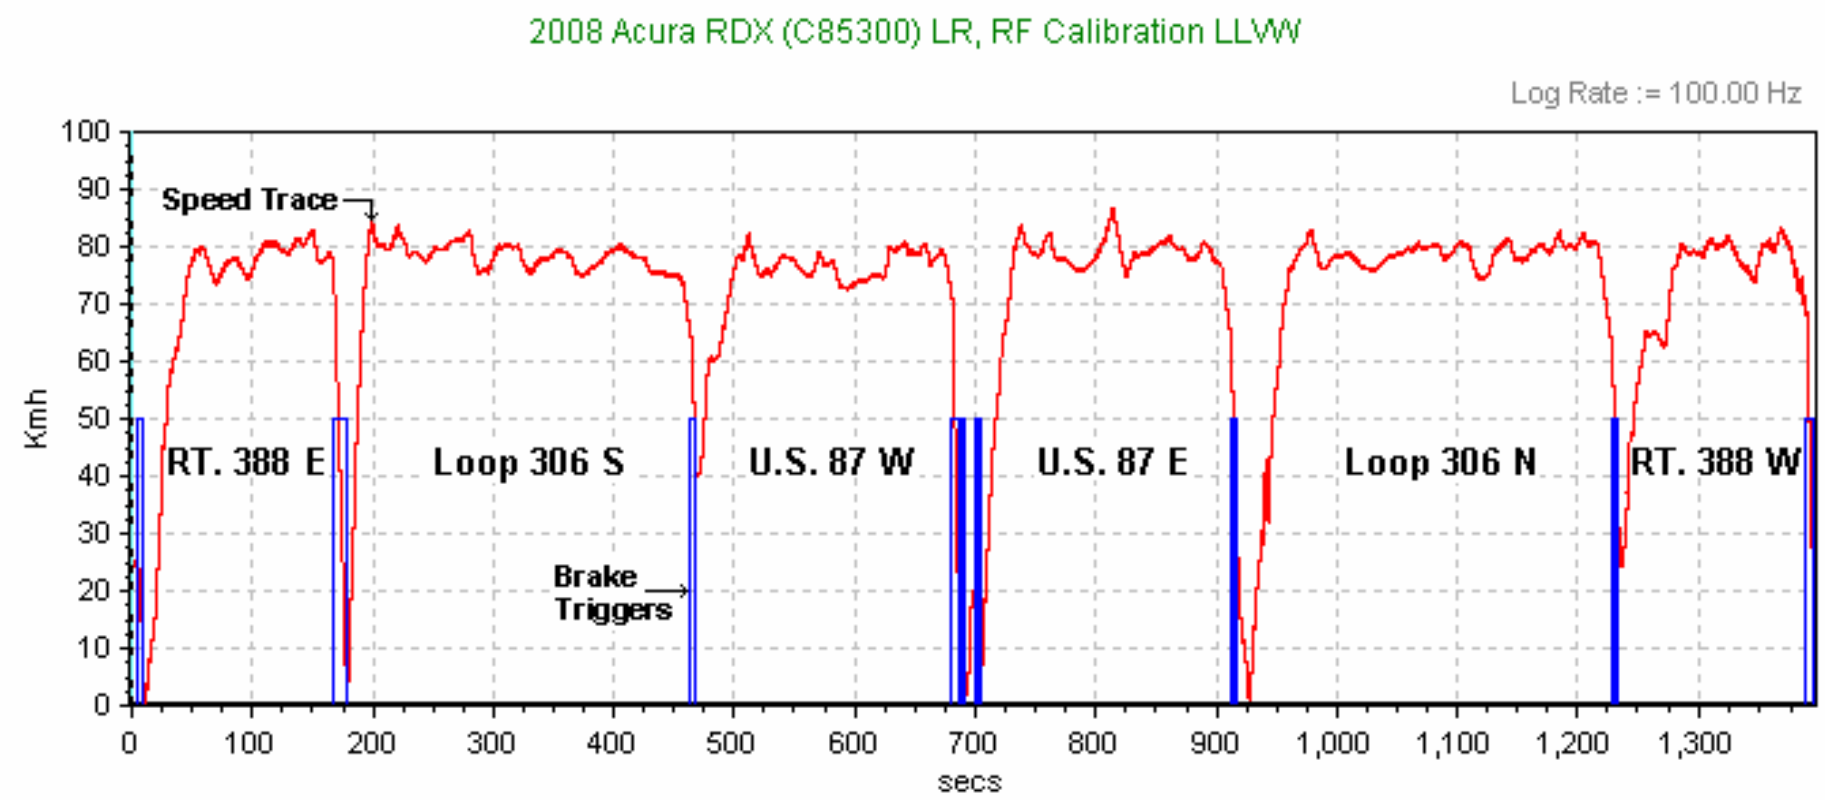
Scenario C: Left Rear, Right Front Tires
Test Date: 10/24/07
Data File Time: 23:18 minutes
Cumulative Driving Time: 20:41 minutes
Start Point: GAFB North Gate

LR, RF Detection Phase: Illumination 4.7 seconds. Driving was not required.

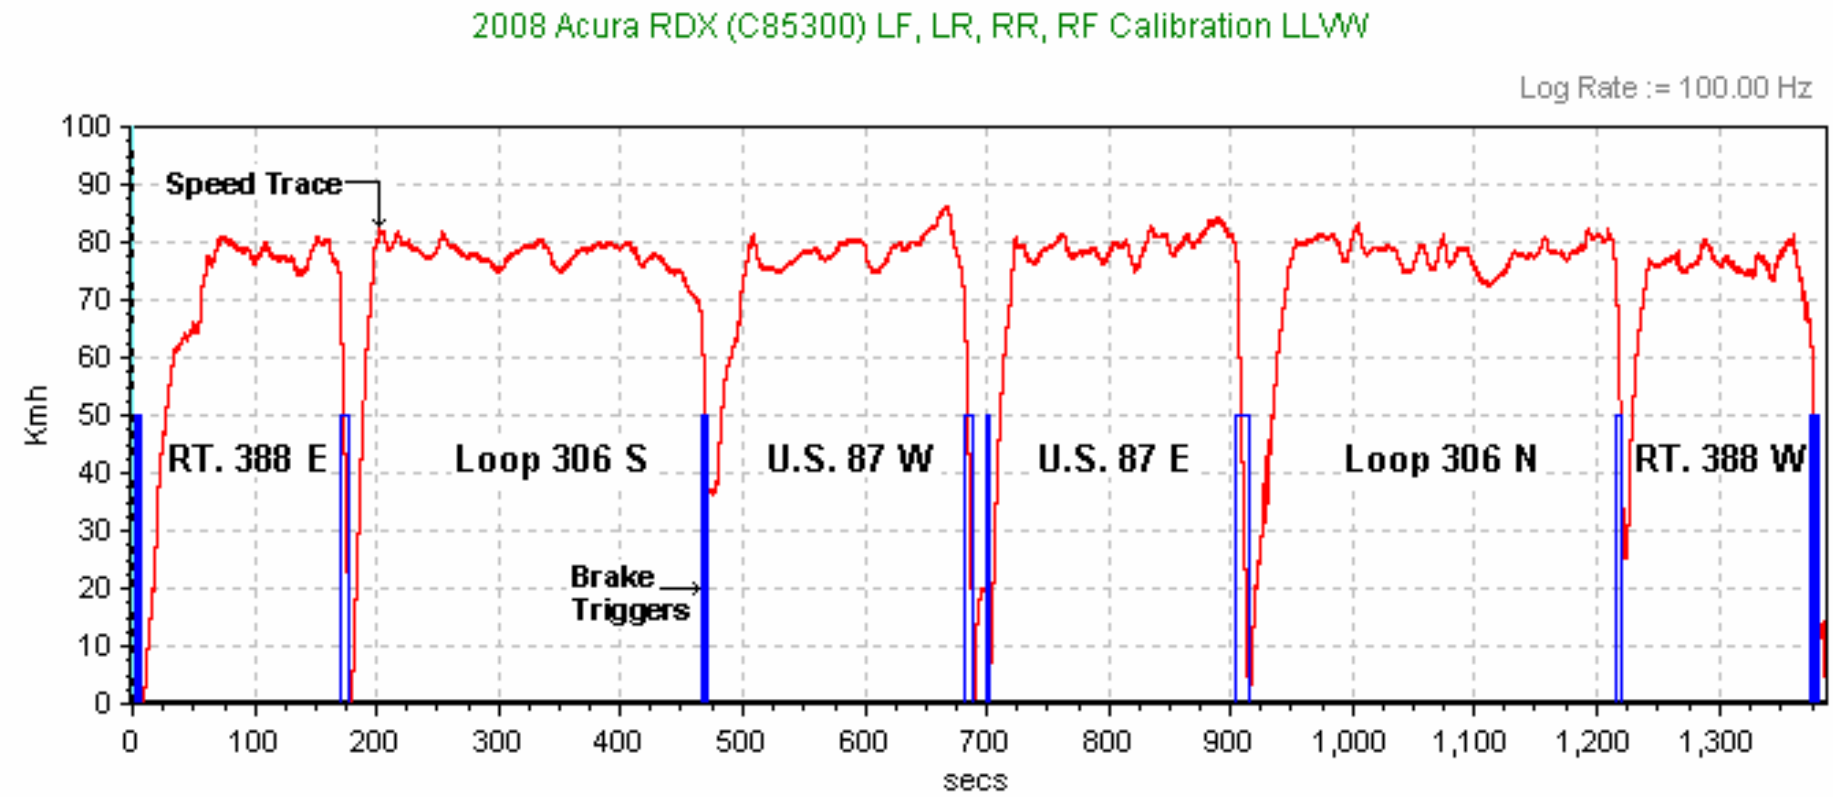
Scenario D:	Left Front, Left Rear, Right Rear, Right Front Tire
Test Date:	10/24/07
Data File Time:	23:08 minutes
Cumulative Driving Time:	20:42 minutes
Start Point:	GAFB North Gate

LF, LR, RR, RF Detection Phase: Illumination in 7.0 seconds. Driving was not required.

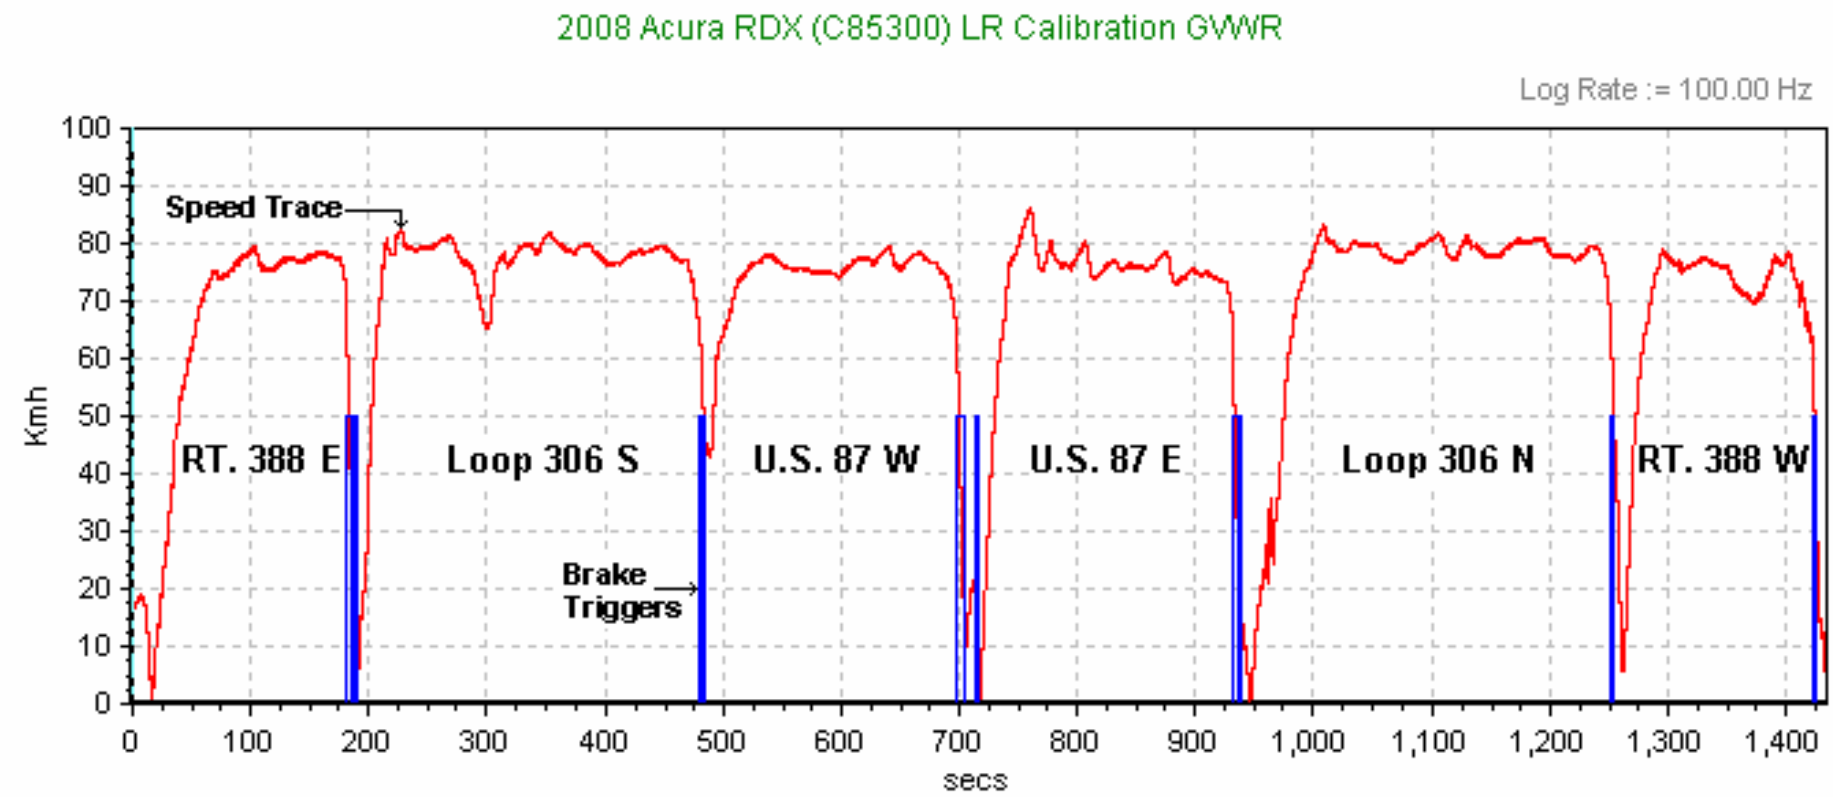
Scenario E:	Left Rear Tire
Test Date:	11/06/07
Data File Time:	23:55 minutes
Cumulative Driving Time:	20:51minutes
Start Point:	GAFB North Gate

LR Detection Phase: Illumination in 5.7 seconds. Driving was not required.

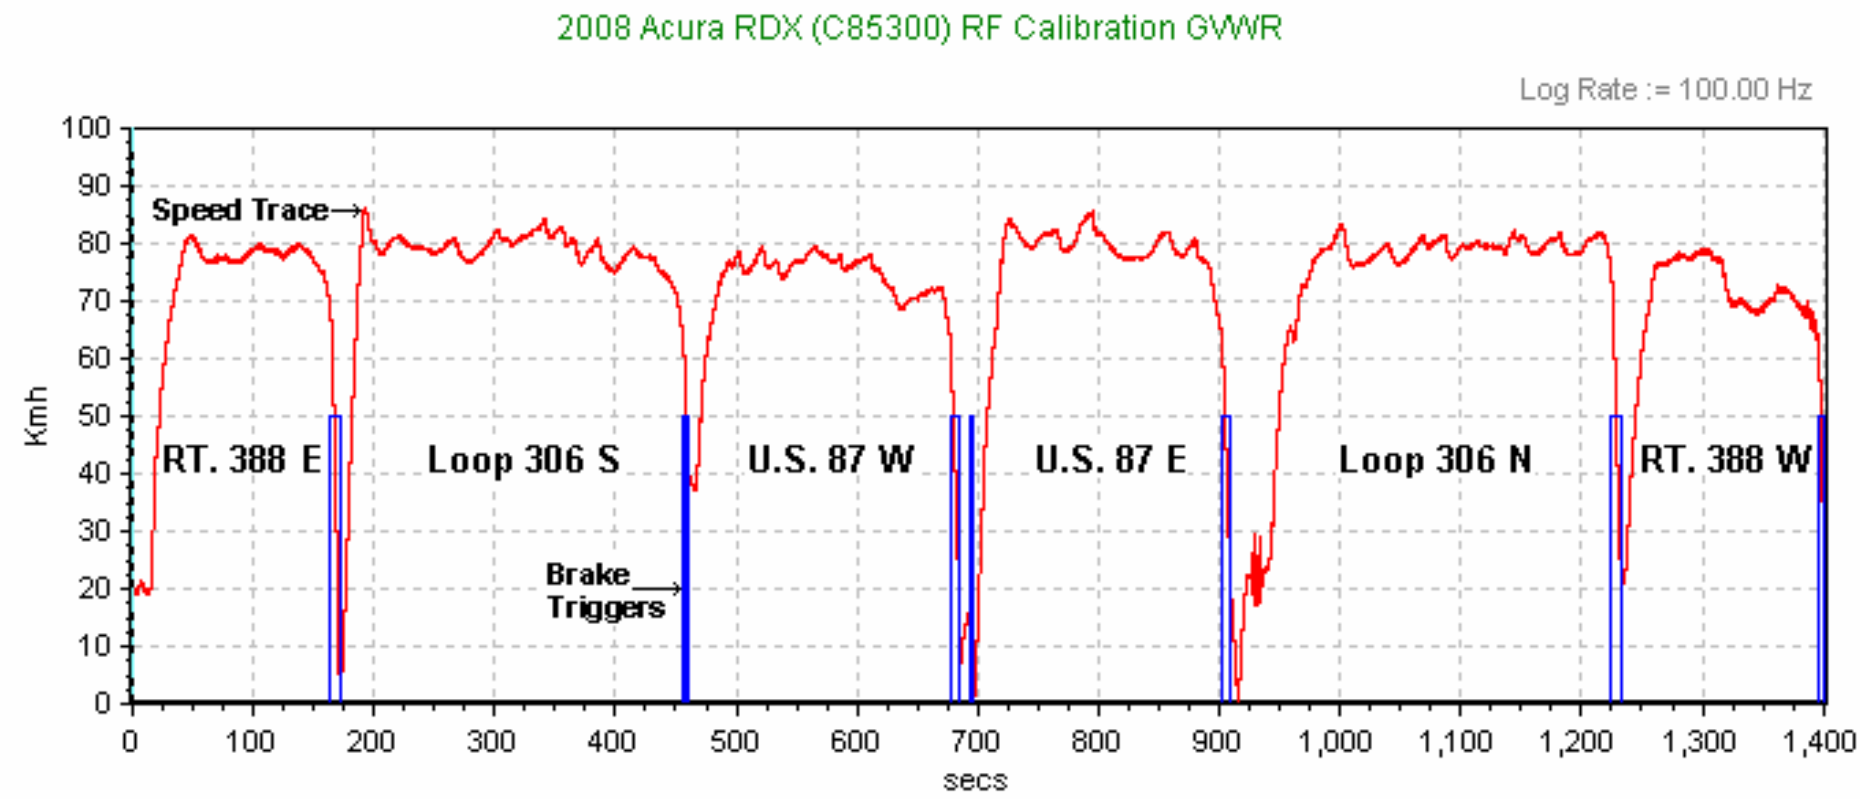
Scenario F: Right Front Tire
Test Date: 11/06/07
Data File Time: 23:23 minutes
Cumulative Driving Time: 20:43 minutes
Start Point: GAFB North Gate

RF Detection Phase: Illumination in 2.6 seconds. Driving was not required.

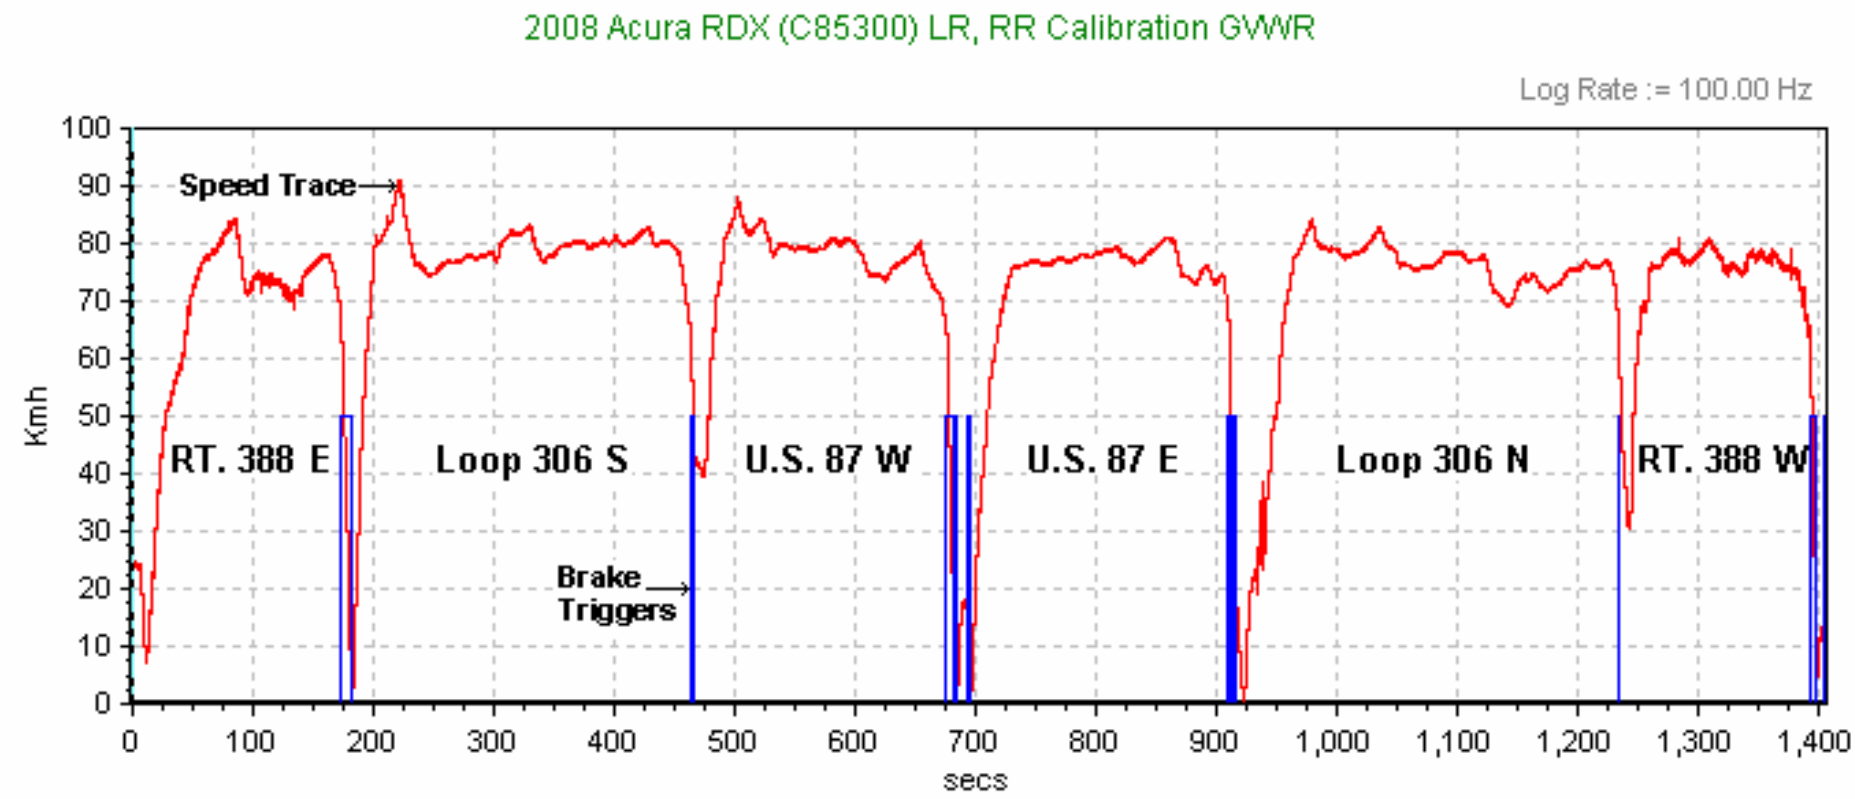
Scenario G:	Left Rear, Right Rear Tires
Test Date:	11/06/07
Data File Time:	23:27 minutes
Cumulative Driving Time:	20:47 minutes
Start Point:	GAFB North Gate

LR, RR Detection Phase: Illumination in 6.4 seconds. Driving was not required.

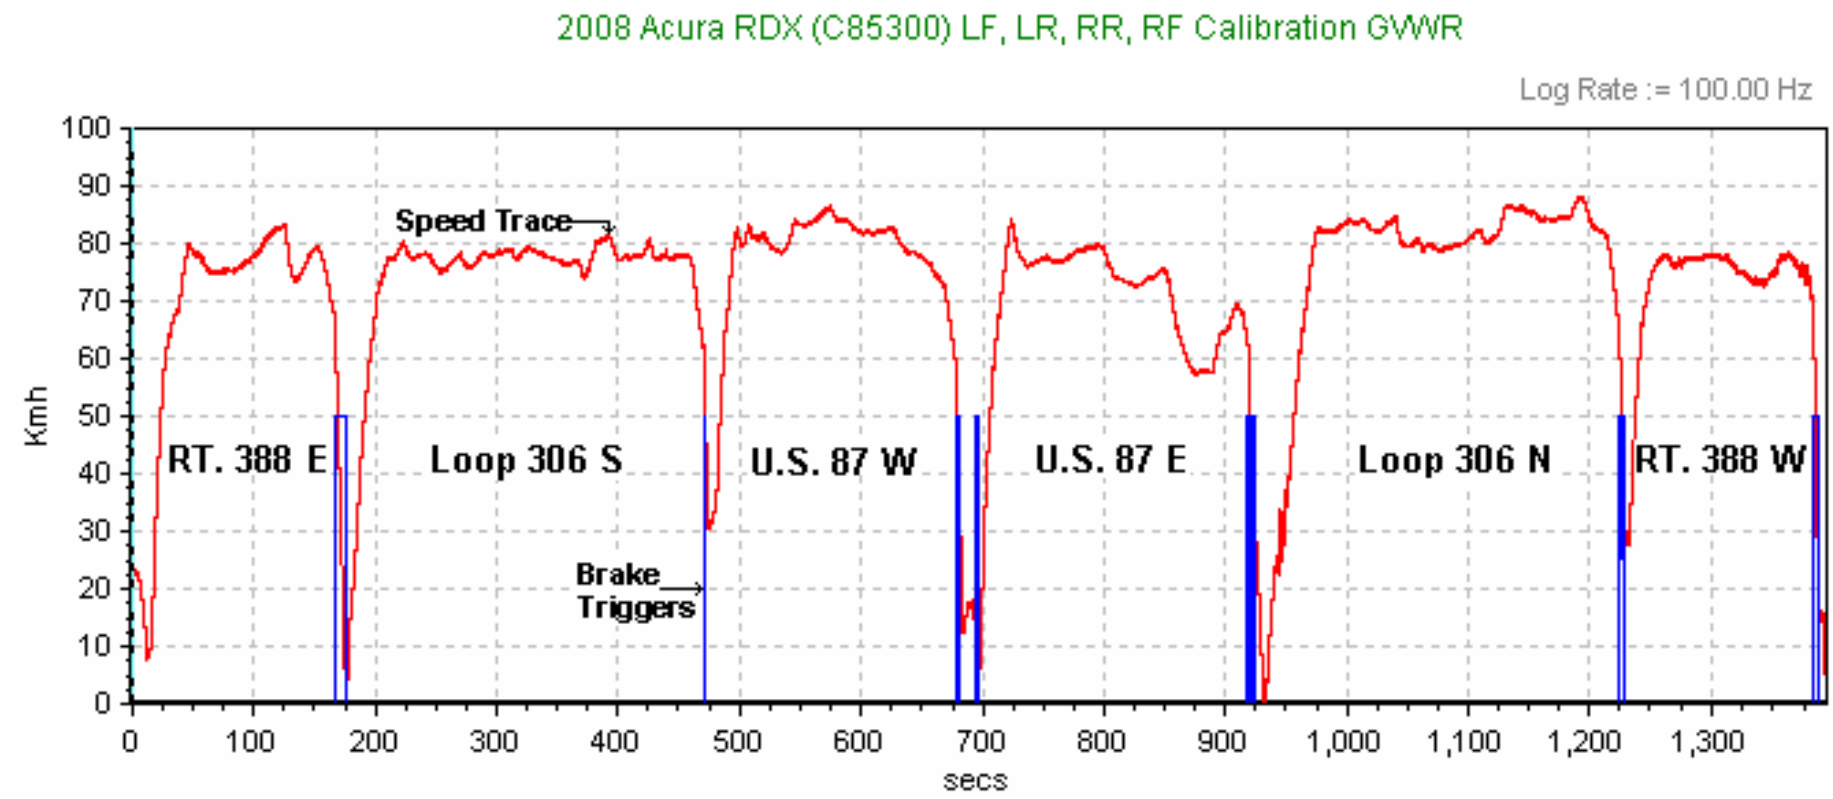
Scenario H:	Left Front, Left Rear, Right Rear, Right Front Tires
Test Date:	11/07/07
Data File Time:	23:15 minutes
Cumulative Driving Time:	20:42 minutes
Start Point:	GAFB North Gate

LF, LR, RR, RF Detection Phase: Illumination in 4.9 seconds. Driving was not required.
