REPORT NO. 111-KAR-09-005

SAFETY COMPLIANCE TESTING FOR FMVSS 111

2009 AUDI A6
4-DOOR SEDAN

NHTSA NO: C95800

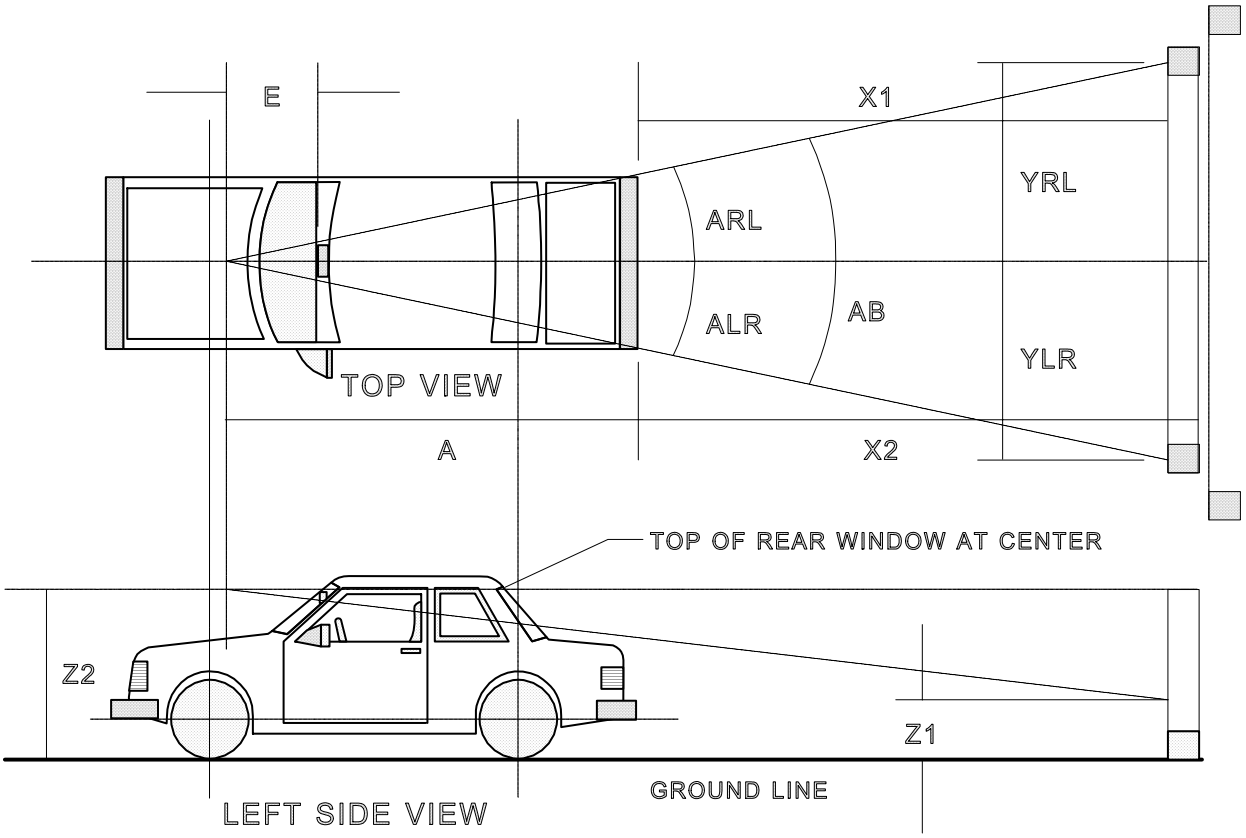
INSIDE REARVIEW MIRROR FIELD OF VIEW
TEST GRID AND MARKER SETUP

ANGLE AB = **25.9°** (S111 REQUIREMENT = 20 degrees minimum)

REMARKS: Passed, has a passenger side mirror

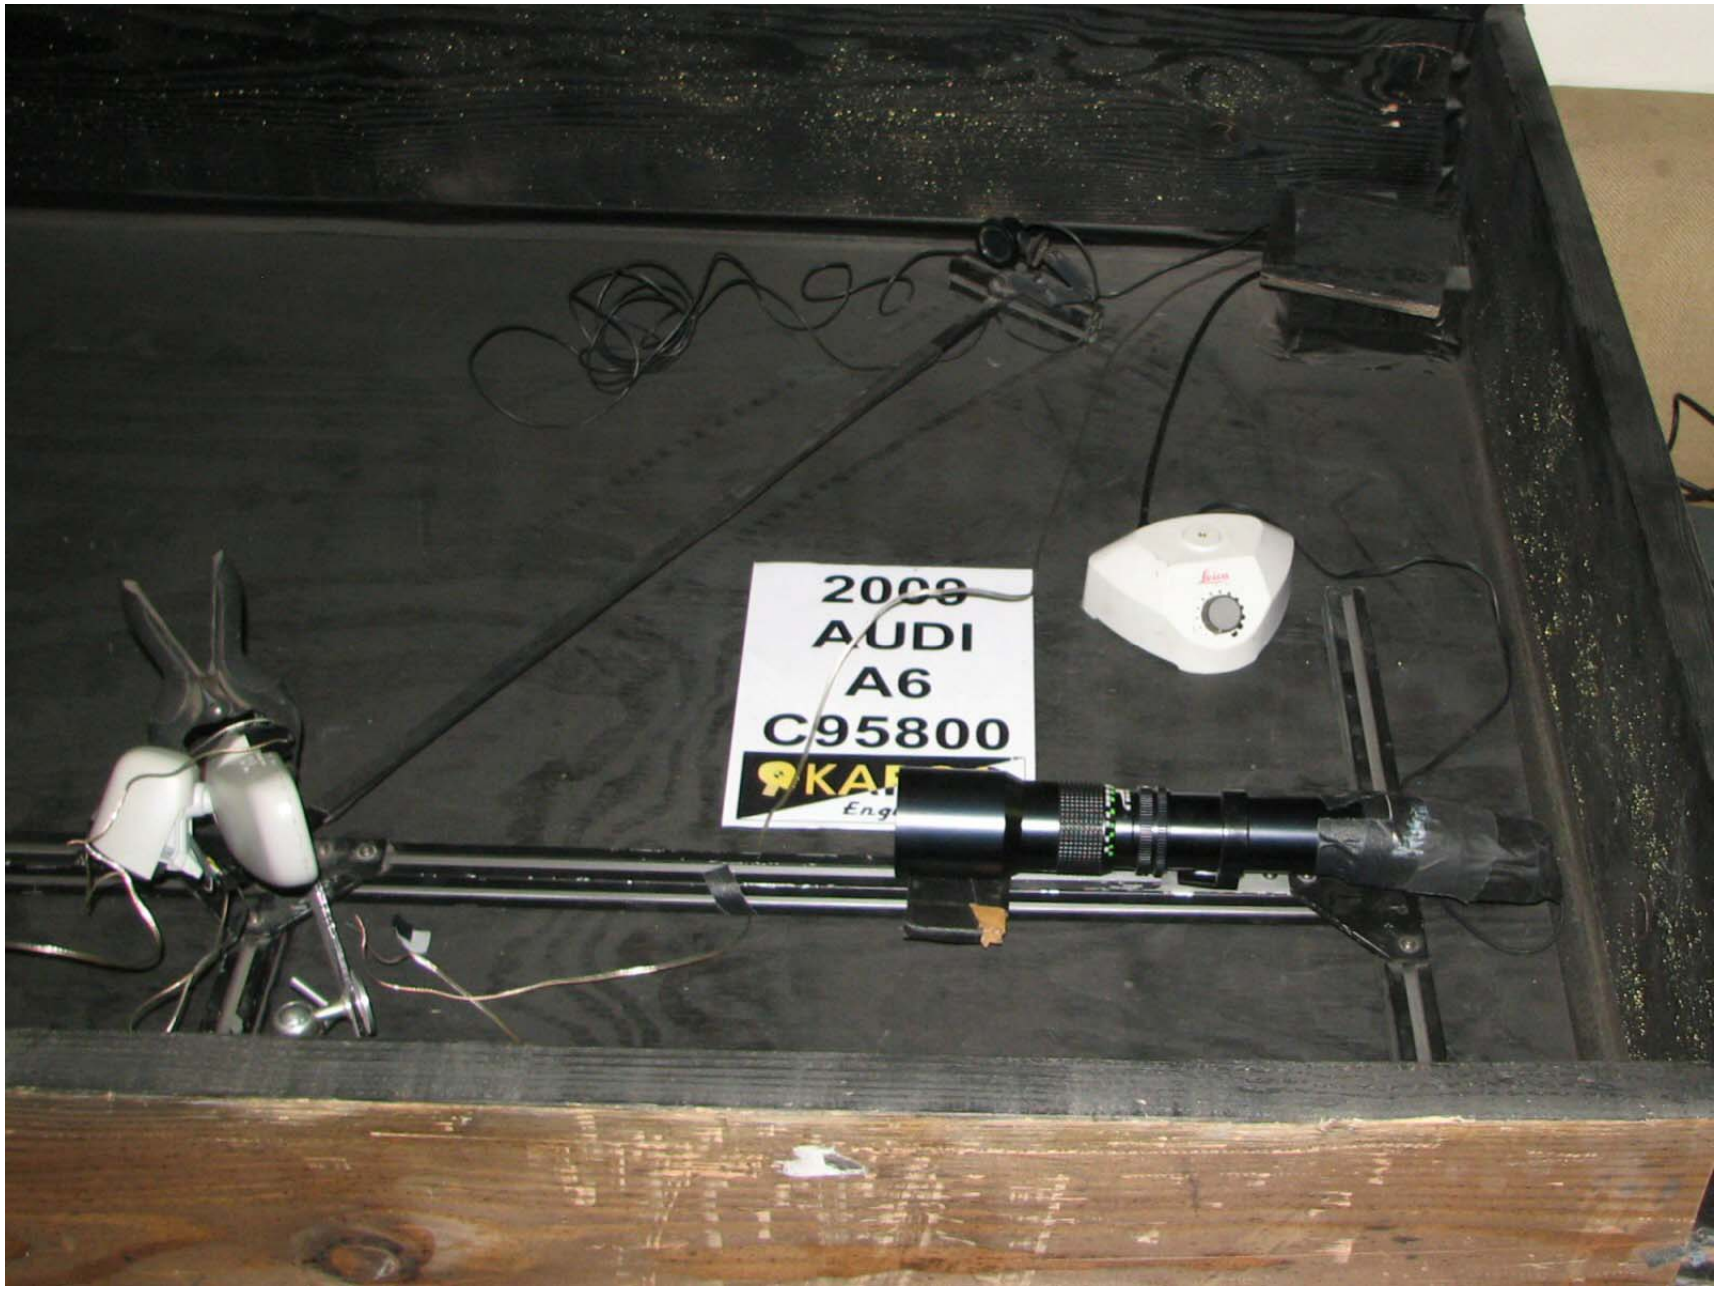
FIGURE 13:CLOSE-UP OF MIRROR BREAK- AWAY TEST

NONE

TEST STATUS:	PASSED —	**X**	FAILED —
