REPORT NO. 111-KAR-10-001

SAFETY COMPLIANCE TESTING FOR FMVSS 111

2010 FORD TAURUS

NHTSA NO: CA0211

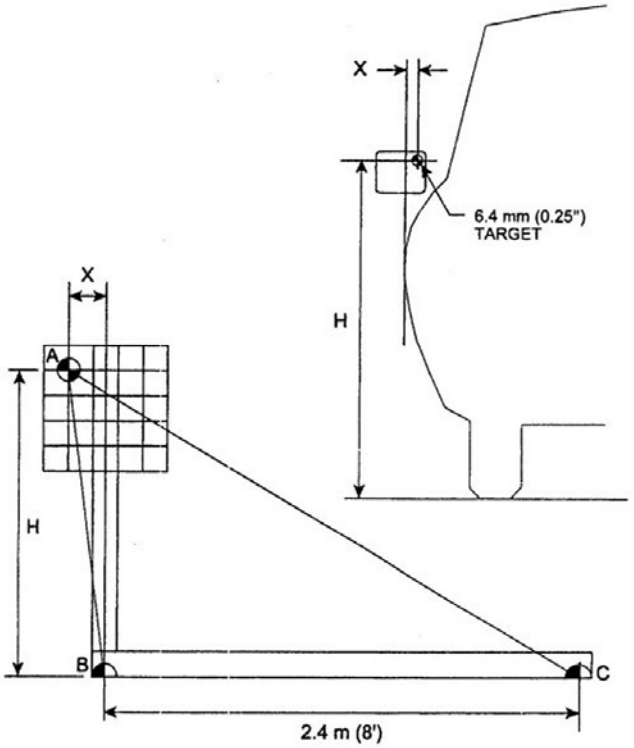
DRIVER SIDE OUTSIDE MIRROR TARGET DISC
LOCATION WITH X AND H DIMENSIONS

HEIGHT OF TARGET DISC ON MIRROR **1218mm**

DISTANCE OF TARGET DISC ON MIRROR FROM VEHICLE TANGENT PLANE **59mm**

TARGET DISC LOCATION RELATIVE TO VEHICLE TANGENT PLANE **Inboard**
(Inboard or Outboard)

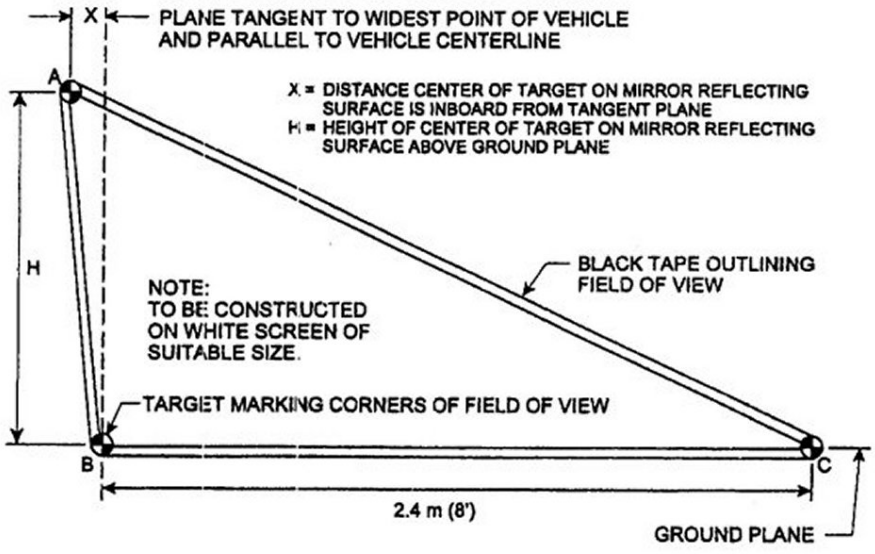
DRIVER SIDE OUTSIDE MIRROR REQUIRED
FIELD OF VIEW TRIANGLE

ENTIRE TRIANGULAR TEST TARGET AREA ON SCREEN VISIBLE YES __**X**__ NO _____

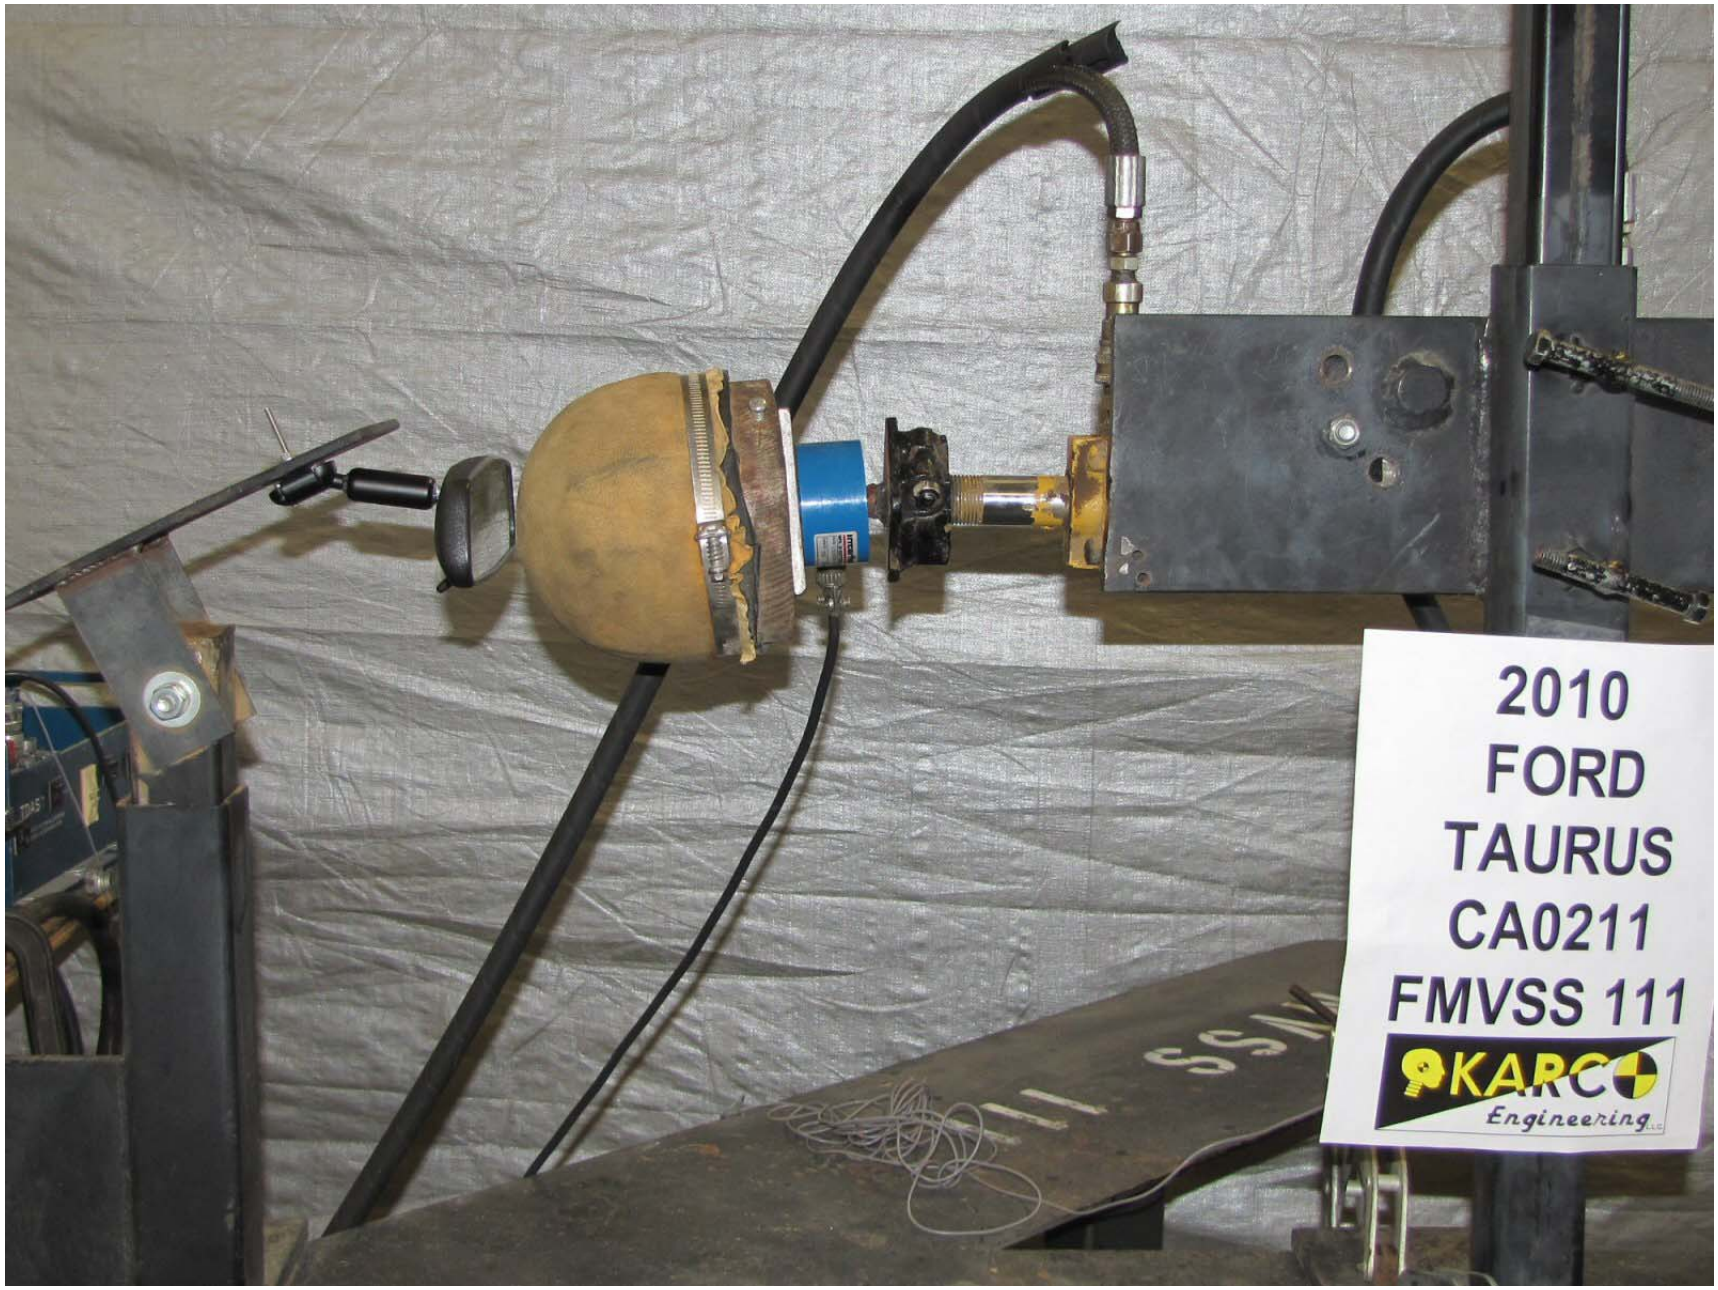
FIGURE 12: OVERALL SET-UP AND INSTRUMENTATION FOR MIRROR BREAK- AWAY TEST

TEST NO.	LOAD DIRECTION VERTICAL/HORIZONTAL	MAXIMUM FORCE (N)	DISPLACEMENT (MM)	PASS	FAIL
1	**0-90 DEGREES**	**244.9**	**8.3**	**X**	
2	**+45/90 DEGREES**	**249.9**	**11.5**	**X**	
3	**-45/90 DEGREES**	**119.8**	**12.8**	**X**	
4	**-45/+45 DEGREES**	**51.7**	**43.2**	**X**	
5	**+45/+45 DEGREES**	**79.1**	**18.2**	**X**	
6	**+45/-45 DEGREES**	**61.5**	**18.9**	**X**	
7	**-45/-45 DEGREES**	**85.9**	**19.7**	**X**

NONE

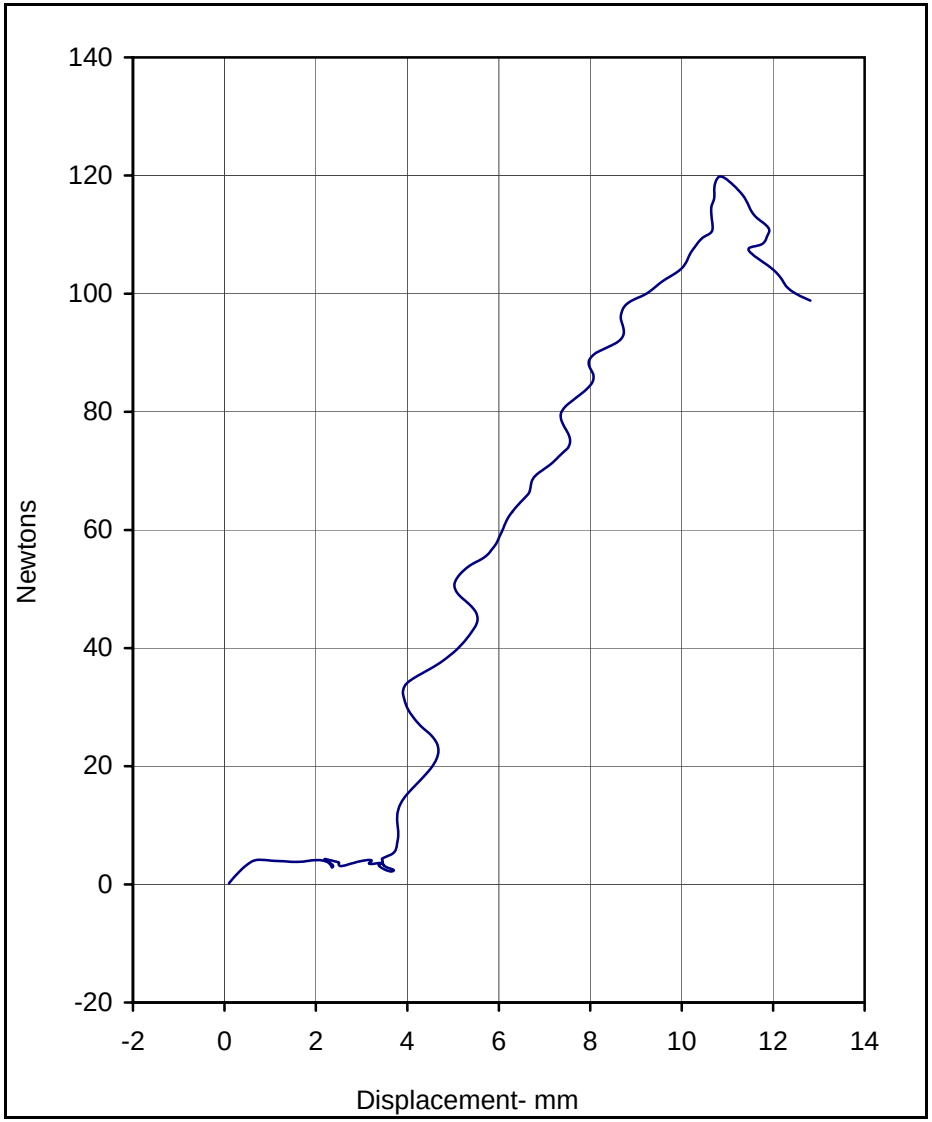
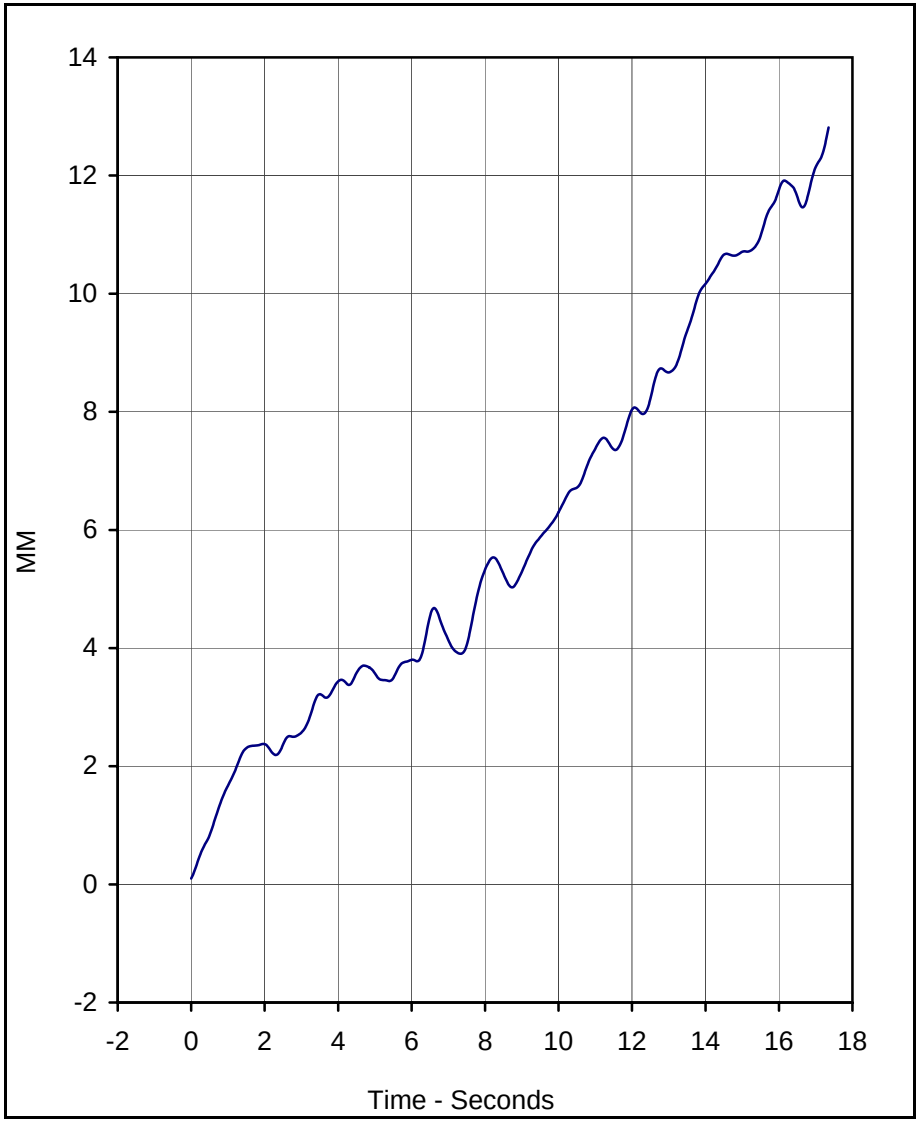
Units	Peak Force	Displacement	Filter (Hz)
Newtons	119.8	10.8	1

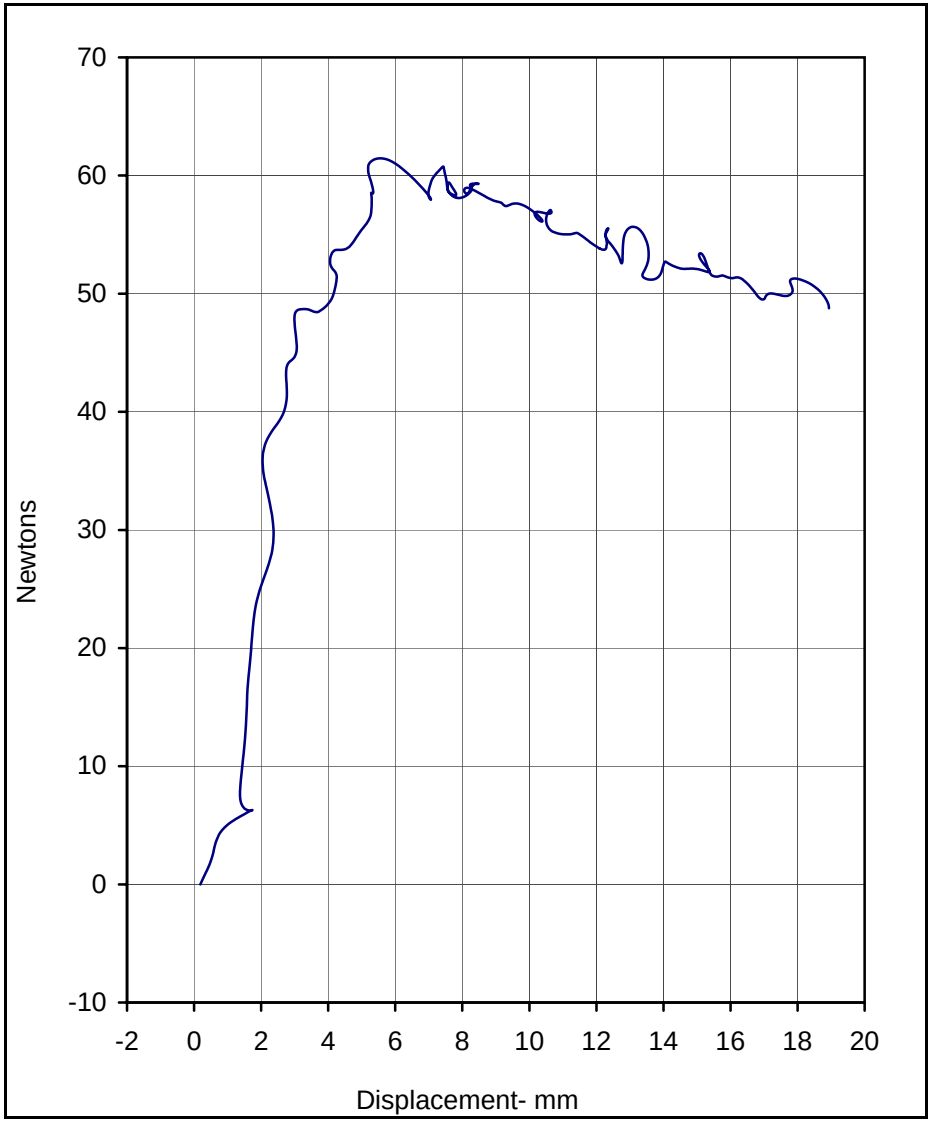
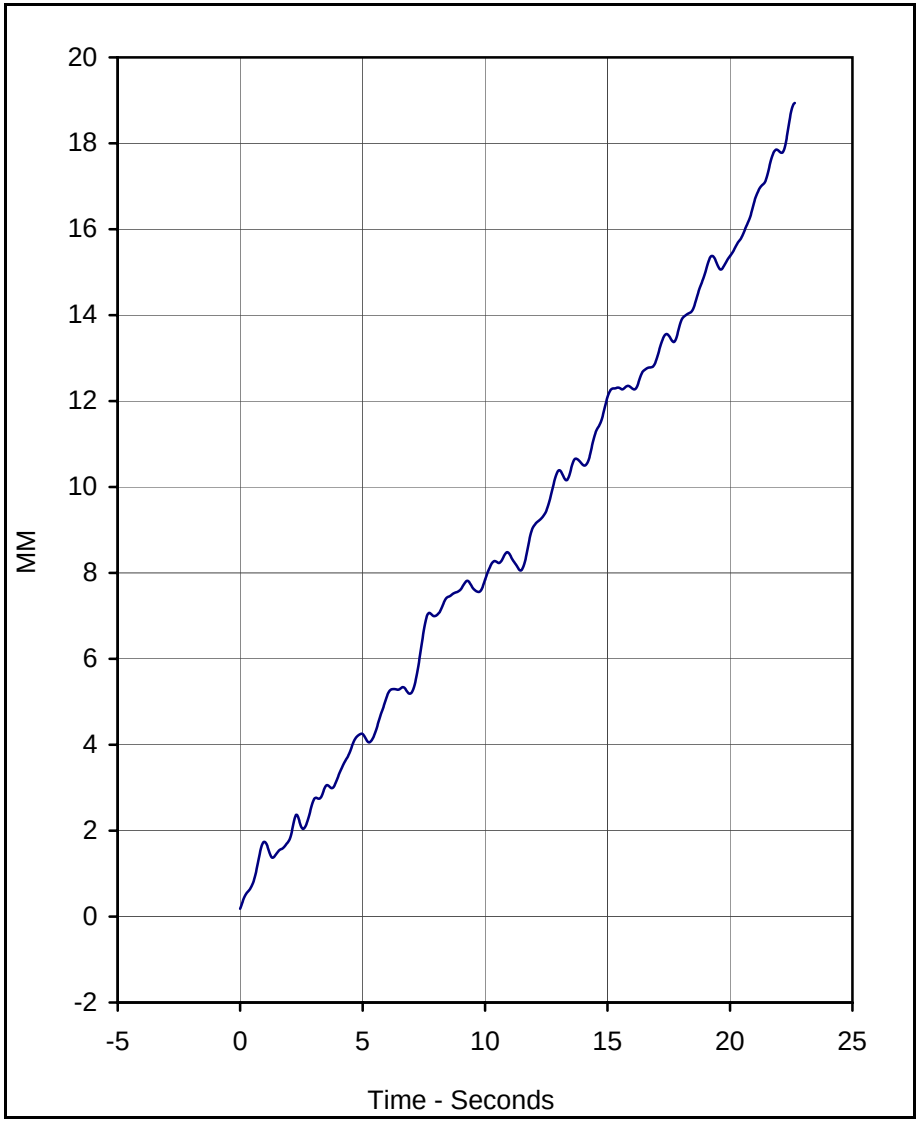
Units	Peak Force	Displacement	Filter (Hz)
Newtons	61.5	5.6	1

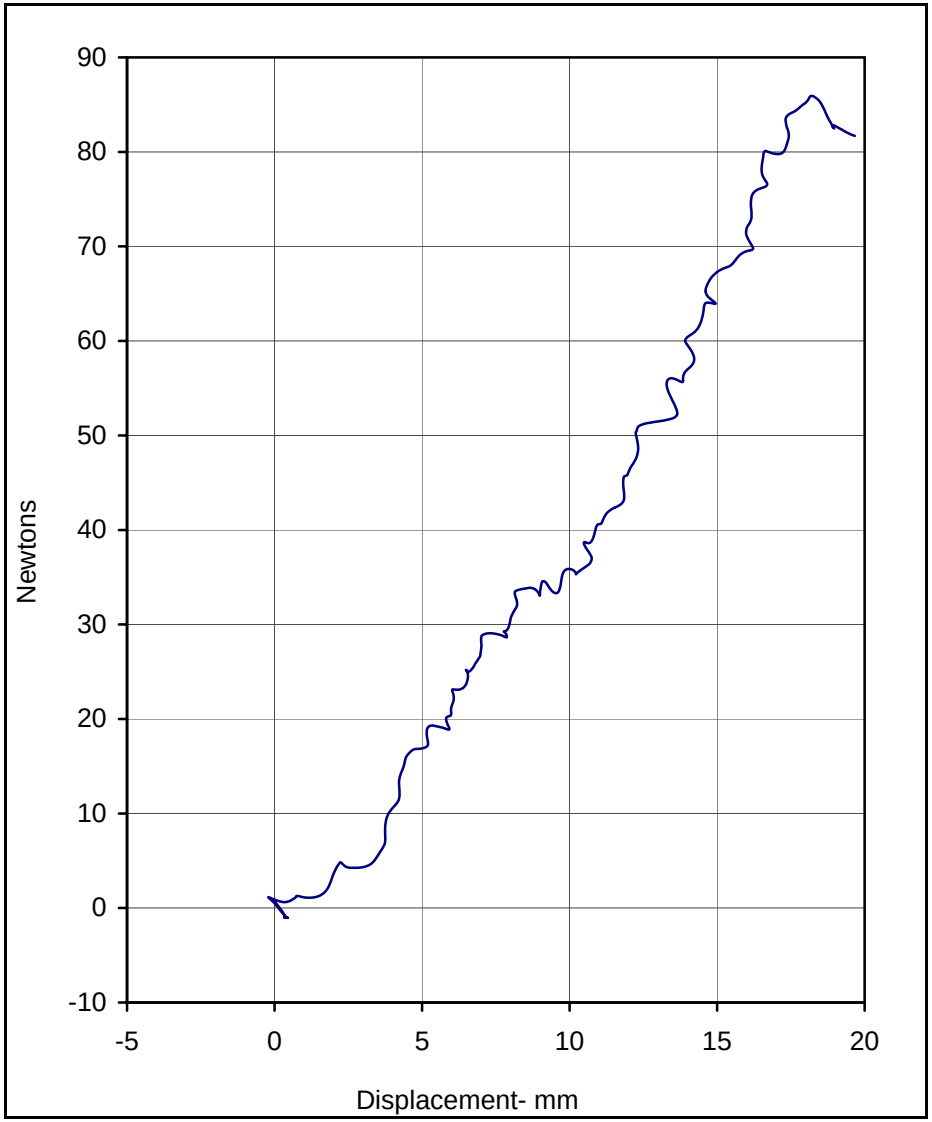
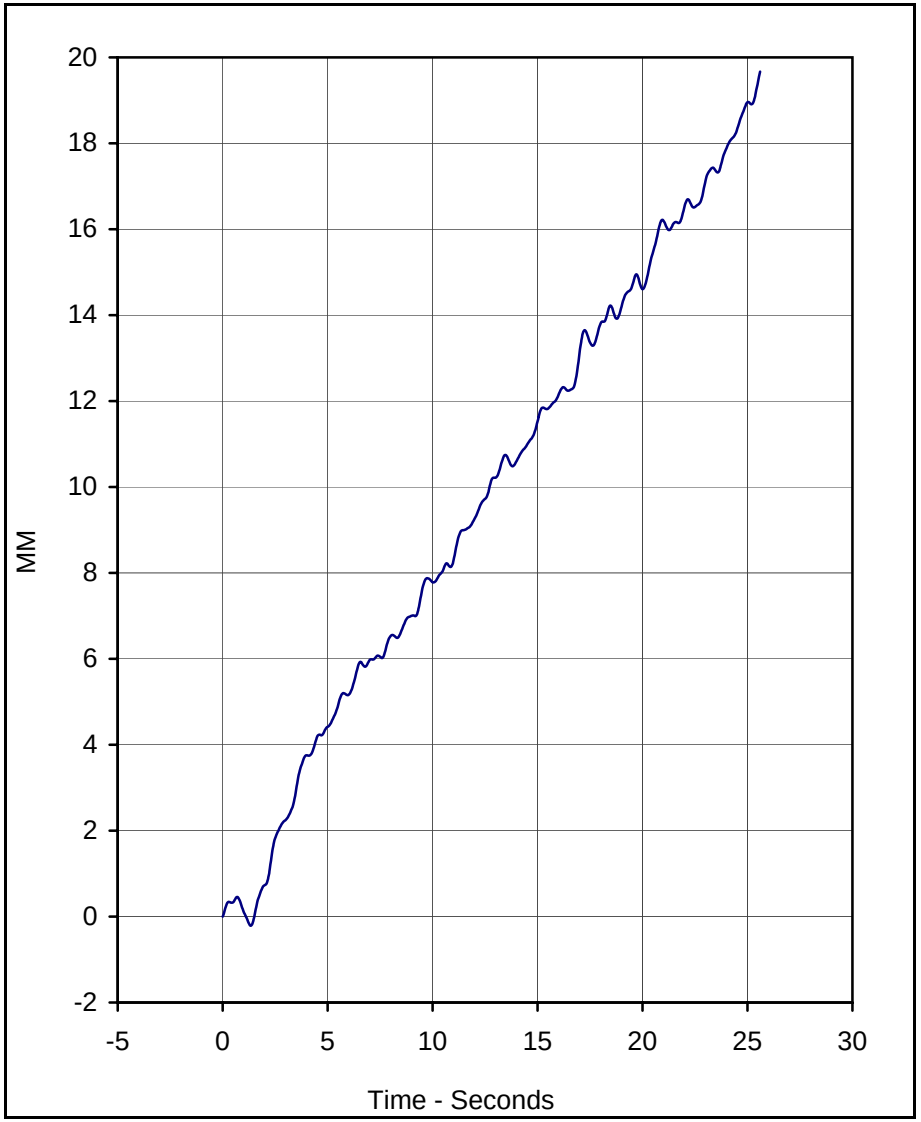
Units	Peak Force	Displacement	Filter (Hz)
Newtons	85.9	18.2	1
