REPORT NO. 111-KAR-10-004

SAFETY COMPLIANCE TESTING FOR FMVSS 111

2010 HONDA ODYSSEY LX

FINAL REPORT

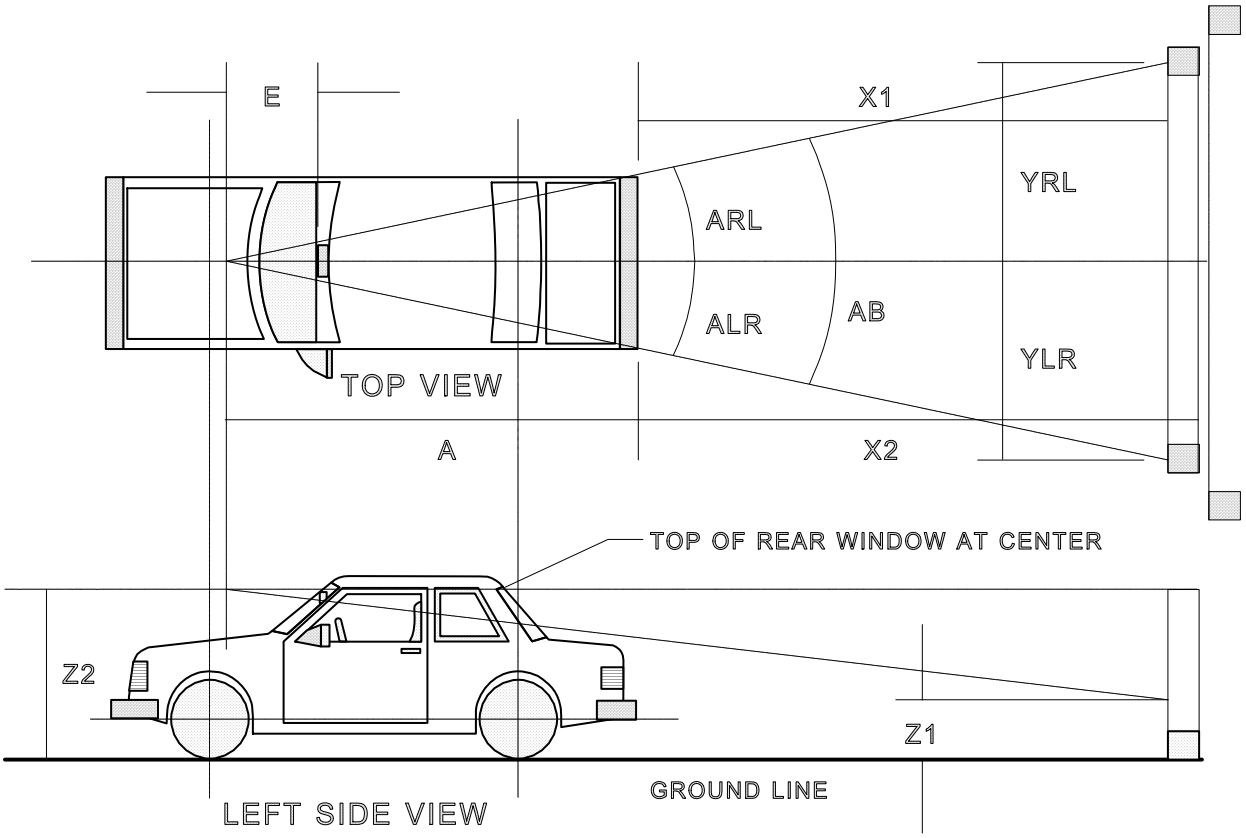
INSIDE REARVIEW MIRROR FIELD OF VIEW
TEST GRID AND MARKER SETUP

X2 Distance from rear of vehicle where the road surface is first visible
X2 = [(Z2 x X1) + (Z1 x A)]/(Z2 - Z1) =
(S111 REQUIREMENT = 61m maximum) **14.843 m**

ANGLE AB = **17.95°** (S111 REQUIREMENT = 20 degrees minimum)

Note: Has a passenger side mirror (S5.3)
