FINAL REPORT NUMBER 201UI-MGA-10-01

SAFETY COMPLIANCE TESTING FOR FMVSS 201
Occupant Protection In Interior Impact
Upper Interior Head Impact Protection

CAMI AUTOMOTIVE, INC.
2010 Chevrolet Equinox MPV
NHTSA No. CA0109

MGA RESEARCH CORPORATION
446 Executive Drive
Troy, Michigan 48083

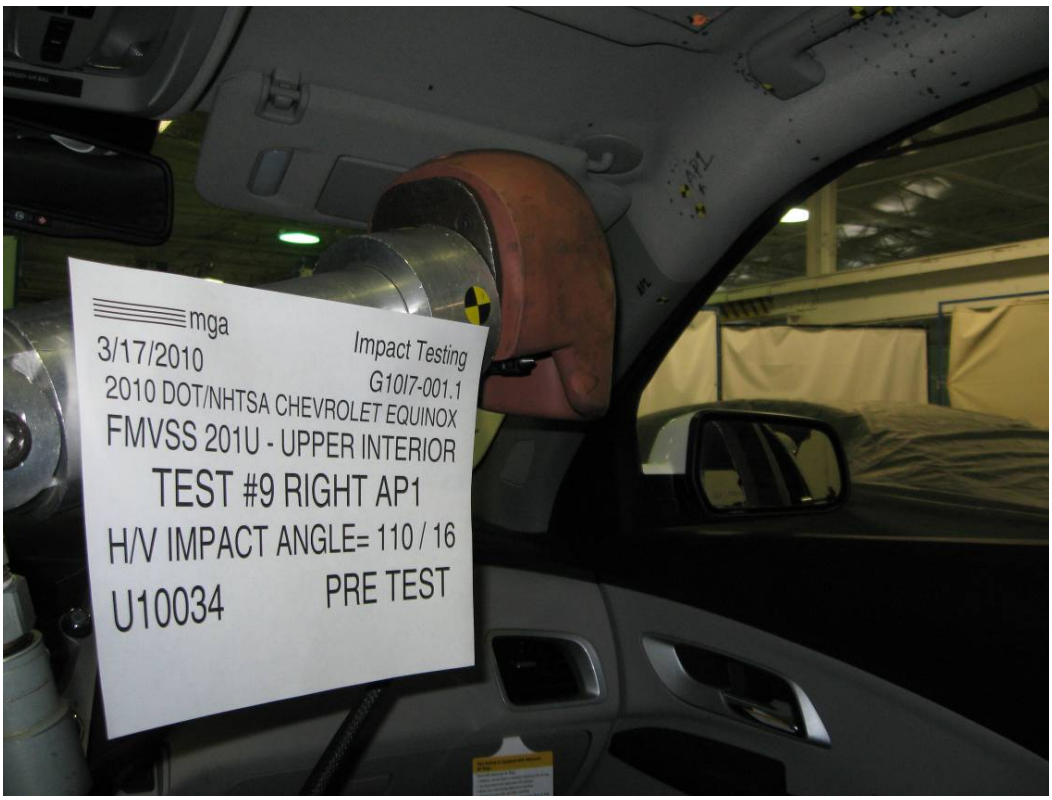
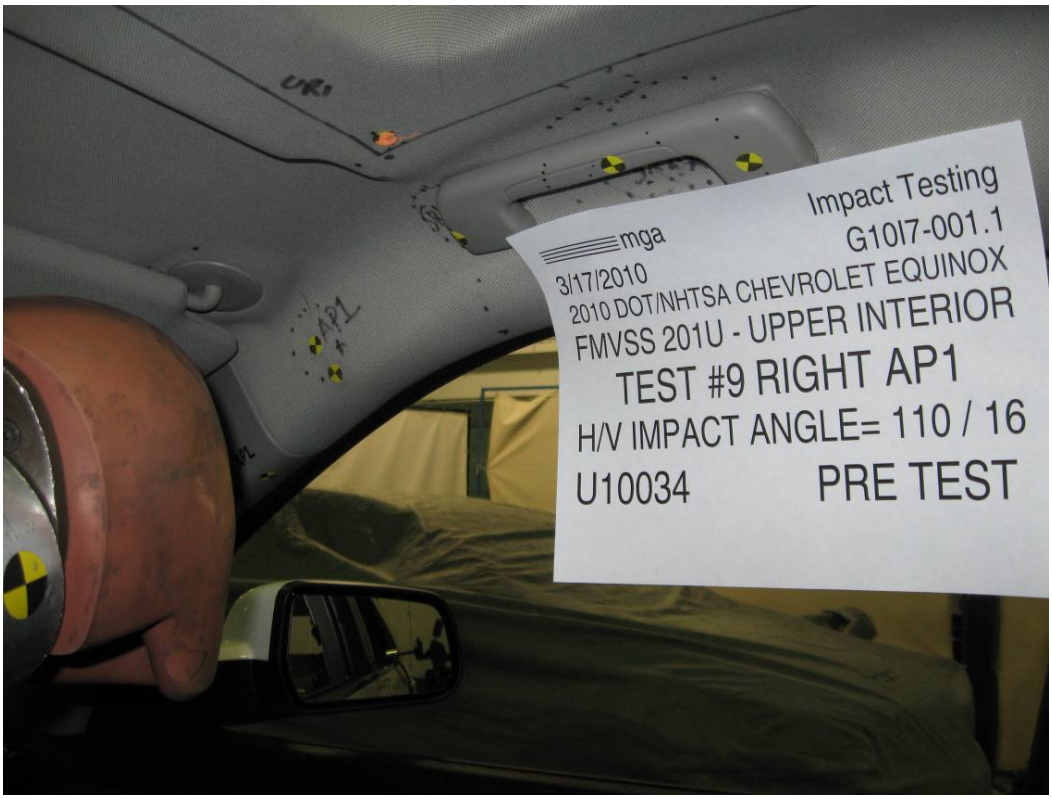
mga
Impact Testing
3/17/2010
G10I7-001.1
2010 DOT/NHTSA CHEVROLET EQUINOX
FMVSS 201U - UPPER INTERIOR
TEST #9 RIGHT AP1
H/V IMPACT ANGLE= 110 / 16
U10034
POST TEST
CA0109
U10034
RIGHT AP1
H/V 110/16

No visible damage

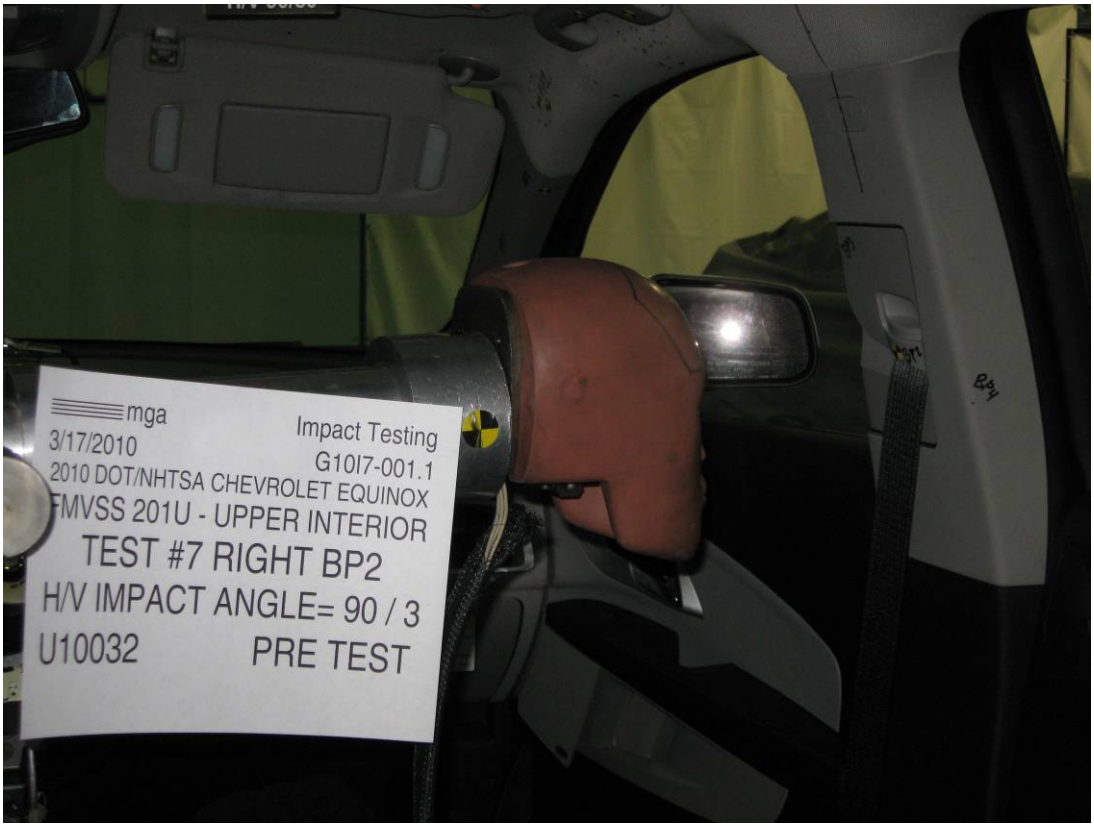
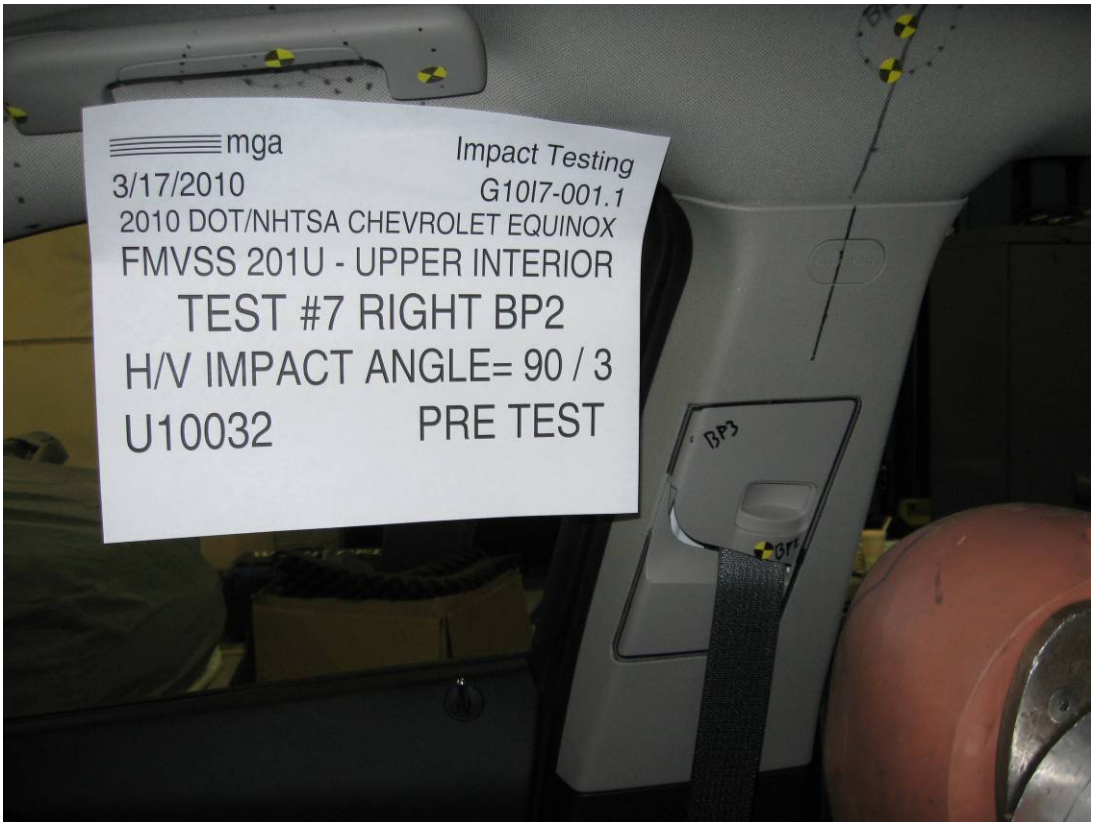
mga
Impact Testing
3/17/2010
G10I7-001.1
2010 DOT/NHTSA CHEVROLET EQUINOX
FMVSS 201U - UPPER INTERIOR
TEST #7 RIGHT BP2
H/V IMPACT ANGLE= 90 / 3
U10032
PRE TEST

BP2 Right: Damaged anchor button, but still functional.

Damaged anchor button but still functional

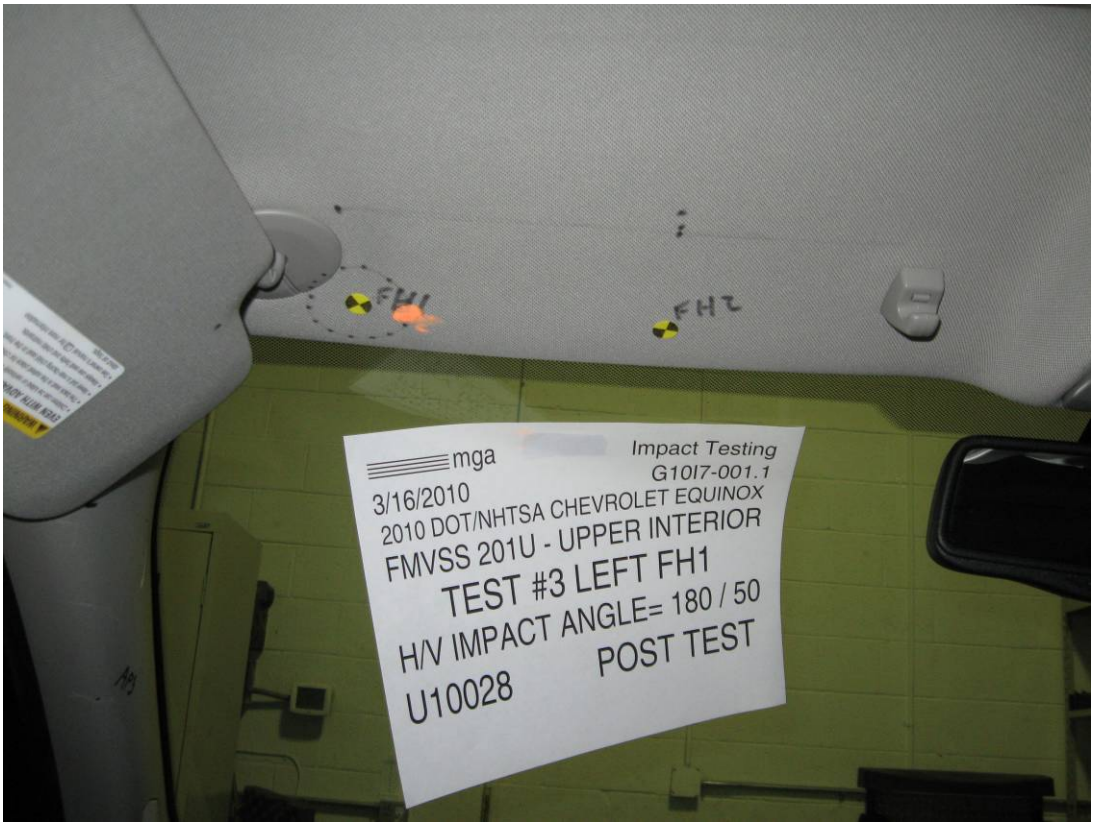
mga
Impact Testing
G10I7-001.1
3/16/2010
2010 DOT/NHTSA CHEVROLET EQUINOX
FMVSS 201U - UPPER INTERIOR
TEST #3 LEFT FH1
H/V IMPACT ANGLE= 180 / 50
U10028
POST TEST
FH1
FH2

No visible damage

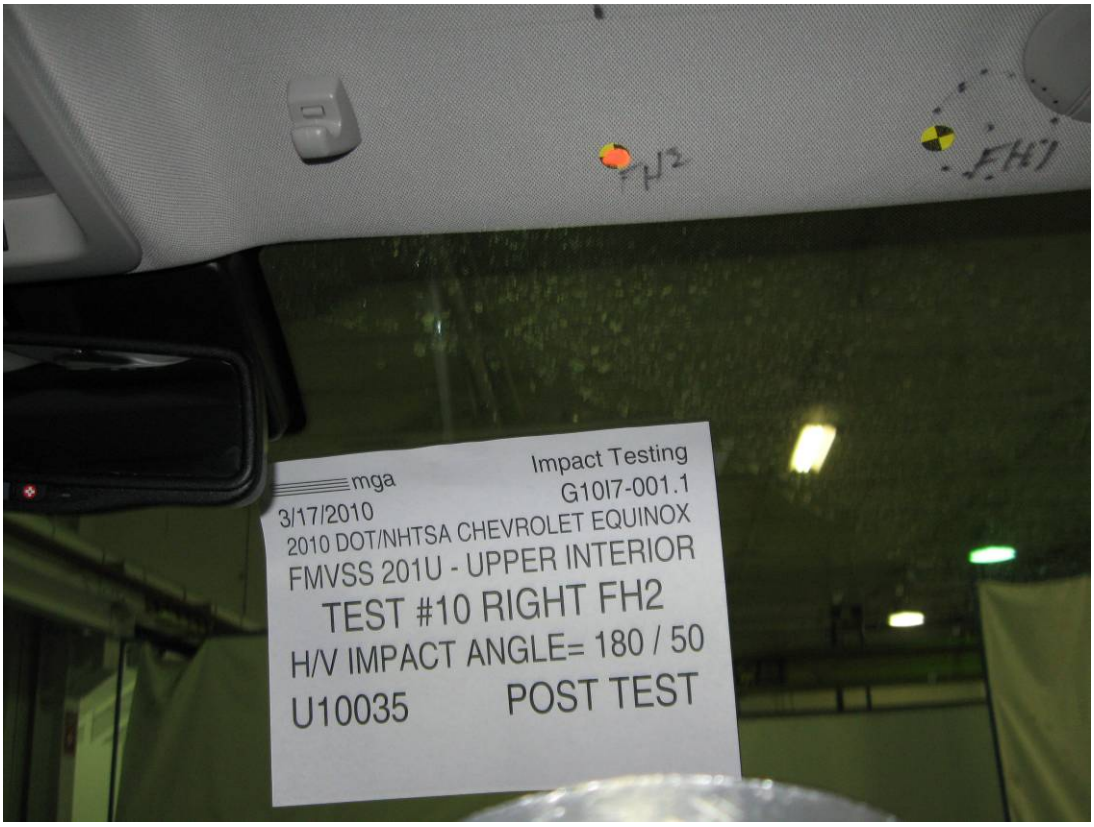
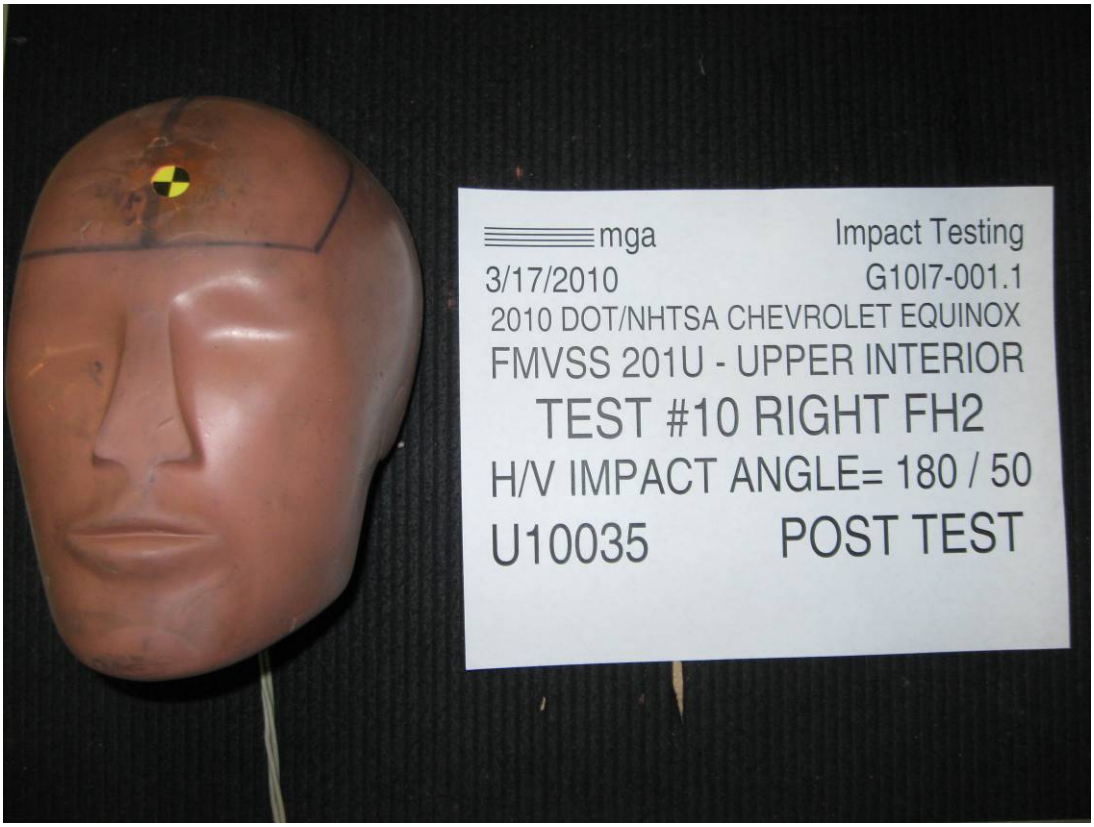
FH2
FH1
mga
Impact Testing
3/17/2010
G10I7-001.1
2010 DOT/NHTSA CHEVROLET EQUINOX
FMVSS 201U - UPPER INTERIOR
TEST #10 RIGHT FH2
H/V IMPACT ANGLE= 180 / 50
U10035
POST TEST

No visible damage

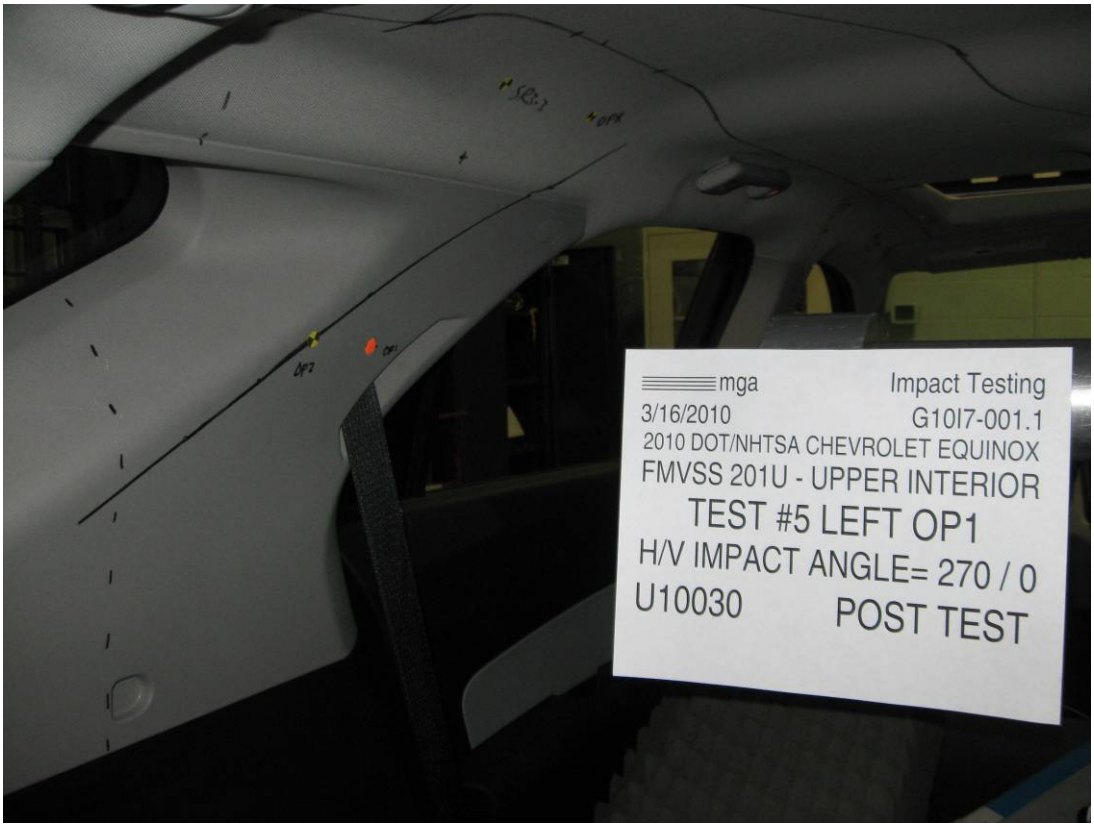
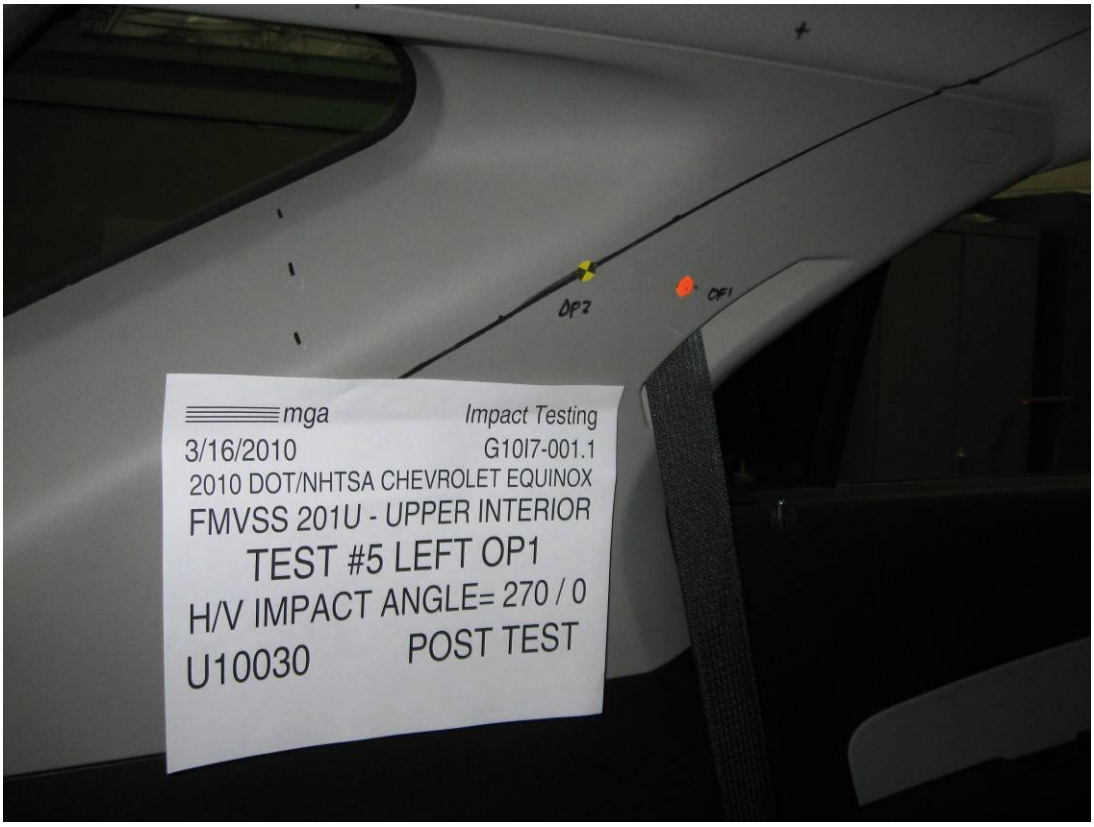
mga
Impact Testing
3/16/2010
G10I7-001.1
2010 DOT/NHTSA CHEVROLET EQUINOX
FMVSS 201U - UPPER INTERIOR
TEST #5 LEFT OP1
H/V IMPACT ANGLE= 270 / 0
U10030
POST TEST

No visible damage

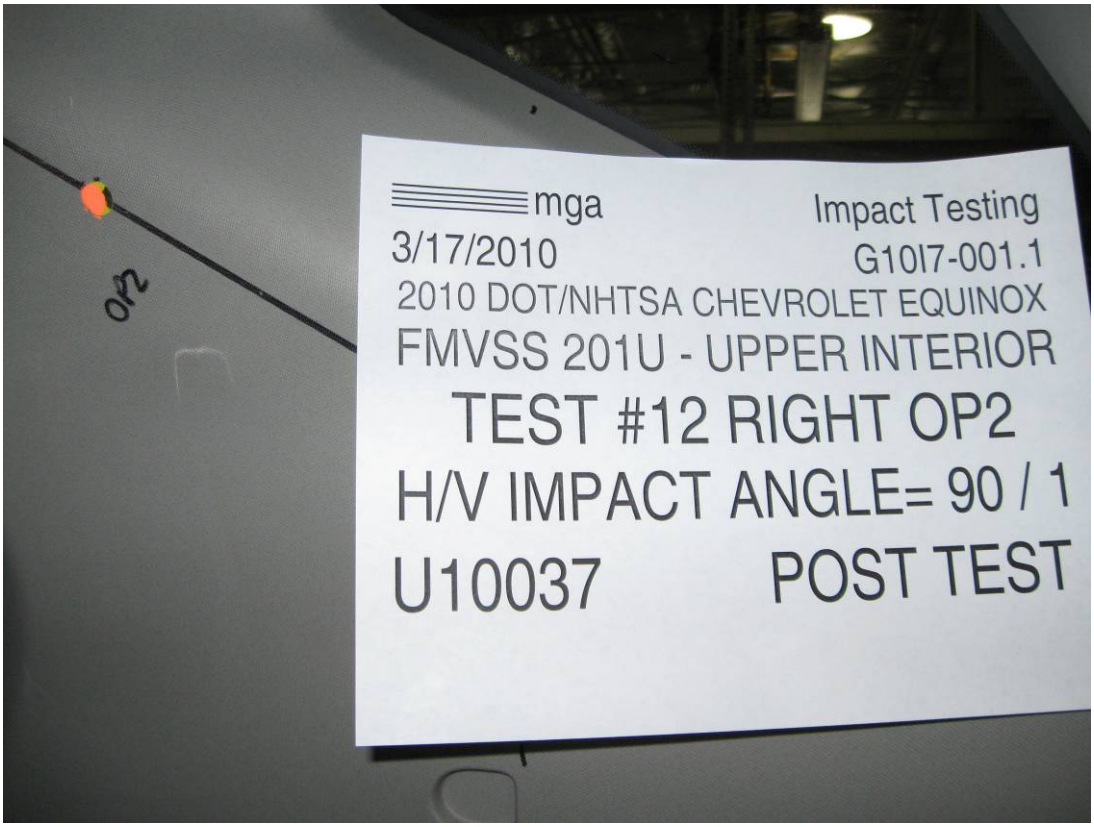
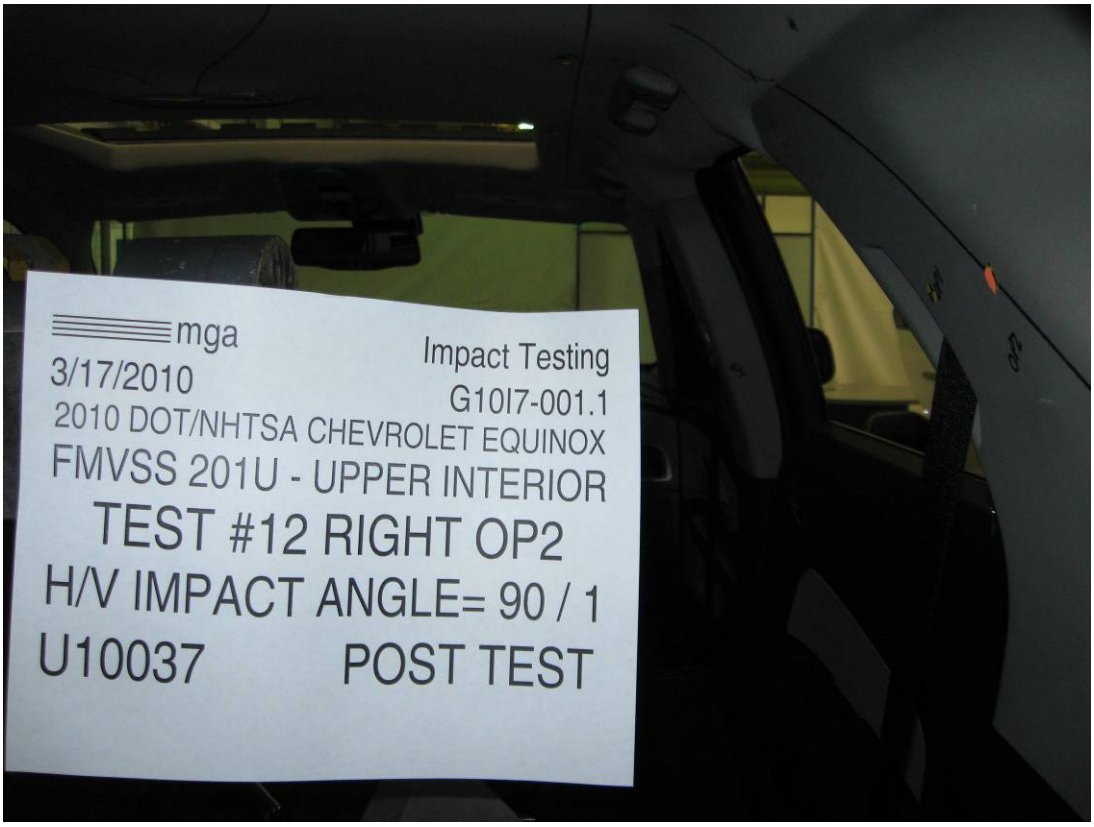
mga
Impact Testing
3/17/2010
G10I7-001.1
2010 DOT/NHTSA CHEVROLET EQUINOX
FMVSS 201U - UPPER INTERIOR
TEST #12 RIGHT OP2
H/V IMPACT ANGLE= 90 / 1
U10037
POST TEST

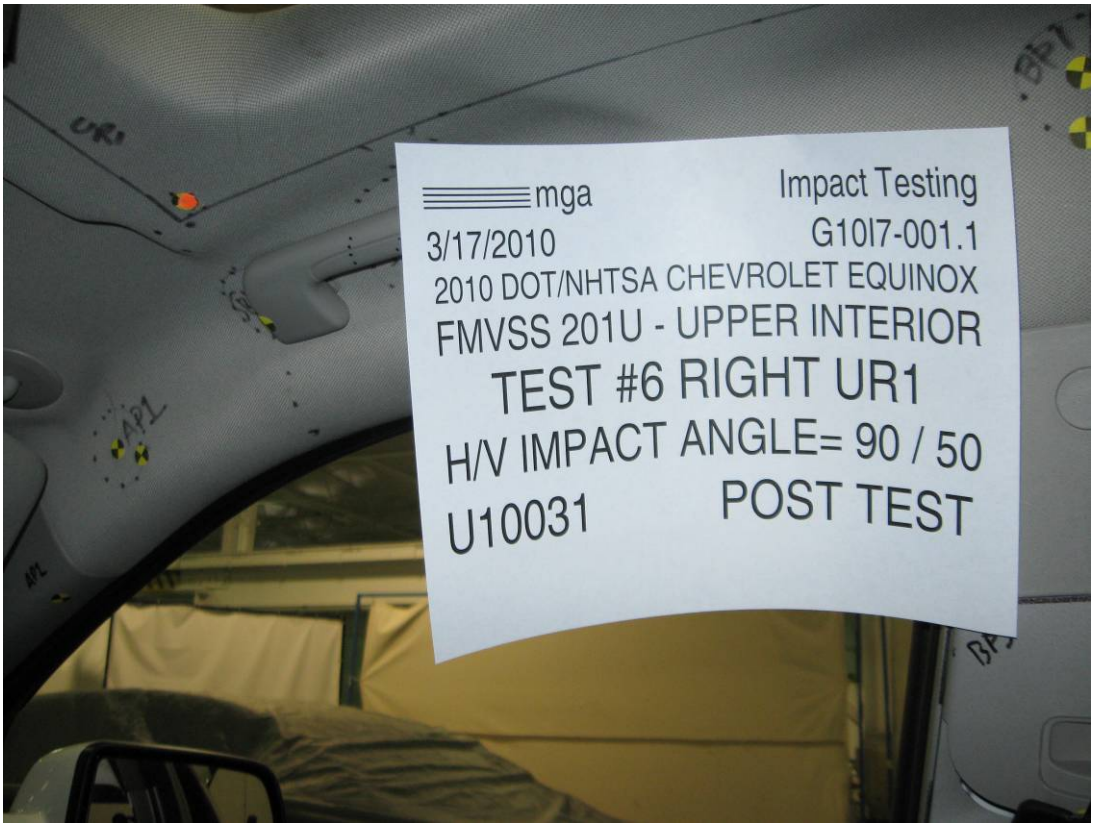
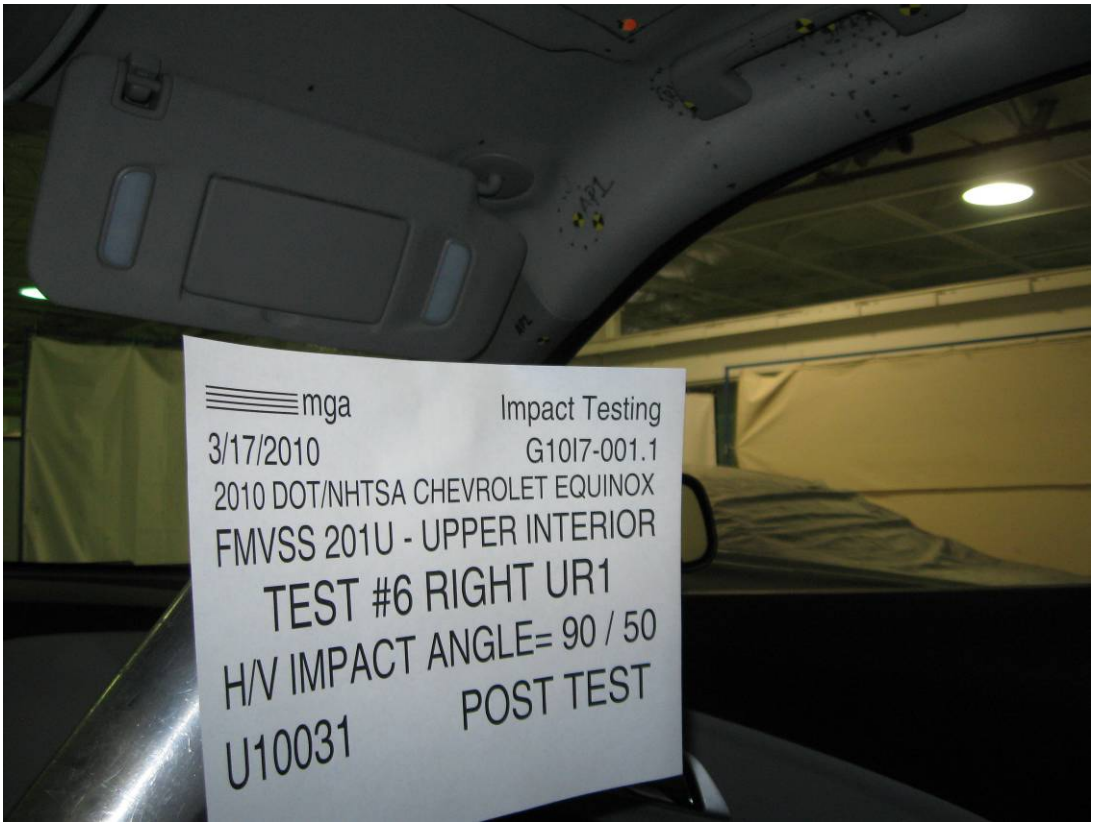
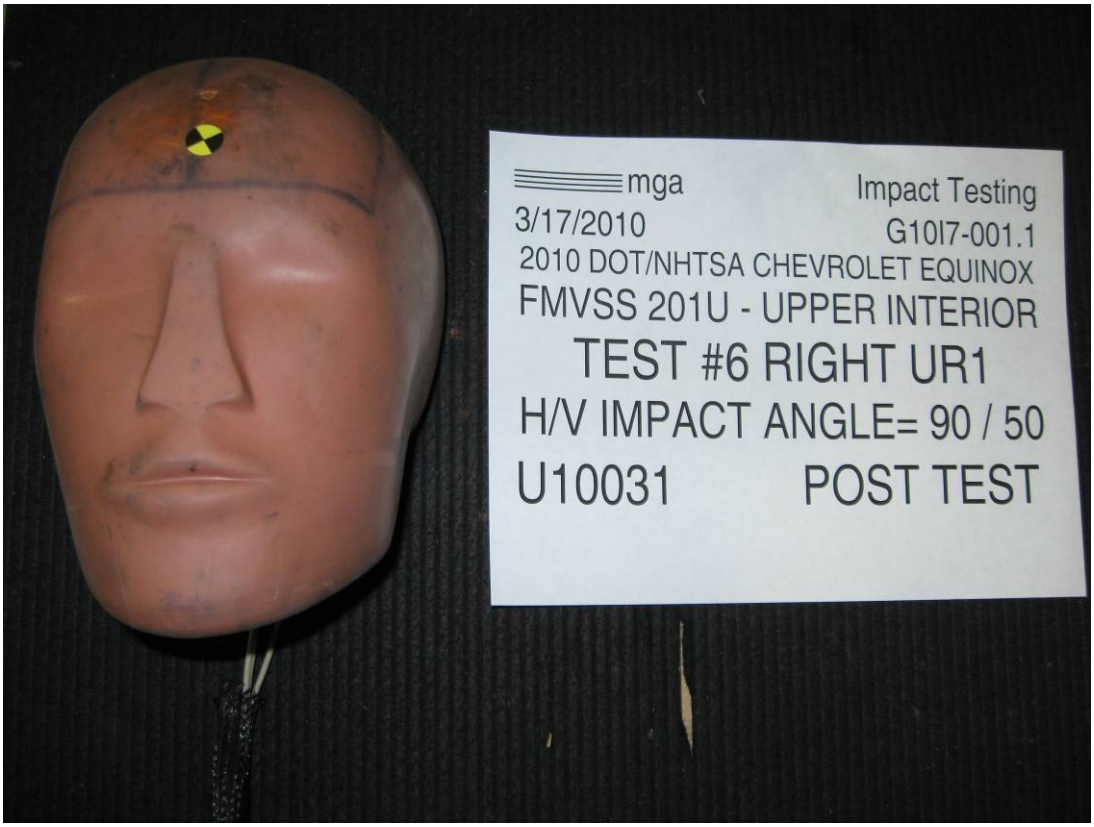
mga
Impact Testing
3/17/2010
G10I7-001.1
2010 DOT/NHTSA CHEVROLET EQUINOX
FMVSS 201U - UPPER INTERIOR
TEST #6 RIGHT UR1
H/V IMPACT ANGLE= 90 / 50
U10031
POST TEST

No visible damage

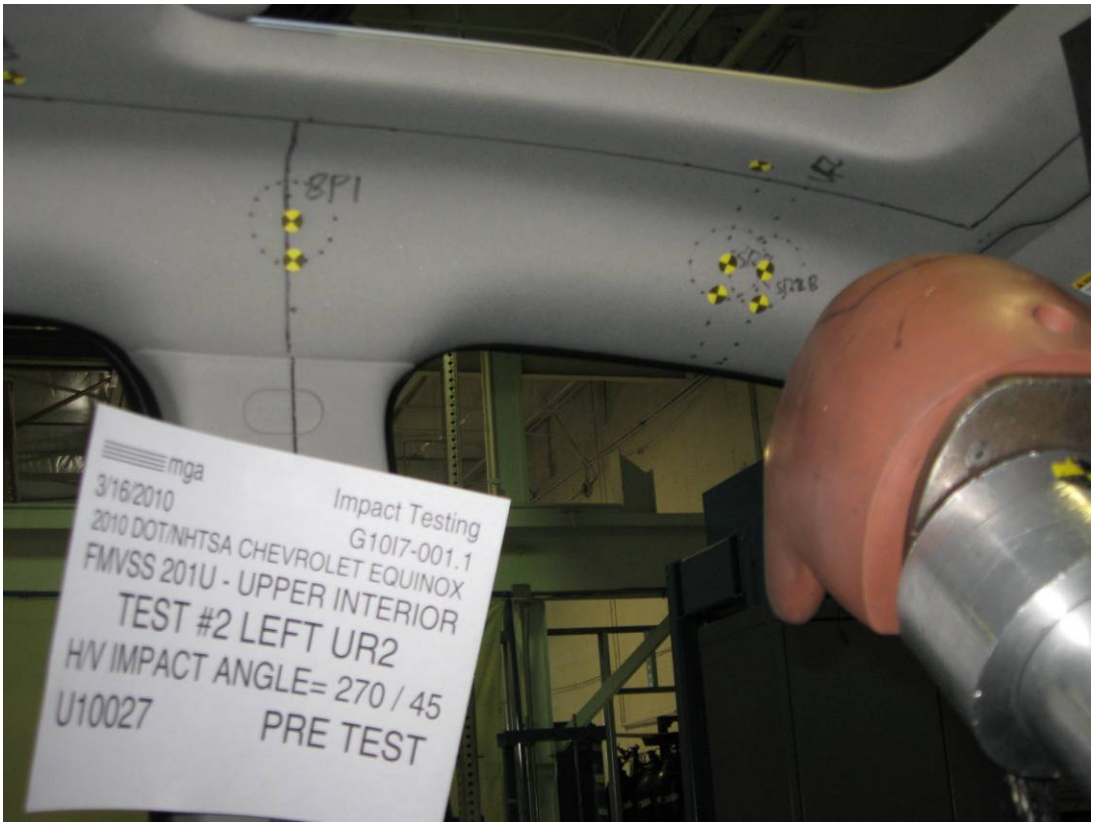
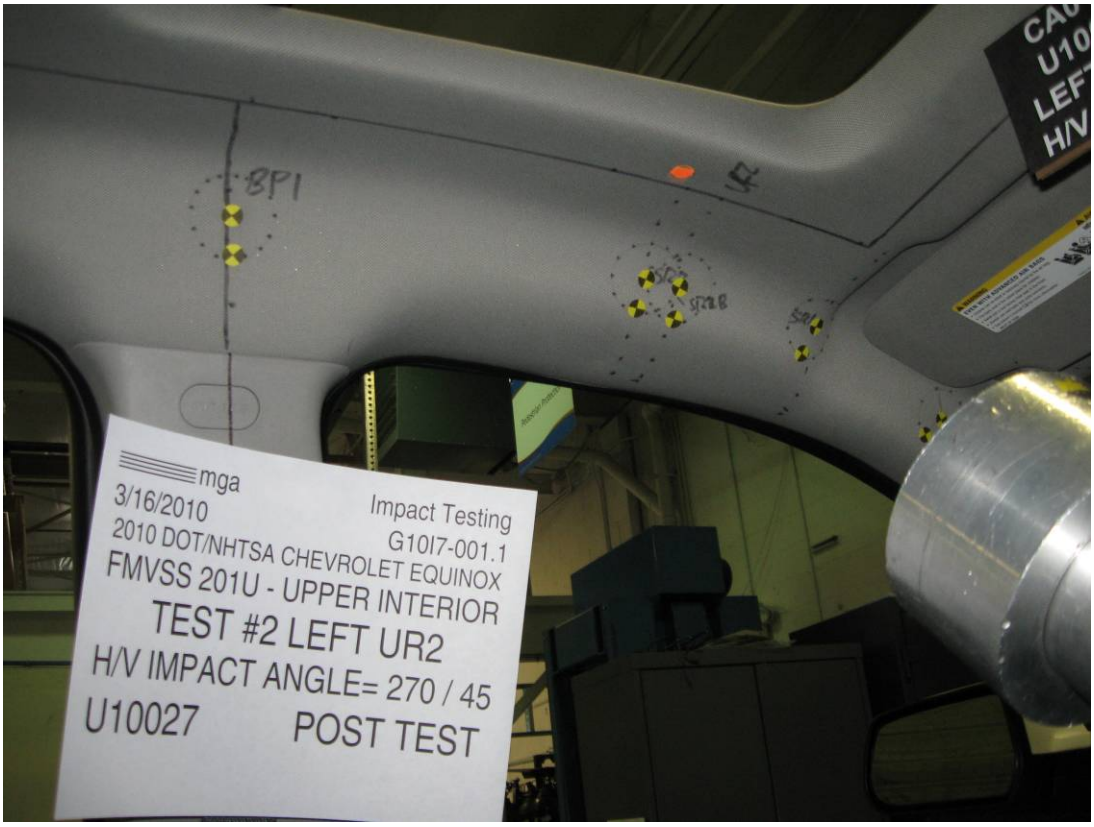
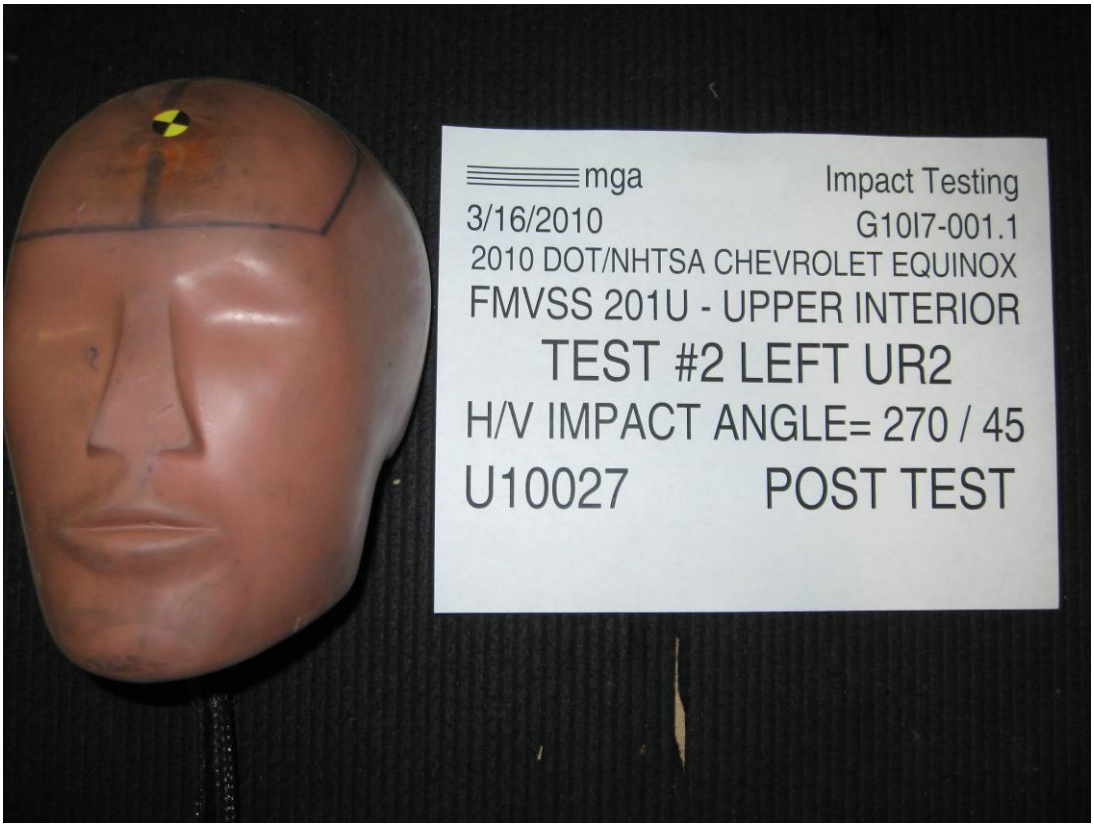
CA0109
U10027
LEFT UR2
H/V 270/45
mga
Impact Testing
3/16/2010
G10I7-001.1
2010 DOT/NHTSA CHEVROLET EQUINOX
FMVSS 201U - UPPER INTERIOR
TEST #2 LEFT UR2
H/V IMPACT ANGLE= 270 / 45
U10027
POST TEST

mga
3/16/2010
Impact Testing
G10I7-001.1
2010 DOT/NHTSA CHEVROLET EQUINOX
FMVSS 201U - UPPER INTERIOR
TEST #2 LEFT UR2
H/V IMPACT ANGLE= 270 / 45
U10027
POST TEST

mga
Impact Testing
3/16/2010
G10I7-001.1
2010 DOT/NHTSA CHEVROLET EQUINOX
FMVSS 201U - UPPER INTERIOR
TEST #2 LEFT UR2
H/V IMPACT ANGLE= 270 / 45
U10027
POST TEST

No visible damage

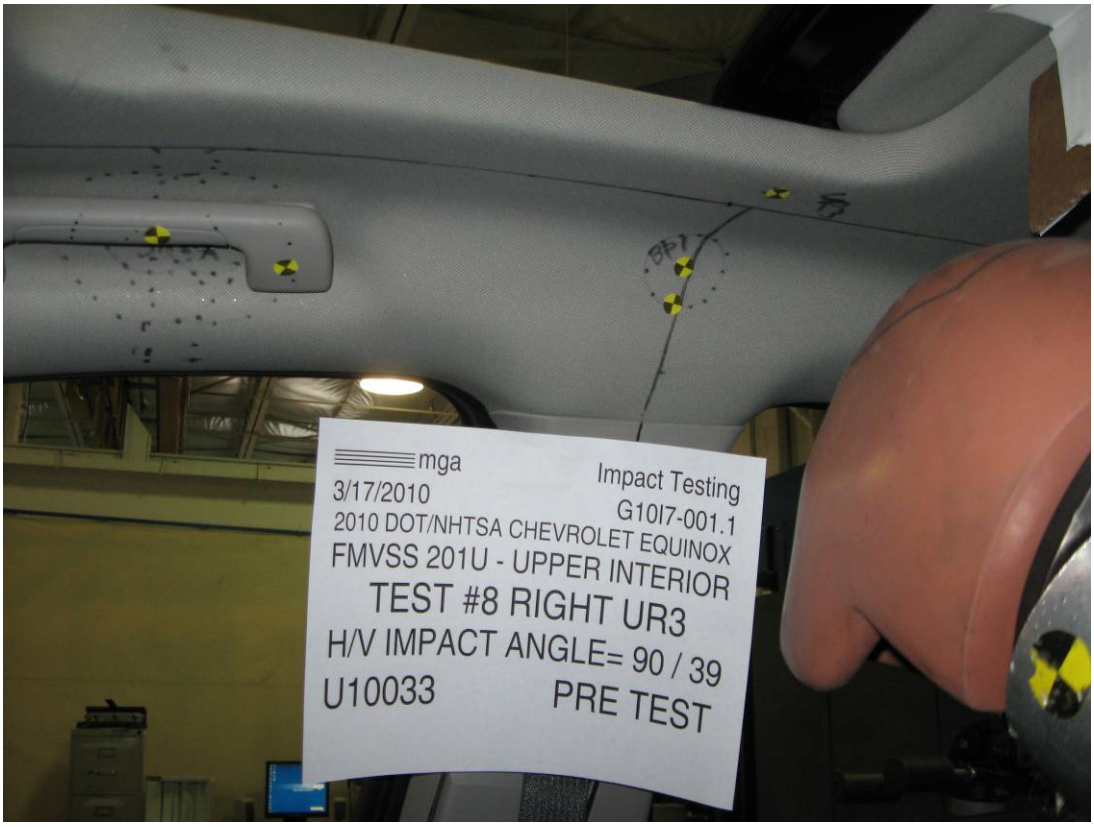
CA0109
U10033
RIGHT UR3
H/V 90/39
mga
Impact Testing
3/17/2010
G10I7-001.1
2010 DOT/NHTSA CHEVROLET EQUINOX
FMVSS 201U - UPPER INTERIOR
TEST #8 RIGHT UR3
H/V IMPACT ANGLE= 90 / 39
U10033
PRE TEST

No visible damage
