**VERIDIAN ON-SITE AIR BAG NON-DEPLOYMENT INVESTIGATION**

**VERIDIAN CASE NO. CA01-025**

**VEHICLE - 2000 FORD EXPLORER XLS 4X4**

**LOCATION - STATE OF NEW JERSEY**

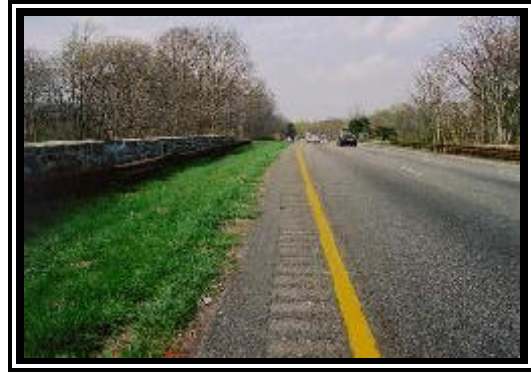
The 20 year old male driver of the 2000 Ford Explorer XLS was operating the vehicle northbound (**Figure 1**) on the inboard lane when he apparently fell asleep and allowed the vehicle to depart the left (west) pavement edge in a forward tracking mode. The police reported no pre-impact tire marks at the scene indicative of driver avoidance maneuvers.

**Figure 1.** Northbound approach for the 2000 Ford Explorer XLS 4x4.
