On-scene Investigation / Vehicle to Vehicle
Dynamic Science, Inc. / Case Number: DS02003
Wheeled Coach Moduvan ambulance on a 1997 Ford E350 series chassis
Washington
February, 2002

1. Report No. DS02003		2. Government Accession No.		3. Recipient Catalog No.	
4. Title and Subtitle In-Depth Accident Investigation				5. Report Date	
				6. Performing Organization Report No.

Dynamic Science, Inc.
Accident Investigation
Case Number: DS02003

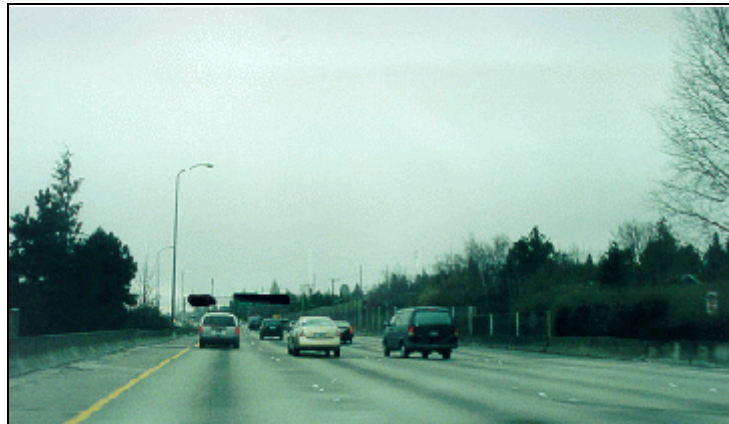
Figure 1. Area of POI, traveling south

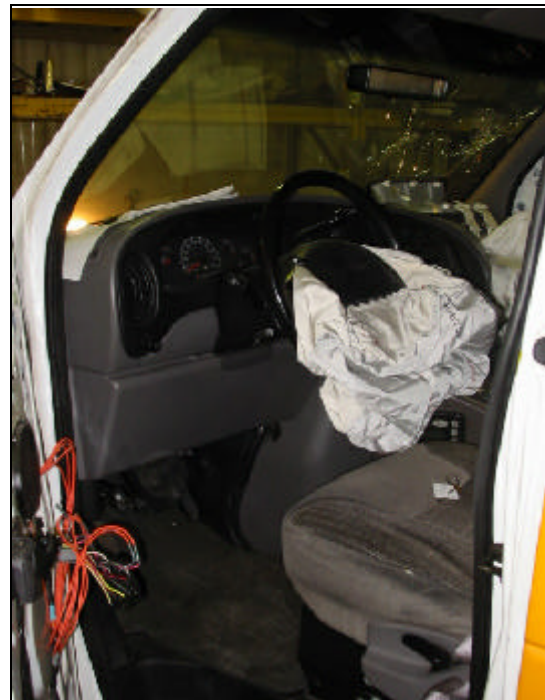
Figure 3. Driver's seated position

The 29-year-old male driver of the case vehicle was seated in a normal, upright fashion. He was wearing the available lap and shoulder belt. The cloth-covered bucket seat was adjusted to the rear most track position. The ambulance was traveling to the hospital with a patient on board. The emergency lights and sirens had been activated. Just prior to the crash, the driver began braking. At impact, the driver's frontal air bag deployed. The driver responded to the 12 o'clock direction of force by exhibiting a forward trajectory and loading the manual lap and shoulder belt. The driver was held in place by the restraint system and did not sustain any injuries.

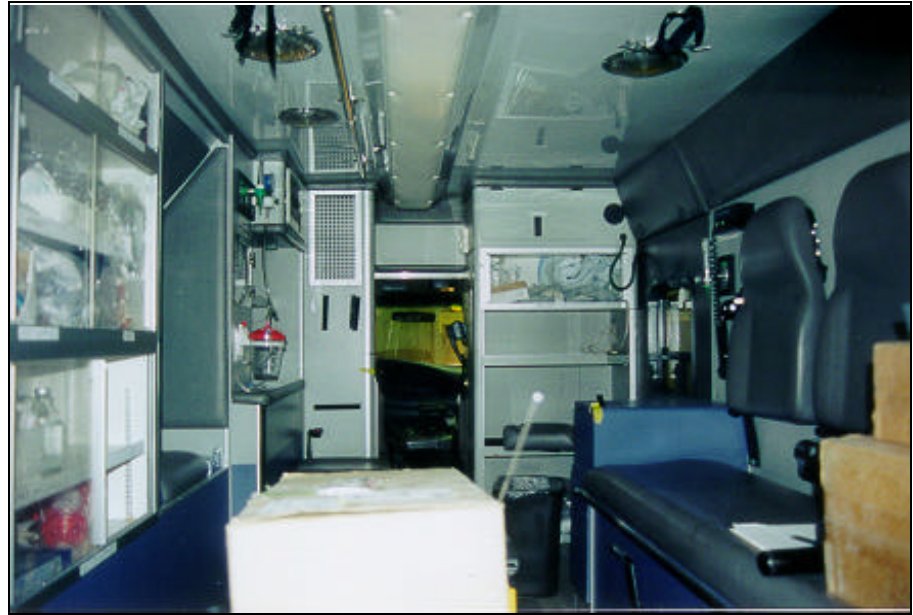
Figure 4. Overview of patient compartment

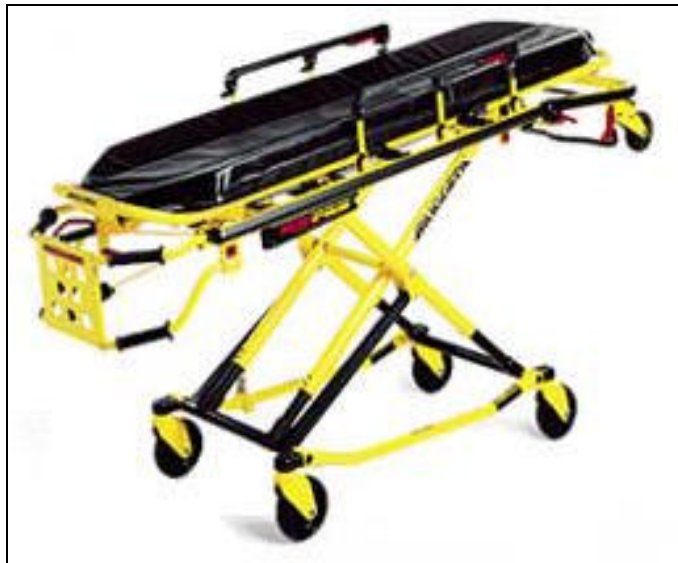
Figure 5. Rugged brand ambulance cot

The 78-year-old female middle rear occupant was lying face up on a Rugged brand ambulance cot. The cot was attached to the wall of the ambulance using a Stryker 6371 cot fastener system. This occupant was lying down with her head towards the front of the vehicle. She was strapped to the cot. The cot was equipped with a four-point shoulder harness and two manual lap belts. It is not known how many of the restraints were in use. At impact, this occupant would have traveled forward to some degree but the restraints and her supine position would have limited her movement. She did not sustain any injuries.

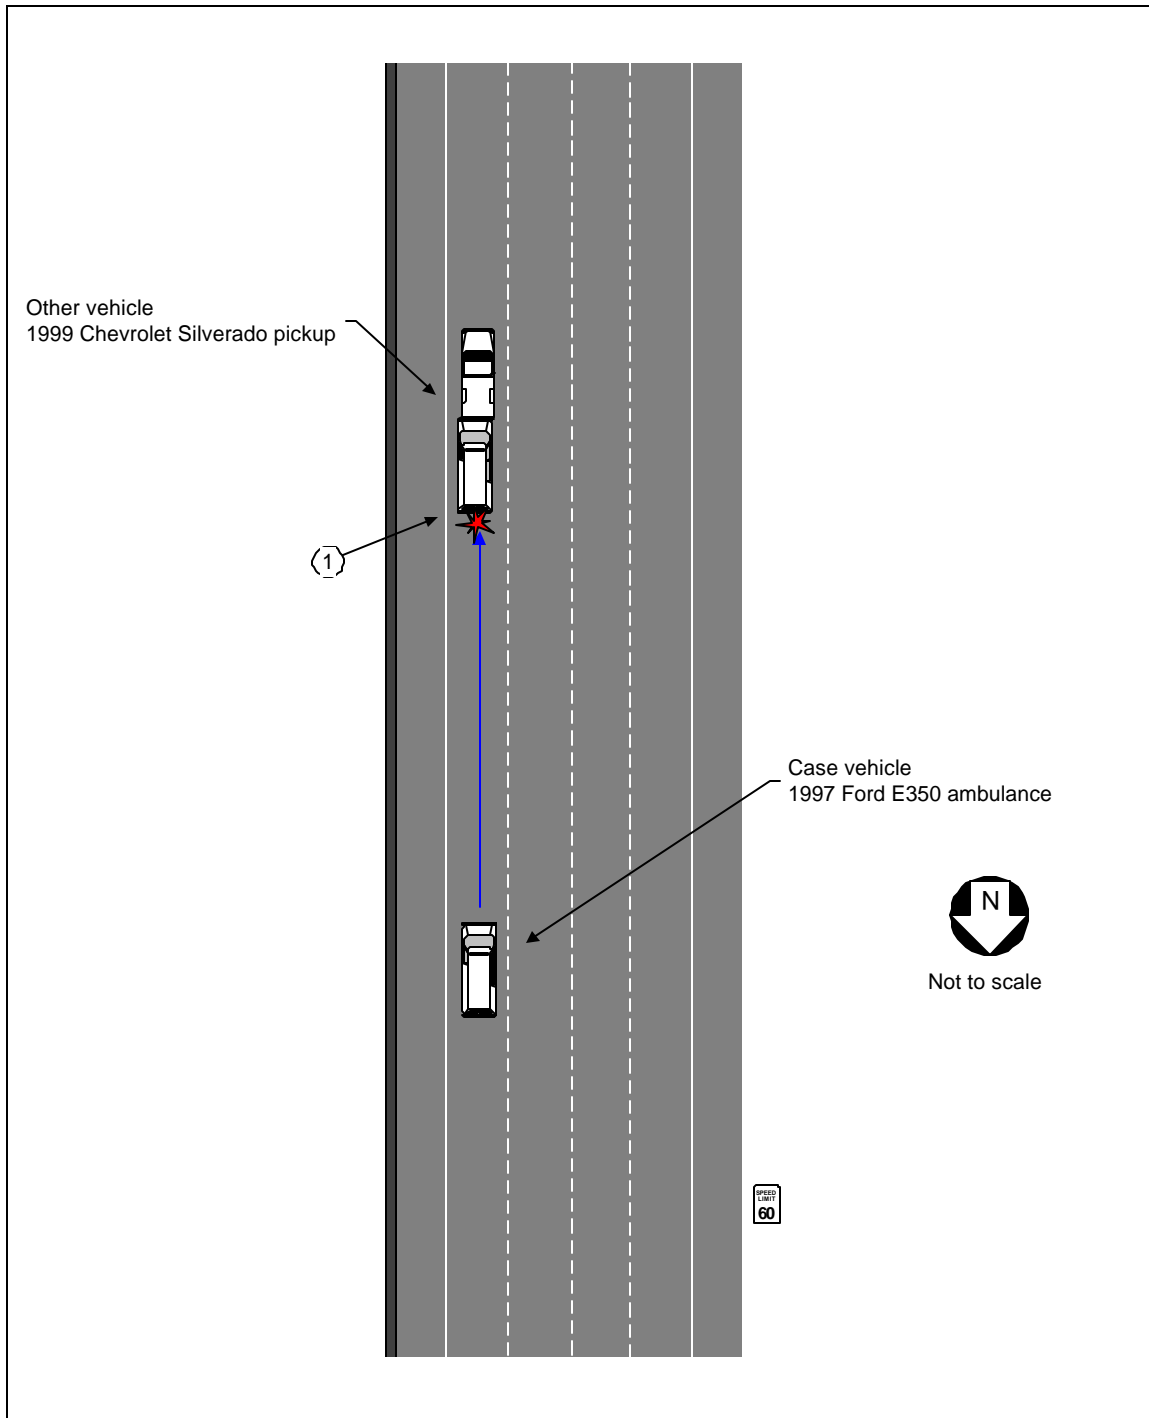
Figure 6. Scene diagram

The driver of the other vehicle slowed and the case vehicle could not stop in time and the front of the case vehicle (12FZEW1) struck the rear of the other vehicle.

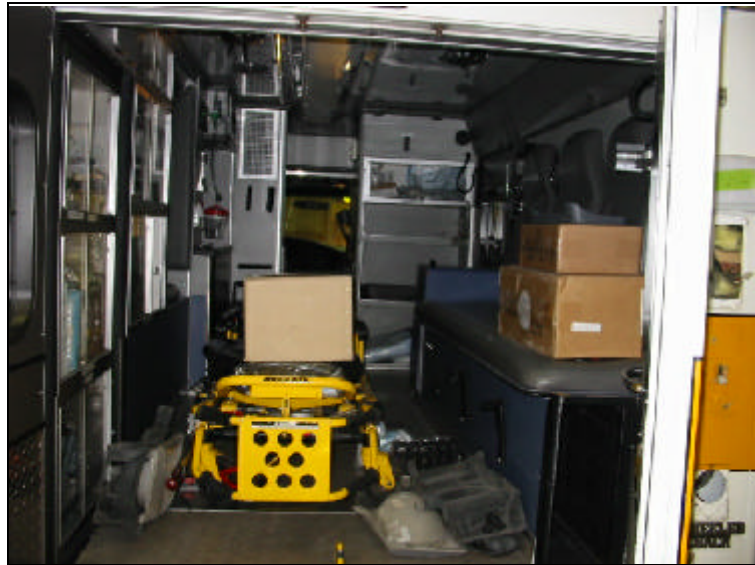
Interior: The left interior side has cabinets from floor to ceiling and a single patient care seat facing to the right. The right interior side is equipped with a 183 cm (72 in) squad bench with three individual backrests. The front of the module contains a single patient care seat facing to the rear and a set of cabinets. The interior cabinetry features what Wheeled Coach calls “Radius Corner Cabinetry” that is designed to prevent blunt trauma injuries.

Figure 8. Overview of Wheeled Coach Moduvan patient compartment

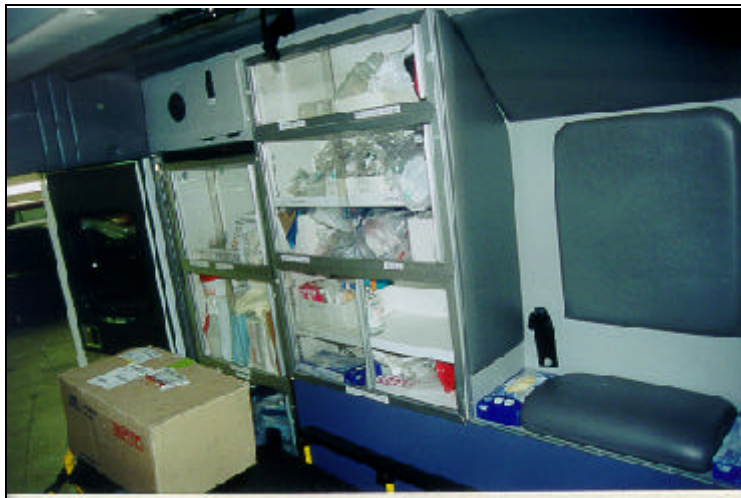
Figure 9. Left side, ambulance compartment

The left side patient care seat was equipped with a manual lap belt. The seat back was padded and covered with a vinyl material. It was attached to the side of the compartment using Velcro straps. The left, right, and top of the seating area was constructed with vinyl covered padding.

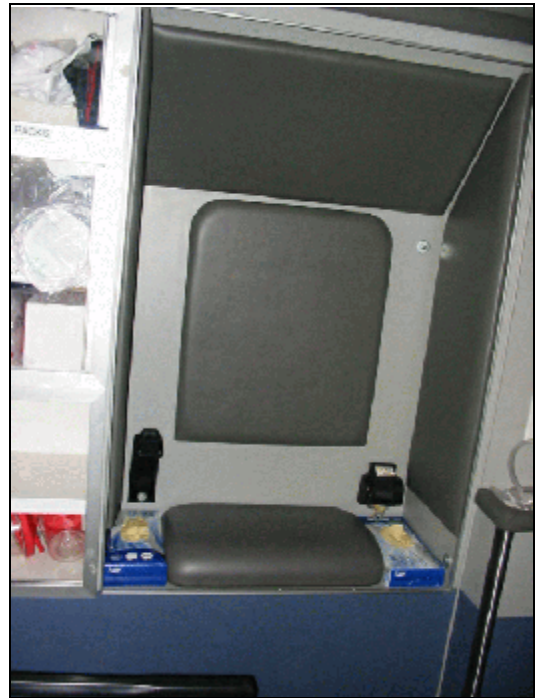
Figure 10. Left side patient care seat

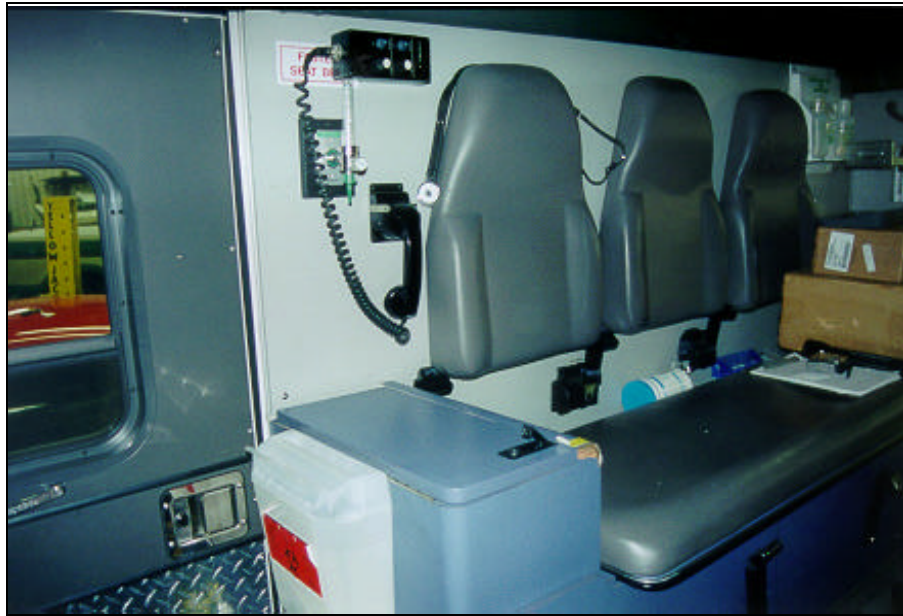
The right side squad bench was equipped with three safety belts—one each at the base of the three backrests. The safety belts can be secured to buckles on the right hand wall and used as lap belts for seated occupants. The safety belts can also be secured to buckles just below the squad bench seat cushion and used to restrain a patient in a horizontal position. The three seat backs were padded and covered with a vinyl material. They were attached to the side of the compartment using Velcro straps.

Figure 12. Right side, ambulance compartment—showing squad bench

The 28-year-old right rear occupant (188 cm/74 in, 82 kg/180 lbs) was seated in a normal, upright fashion facing the center of the vehicle on the vinyl covered squad bench seat. He was not using the available lap belt. He was attending the 78-year-old female patient. This occupant reacted to the initial braking by pitching somewhat to his right. At impact, he pitched out of his seat to the right—possibly catching the cabinet corner with his right hip. He was projected forward and onto the floor—sliding forward into the left side of the door panel—causing it to shift and displacing the Velcro-attached seat back. It is believed that he came to rest near the passage between the ambulance body and the ambulance cab. He complained of pain to his neck and back, but was otherwise unhurt.

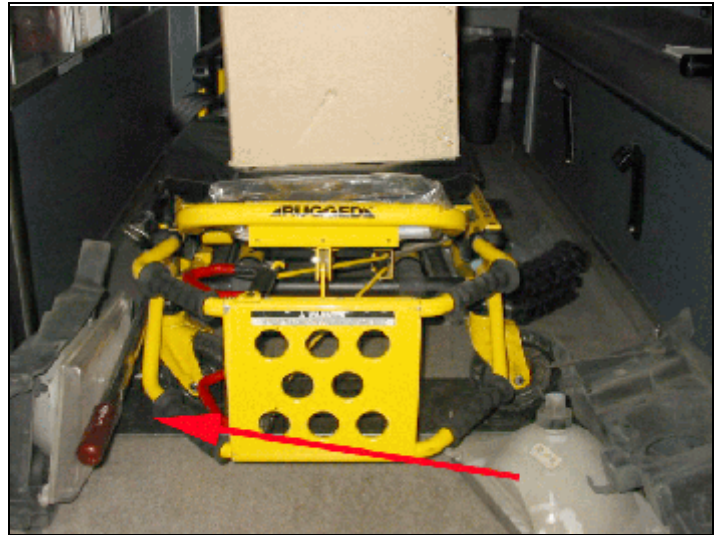
Figure 19. Cot fastener

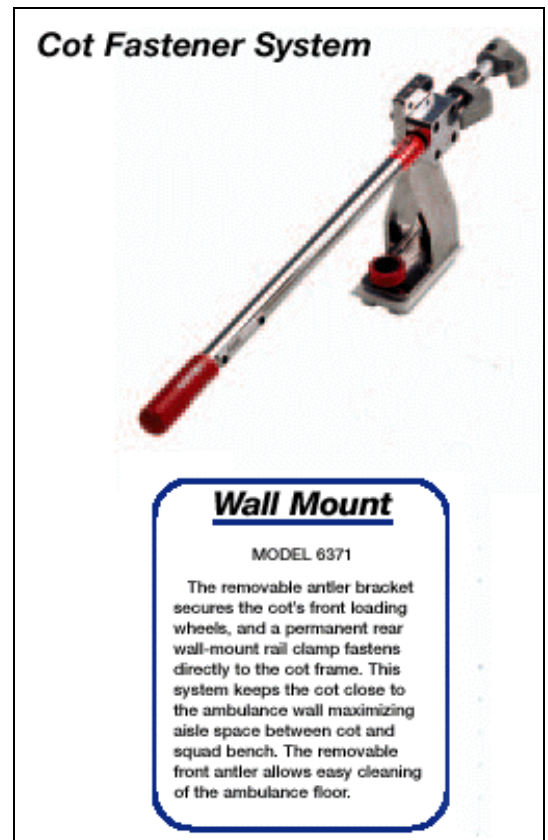
Figure 20. Cot fastener system
