ON-SITE POTENTIAL SAFETY-RELATED DEFECT INVESTIGATION

CASE NUMBER - IN07035
LOCATION - INDIANA
VEHICLE - 1993 FORD E350 SUPER CLUB WAGON
CRASH DATE - October 2007

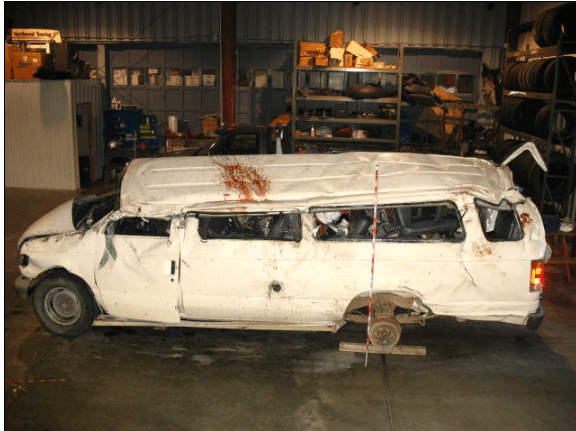
The police crash report indicated that there were 16 occupants in the Ford. The report indicated that there were 5 fatalities. The remaining 11 occupants were injured. The police crash report also indicated that multiple occupants were ejected and at least one occupant was partially ejected. Body fluid, body tissue and hair on the exterior of the Ford indicated that some of the ejected occupants had been rolled upon by the vehicle (Figures 18, 19, 20 and 21). The table on the following page shows the known information for each occupant based on the police crash report.

Figure 18: Top and left side of Ford showing overview of locations shown in Figures 19 and 20
