On-Site Ambulance Investigation
Dynamic Science, Inc. (DSI), Case Number DS09001
2005 Ford E350 Econoline Type II Ambulance
California
December 2008

1. Report No. DS09001		2. Government Accession No.		3. Recipient Catalog No.	
4. Title and Subtitle On-Site Ambulance Investigation				5. Report Date August 10, 2009

This on-site investigation focused on the crash dynamics and injuries sustained in a crash involving a 2005 Ford E350 Econoline van that was configured as Type II¹ ambulance (**Figure 1**). This single vehicle crash occurred in December 2008 at 1059 hours in California. The subject vehicle was being driven by a restrained 19-year-old male. Two unrestrained Emergency Medical Technicians (EMTs) and a 56-year-old female patient were positioned in the rear of the ambulance. The Ford was traveling westbound at an unknown speed. There were other vehicles in front of the Ford. The Ford was transporting the patient from a nursing facility to a local hospital for a medical appointment. The Ford was not traveling with the lights and siren. While negotiating a left curve, the Ford departed the right side of the roadway. According to the investigating officer, there were no indicati

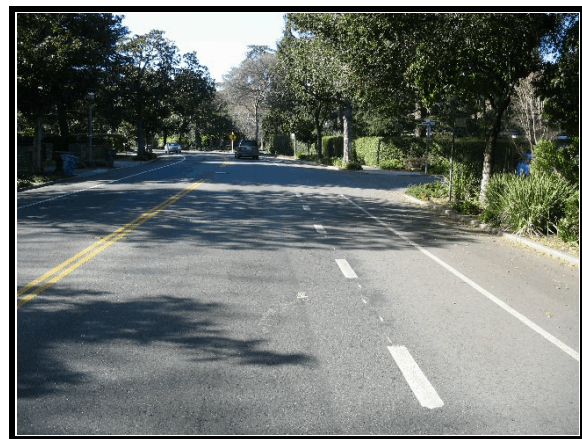
Figure 2. Approach westbound along straight roadway

The crash occurred on the roadside of an east/west two-lane, residential roadway. The initial approach to the crash area was straight (**Figure 2**), but the road began curving to the left (**Figure 3**).

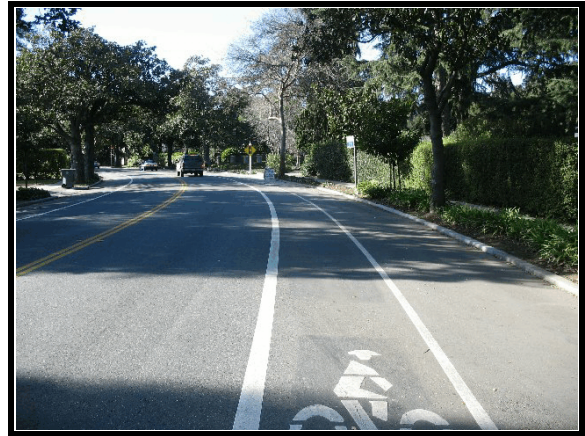
Figure 3. Approach westbound after entering curved roadway

The distance between the start of the curve and the impacted tree measured 49.6 m (163 ft). At the area of impact, the roadway was level. The east/west travel lanes were separated by double yellow center lines. The westbound travel lane was bordered on the north by a bike lane, a parking lane, and an 8 cm (3.1 in) concrete curb. A 45 cm (17.8 in) diameter tree was located adjacent to the concrete curb. The eastbound travel lane was bordered on the south by a parking lane. The weather was partly cloudy and the travel lanes were dry. Portions of the bike lanes were covered with wet leaves. The posted speed limit for this roadway was 40 km/h (25 mph).

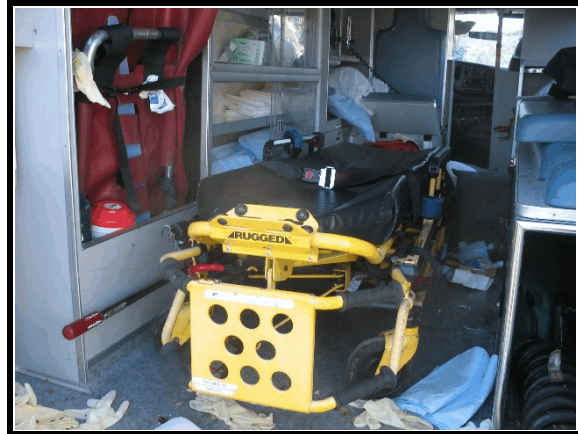
Figure 15. Overview of cot and Occupant 04 position

The 56-year-old female was a patient and was being transported from a care facility to a hospital for a doctor's appointment. She had an unknown surgery on her right side, so she was placed on the ambulance cot on her left side for comfort (**Figures 15**). Her head was oriented towards the front of the vehicle. The forward and aft lap belts on the cot were being used to secure the patient's torso and lower extremities at the time of the crash. The shoulder restraint was not being used. The cot itself was anchored to the side of the ambulance using the rail clamp. Prior to impact, the EMTs were trying to obtain a blood pressure reading from her. At impact, this occupant slid forward on the cot.

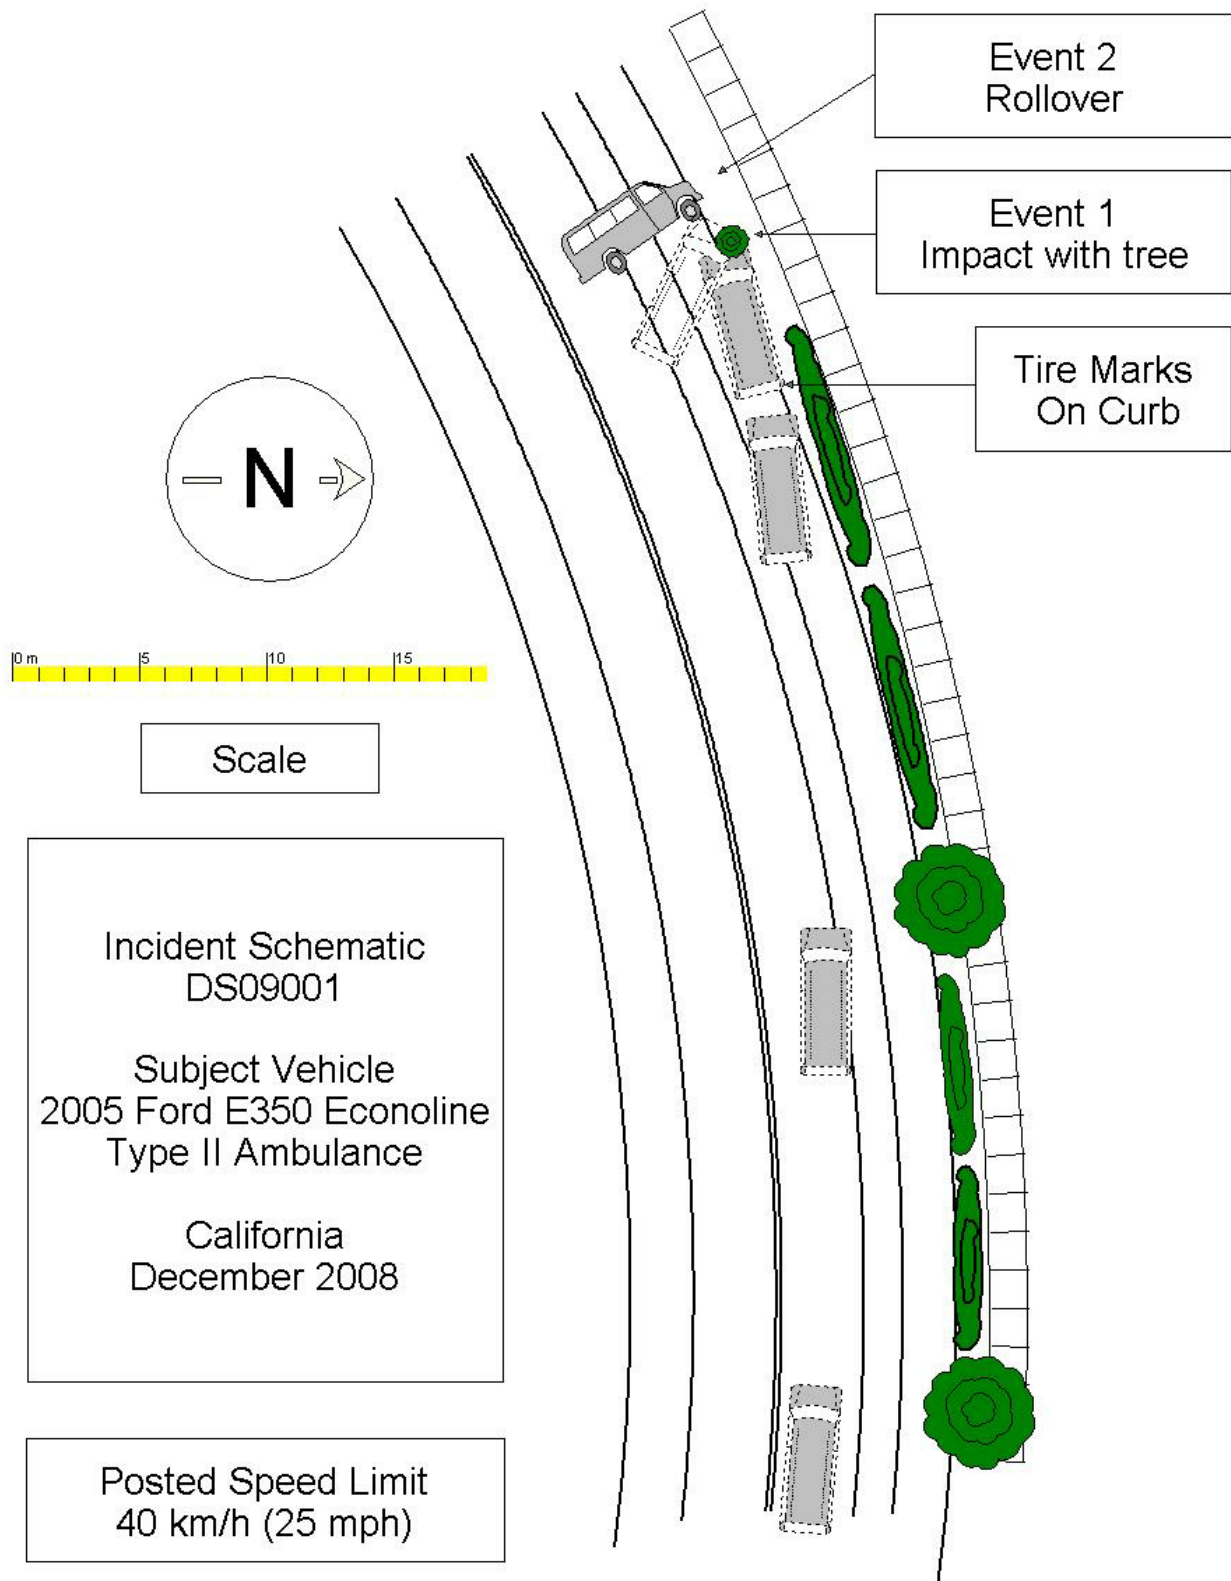
Attachment 1. Scene Diagram

As the Ford entered the curved aspect of the roadway, it continued in a straight line. There were no indications that the driver attempted to brake or steer the vehicle. The Ford traveled over the north curb edge and continued forward until striking the tree with its front right bumper corner (**Figure 4**). The damage to the tree extended vertically from the ground upward 193 cm (76 in). The impact severity was moderate and resulted in the deployment of the frontal air bag system in the Ford. The Barrier algorithm of the WinSMASH program computed a Total Delta-V of 14 km/h (8.7 mph), based on the front bumper damage profile. The results were low because most of the damage was outboard of the right frame rail and was not included in the crush profile per the measurement
