# Case Report

CASE # 2003-079-057

Vehicle one, a 1998 Ford Mustang, was traveling north in the number four lane of a six lane, physically divided, concrete, level, dry highway. Vehicle two, a 1995 Chevy Camaro, was traveling north in the number five lane of the same highway. Vehicle three, a 2003 Volvo XC90, was traveling north in the number five lane of the same highway. As vehicle one negotiated a lane change, from number five to number six, its left front plane contacted the right rear plane of vehicle three. Vehicle one spun counter clockwise then it's right rear contacted the right plane of vehicle two as vehicle two veered to the left to attempt to avoid the crash. Vehicle three, after being contacted by vehicle one on its right rear plane then spun clockwise and rolled over about six quarter turns, landing on its roof. Vehicle one was towed with moderate damage.

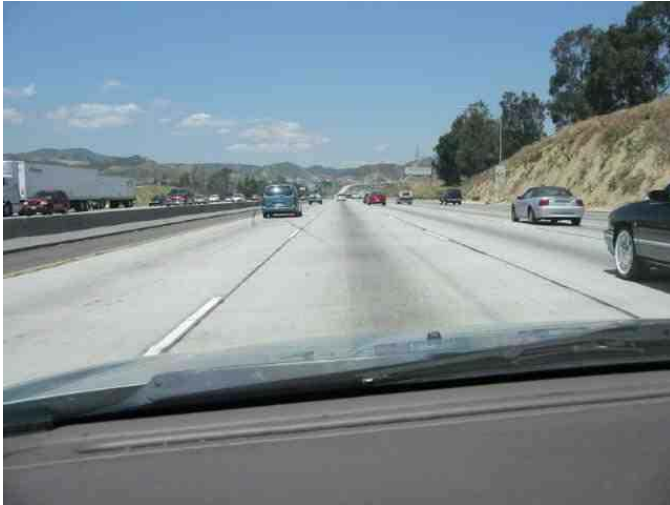
**CRASH SCENE**  
Vehicle Point of Impact - #

**SKIDS OF V-2 TO THE LEFT / SKIDS FROM V-1 ON RIGHT SIDE OF L (ID=210209246)**

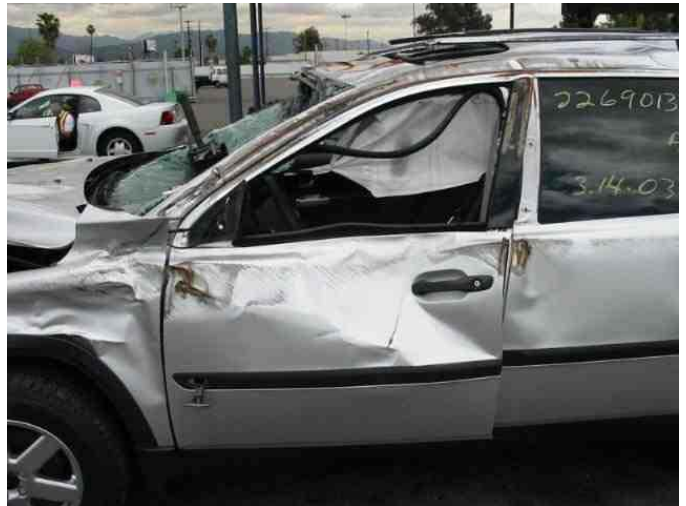
VEHICLE 3  
LEFT

LEFT FRONT DOOR AREA

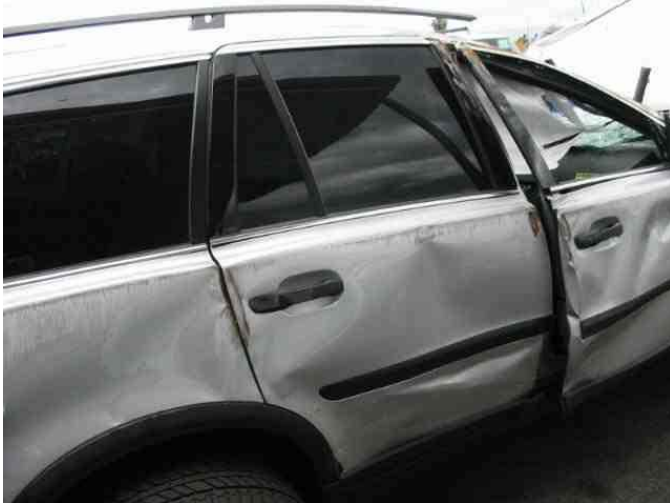
RIGHT REAR DOOR AREA

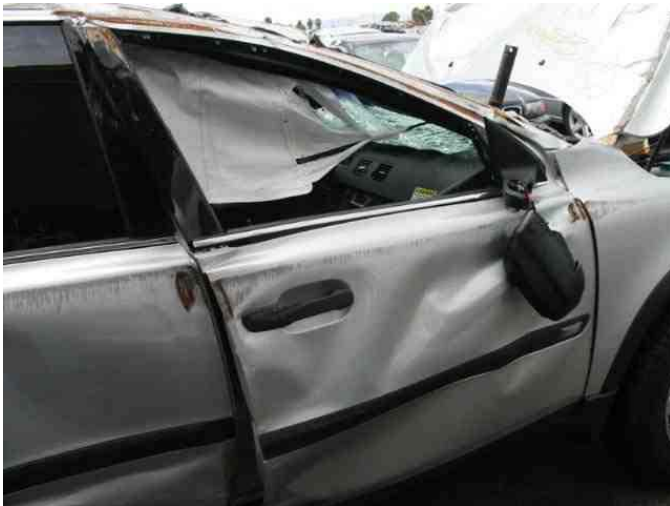
RIGHT FRONT DOOR AREA

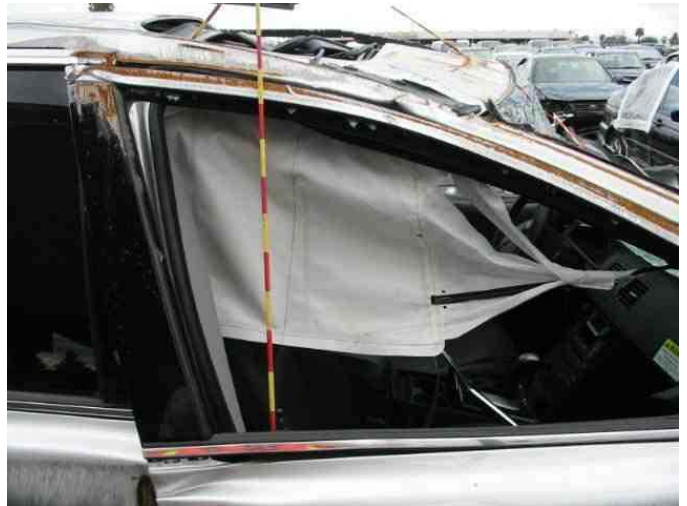
RIGHT FRONT DOOR AREA REAR

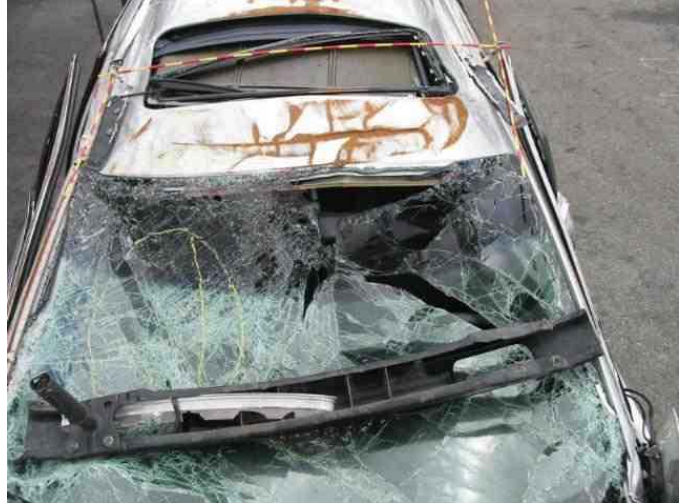
SUN ROOF AREA

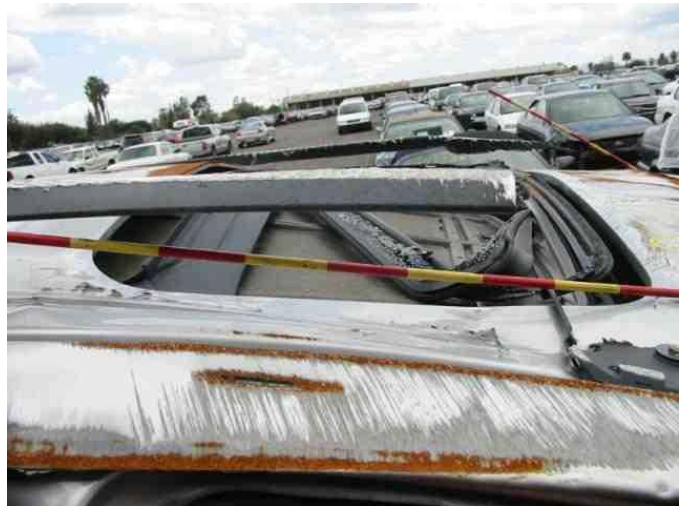
SIDE VIEW OF SUN ROOF

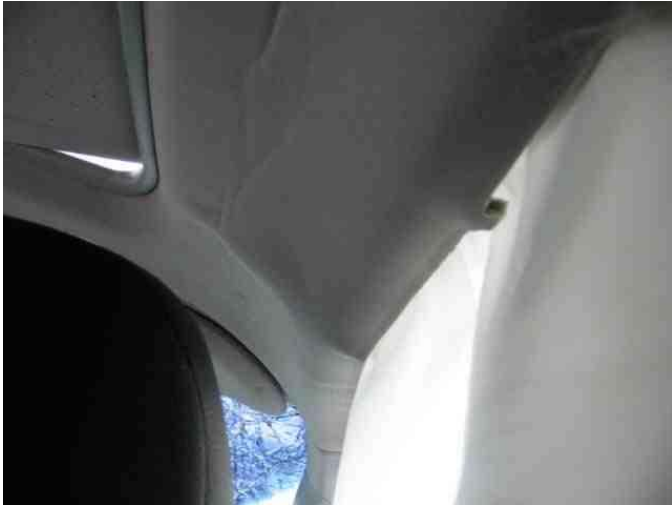
VEHICLE 3  
Int 1st Row - Passenger Air Bag

UPPER CURTAIN COMING OUT OF ROOF (ID=210206558)
