DOT HS 812 836

**Special Crash Investigations
On-Site Guardrail End
Terminal Investigation
Vehicle: 2008 Ford Explorer
Location: Pennsylvania
Crash Date: November 2016**

SPECIAL CRASH INVESTIGATIONS
ON-SITE GUARDRAIL END TERMINAL IMPACT INVESTIGATION
CASE NO.: CR16030
VEHICLE: 2008 FORD EXPLORER
LOCATION: PENNSYLVANIA
CRASH DATE: NOVEMBER 2016

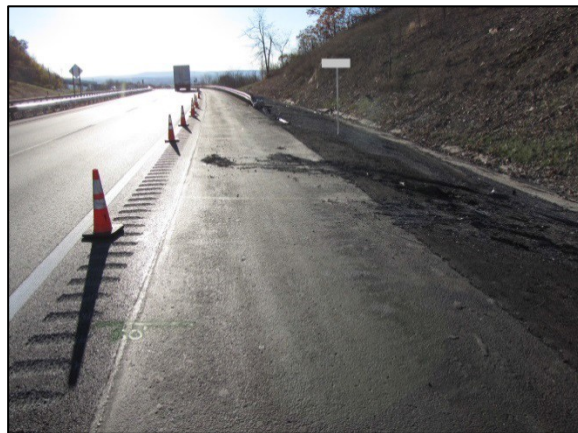
The trafficway was oriented in an east/west direction in the vicinity of the crash site, t. The westbound portion consisted of two 3.5 m (11.5 ft) lanes with a large radius left curve. The radius of curvature measured approximately 1,220 m (4000 ft). Along the approach, the grade was level, having transitioned from a positive grade at a hillcrest that was located approximately 0.8 km (0.5 miles) east of the crash site. The travel lanes and shoulders were surfaced with asphalt, while the north roadside was gravel. The right westbound lane measured 3.4 m (11.1 ft) wide and the left westbound lane measured 3.6 m (11.8 ft) in width. The lanes were separated by broken white lines and delineated by a solid yellow left edge line and a solid white right edge line. The right shoulder measured 3.7 m (12.1 ft). A tactile warning (rumble strip) was cut into the shoulder surface immediately adjacent to the right edge line. The ET-Plus end-terminal and guardrail was installed adjacent to the right shoulder edge (**Figure 2**). This guardrail protected the swale, embankment, and negative grade located in the roadside.

Figure 2: West-facing image approaching the crash site 15 m (50 ft) east of the point of impact.

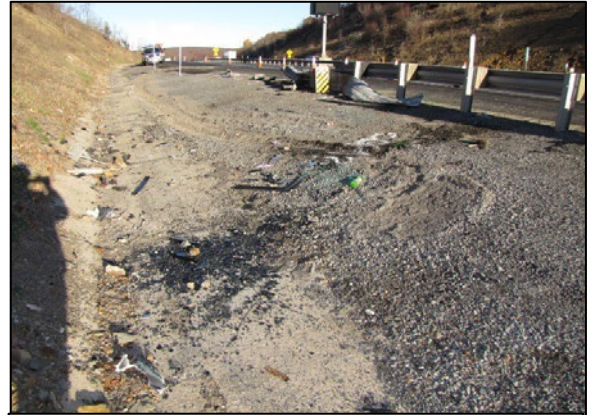
Figure 8: Southeast-facing lookback view from the vehicle's final rest position.

The Ford began to override and then climbed over the deformed W-beam guardrail at Posts 5, 6, and 7. Black scuff marks indicative of tire contact were observed on the face of the guardrail in the vehicle's trajectory. Instability was created as the vehicle climbed over the guardrail, which resulted in a left side leading rollover (Event 3). The Ford rolled one quarter-turn about its longitudinal axis as it continued to rotate clockwise about the vertical axis. The vehicle then slid to rest on its left plane on the field side (north) of the guardrail, facing south (**Figure 8**). Neither the left side-mounted side impact air bag nor the inflatable curtain air bags deployed in the event. At rest, the Ford had rotated approximately 250 degrees clockwise of its initial pre-crash trajectory and its center of mass was located approximately 20.9 m (68.6 ft) west of Post 1.

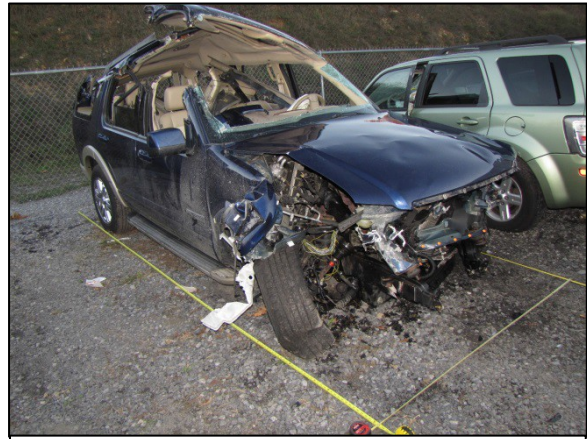
The 2008 Ford Explorer (**Figure 17**) was manufactured in September 2007 and was identified by the Vehicle Identification Number 1FMEU74EX8Uxxxxxx. This sport utility vehicle (SUV) was configured on a 289 cm (113.7 in) wheelbase and outfitted with the Eddie Bauer trim package. The all-wheel drive powertrain consisted of a 4.0 liter gasoline engine linked to a 6-speed automatic transmission with a console-mounted shifter. Service brakes were power-assisted, hydraulic, 4-wheel discs with ABS. Standard equipment included traction control, electronic stability control, and an indirect tire pressure monitoring system. The exterior was configured with original equipment manufacturer's step bars that extended from the A- to C-pillars, a roof rack with lateral load bars, and a frame-mounted Class III receiver trailer hitch. The gross vehicle weight rating was 2,808 kg (6,190 lb), with specific gross axle weight ratings of 1,343 kg (2,960 lb) front and 1,515 kg (3,340 lb) rear. The curb weight was 2,100 kg (4,630 lb). The Ford was equipped with Firestone Destination tires of the vehicle manufacturer recommended size of P235/65R18, with matching Tire Identification Numbers. The vehicle manufacturer's recommended tire pressure was 221 kPa (32 PSI) for all axle positions. An invoice found in the Ford documented the purchase of four new tires on October 16, 2016, at odometer reading of 145,862 km (90,627 mi). Specific tire data at the time of the SCI vehicle inspection included the following.

Figure 17: Right front oblique view of the Ford.

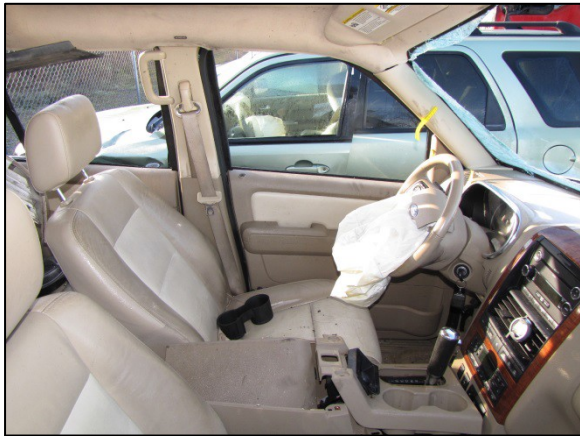
The interior of the Ford (**Figure 20**) sustained minor severity damage from the multiple event crash. The damage was associated with the deployment of the driver air bag and driver contact to the interior. There was no measureable intrusion. The driver seat was located in a full-rear track position with the seatback reclined 35 degrees aft of vertical. The horizontal distance from the seatback to the center hub of the steering wheel rim measured 82 cm (32.3 in) at a height of 46 cm (18 in) above the seat bight. There was no deformation of the steering wheel rim or movement of steering column’s shear capsules.

Figure 20: Overall right interior view of the Ford.

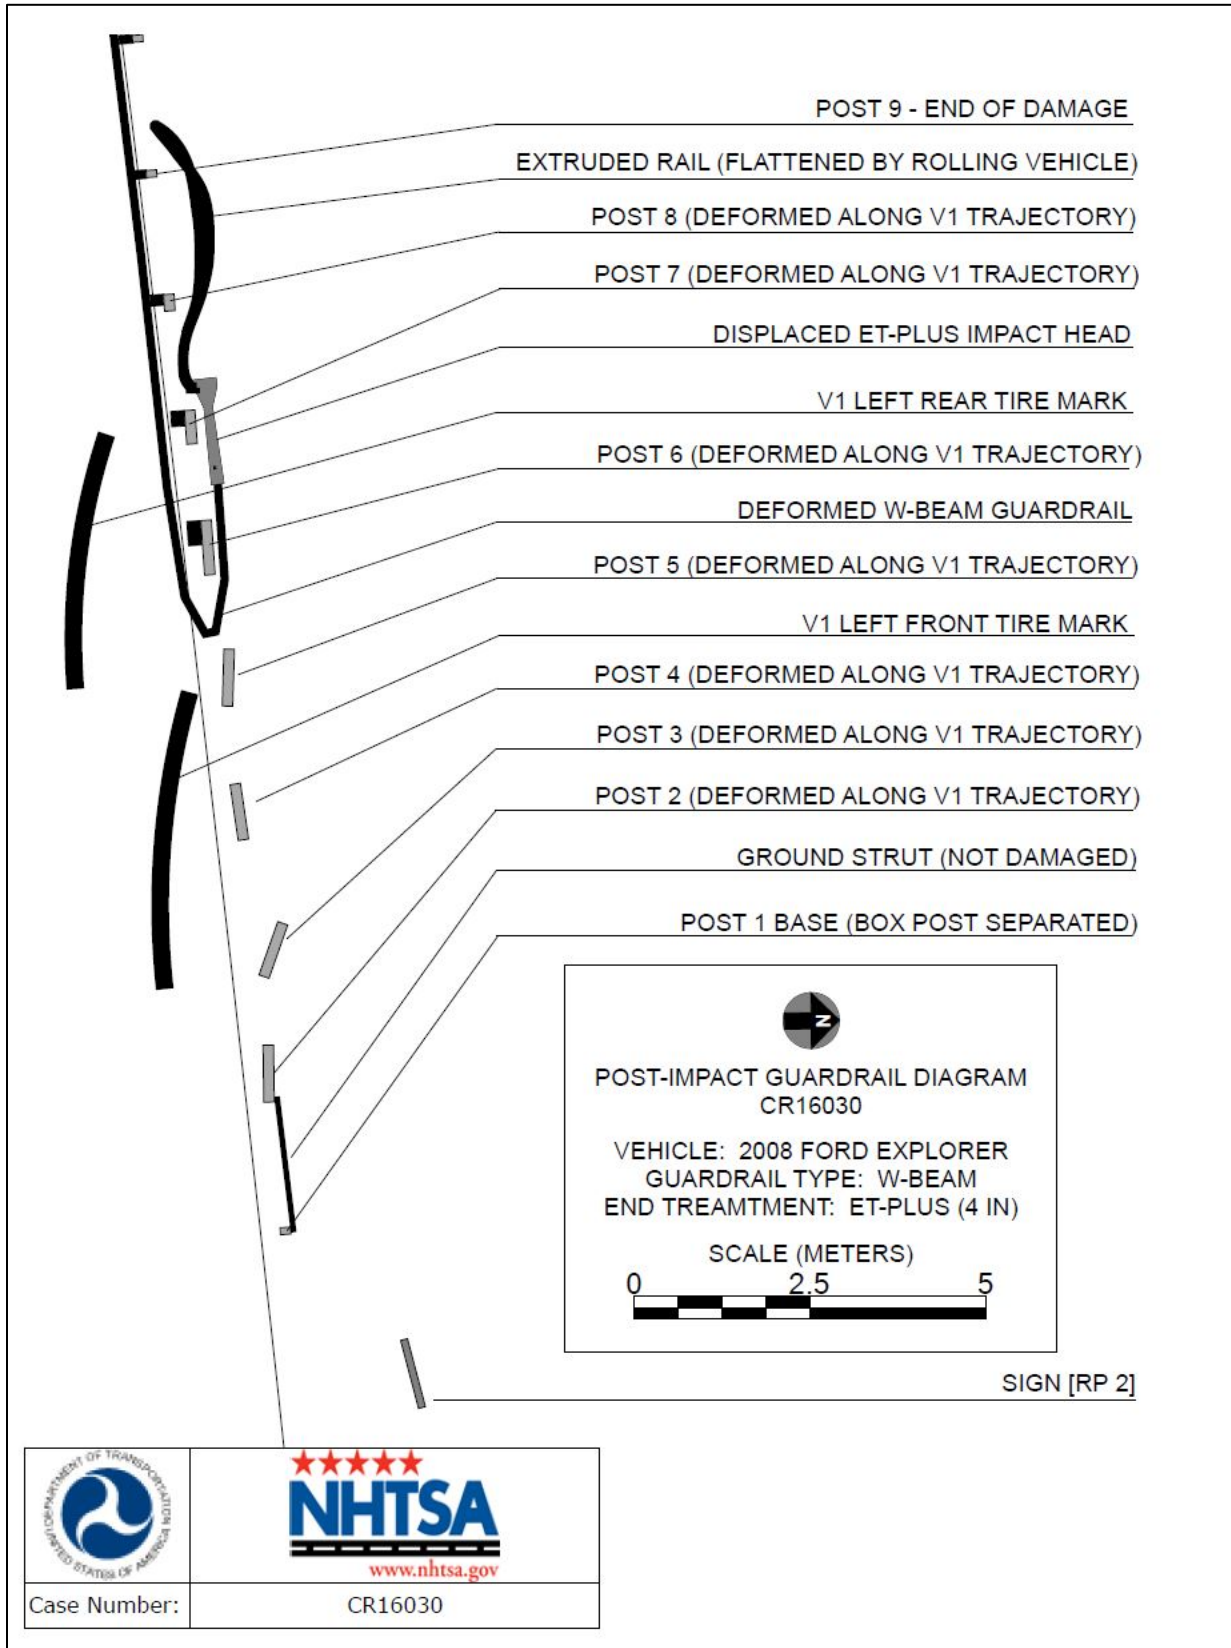
POST-IMPACT GUARDRAIL DIAGRAM

Inspection of the installation determined that the crash resulted in an approximate overall damage length of 12.8 m (42.0 ft) that extended to the area of Post 8. The HBA-designed Post 1 separated from its foundation on impact; however, the hanger bolt between the end terminal and the post did not shear. Post 1 remained attached to the end terminal during the crash sequence. The SYT-designed Post 2 was deformed 80 degrees to the west, bent at ground level, and sheared at the weakening holes. The ground strut between Posts 1 and 2 remained in place. SYT-designed Posts 3, 4, and 5 were deformed approximately 80 to 90 degrees along the vehicle's trajectory at the ground-level weakening holes.

The W-beam deformed into a U-shape at the vertex between Post 5 and 6 (**Figure 12**). Post 6 was deformed approximately 60 degrees to the west, and bent at ground level. Post 7 was deflected approximately 30 degrees. The carriage bolts at both posts pulled through and separated from the W-beam and the composite block-outs remained attached. The carriage bolt at Post 8 had only partially pulled through the W-beam. The deflection at this post was approximately 10 degrees to the west. There was no damage to Post 9 and beyond. The height of the W-beam at an undamaged location between Posts 10 and 11 measured 72 cm (28.5 in).
