NATIONAL TRANSPORTATION SAFETY BOARD

HIGHWAY SPECIAL INVESTIGATION REPORT

BUS CRASHWORTHINESS ISSUES

National Transportation Safety Board. 1999. *Bus Crashworthiness Issues. Highway Special Investigation Report NTSB/SIR-99/04. Washington, DC.*

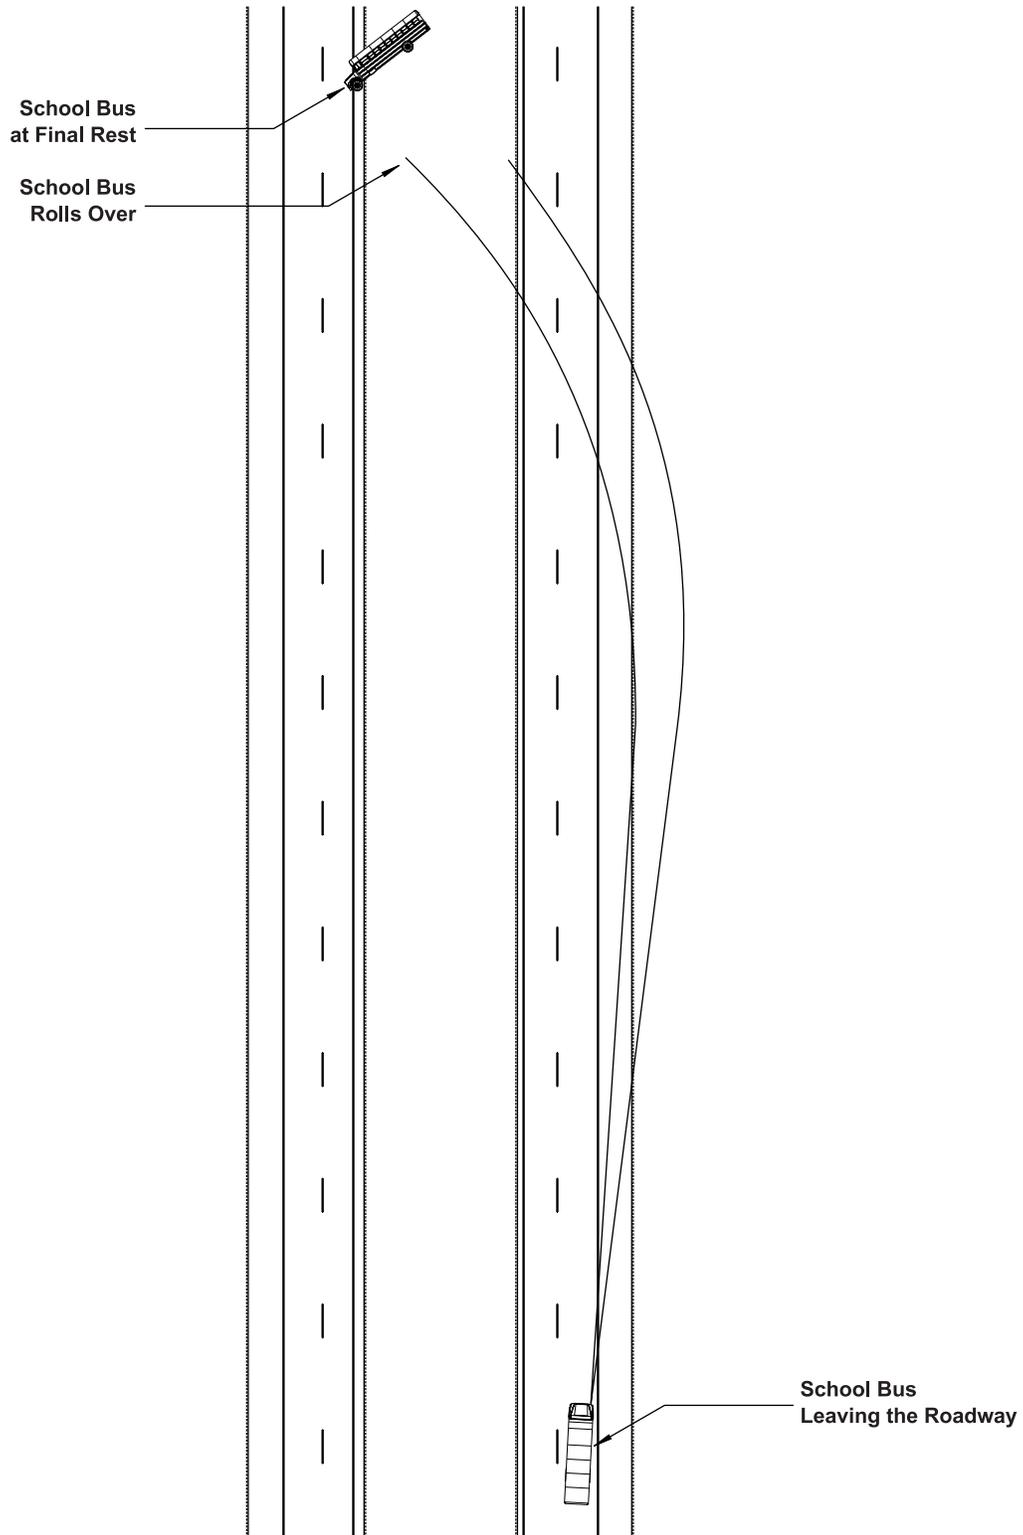
Figure 2. Flagstaff accident scene diagram

In this accident, a 72-passenger school bus rolled over after the driver lost control of it. Although no fatalities resulted, five passengers were ejected from the bus. (See figures 1 and 2.) Of the ejected passengers, one was severely injured (AIS-4)^{8,9} and four received minor to moderate injuries (AIS-1 and -2). (See seats 1A, 1F, 8A, 9A, and 10A in figure 3.) The lap-belted driver received severe injuries (AIS-4). The passengers on the driver's side received minor to moderate injuries (AIS-1 and -2). The only serious to critical injuries (AIS-3 to -5) occurred to passengers seated on the right-hand side of the bus (seats 1F, 5E, 6F, and 12D), most likely as the result of being propelled out of their compartments and striking surfaces not designed to absorb impact energy. Because only one of five ejected passengers was seriously injured and because the injury levels of passengers located in proximity to each other on the bus differed substantially, it is difficult to determine whether an occupant restraint system would have mitigated or prevented injuries.

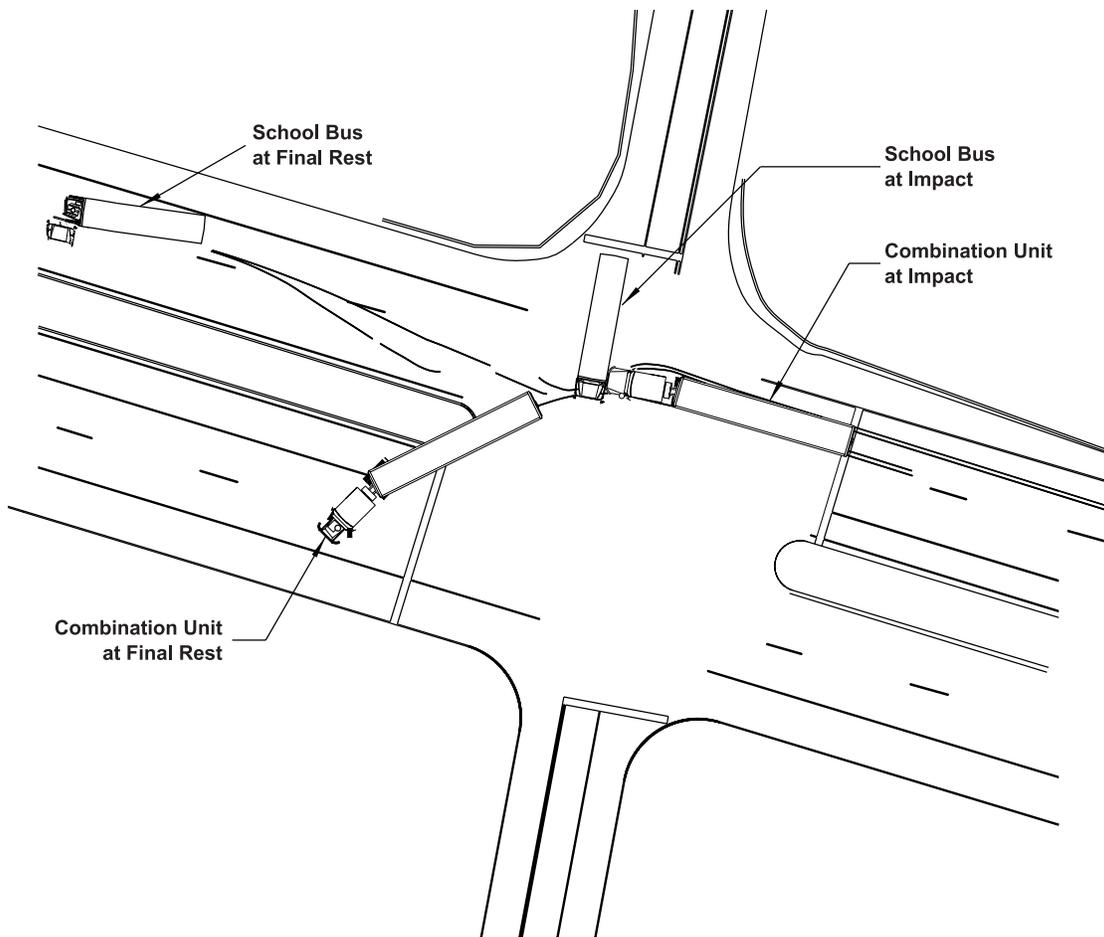
Figure 5. Easton accident scene diagram

In this accident, a 66-passenger school bus was struck at an intersection by a truck pulling an empty semitrailer. The truck cab initially struck the left side of the school bus near the driver's window, causing the bus to rotate in a clockwise direction. The second impact occurred when the right-front corner of the semitrailer swung into the rotating bus, then struck the left side of the school bus near the rear axle. (See figures 4 and 5).

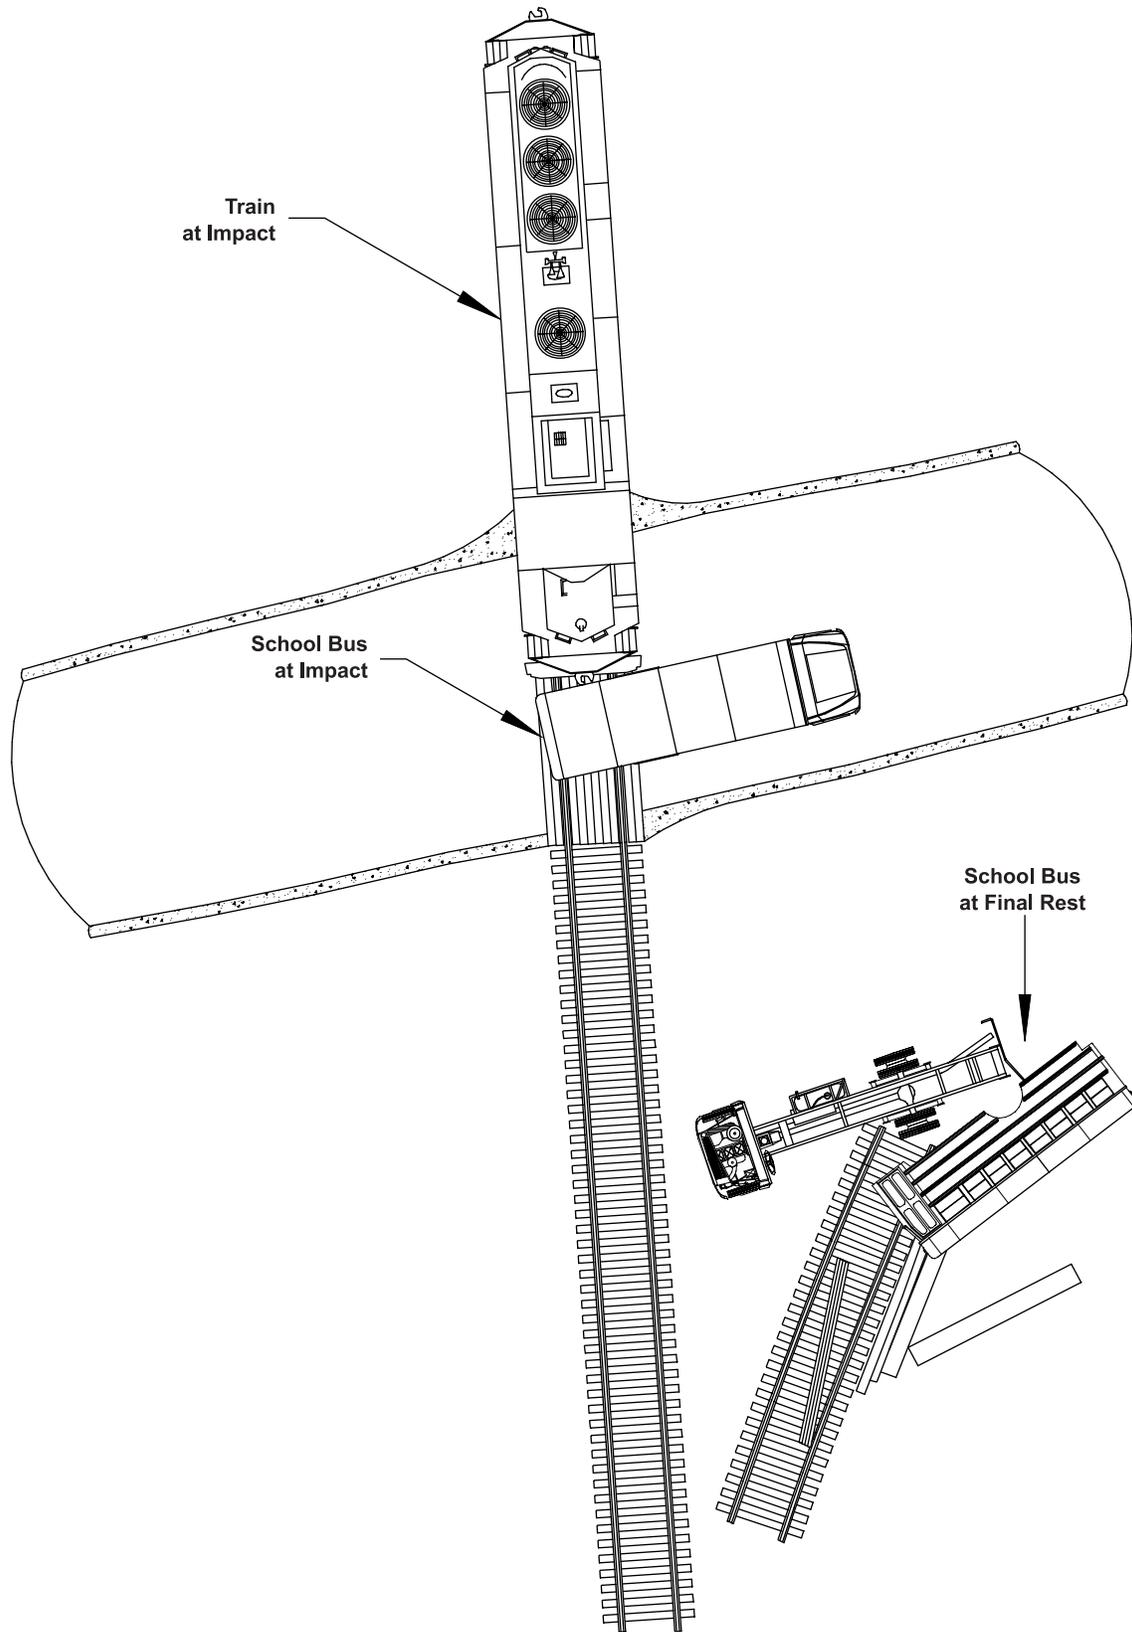
Figure 8. Buffalo accident scene diagram

In this accident, a freight train traveling 45 mph struck a school bus between the bus' rear axle and left rear bumper. The impact caused the bus to rotate 180 degrees counterclockwise, and the bus body to separate from its chassis. (See figures 7 and 8.) The passenger in seat 7B was fatally injured from the train's intrusion and resulting crash forces. (See figure 9.) The other fatally injured passenger (seat 7E) was likely thrown into the impact zone during the collision and sustained critical head injuries from the impact forces. Although a restraint system would have reduced the chances of this passenger being propelled into the impact zone, the restraint may not have prevented injuries resulting from the high crash forces due to the severe lateral impact. In addition, had the restraint been a correctly worn lap belt, the passenger's pelvis motion would have been limited relative to the seat, causing his upper body to be whipped sideways, potentially resulting in head injuries similar to those actually received in the accident.¹¹ The driver and other passengers, who were seated at the front of the bus, did not receive serious injuries.

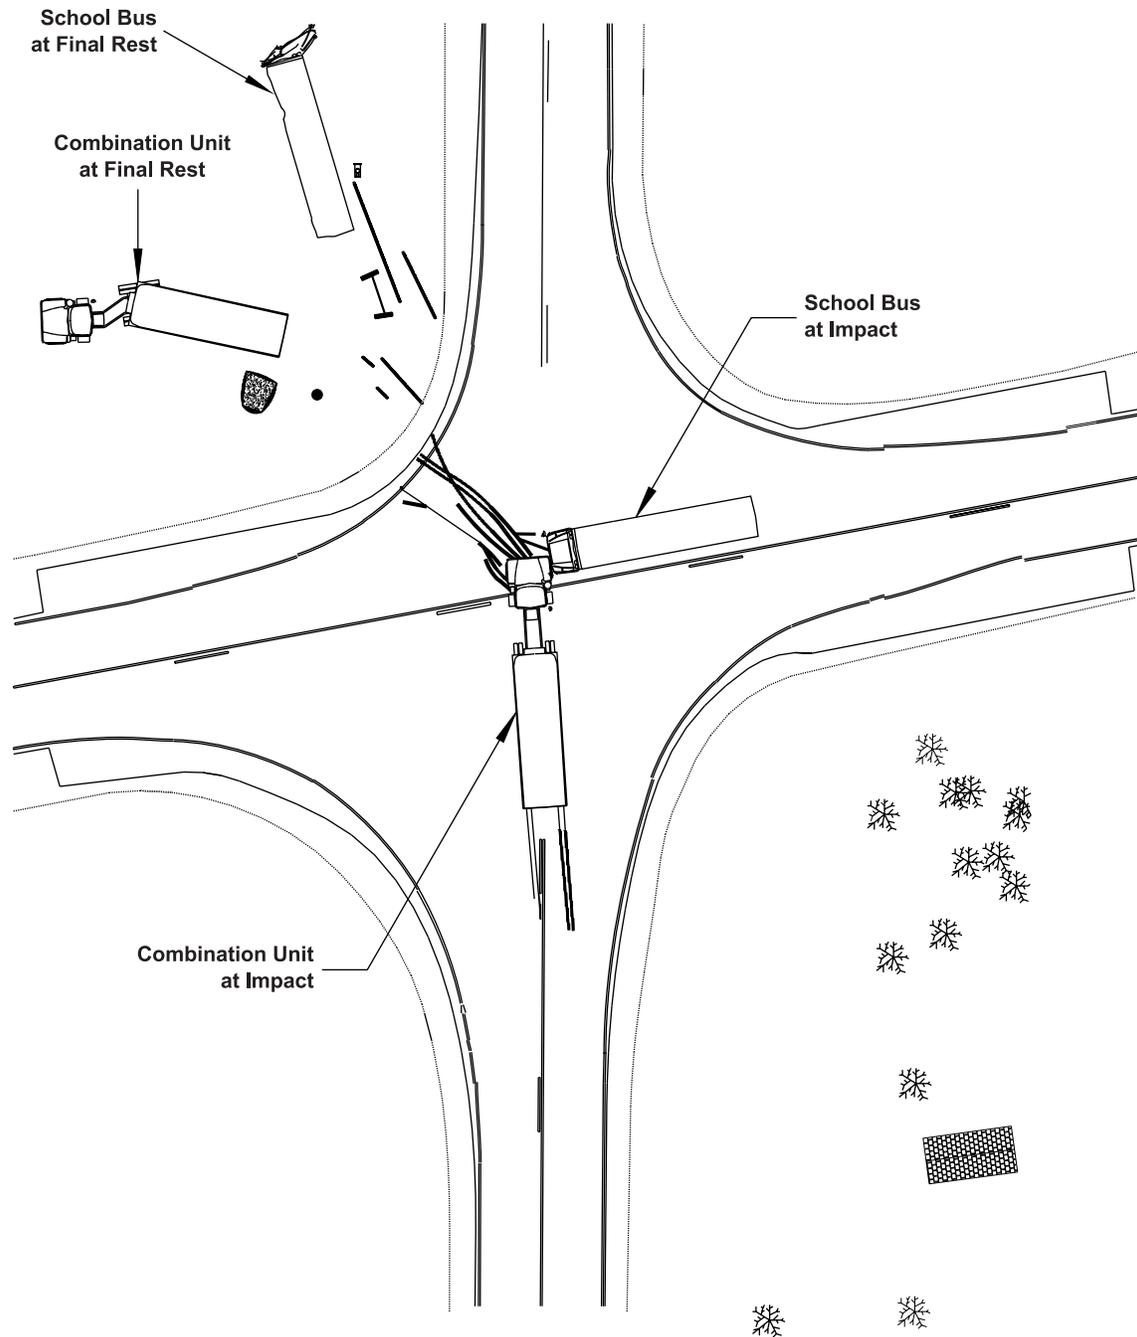
Figure 11. Monticello accident scene diagram

According to a witness, both vehicles approached the intersection where the tractor-semitrailer failed to stop for the posted stop sign, skidded into the intersection, and was struck by the school bus. At impact, the front of the school bus contacted the right side of the tractor at the right front wheel with approximately 43 inches of overlap. A second impact occurred when the right front corner of the semitrailer struck the left side of the school bus at the roofline, which resulted in a 17.5-inch-deep depression. During the second impact, the tractor's tandem wheels deformed the lower part of the side panel of the school bus. A third impact then occurred, when the semitrailer side-slapped the school bus, which was rotating clockwise as a result of the first two impacts. (See figures 10 and 11.)

Simulated Vehicle Dynamics. The m-smac results indicated that the tractor-semitrailer was traveling approximately 49 mph, and the bus was traveling approximately 50 mph at impact. As discussed above, three separate impacts occurred between the bus and the tractor-semitrailer: a frontal impact of the bus into the side of the trailer, a side impact of the semitrailer into the side of the bus, and a side slap of the semitrailer into the side of the bus.

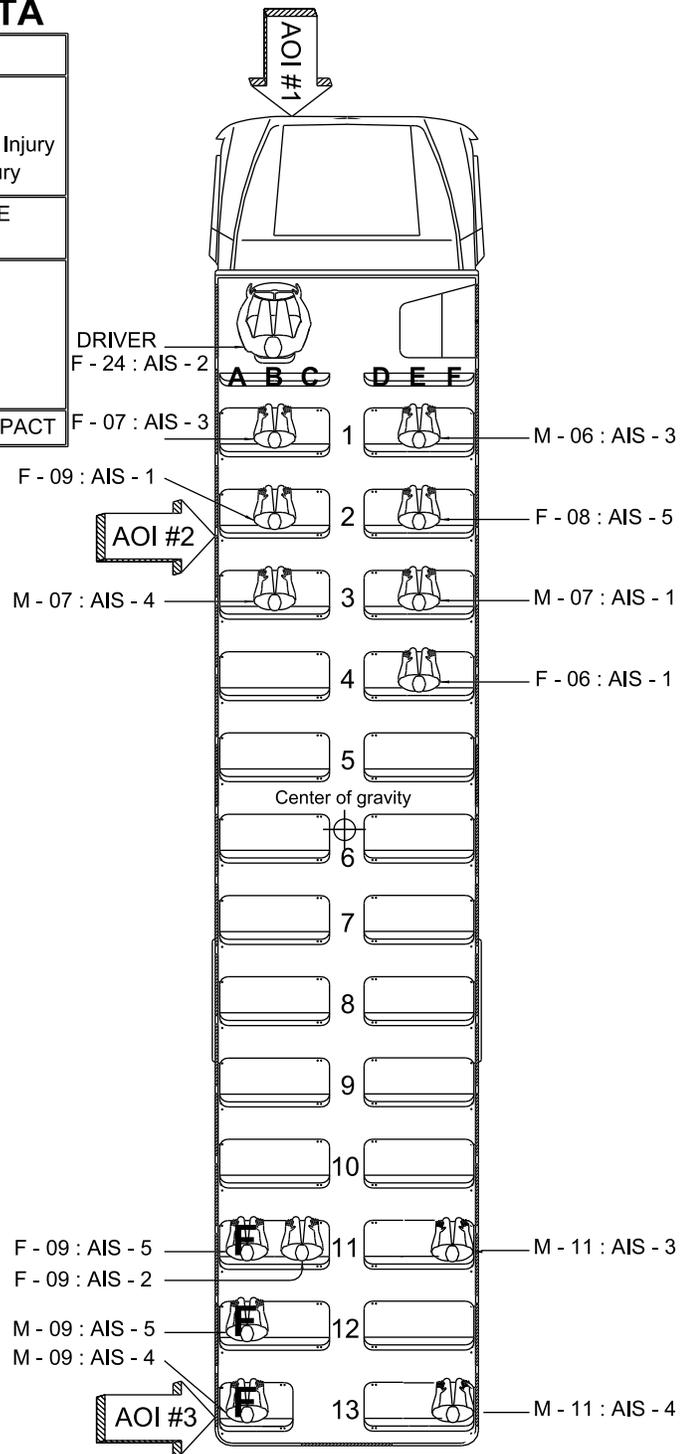
Figure 13. Monticello bus seating diagram

When restrained by a lap belt, the simulated occupant's pelvis was essentially fixed to the seat, causing the upper torso to whip sideways. This whipping action, in turn, caused the simulated occupants seated opposite the impact area (seats 11F and 13F in figure 13) to pivot about the pelvis and strike their heads and torsos on the seat cushions. Head injuries were predicted from these impacts. In addition, due to the seats' configuration and the dynamics of the bus, the simulation predicted hyperextension of the neck as simulated occupants on both sides of the bus rotated about the seatback.

In the unrestrained condition, three simulated occupants were predicted to sustain head injuries. These simulated occupants represented the fatally injured passengers during the actual accident (seats 11A, 12A, and 13A). Four simulated occupants wearing lap belts were predicted to sustain head injuries; five simulated occupants wearing lap/shoulder belts were predicted to sustain head injuries. During the restrained conditions, simulated occupants seated on the side of the bus opposite the impact area were predicted to sustain injuries from the head's impact onto the seat cushion as the upper body whipped about the fixed pelvis.

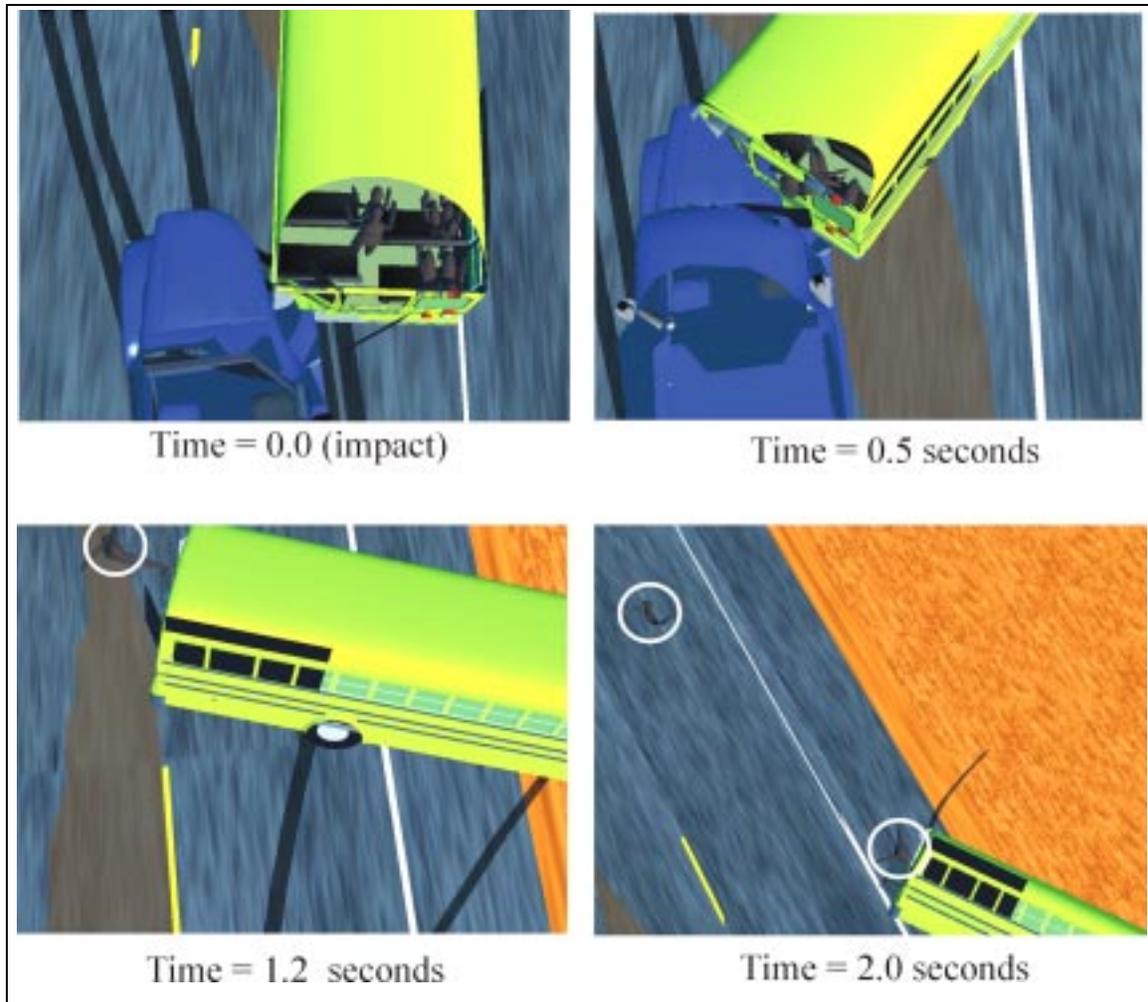
Figure 17. Holyoke simulation time sequence history

The ejection path and rest positions of the two ejected passengers (seats 8C and 9C in figure 16) were most closely matched by the simulated occupants when they stood in the aisle before impact. (See figure 17.) A slight opening of the rear emergency exit door facilitated the complete ejection of these simulated occupants.²⁶ Higher injury levels were seen for the two reportedly ejected simulated occupants in the standing position than in the seated position because they were not protected by the seating compartment. Although the bus' accelerations were low, the simulated standing occupants contacted surfaces inside

occupants. When the two simulated occupants (seats 8C and 9C) were seated, only the simulated occupant in seat 8C was predicted to sustain a head injury, which would have occurred as the head contacted the side window during the overturn sequence. Head injuries were not predicted for any restrained simulated occupant. Chest accelerations were predicted only for the standing simulated occupant near seat 9C. Neck injuries were not predicted for any of the simulated occupants in any condition.

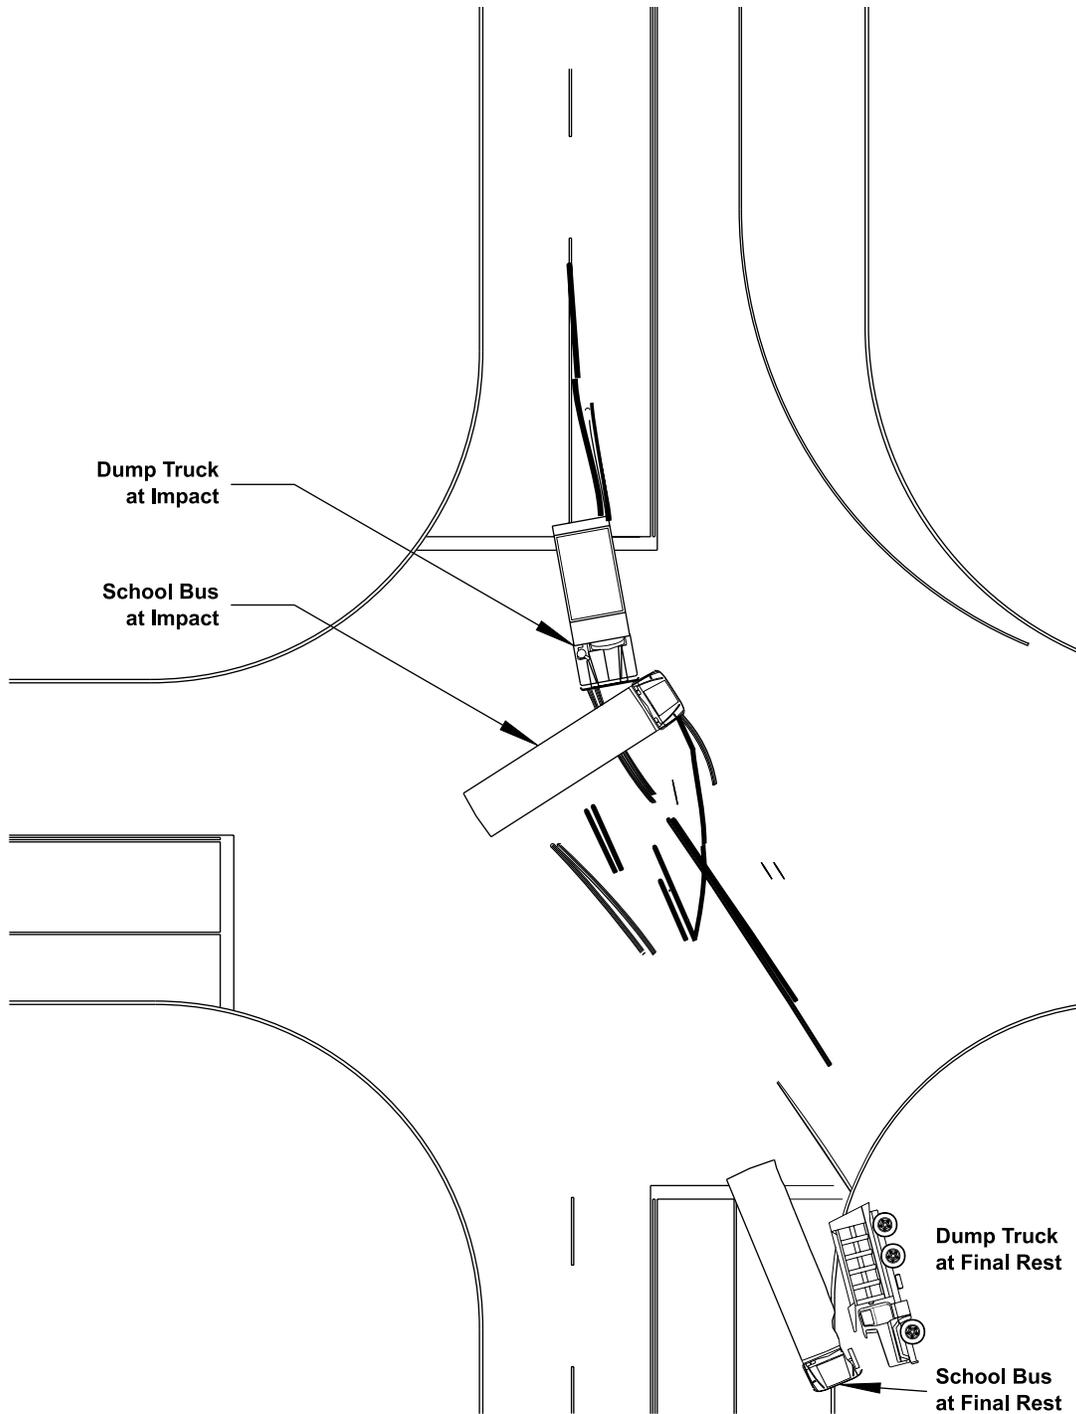
Figure 19. Holmdel accident scene diagram

The school bus was traveling approximately 22 mph when it began to turn into the intersection and approximately 21.3 mph at impact. The bus' change in velocity was estimated at 39.4 mph, and the peak acceleration for the bus was calculated to be 37.9 g at the center of gravity, an acceleration greater than that calculated for the Monticello accident.

The accelerations at different locations inside the bus were also investigated during this reconstruction. Table 7 details the accelerations experienced at the bus' center of gravity as well as at the driver's seat and on the left and right sides of the first row of passenger seats. The maximum acceleration at the center of gravity occurred slightly before the maximum acceleration of the simulated accelerometers placed on the passenger seats. Therefore, both acceleration values are reported in table 7. The values indicate that the accelerations at the driver's seat were greater than those experienced in the row directly behind the driver. In addition, at these seats, the accelerations were predominantly lateral.

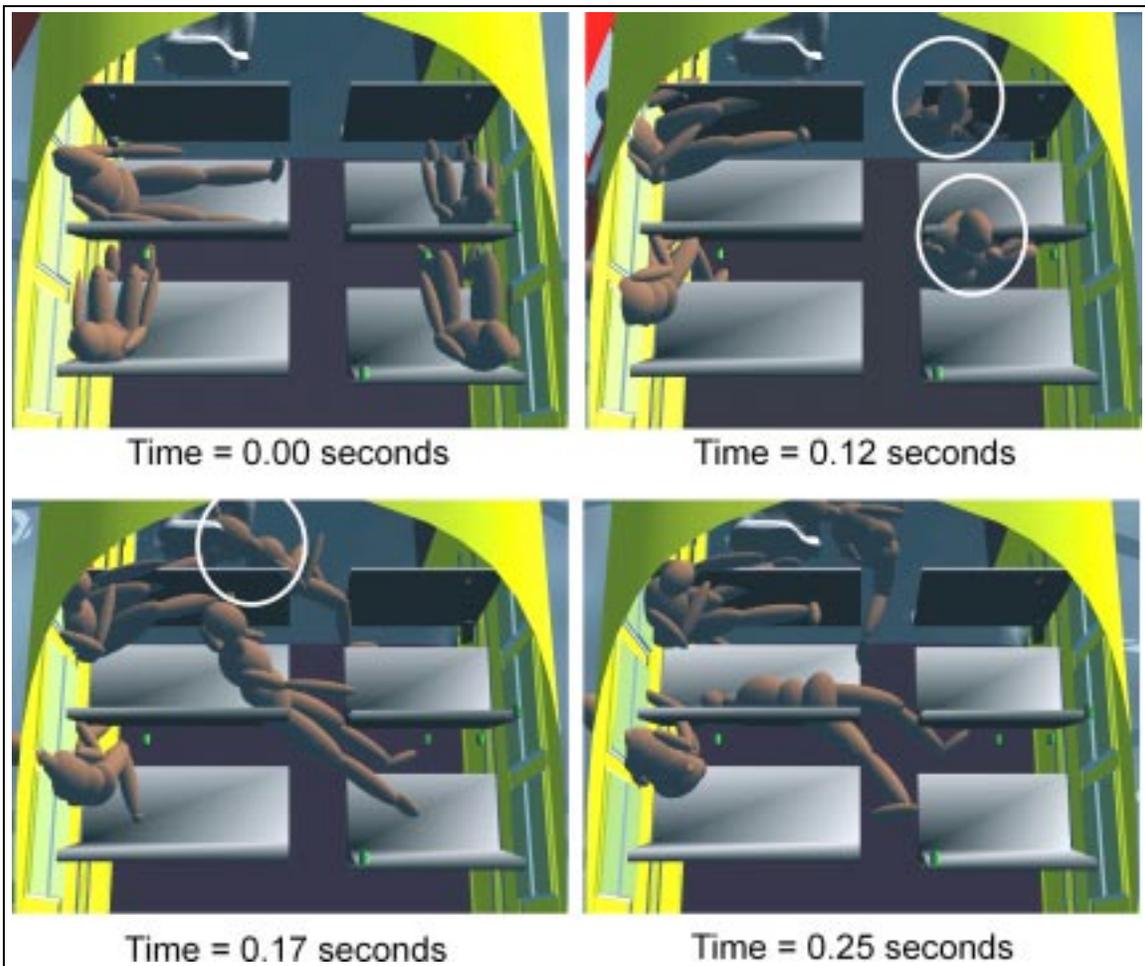
Figure 20. Holmdel simulation time sequence history (unrestrained condition)

Simulated Occupant Kinematics. The simulated occupant kinematics experienced during this accident were similar to those seen in the simulation of the Monticello accident. In general, the simulated occupants first went diagonally toward the driver's side of the bus and slightly forward. (See figure 20.) Those simulated occupants originally located on the driver's side of the bus (the side contacted during the collision

with the dump truck) quickly contacted the side of the bus and the windows. Those on the opposite side slid across the seat toward the driver's side, contacting the seat in front (or the modesty panel) and the sides of the seatbacks (or of the modesty panel), and then continued into the row in front of the original seating location due to the bus' kinematics.

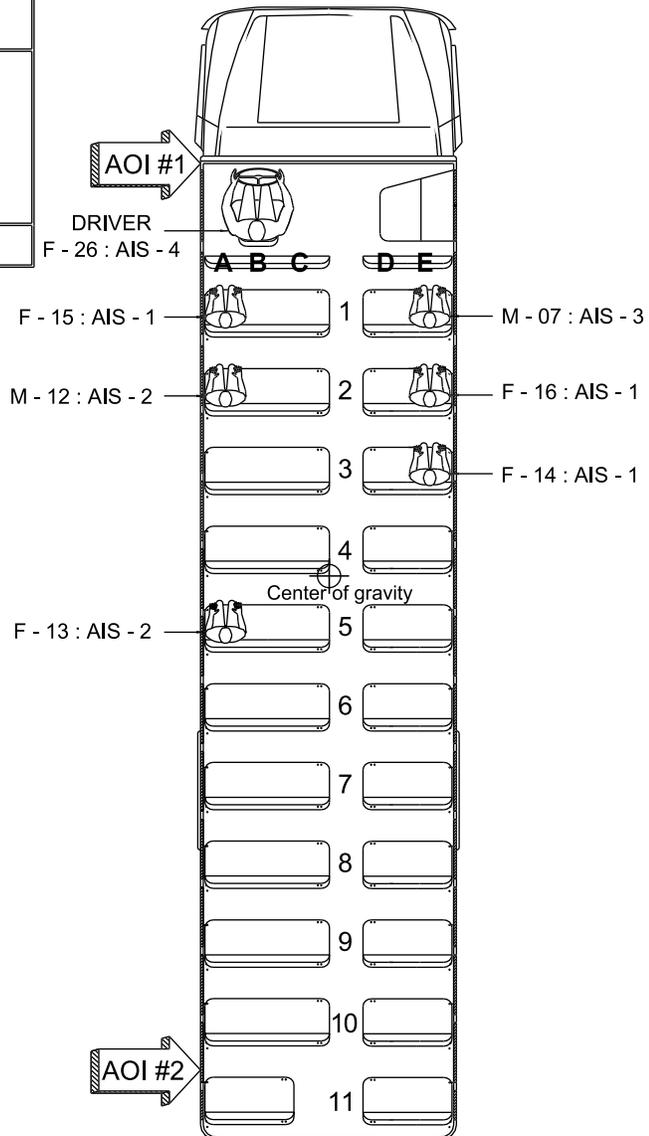
Figure 22. Holmdel bus seating diagram

The lap belt in this simulation restrained the pelvis of the simulated occupant to the seat. (See figure 21.) For the two simulated occupants on the opposite side of the bus from the impact, the kinematics were dramatically altered from the unrestrained condition. The simulated occupant in seat 1E (see figure 22) did not contact the modesty panel as in the unrestrained condition. Instead, this simulated occupant rotated about the pelvis and struck the seat cushion with the head, resulting in a predicted head injury. (The predicted head injury level in the lap belt-restrained condition was lower than the predicted head injury level in the unrestrained condition.) Similarly, the simulated occupant in seat 2E rotated about the pelvis, but because this simulated occupant was larger than the simulated occupant in 1E, the simulated occupant in seat 2E contacted the seatback in front with the head concentrating the force of the impact in a small region. This impact resulted in a predicted head injury for this simulated occupant.

In the lap/shoulder belt-restrained condition, although the chest acceleration values were higher than in the unrestrained condition, the simulated occupants on the opposite side of the bus from the impact (seats 1E and 2E) were not predicted to sustain head injuries because the shoulder harnesses were able to restrain the upper torso and thus
