PUBLIC ROADS

VOL. 24, NO. 7

JOINTS AND CRACKS IN CONCRETE PAVEMENTS

Reported by EARL C. SUTHERLAND, Senior Highway Engineer

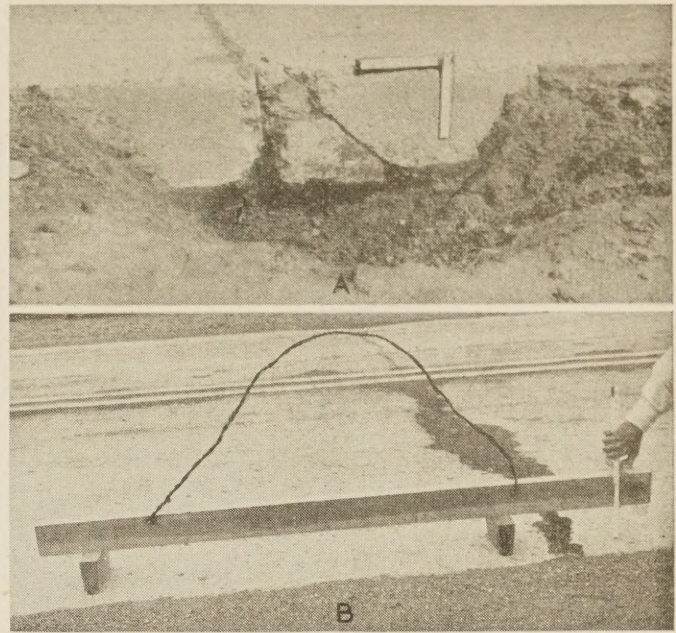
FIGURE 3.—A, SHOULDER REMOVED FOR INSPECTION OF EXPANSION JOINT; B, DEVICE FOR MEASURING FAULTING AT JOINTS AND CRACKS.

Figure 3, A shows the method of exposing the joints for study. It was not practical to expose all of the joints as shown, but this was the general procedure followed. Some joints were examined in more detail than others.

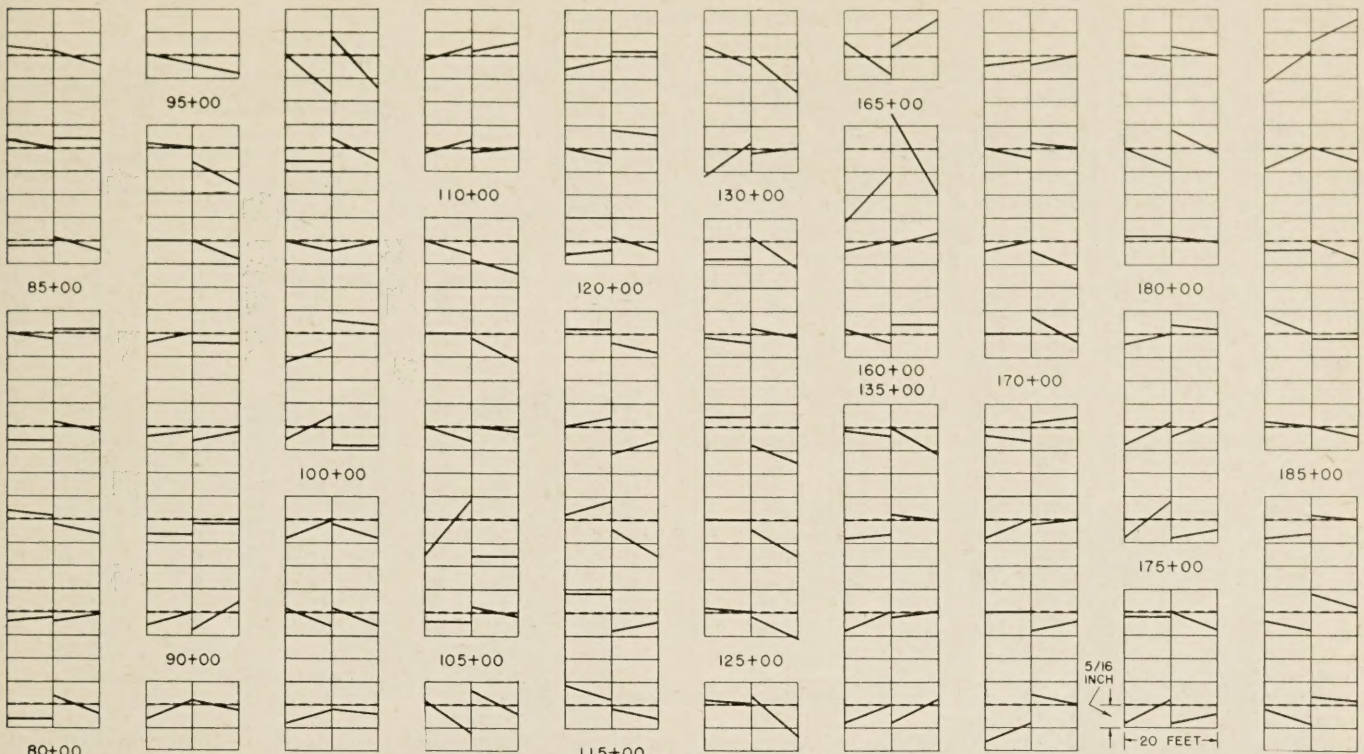
FIGURE 4.—TYPICAL FAULTING MEASUREMENTS SHOWING THE VERTICAL POSITION OF THE SLAB BEYOND THE JOINT WITH RESPECT TO THE APPROACH SLAB IN THE DIRECTION OF TRAFFIC.

Typical data showing the magnitude and direction of faulting at a number of the joints on a two-lane pavement are shown in figure 4. The points at which faulting was measured on two-, three-, and four-lane pavements and the numbers identifying the points are shown in figure 5. Figure 4 indicates the vertical position at the different points on the slab beyond the

joint with respect to the approach slab. Thus, a minus value at a given point indicates that, at this point, the slab beyond the expansion joint is below the approach slab. A positive value indicates the opposite condition.

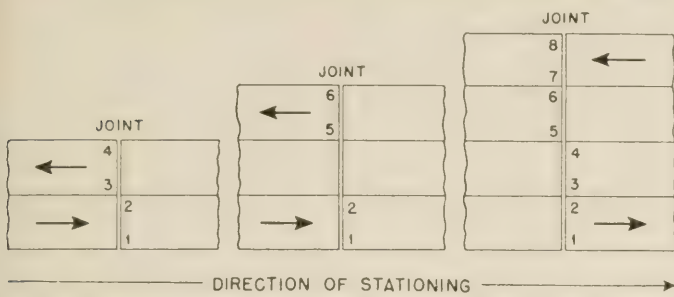
FIGURE 5.—POINTS AT WHICH FAULTING MEASUREMENTS WERE MADE ON TWO-, THREE-, AND FOUR-LANE PAVEMENTS.

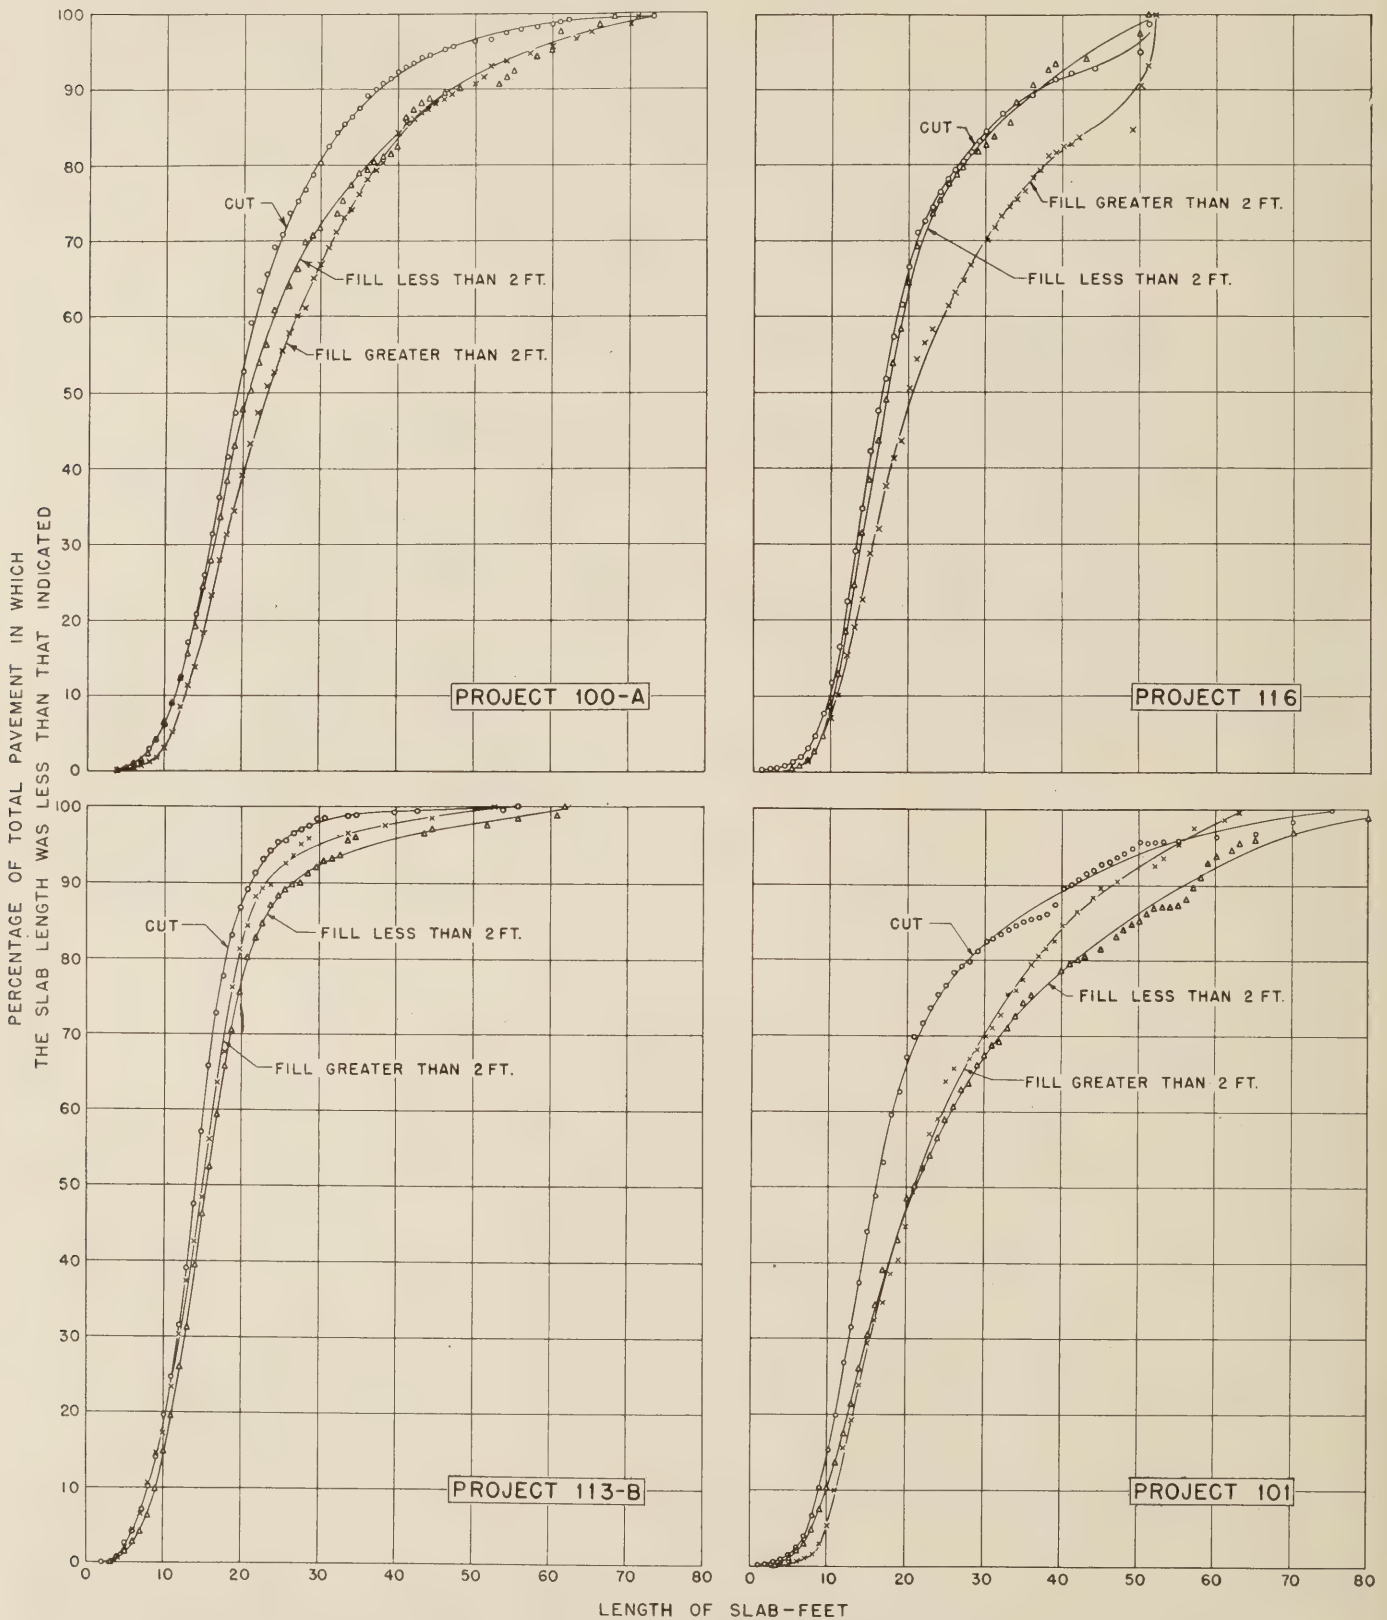
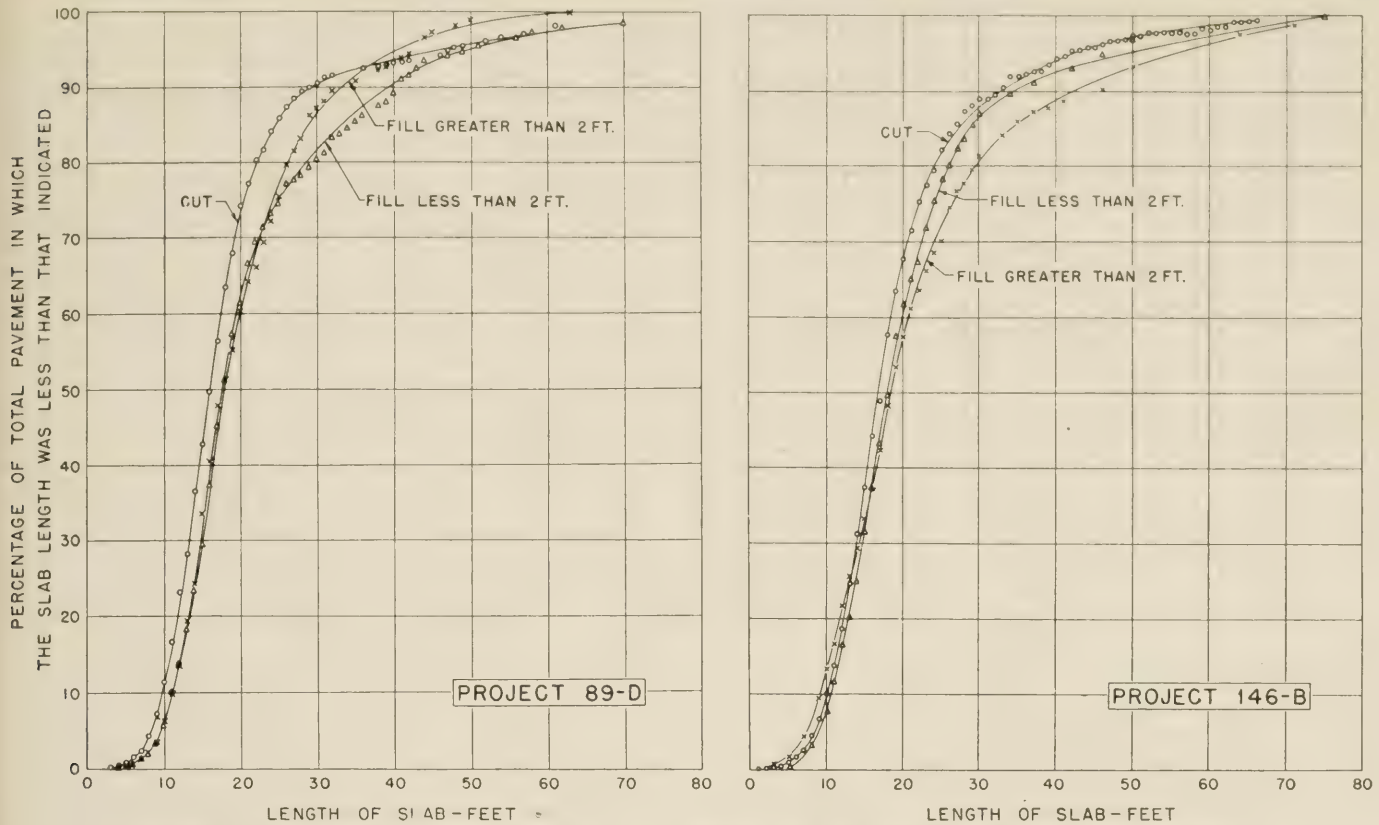
FIGURE 8.—PERCENTAGE DISTRIBUTION OF SLAB LENGTHS IN CUTS AND ON FILLS ON FOUR PROJECTS.

FIGURE 9.—PERCENTAGE DISTRIBUTION OF SLAB LENGTHS IN CUTS AND ON FILLS ON TWO PROJECTS.

The effect of cut and fill on average slab length.—This relation is shown in figures 8 and 9, inclusive. These are typical distribution curves in which the abscissas indicate slab lengths while the corresponding ordinates represent the percentage of the total pavement length formed by slabs of that length or less.

In interpreting the graphs, it should be emphasized that there are relatively few long slabs in many of the pavements from which the data were obtained. Thus the upper parts of these curves represent only small samples of pavements. Also, on some of the projects the total length of pavement, on fills greater than 2 feet in height, was relatively small. These facts may ex-

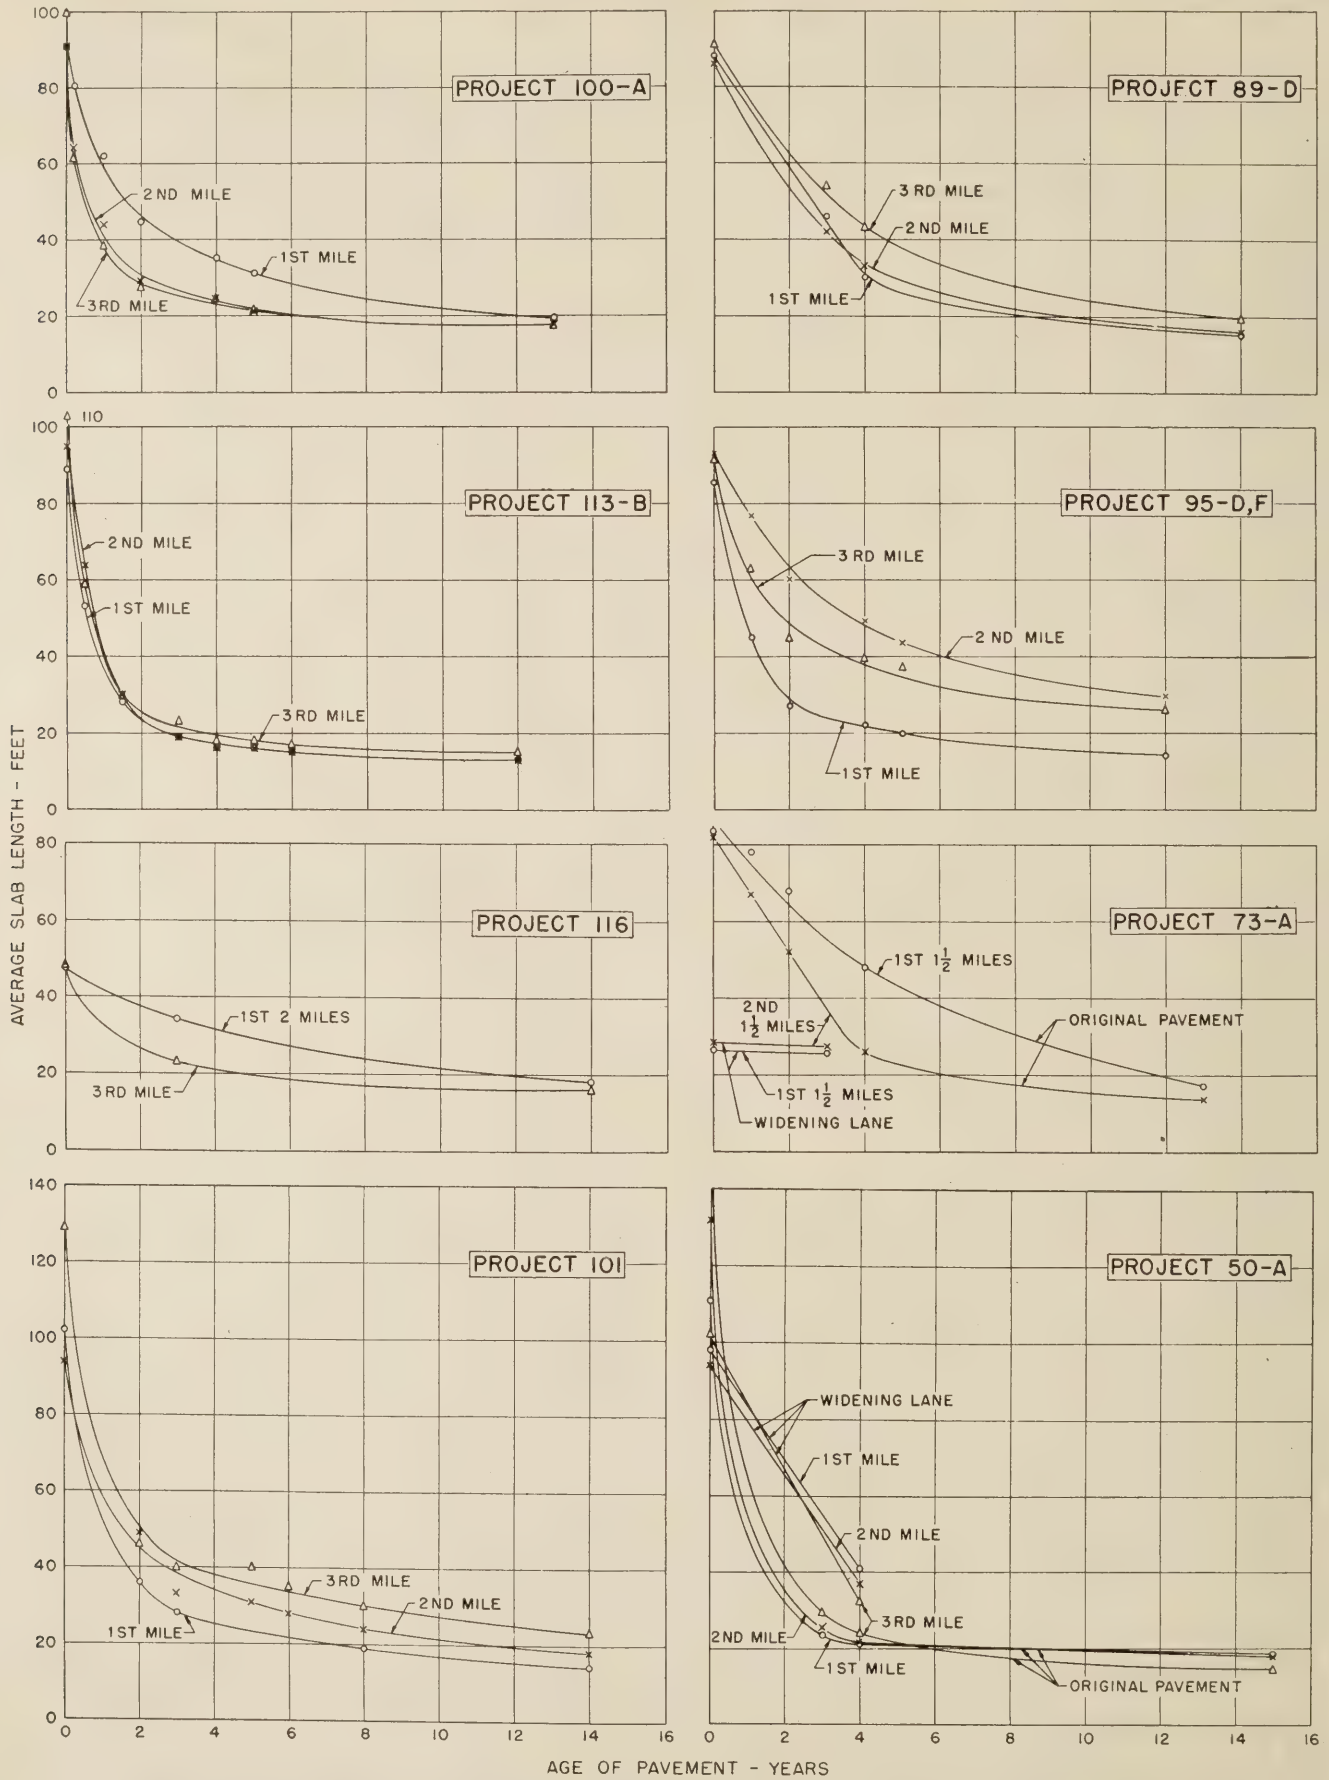
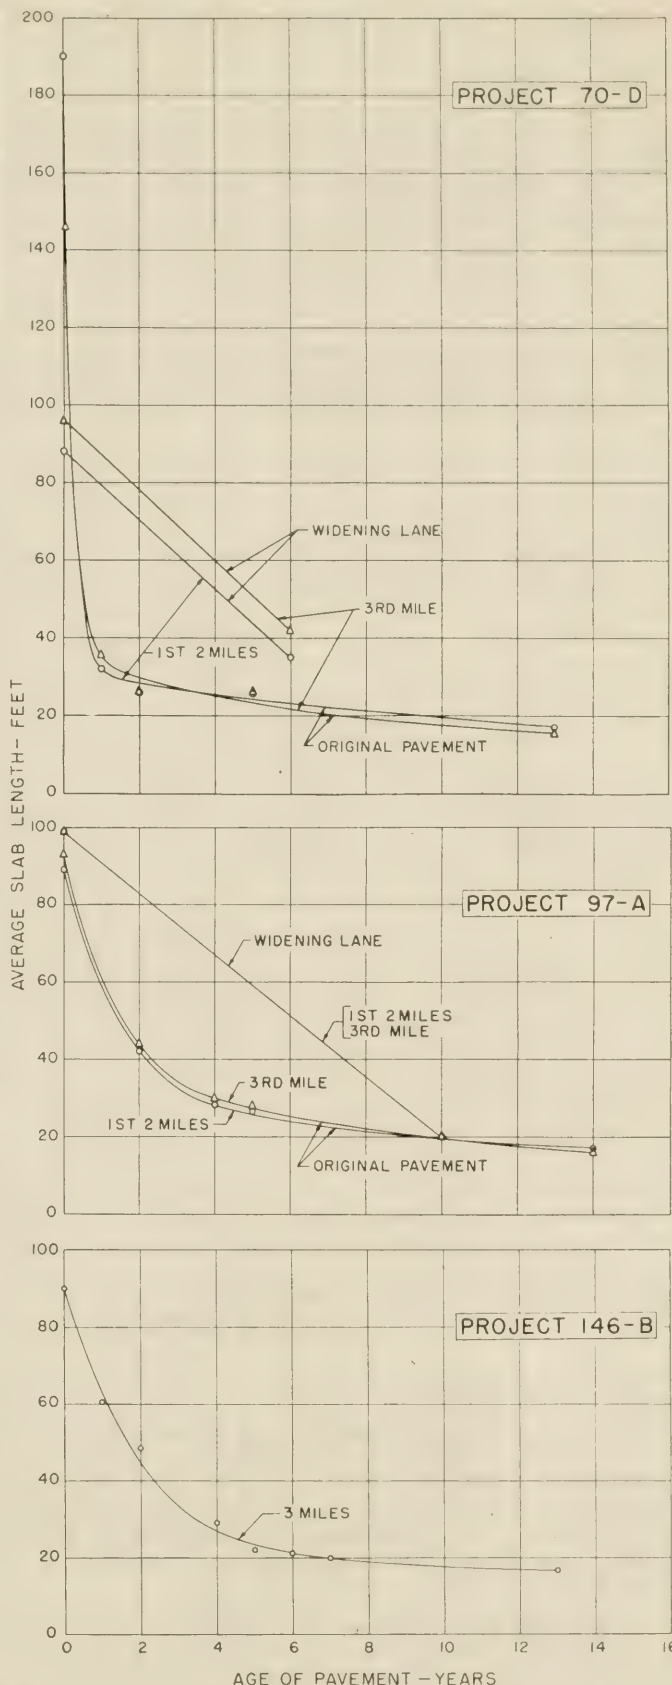
FIGURE 10.—CHANGE IN AVERAGE SLAB LENGTH WITH AGE OF PAVEMENT ON EIGHT PROJECTS.

The average slab lengths at different ages for certain sections examined for which data from former crack surveys were available are shown in figures 10 and 11. On some of the newer pavements only one crack survey had been made and for these only the original slab lengths and slab lengths at the time of this survey can be shown.

The average slab length of the new pavement on project 73-A is much less than that of the old pavement at the same age, for the reason that joints were placed at intervals of approximately 25 feet in the new pavement at the time it was built. Figure 10 (project 73-A) shows that very little cracking occurred during the first 3 years of the life of the new pavement, a condition that is undoubtedly due to the fact that the pavement was originally constructed in 25-foot slabs.

FIGURE 11.—CHANGE IN AVERAGE SLAB LENGTH WITH AGE OF PAVEMENT ON THREE PROJECTS.

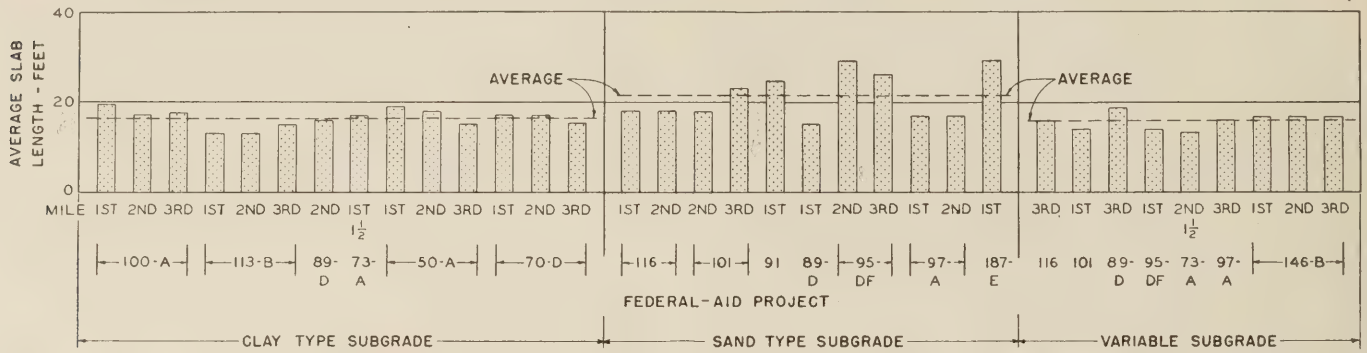
FIGURE 12.—COMPARISON OF THE AVERAGE SLAB LENGTHS OF PAVEMENTS ON DIFFERENT TYPES OF SUBGRADES. THESE PAVEMENTS RANGE IN AGE FROM 12 TO 15 YEARS, WITH THE EXCEPTION OF 187-E WHICH IS 20 YEARS OLD.

Figure 12 shows an average slab length of approximately 16 feet on both the clay and the variable type subgrades, while that on the sandy material was approximately 21 feet. Thus the average slab length on the sandy soils was approximately 30 percent greater than that on the clay soils. It is noted that the average slab length for project 187-E was greater than that on any other project. This was probably the result of favorable subgrade conditions and the removal of some of the poorest sections of the pavement before the survey was made.

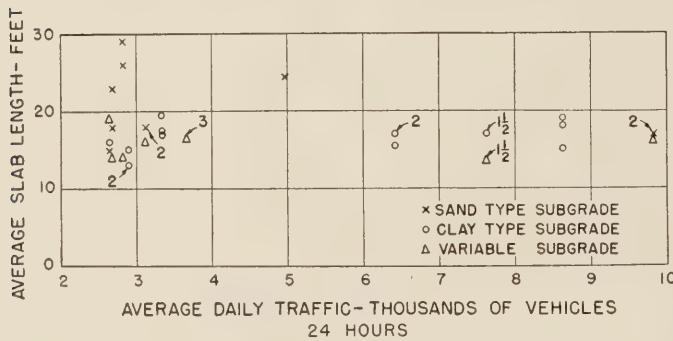
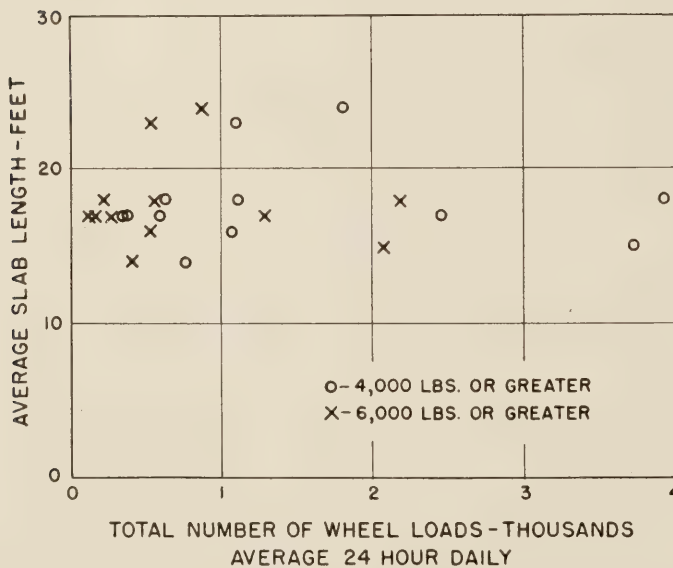
FIGURE 13.—COMPARISON OF AVERAGE SLAB LENGTHS ON PAVEMENTS WITH DIFFERENT AMOUNTS OF TRAFFIC. EACH POINT REPRESENTS 1 MILE EXCEPT WHERE INDICATED DIFFERENTLY. PAVEMENTS RANGE IN AGE FROM 12 TO 15 YEARS.

FIGURE 14.—COMPARISON OF AVERAGE SLAB LENGTHS ON PAVEMENTS HAVING DIFFERENT AMOUNTS OF HEAVY TRUCK TRAFFIC. EACH POINT REPRESENTS A SECTION OF PAVEMENT OF ABOUT 3 MILES. PAVEMENTS RANGE IN AGE FROM 12 TO 15 YEARS.

Figures 13 and 14 show the relation between the average slab lengths of the various pavements and the amount of traffic they carry. The slab length and traffic data from which these graphs were constructed are shown in table 5. These traffic data were collected during 1936 after most of the cracking in the pavements had already occurred. Also a few of the surfaces were widened to three and four lanes some time after they were built and this has had an important effect on the traffic in a given pavement lane. Figure 13 indicates that there were a greater number of the longer slabs on the pavements with light traffic however, the longer average slab lengths were for pavements laid on the sandy subgrades.

In figure 14 the average slab lengths are plotted against the daily number of wheel loads of different weight classes. Neither the number of wheel loads of a magnitude of 4,000 pounds or greater, nor the number of a magnitude of 6,000 pounds or greater appears to have had any important influence on the amount of transverse cracking that had occurred. Table 5 shows that there were very few wheel loads exceeding 9,000 pounds on these pavements.

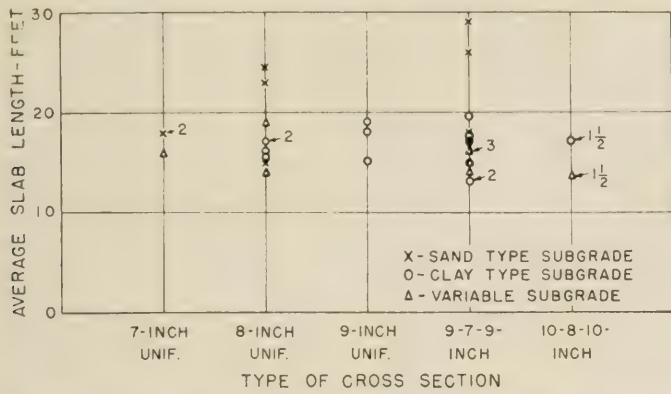
FIGURE 15.—COMPARISON OF AVERAGE SLAB LENGTHS WITH DIFFERENT TYPES OF CROSS SECTIONS EACH POINT REPRESENTS 1 MILE EXCEPT WHERE INDICATED DIFFERENTLY. PAVEMENTS RANGE IN AGE FROM 12 TO 15 YEARS.

To draw definite conclusions from data of the kind presented in figure 15, it is necessary that all other factors are constant throughout. This obviously is not the case. The comparison has other weaknesses. Only the 8-inch uniform thickness and the 9-7-9 inch thickened-edge pavements are represented by a sufficient number of miles to make the values dependable. Also the range of types is not as wide as is desirable. It can only be concluded that the data presented indicate that the shape and thickness of the pavement cross section has little or no influence on the average slab length.

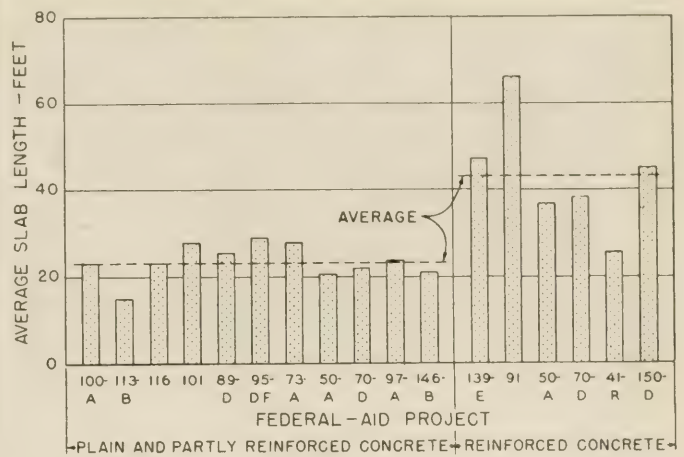
FIGURE 16.—COMPARISON OF THE AVERAGE SLAB LENGTHS ON PLAIN AND REINFORCED CONCRETE PAVEMENTS. THE REINFORCED PAVEMENTS VARY IN AGE FROM 5 TO 7 YEARS AND HAVE AN AVERAGE AGE OF 6.3 YEARS. THE AVERAGE SLAB LENGTHS OF THE PLAIN CONCRETE PAVEMENTS WERE TAKEN AT A CORRESPONDING AGE. THE REINFORCED PAVEMENTS WERE REINFORCED WITH A 60-POUND WIRE FABRIC.

ments had ¾-inch diameter edge bars and projects 100-A, 101, 50-A, and 70-D had small amounts of special reinforcing in certain areas. The details of the special reinforcement are given in tables 1 and 2. A study of the parts of the pavements with special reinforcement indicated that it had no appreciable effect on the structural properties or condition of the pavement. This was probably due to the small amounts of reinforcement used or to the manner in which it was placed.

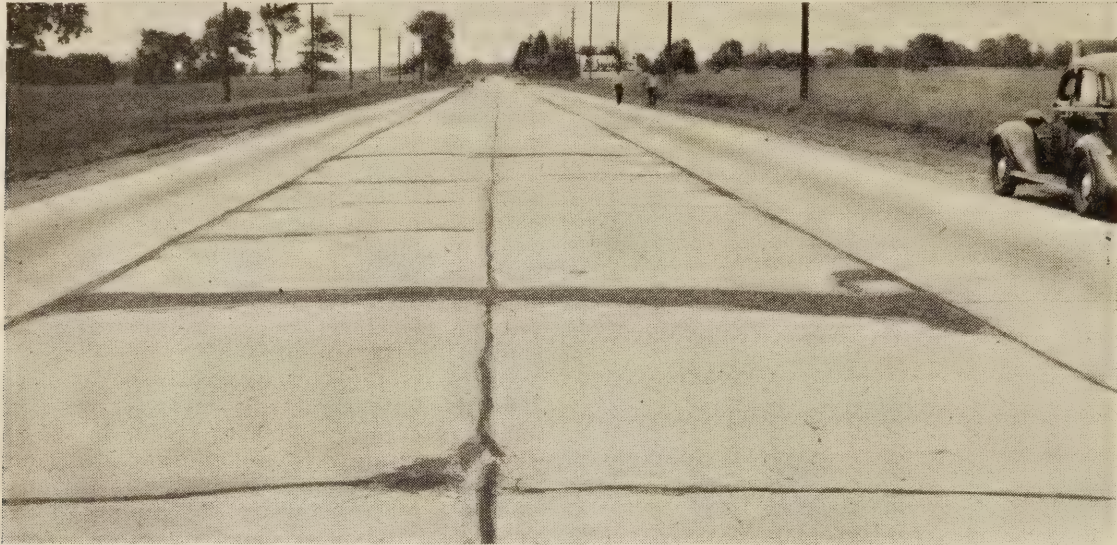
FIGURE 18.—A SECTION OF PAVEMENT TYPICAL OF THOSE STUDIED.

A pavement typical of those studied is shown in figure 18. The inside lanes of this highway were approximately 13 years old and the outside lanes were approximately 4 years old.

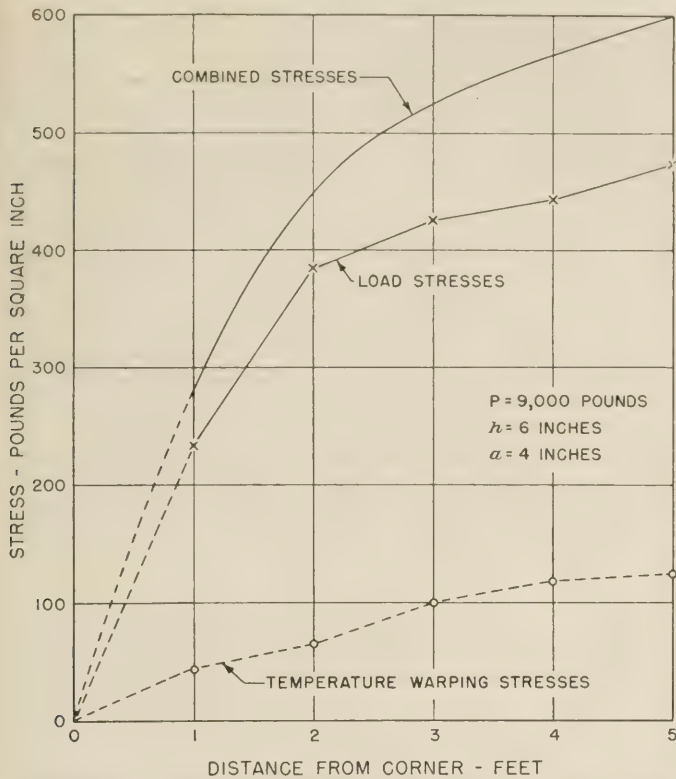
Figure 26 was prepared to study the possible effect of combined load and temperature warping stresses in causing infiltration cracks. The load stresses were obtained by applying a static load at points 1 foot apart across the free end of a pavement slab. These stresses are the averages obtained from tests on several slabs. In each case the center of the loaded area was placed 9 inches from the end of the slab and the critical stress was measured directly under the load in the direction parallel to the joint. The warping stresses were measured at corresponding points also in a direction parallel to the transverse joints at a time when the warping stress conditions were critical.

FIGURE 26.—TYPICAL COMBINED LOAD AND WARPING STRESS CURVE ACROSS FREE END OF PAVEMENT SLAB.

and with no provision for load transfer. It is evident that for the conditions described, the load stresses are far more important than the warping stresses.

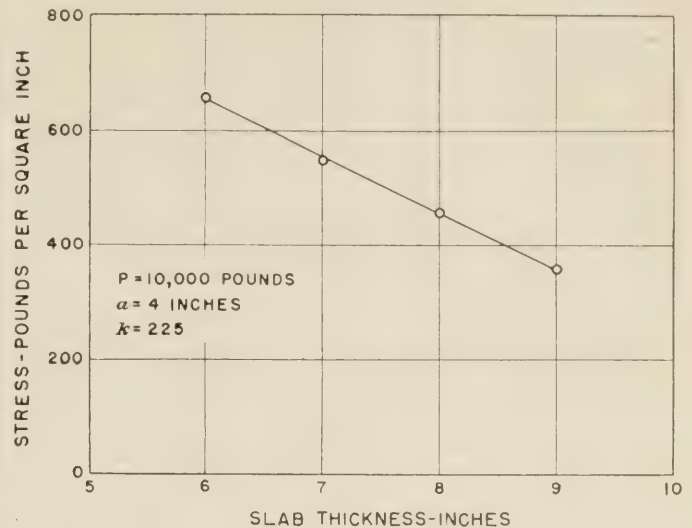
FIGURE 30.—COMBINED LOAD AND WARPING STRESSES MEASURED AT THE EDGES OF FREE TRANSVERSE JOINTS. THE LOAD STRESSES WERE MEASURED DIRECTLY UNDER THE LOAD IN THE DIRECTION PARALLEL TO THE JOINT EDGE. THE WIDTH OF THE SLAB WAS 10 FEET.
