Public Roads

A JOURNAL OF HIGHWAY RESEARCH

THIS report presents the results of an inspection of concrete pavements on the German motor-road system made by the authors during the summer of 1947 under instructions from the Commissioner of Public Roads. The inspection was made with the object of determining first, in what respects, if any, the German pavements are superior to ours; and second, what features of German design and construction practice, if any, can be adopted with profit by American engineers.

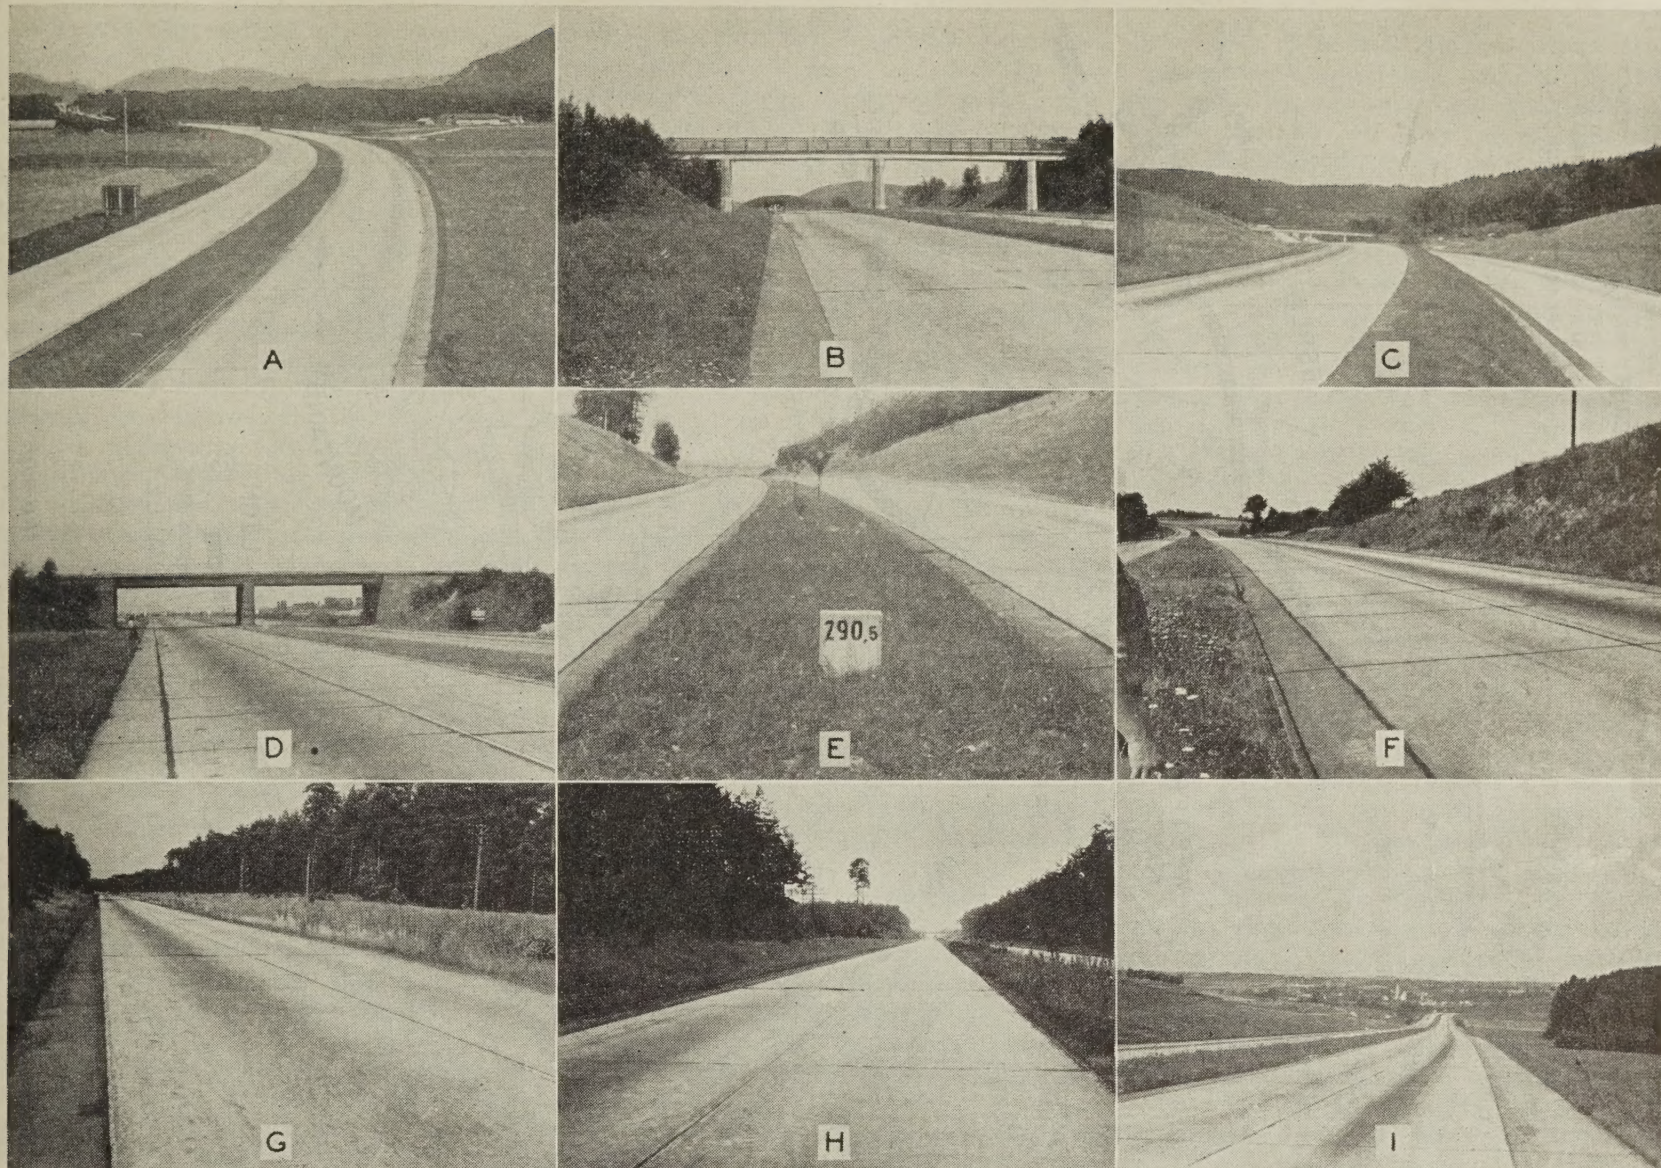
Figure 2.—Typical views of the autobahnen: (A-C) München-Salzburg; (D-F) Hannover-Ruhr; (G, H) Frankfurt-Stuttgart; (I) Stuttgart-München.

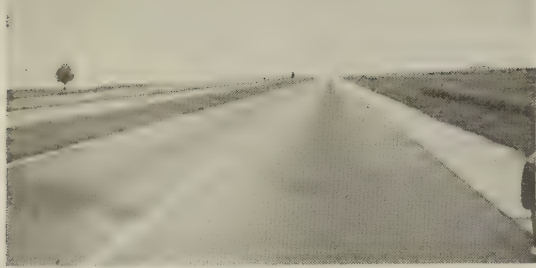
Figure 6.—Where dark-colored pavement was used, the shoulder strips were of plain concrete for contrast.

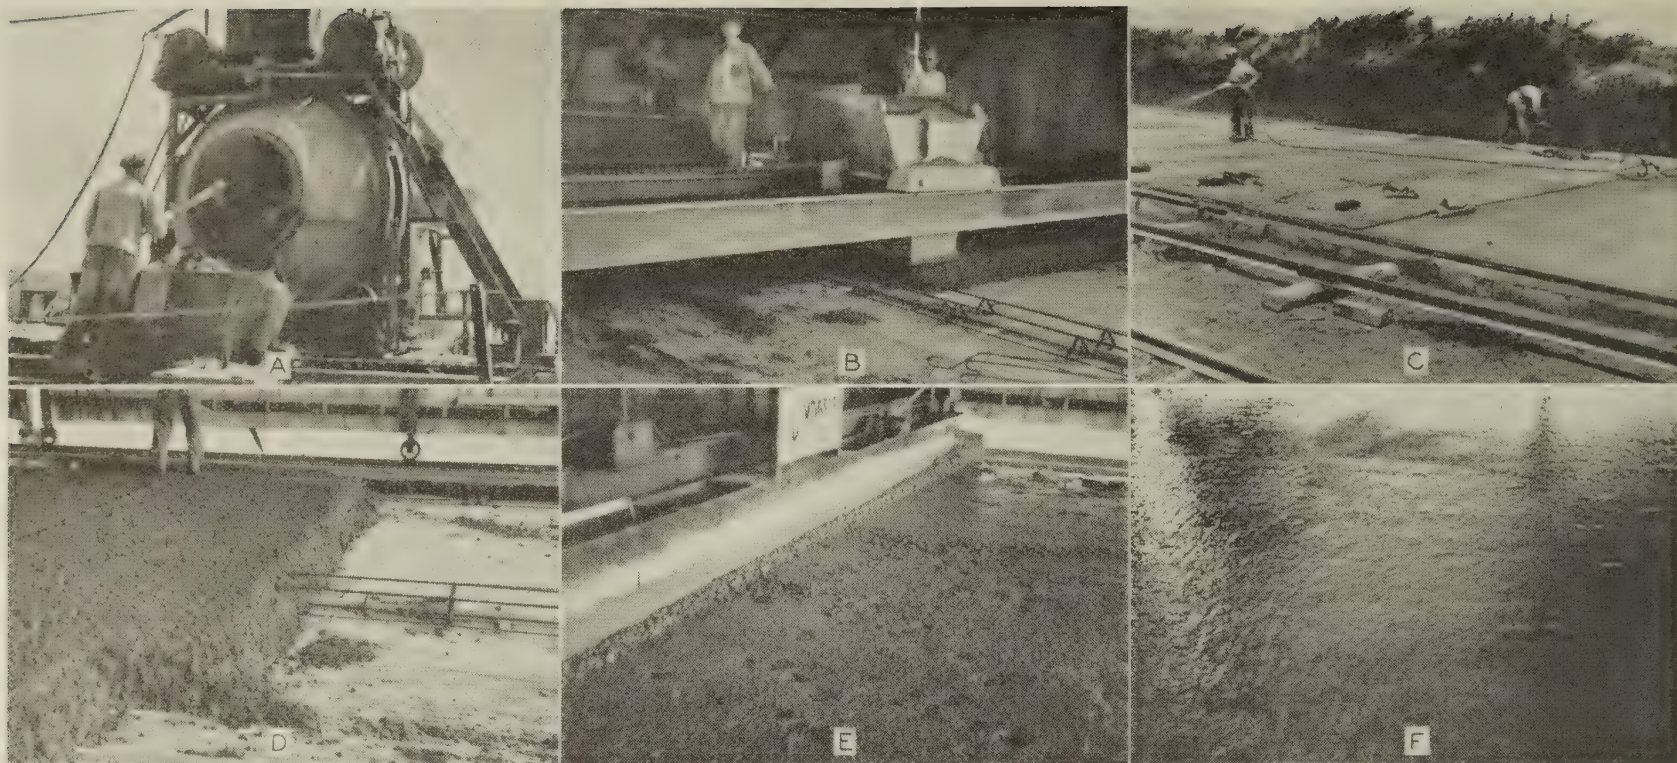
Figure 8.—Construction on the autobahn south of Stuttgart: (A) Dumping concrete into spreader hopper; (B) spreading concrete; (C) watering curing mats. Texture of the concrete is shown (D) after spreading, (E) as the Vögele vibrator began a second pass, and (F) after the final finishing.

Figure 8 illustrates several operations on sections of the autobahnen just south of Stuttgart. The pictures were taken on July 23, 1936, and this particular section was inspected by the authors on July 28, 1947, just 11 years later. Figure 8A shows the mixer discharging a batch of concrete into the

spreading hopper which then moves forward under the sunshade and discharges as shown in figure 8B. The spreader was moving from right to left when the photograph was taken. Note the very dry concrete, shown in greater detail in figure 8D. Figure 8E shows the Vögele finisher starting its second pass and figure 8F the final finish which, in this case, was only secured after several passes of the machine. Figure 8C is another view of the final surface. It also shows the woven-reed curing mats which were left in place for 3 weeks and were kept continuously wet during that period. This view also shows the light rail used to carry the sunshade frames. In his notes accompanying the photographs, Mr. McMillan states that the usual rate of progress, using machinery of the type de-

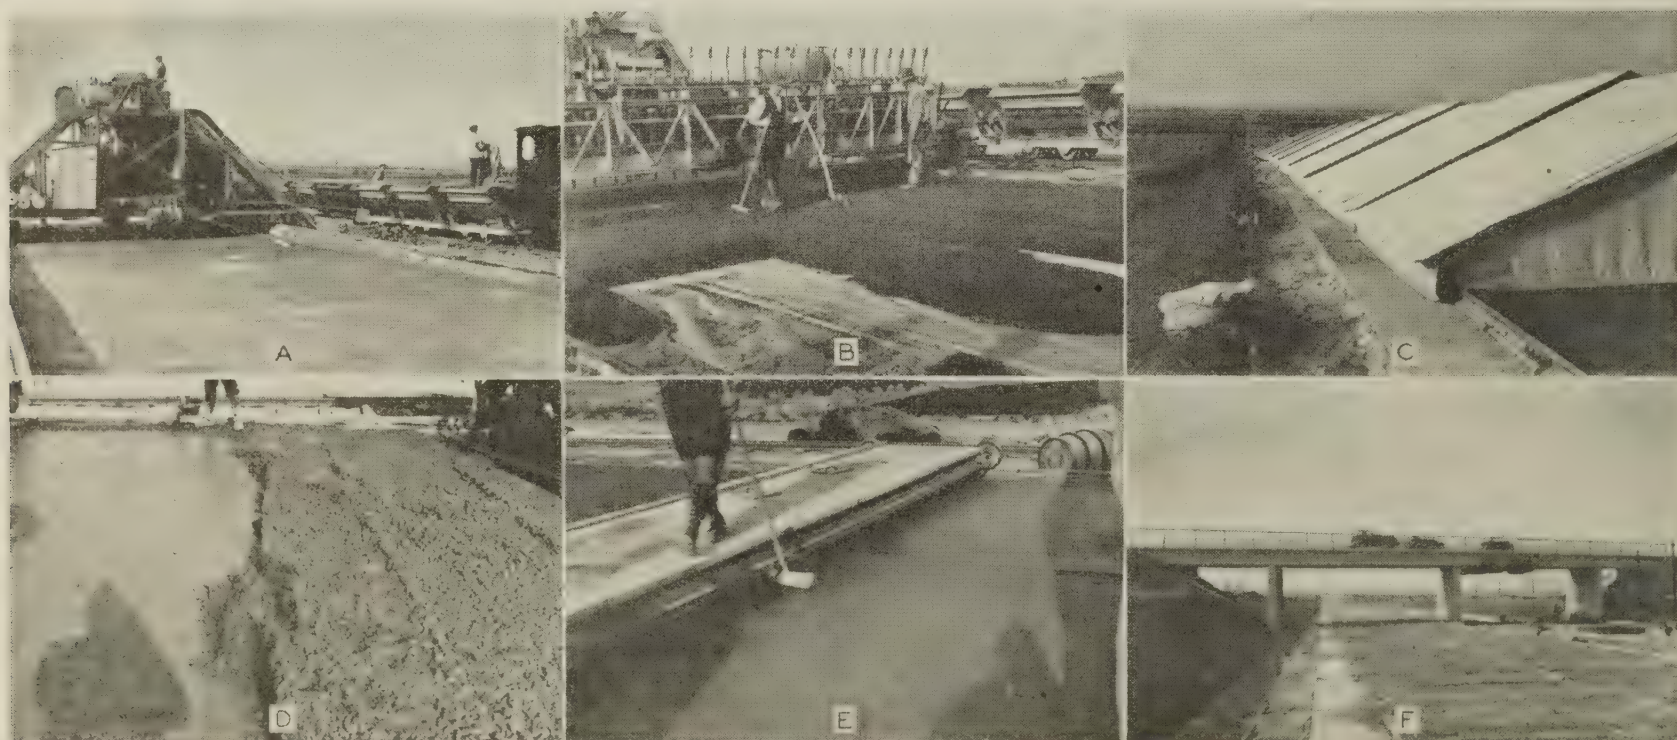
Figure 9.—Construction on the autobahn north of Kassel: (A) Mixer spanning subgrade, with industrial railway alongside; (B) Dinger tamper in operation; (C) sunshades used for preliminary curing. Texture of the concrete is shown (D) before and after tamping, and (E) after brooming. (F) Woven-reed curing mats were used.

Figure 9 illustrates operations on a section about 40 miles north of Kassel on which the Dingler machine was being used. Figure 9A shows the concrete mixer spanning the subgrade with the industrial railway on the right. Figure 9B shows the tamping machine in action compacting the lower course. Note again the dry consistency of the concrete. Also note that this particular operation was not protected by sunshades. Figure 9D illustrates the appearance of the concrete in the surface course before and after compaction by the tamping screed. Figure 9E shows the finished surface being given a light brooming and figure 9C shows the low sunshades used during the preliminary curing. Figure 9F is a general view of the pavement with the curing mats in place.
