**VERIDIAN REMOTE SIDE IMPACT AIR BAG AND SIDE CURTAIN
DEPLOYMENT INVESTIGATION
SCI TECHNICAL SUMMARY REPORT**

NASS/SCI COMBO CASE NO. 2000-09-004C

VEHICLE - 2000 MERCEDES-BENZ S500

CRASH DATE - JANUARY, 2000

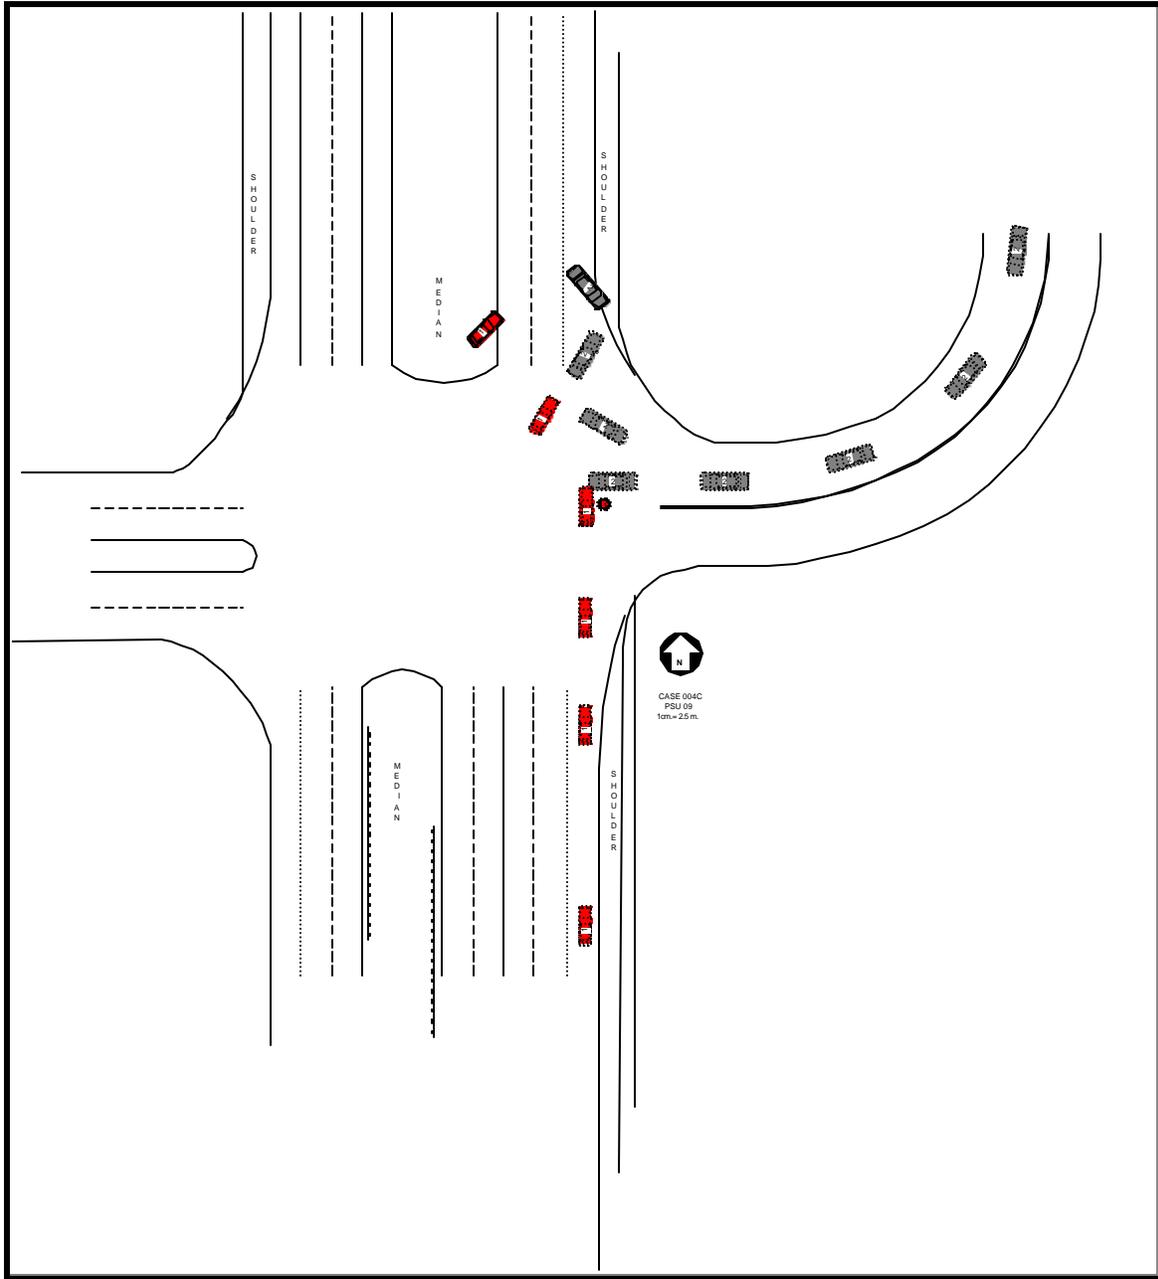
Figure 8. NASS Scene Diagram.

This two vehicle crash occurred during the afternoon hours of January, 2000. At the time of the crash, it was daylight with no adverse conditions as the roads were dry. The crash occurred in the northbound lanes of a level/asphalt 4-leg intersection (**Figure 8 - page 6**) which was controlled by an overhead signal system. The northbound lanes consisted of five lanes with a negative grade to the north. The signal system was in red phase for north/southbound traffic. The posted speed limit at the crash scene was 89 km/h (55 mph).
