**REMOTE REDESIGNED AIR BAG RELATED ADULT PASSENGER FATALITY  
INVESTIGATION  
SCI TECHNICAL SUMMARY REPORT**

**NASS/SCI COMBO CASE NO. 00-12-091A**

**VEHICLE - 1999 BUICK PARK AVENUE**

**CRASH DATE - MAY 2000**

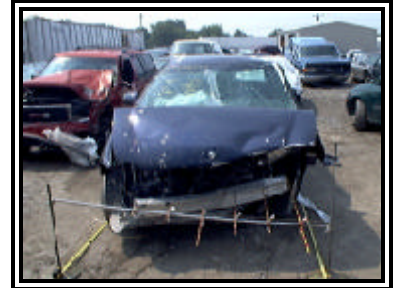
**Figure 1. 1999 Buick Park Avenue**

This remote investigation focused on a 1999 Buick Park Avenue sedan (**Figure 1**) that was equipped with redesigned air bags for the driver and front right positions. The Buick Park Avenue impacted a 1989 Chevrolet Corsica in a head-on configuration. The impact was sufficient to deploy the redesigned frontal air bag system in the Park Avenue. The Buick Park Avenue was occupied by 73-year-old male driver, a 91-year-old female front right passenger, and a 69-year-old female and a 72-year-old male seated in the left and right rear outboard positions, respectively. All of the occupants were restrained except the front right passenger. Pre-crash braking displaced the unrestrained front right passenger forward into the path of the redesigned front right passenger's air bag.

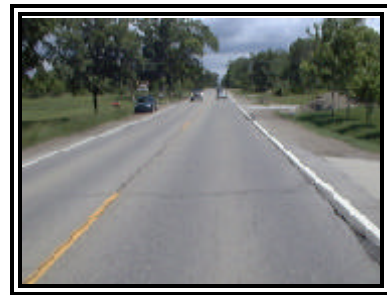
**Figure 2. Northbound approach for the Corsica**

The 19-year-old female driver of the 1989 Chevrolet Corsica was operating the vehicle northbound on the two-lane roadway in rain conditions behind several uninvolved vehicles (**Figure 2**). According to a witness, traffic ahead of the Corsica had slowed due to a slow-moving truck that had entered the roadway. The driver of the Corsica lost control of the vehicle as she attempted to slow for the traffic ahead. The Corsica traveled across the centerline into the southbound lane, and into the path of the Buick Park Avenue. It was unknown if the driver of the Corsica attempted any avoidance maneuvers.

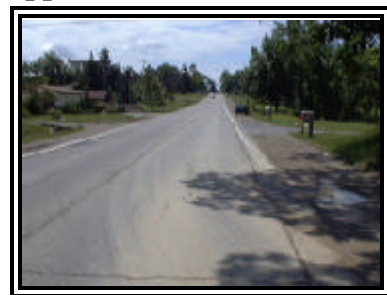
**Figure 3. Southbound approach for the Park Avenue**

The 73-year-old male driver of the Buick Park Avenue was operating the vehicle southbound on the two-lane roadway (**Figure 3**). When he detected the Chevrolet Corsica encroaching into the southbound lane, he applied the brakes in an attempt to avoid the collision.
