**VERIDIAN ON-SITE AIR BAG ASYMMETRICAL  
DEPLOYMENT INVESTIGATION**

**VERIDIAN CASE NO. CA00-028**

**VEHICLE - 1996 DODGE CARAVAN SE**

**CRASH DATE - JULY, 2000**

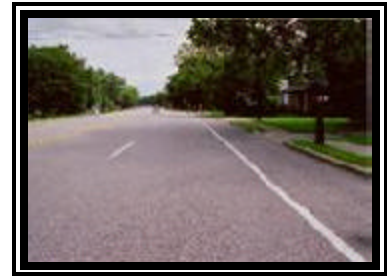
vehicle into the outboard lane (**Figure 1**) in an attempt to pass another eastbound vehicle ahead. As the vehicle reached the apex of the roadway curvature, it continued in a southeasterly direction toward the right (south) pavement edge in a forward tracking mode.

**Figure 1. Eastbound approach for the 1996 Dodge Caravan SE.**

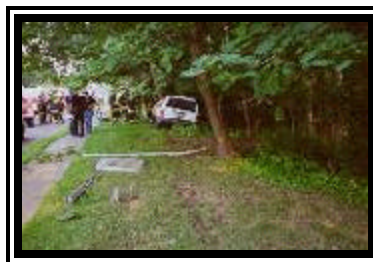
**Figure 3. Police photo (east) of vehicle trajectory to final rest showing struck signpost and tree.**

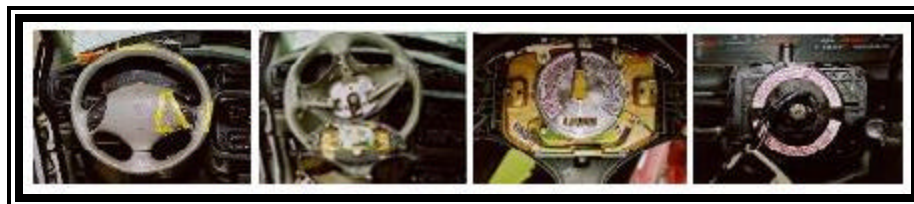
**Figure 10.** Disassembly process to obtain clock spring.

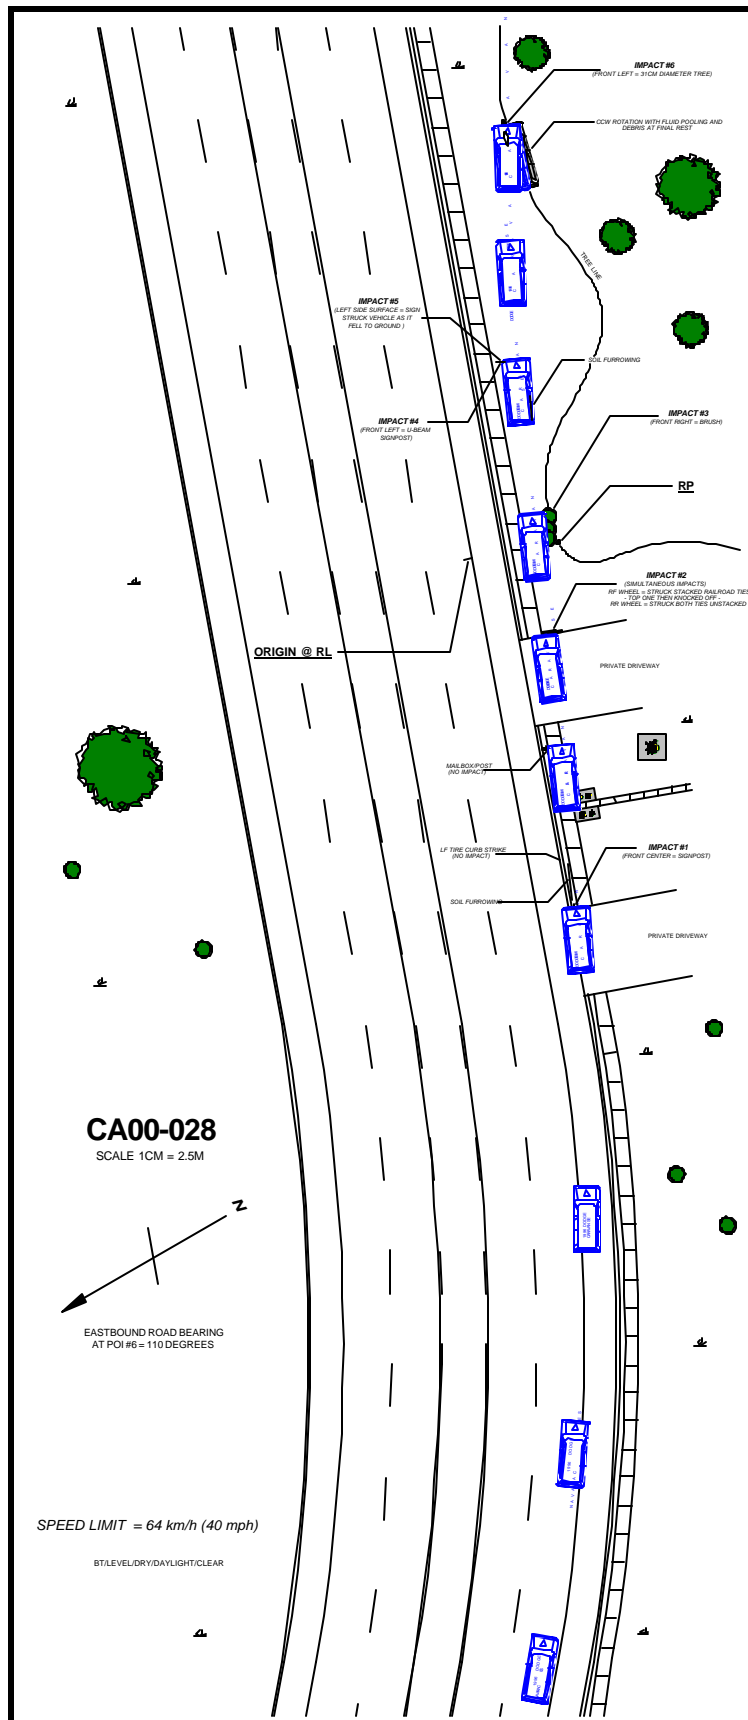
Figure 11. Scene Diagram.

This single vehicle crash occurred during the early evening hours of July, 2000. At the time of the crash, it was daylight with no adverse conditions as the roads were dry. The crash occurred off the south pavement edge of a 5-lane east/west urban roadway which curved left for eastbound traffic (**see Figure 11 - page 8**). The level/asphalt roadway was bordered by barrier curbs and sidewalks located 0.6 meters (2.0 feet) off the south curbline. Roadside environmental features included mailboxes, driveway marker posts, a regulatory sign (supported by dual U-beam posts affixed to anchor posts just above ground level) and a wooded area located approximately 7.8 meters (25.6 feet) off the south pavement edge. The posted speed limit at the crash site was 64 km/h (40 mph).
