**VERIDIAN ON-SITE SEAT BELT INVESTIGATION
VERIDIAN CASE NO. CA00-040
VEHICLE: 2000 FORD EXPLORER XLS SPORT
LOCATION: FLORIDA
CRASH DATE: SEPTEMBER 2000**

1. <i>Report No.</i> CA00-040	2. <i>Government Accession No.</i>	3. <i>Recipient's Catalog No.</i>	
4. <i>Title and Subtitle</i> Veridian On-Site Seat Belt Investigation Vehicle: 2000 Ford Explorer XLS Sport Location: Florida		5. <i>Report Date:</i> January 2002

14. <i>Sponsoring Agency Code</i>	
15. <i>Supplementary Notes</i> On-site investigation of a front-to-rear crash and a subsequent rollover of a 2000 Ford Explorer that resulted in the death of the belted 22 year old female front right passenger.

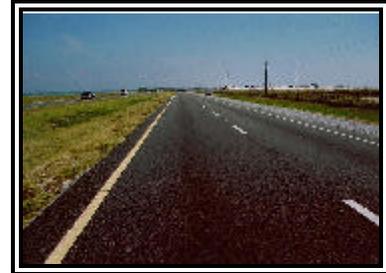
Figure 2. Overall view of the crash site at the initial point of impact.

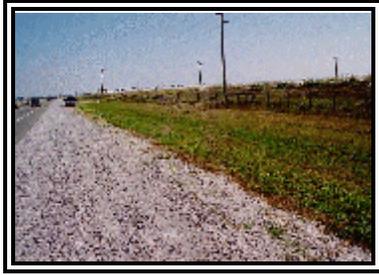
Following the impact with the Ford Explorer, the front right tire of the 1992 Jaguar locked due to rearward displacement of the right front fender. This, in combination with a possible clockwise (CW) steering input by the driver, initiated a CW yaw to the vehicle's eastbound trajectory. The Jaguar traveled approximately 56.5 m (185.4') across the eastbound travel lanes before departing the right (south) edgeline onto the stabilized shoulders (**Figure 5**). At the point of departure, the Jaguar had rotated approximately 50 degrees CW. The vehicle continued to rotate to a broadside trajectory on the sand and grass covered surface adjacent to the eastbound travel lanes. As the Jaguar yawed to 90 degrees CW of its initial trajectory, the yaw marks in the sandy surface hooked in a counterclockwise direction with respect to the vehicle's continued CW yaw. The Jaguar continued to yaw CW as evidence by the pronounced left side (leading side) tire marks (**Figure 6**). The reverse hook of the yaw marks was possibly due to the unequal weight distribution of the predominately front heavy vehicle. The Jaguar rotated approximately 171 degrees CW of its initial trajectory, coming to rest against a wire fence that was located 17.4 m (57.1') outboard

of the south edgeline of the eastbound travel lanes. The total yaw travel distance for the vehicle was documented by the SCI investigator at 104.6 m (343.2').

Figure 5. Off-road trajectory of the Jaguar.

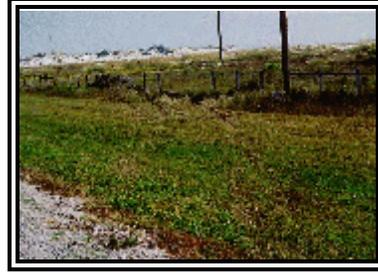
Figure 6. Clockwise yaw trajectory of the Jaguar with reverse hook of the yaw marks.

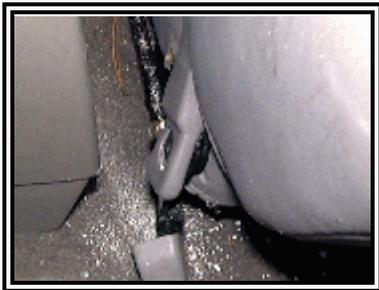
The front right passenger's belt system was configured the same as the driver's belt system. The adjustable D-ring was found adjusted to the top position during the SCI inspection of the Ford Explorer. The buckle sleeve was present and attached to the inboard aspect of the front right seat track (**Figures 15 and 16**). The buckle and tether webbing had separated from the sleeve and was retrieve by the legal team's investigators and placed in a sealed in plastic bag. It should be noted that the front right passenger's seat back rest was reclined to a measured angle of 40 degrees aft of vertical.

Figure 15. Sleeve/buckle attachment viewed from rear aspect of passenger's seat.

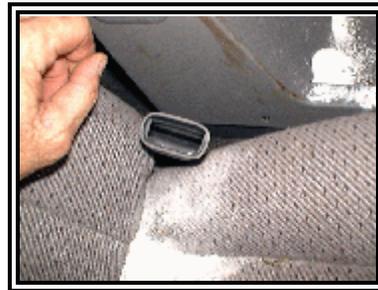
Figure 16. Passenger's buckle sleeve at inboard aspect of seat cushion.

The SCI inspection of the buckle assembly found the buckle unit intact with the top mounted release button spring loaded and operational. The webbing tether had separated from the lower anchorage bracket which remained bolted to the seat frame bracket. The webbing tether was cut in an irregular pattern above the lower anchorage bracket. That is, removed from the vehicle, the outboard aspect side of the webbing tether (side exposed to the inboard aspect of the seat cushion) was shorter in length than the opposing aspect. The outboard aspect of the webbing tether measured 9.0-10.0 cm (3 9/16 - 3 15/16") in length from the base of the buckle unit to the frayed cut points. The opposing length ranged from 11.1-11.7 cm (4 3/8-4 5/8"). All stitching remained intact and was located above the cut location. **Figure 17** is a view of the partially retracted passenger's belt system.

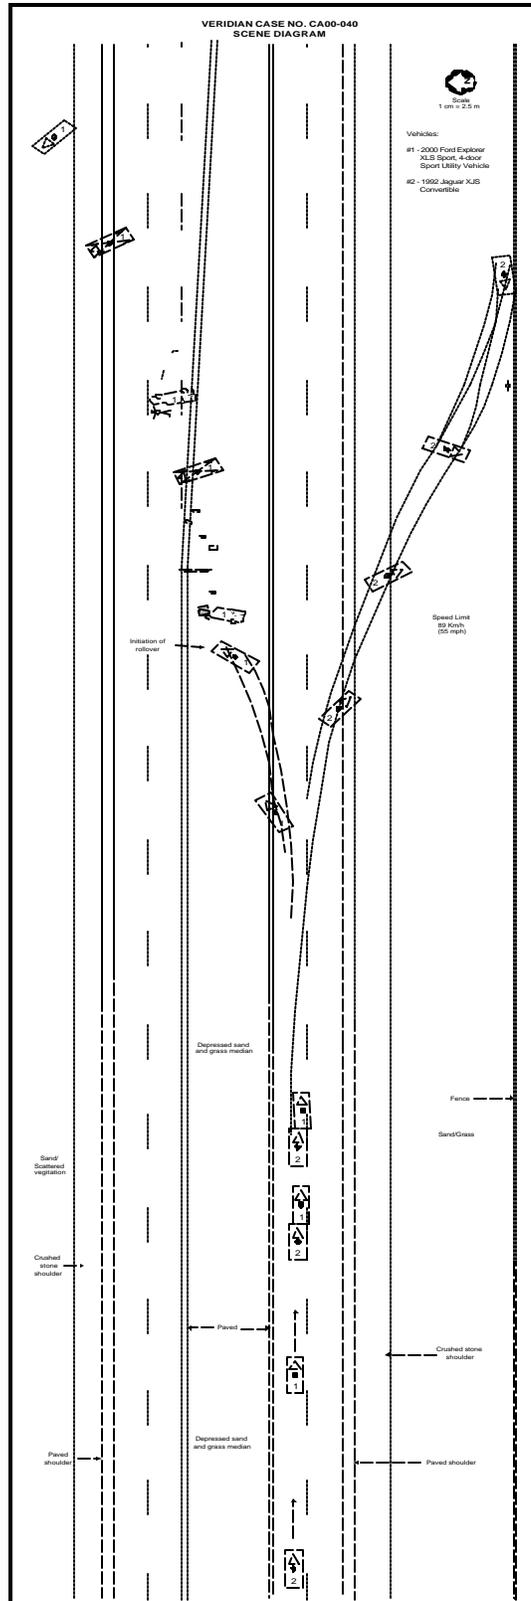
Figure 24. Scene Schematic

The 45 year old female driver of the 1992 Jaguar and her 51 year old male passenger had departed a local restaurant/lounge and were traveling in an easterly direction on the inboard lane of the U.S. Route. The driver accelerated the vehicle to a high rate of speed that was estimated by the investigating officer at 145-157 km/h (90-95 mph) and traveled a distance of approximately 1.6 km (1.0 mile). The driver of the Jaguar was under the influence of alcohol with a police reported BAC of 0.225. She failed to detect the taillights of the Ford Explorer and continued forward to impact. There was no evidence of pre-crash braking at the scene from the driver of the Jaguar. The crash schematic is attached as **Figure 24**.
