**VERIDIAN ON-SITE ALLEGED INADVERTENT AIR BAG  
DEPLOYMENT INVESTIGATION**

**VERIDIAN CASE NO. CA00-057**

**VEHICLE - 2001 FORD FOCUS LX**

**CRASH DATE - OCTOBER, 2000**

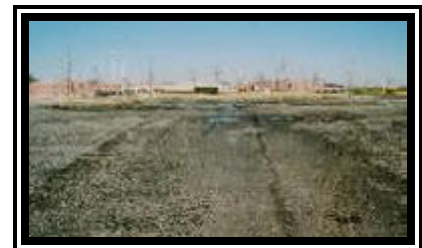
The 49 year old female driver of the 2001 Ford Focus had concluded afternoon activities at an adjacent recreational area and was exiting the parking lot in an easterly direction (**Figure 1**) when she reportedly straddled the sewer grate at a (driver reported) speed of 8 km/h (5 mph).

**Figure 1. East view of parking lot.**

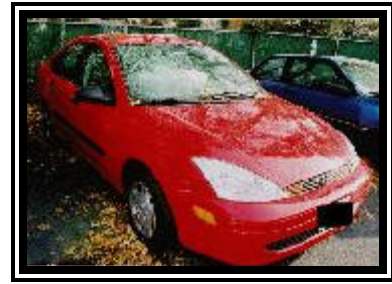
**Figure 5. Oblique view of the 2001 Ford Focus LX.**

The 2001 Ford Focus LX sustained minor undercarriage damage as a result of the impact with the sewer grate. The direct contact damage was centered along the catalytic converter and extended 44.4 cm (17.5 in) laterally outward to the (front) lower suspension pivot supports (**Figures 6 & 7**). No contact damage was identified to the front air dam. Although the event could be considered a *low frontal* impact with a principal direction of force within the horizontal plane, this impact resulted in snagging of undercarriage components which tends to produce significant vertical as well as longitudinal components of force. Therefore, a Collision Deformation Classification (CDC) of 00-UFDW-1 was assigned to the Ford. The vehicle's ground clearance measured 15.2 cm (6.0 in) at the catalytic converter, 12.1 cm (4.8 in) at the leading edge of the exhaust pipe and 11.4 cm (4.5 in) at the pivot supports. Reduction in the right side wheelbase measured 2.0 cm (0.8 in).

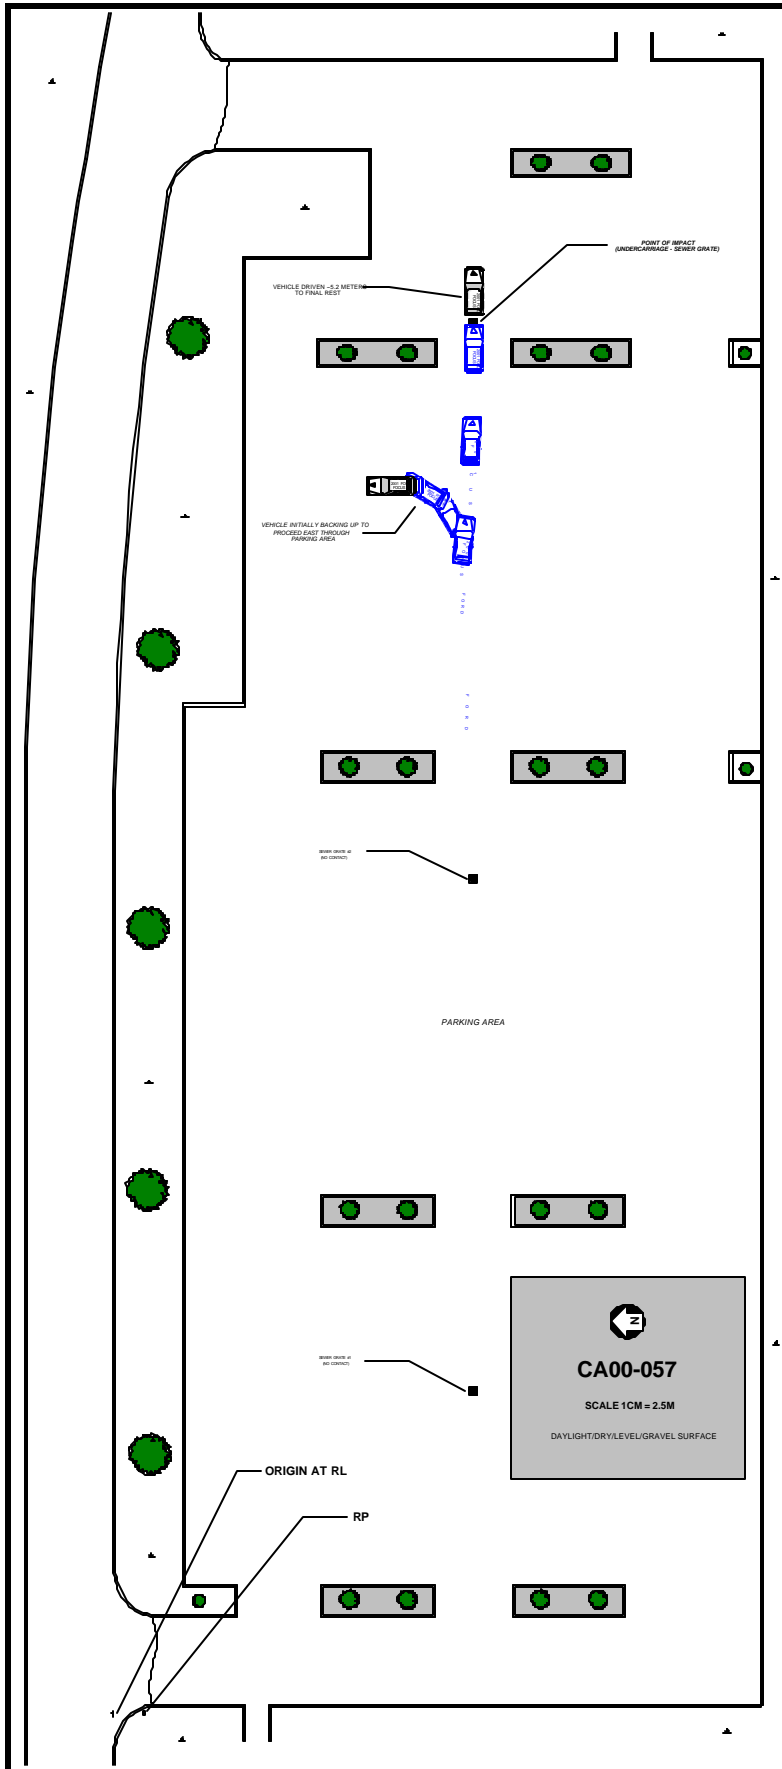
Figure 16. Scene Diagram.

This single vehicle crash occurred during the afternoon hours of October, 2000. At the time of the crash, it was daylight with no adverse conditions as the parking lot and nearby road were dry. The crash occurred in close proximity to the east entrance of a large parking lot with sewer grates located along the centerline of the ingress/egress lane. Although the dirt/gravel surface was level, traffic and past weather conditions had eroded the soil from the edges of the sewer grate. This erosion produced a 3.8 cm (1.5 in) protrusion of the grate above the surface of the parking lot. During the SCI scene inspection, large furrows were also noted in the surface which produced “humps” to the outboard parking spaces, however, they were later discounted as a source of pre-crash movement of the vehicle’s front suspension system upon receipt of on-scene photographs from the driver. Environmental features also included trees and landscaped railroad ties that surrounded the parking area (see **Figure 16 - page 8**). No traffic control or posted speed limit was present at the scene.
