**VERIDIAN ON-SITE ADVANCED OCCUPANT PROTECTION
SYSTEMS INVESTIGATION
VERIDIAN CASE NO. CA00-059
VEHICLE: 2000 FORD TAURUS
LOCATION: VIRGINIA
CRASH DATE: NOVEMBER 2000**

1. <i>Report No.</i> CA00-059	2. <i>Government Accession No.</i>	3. <i>Recipient's Catalog No.</i>	
4. <i>Title and Subtitle</i> Veridian On-Site Advanced Occupant Protection Systems Investigation Vehicle: 2000 Ford Taurus Location: Virginia		5. <i>Report Date:</i> June, 2001

14. <i>Sponsoring Agency Code</i>	
15. <i>Supplementary Notes</i> On-site investigation of a 2000 Ford Taurus crash that resulted in deployment of the frontal Advance Occupant Protection System (AOPS).

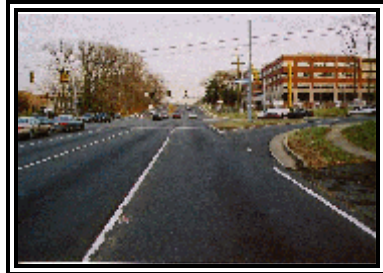
The Ford Taurus was traveling in a easterly direction on a multi-lane divided roadway at a driver estimated speed of 77 km/h (48 mph). He approached the four-leg intersection on a green signal phase and proceeded into the intersection (**Figure 2**) to continue eastbound. The driver of the Mercury Tracer was

Figure 2. Pre-crash trajectory of the Ford Taurus.

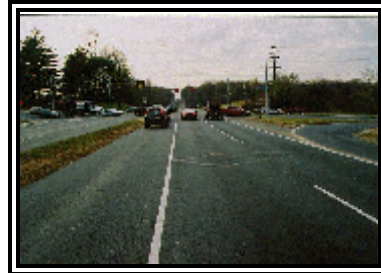
westbound (**Figure 3**) on the opposing side of the highway. She decelerated and stopped at the mouth of the intersection in preparation for a left turn at the intersection. The driver of the Tracer failed to detect the Taurus and initiated a left turn across the Taurus' path of travel. The driver of the Taurus braked the ABS equipped vehicle in an attempt to avoid the impending impact.

Figure 3. Pre-crash Trajectory of the Mercury Tracer.

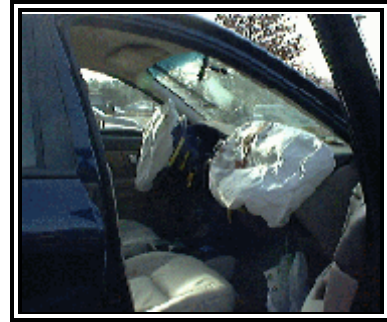
The front right passenger of the Taurus was a 60 year old female with a stated height of 160 cm (63") and weight of 91 kg (200 lb). She was not restrained by the manual belt system. The lack of belt usage was determined by the non-fire status of the pre-tensioner and the contact evidence within the vehicle from this passenger. At the initial impact with the Tracer, the unrestrained passenger initiated a trajectory that was forward and to her left (**Figure 13**). She loaded the deployed front right air bag and deflected the air bag into the windshield as evidenced by a membrane fabric transfer was to the windshield. Her knees loaded the glove box door and the side aspect of the center lower instrument panel. A large black fabric transfer was noted to the left side of the glove box door. The passenger's right knee was abraded with swelling from the contact sequence. Her face and torso probably contacted the deployed front right passenger air bag. There was no contact evidence on the air bag membrane.

Figure 13. Trajectory of the unrestrained front right passenger of the Taurus.

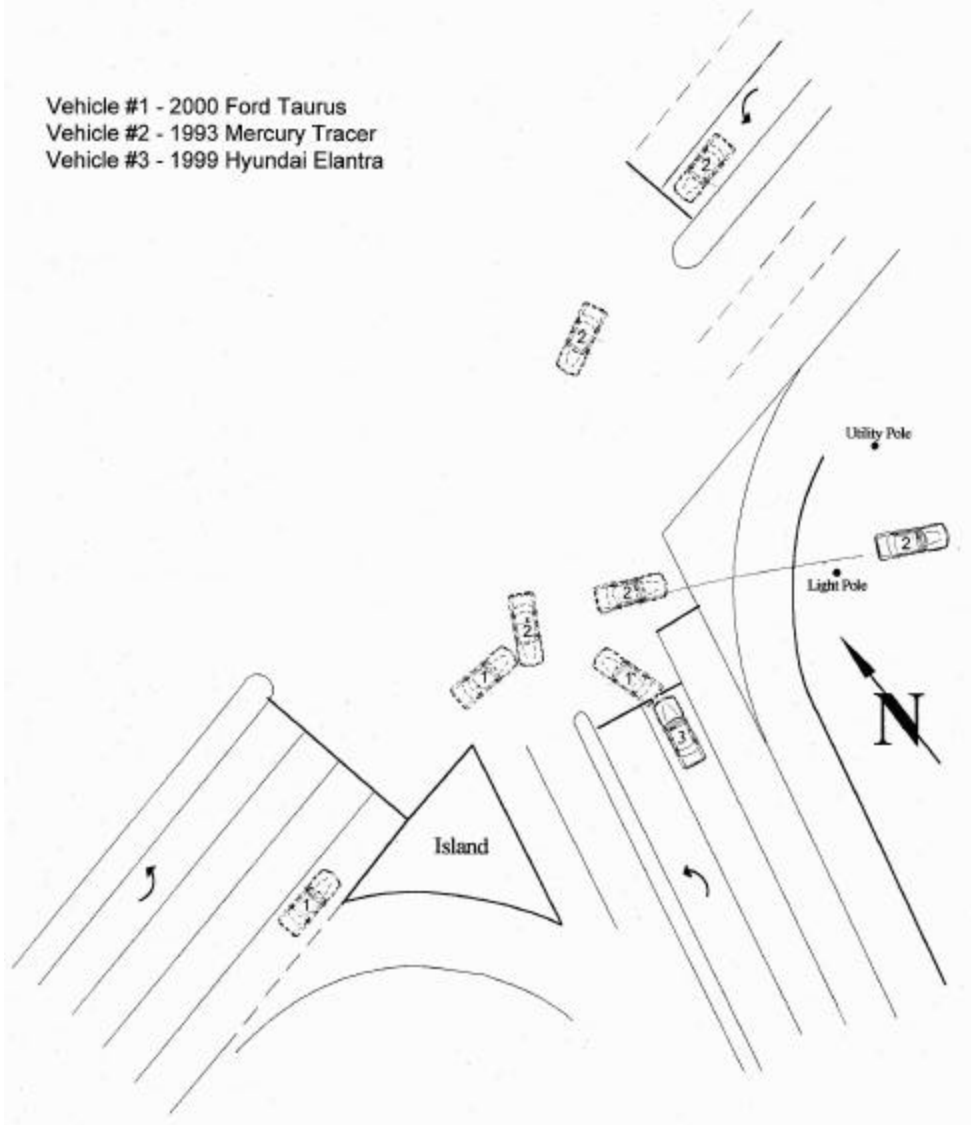
VERIDIAN CRASH SCHEMATIC
CASE NO. CA00-059

The crash occurred during nighttime hours, however, the intersection was illuminated at all four corners. The asphalt road surface was in good condition and was dry. The weather conditions were clear and the grades afforded both drivers an ample line of sight on approach to the intersection. The crash schematic is included as **Figure 16**, Page 16 of this summary report.

Figure 16. Crash schematic

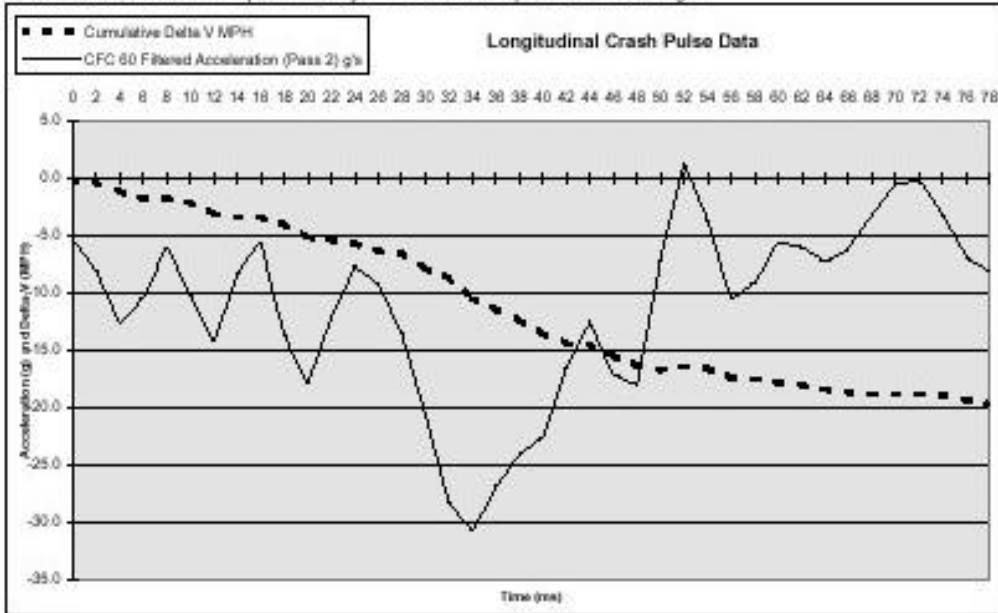
Time (ms)	0	10	20	30	40	50	60	70	78
Delta-V (MPH)	-0.1	-2.1	-5.1	-7.9	-11.0	-14.9	-17.9	-18.9	-19.1

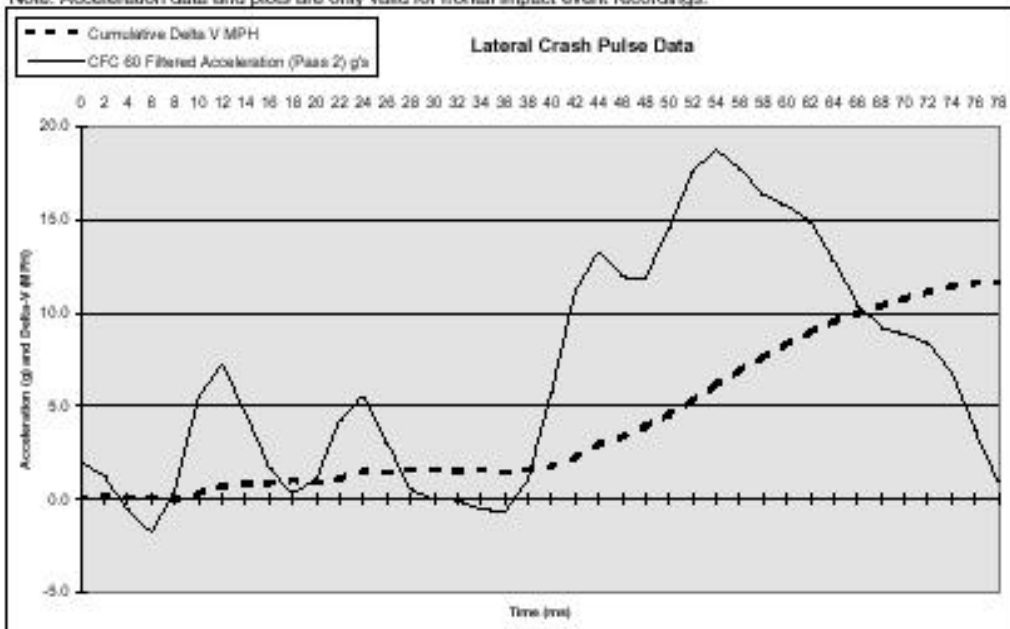
Lateral Cumulative Delta-V

Time (ms)	0	10	20	30	40	50	60	70	78
Delta-V (MPH)	0.1	0.2	0.9	1.6	1.9	4.6	8.2	10.9	11.6
