**VERIDIAN REMOTE SIDE IMPACT OCCUPANT PROTECTION INVESTIGATION  
SCI TECHNICAL SUMMARY REPORT**

**NASS/SCI COMBO CASE NO. 01-45-044A**

**VEHICLE - 2000 LINCOLN TOWN CAR**

**CRASH DATE - APRIL 2001**

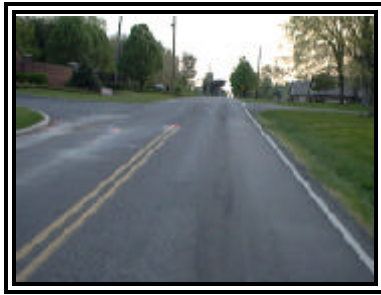
The driver of the 2000 Lincoln Town Car was operating the vehicle in a westbound direction on a two-lane undivided roadway (**Figure 2**). A 1989 Mercedes Benz 300 SE was traveling in the westbound lane behind the Town Car and a 1993 Mercury Cougar was traveling eastbound in the opposite lane toward the hillcrest. As the Mercury Cougar crested the hill (**Figure 3**), the driver of the Town Car initiated a left turn across the path of the Cougar with the intent to enter the driveway. Due to the limited westbound sight distance as a result of the positive westbound grade, the driver of the Town Car may not have detected the approaching Mercury Cougar as he initiated the left turn. Both vehicles maintained pre-impact tracking modes. It was not known if there were any attempted avoidance maneuvers for either vehicle.

**Figure 2. Westbound trajectory for the 2000 Lincoln Town Car**

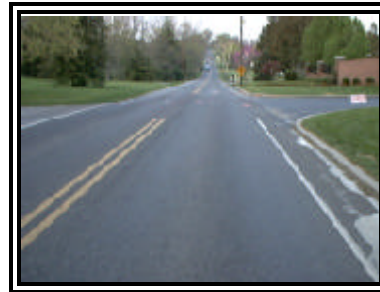
**Figure 3. Eastbound trajectory for the 1993 Mercury Cougar**

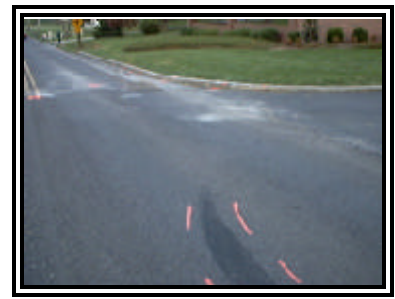
The impact redirected the Town Car in a lateral direction on the eastbound lane. The front of the Town Car impacted the curb with the both front wheels and the rear aspect of the vehicle (rear of the B-pillars) rotated in a slight clockwise (CW) direction from the front aspect. The Town Car came to rest in the eastbound lane against the curb (**Figure 4**). The Mercury Cougar was redirected to the left, traveled across the centerline, and sideswiped the front left corner of the Mercedes with the left rear area. The Mercedes sustained minor right front side damage and came to rest in the westbound lane. The Mercury was subsequently redirected across the eastbound lane and onto the roadside in a tracking mode. It traveled over a culvert and impacted a utility pole with the front area. The Cougar came to rest against the pole.

**Figure 4. Post-impact trajectory and final rest location**
