**SIDE IMPACT OCCUPANT PROTECTION INVESTIGATION**

**VERIDIAN CASE NO. CA01-013**

**VEHICLE - 2001 GMC YUKON XL K1500 4X4**

**CRASH DATE - JANUARY, 2001**

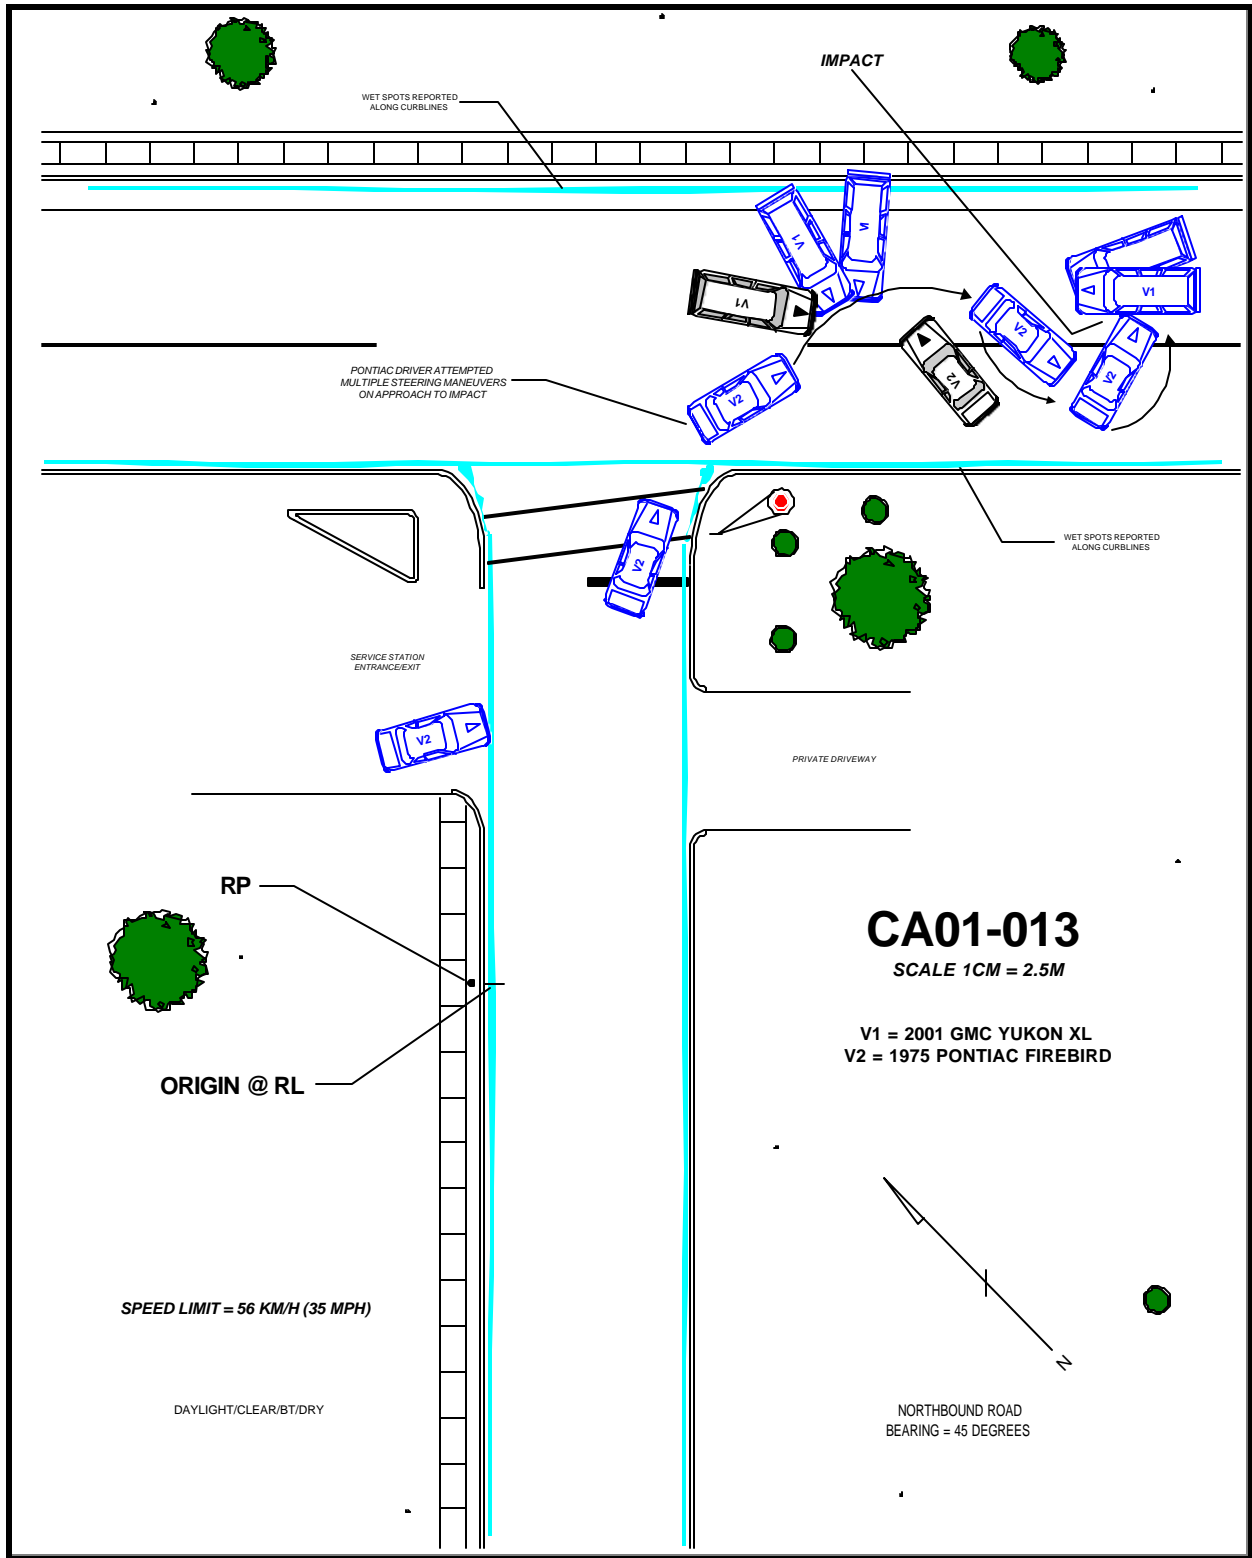
Figure 15. Scene Diagram.

This two vehicle crash occurred during the morning hours of January, 2001. At the time of the crash, it was daylight with no adverse conditions. Although the roads were reported by police as dry, small areas of wet terrain were reported along the curblines from nearby melting snow; which may have contributed to pre-crash circumstances. The crash occurred just east of an urban 3-leg intersection, along the centerline of a (level) two lane east/west roadway (**see Figure 15 - page 10**). The asphalt roadway was bordered by barrier curbs with a narrow paved shoulder to the north. Traffic control consisted of a stop sign for northbound traffic. The posted speed limit at the crash site was 56 km/h (35 mph).
