**VERIDIAN ON-SITE AIR BAG RELATED CHILD PASSENGER
FATALITY INVESTIGATION
VERIDIAN CASE NO. CA01-029
VEHICLE: 1997 MITSUBISHI MONTERO
LOCATION: FLORIDA
CRASH DATE: MAY 2001**

1. <i>Report No.</i> CA01-029	2. <i>Government Accession No.</i>	3. <i>Recipient's Catalog No.</i>	
4. <i>Title and Subtitle</i> Veridian On-Site Air Bag Related Child Passenger Fatality Investigation Vehicle: 1997 Mitsubishi Montero Location: Florida		5. <i>Report Date:</i> December 2002

14. <i>Sponsoring Agency Code</i>	
15. <i>Supplementary Notes</i> On-site investigation of a front-to-rear crash that resulted in frontal air bag deployment and the death of a 3 year old male front right child passenger.

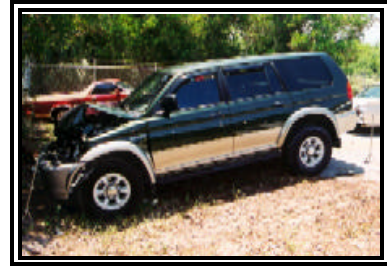
This on-site crash investigation focused on the nature and severity of injuries sustained by a 3 year old male front right passenger of a 1997 Mitsubishi Montero sport utility vehicle (**Figure 1**). The Montero was equipped with frontal air bags for the driver and front right passenger positions. The full frontal area of the Montero impacted the rear of a stopped recycler truck. The impact resulted in moderate damage to the Montero and deployment of the frontal air bag system. The child passenger was displaced forward out-of-position by the pre-crash braking. The anterior chin and neck areas were struck by the air bag module cover flap and the expanding front right air bag which resulted in extensive soft tissue abrasions and contusions, a complete fracture between C1 and C2 with a laceration of the spinal cord, a laceration of the trachea, fractures of the hyoid bone and maxilla., and thoracic injuries. He was removed from the vehicle by the driver and was transported to a local hospital where he expired within 30 minutes of the crash. The Montero was towed from the scene of the crash. The driver and rear seat child passenger were not injured.

Figure 1. 1997 Mitsubishi Montero.

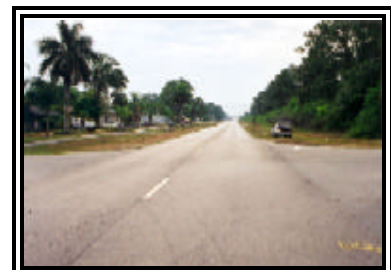
Figure 2. Eastbound view of the crash site.

The east/westbound traffic flow through the intersection was not regulated by traffic controls. Traffic entering the county road was regulated by stop signs. The county road was straight and level which afforded driver's a clear site line. The weather was clear and all environmental surfaces were dry. The speed limit was posted at 48 km/h (30 mph). There was no physical evidence at the crash scene. The crash site was identified by the painted final rest wheel positions of the involved vehicles. **Figure 2** is an eastbound view of the approach to the crash site.

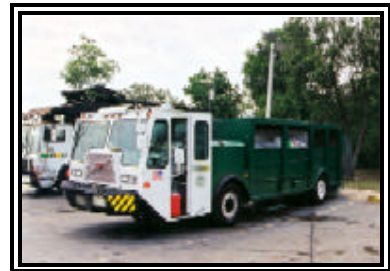
The struck vehicle in this crash was a 1990 recycler truck (**Figure 3**) that was manufactured by Lodal Incorporated of Kingsford, MI. The Model No. was ECO-3030. The truck was a forward control configuration with the two passenger low-mounted cab positioned forward of the steer axle. The rear axle was equipped with single tires/wheels and the Gross Vehicle Weight Rating (GVWR) was 13,608 kg (30,000 lb). The power train consisted of a 5.9 liter diesel engine linked to an automatic transmission with a automatic braking mode (front brakes only) for the neutral transmission position. The vehicle identification number was 1L9EH67B1LK (production number deleted). The odometer reading at the time of the SCI inspection was 247,065 km (153,523 miles).

Figure 3. Lodal Recycler Truck
