**ON-SITE ON-SITE POTENTIAL OVER-SENSITIVE AIR BAG DEPLOYMENT  
INVESTIGATION  
SCI TECHNICAL SUMMARY REPORT**

**VERIDIAN CASE NO. CA01-035**

**VEHICLE - 2001 FORD FOCUS ZX3**

**CRASH DATE - JUNE 2001**

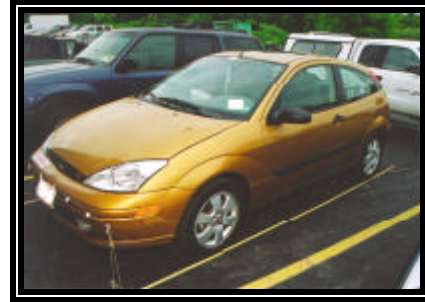
**Figure 1. 2001 Ford Focus ZX3**

This crash involved a 2001 Ford Focus ZX3 (**Figure 1**) that was occupied by a 70-year-old male driver and a 2000 Honda Odyssey occupied by a 47-year-old female driver. Both drivers were restrained by the 3-point lap and shoulder belt systems. The driver of the Ford Focus was operating the vehicle on a three-lane divided roadway in the outboard lane when he failed to detect the slowed Honda Odyssey ahead of his vehicle in the travel lane. The Ford Focus impacted the Odyssey in a front-to-rear configuration. The damage to both vehicles was minor, however, the impact-induced deceleration was sufficient to

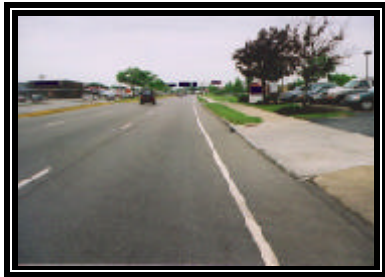
**Figure 2. Westbound path of travel for the Honda Odyssey**

The 46-year-old female driver of the 2000 Honda Odyssey was operating the vehicle on the outboard westbound lane of the state roadway (**Figure 2**). An uninvolved vehicle was traveling in the same lane in front of the Odyssey that slowed quickly to make a right turn onto a local roadway. The driver of the Odyssey applied the brakes and continued to travel in a forward direction while she remained in the travel lane. The 70-year-old male driver of the 2001 Ford Focus was operating the vehicle in the outboard westbound lane (**Figure 3**) behind the Odyssey. The driver of the Focus did not detect the uninvolved vehicle making the right turn and did not realize the Odyssey had slowed in the travel lane ahead. He stated that the sun was very bright at the time of the crash which may have obscured his vision. When the driver of the Focus realized the impending crash, he attempted to apply the brakes. He stated that he may have inadvertently engaged the accelerator and the brake at the same time due to the close proximity of the foot controls. The driver of the Odyssey stated that she was not aware of the approaching Ford Focus behind her vehicle prior to the crash, and did not attempt any avoidance maneuvers. A cellular telephone was present in the Odyssey but was not in use at the time of the crash.

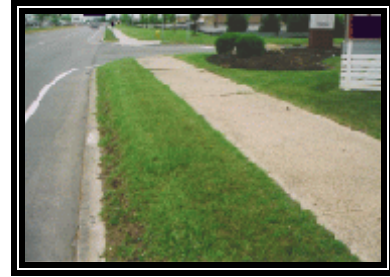
**Figure 5. Final rest position for the Ford Focus**

lane on the right side and traveled over the curb and came to rest facing west on the grassy area adjacent to the sidewalk (**Figure 5**). The driver stated that he did not deliberately maneuver the vehicle after the impact.
