**ON-SITE CHILD SAFETY SEAT CRASH INVESTIGATION
SCI TECHNICAL SUMMARY REPORT**

VERIDIAN CASE NO. CA01-046

SUBJECT VEHICLE - 2000 HONDA ACCORD

CRASH DATE - OCTOBER 2001

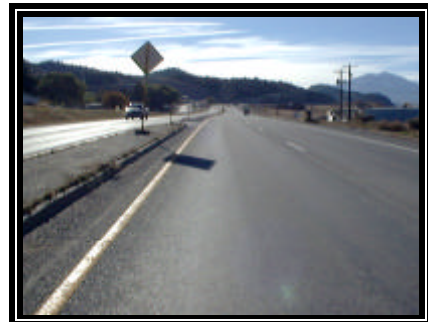
Figure 2. Eastbound approach for the 2000 Honda Accord

The 19-year-old female driver of the Honda Accord was operating the vehicle eastbound on the inboard lane of the state roadway behind two non-contact vehicles (**Figure 2**). The driver stated that there were no distractions within the vehicle prior to the crash. A cellular telephone was present in the Honda Accord, but was not in use prior to the crash. The driver of the Accord had reduced the speed of the vehicle as it traveled through the intersection west of the crash site, as the traffic signal cycled to the green phase for east/west traffic. She accelerated through the intersection and continued in an easterly direction behind the non-contact vehicles at an estimated speed of 72 km/h (45 mph). East of the crash site, the driver of the 1990 Honda CRX made a left turn from a driveway located on the south roadside onto the eastbound lanes of the state roadway. Prior to the crash, he was operating the vehicle at a police-reported speed of 72 km/h (45 mph) in the wrong direction on the inboard eastbound lane (**Figure 3**). As the CRX approached the hillcrest, the vehicles in front of the Accord swerved to the right onto the outboard lane to avoid a head-on collision. The driver of the Accord did not detect the approaching

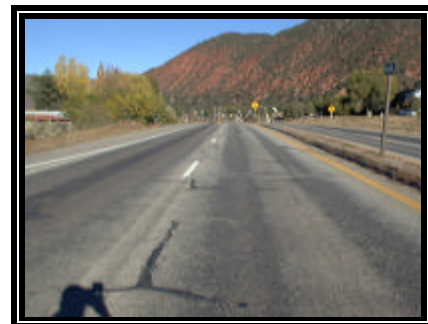
Figure 3. Westbound approach for the Honda CRX

Honda CRX traveling in the opposite direction in the same lane until the vehicle directly in front of the Accord swerved to the right. There were no avoidance maneuvers attempted by the driver of the Accord. It was not known if the driver of the CRX attempted any avoidance maneuvers. There were no pre-crash brake marks visible at the crash scene.

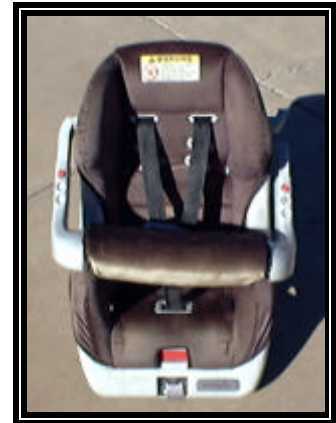
Figure 15. Evenflo convertible child safety seat

The Evenflo Trooper convertible child safety seat (**Figure 15**) was installed in the rear right position of the Honda Accord. The model number was 2191JP1 and the manufacture date was March 2, 1999. There were no NHTSA recalls associated with this child safety seat. The seat was configured with a 3-point harness system and an adjustable rigid plastic tray shield. The tray shield was attached to pivoting arms on the outboard sides of the seat which allowed it to move upward and downward. The tray shield also moved forward and rearward along the plastic arms and was held in position by spring-loaded plastic buttons. The seat was designed for forward-facing use by children who weigh between 9.1 - 18.1 kg (20.0 - 40.0 lb) and measure 66.0 to 101.6 cm (26.0 - 40.0") in height. The Evenflo Trooper convertible seat was occupied by a 2-year-old male child who weighed 15.9 kg (35.0 lb) and measured 96.5 cm (38.0") in height. The child was within the range of the manufacturer's recommended weight and height limits, outlined in the instruction manual for use of the convertible seat in the forward facing orientation.

The driver had not been to any child safety seat checkpoints and had not obtained any additional child safety seat information or literature. The driver admitted that she never read the owner's manual for the child safety seat, and the manual was not attached to the seat at the time of inspection. The locking clip was not attached to the child safety seat.

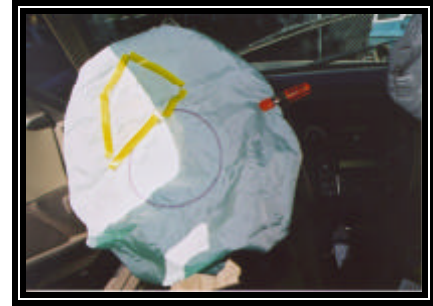
Figure 18. 2000 Honda Accord driver's air bag

The 2000 Honda Accord was equipped with dual stage air bags for the driver and front right passenger positions that deployed as a result of the impact with the Honda CRX. The driver's air bag was housed in the center of the steering wheel with asymmetrical H-configuration module cover flaps. The top flap measured 17.8 cm (7.0") in width at the top aspect, 13.3 cm (5.3") in width at the tear seam, and 8.3 cm (3.3") in height. The bottom flap measured 13.3 cm (5.3") in width at the tear seam, 7.6 cm (3.0") in width at the bottom aspect, and 4.4 cm (1.8") in height. The driver's air bag (**Figure 18**) measured 53.3 cm (21.0") in diameter in its deflated state. Makeup transfers and lateral mascara transfers were present on the left aspect of the air bag membrane from the driver's face (**Figure 19**). The air bag was vented by two external ports that measured 3.8 cm (1.5") in diameter and were located at the 11 and 1 o'clock positions on the rear aspect of the air bag and 17.8 cm (7.0") inboard of the outer seam. The air bag was tethered by one internal strap that was located at the 12 o'clock aspect.

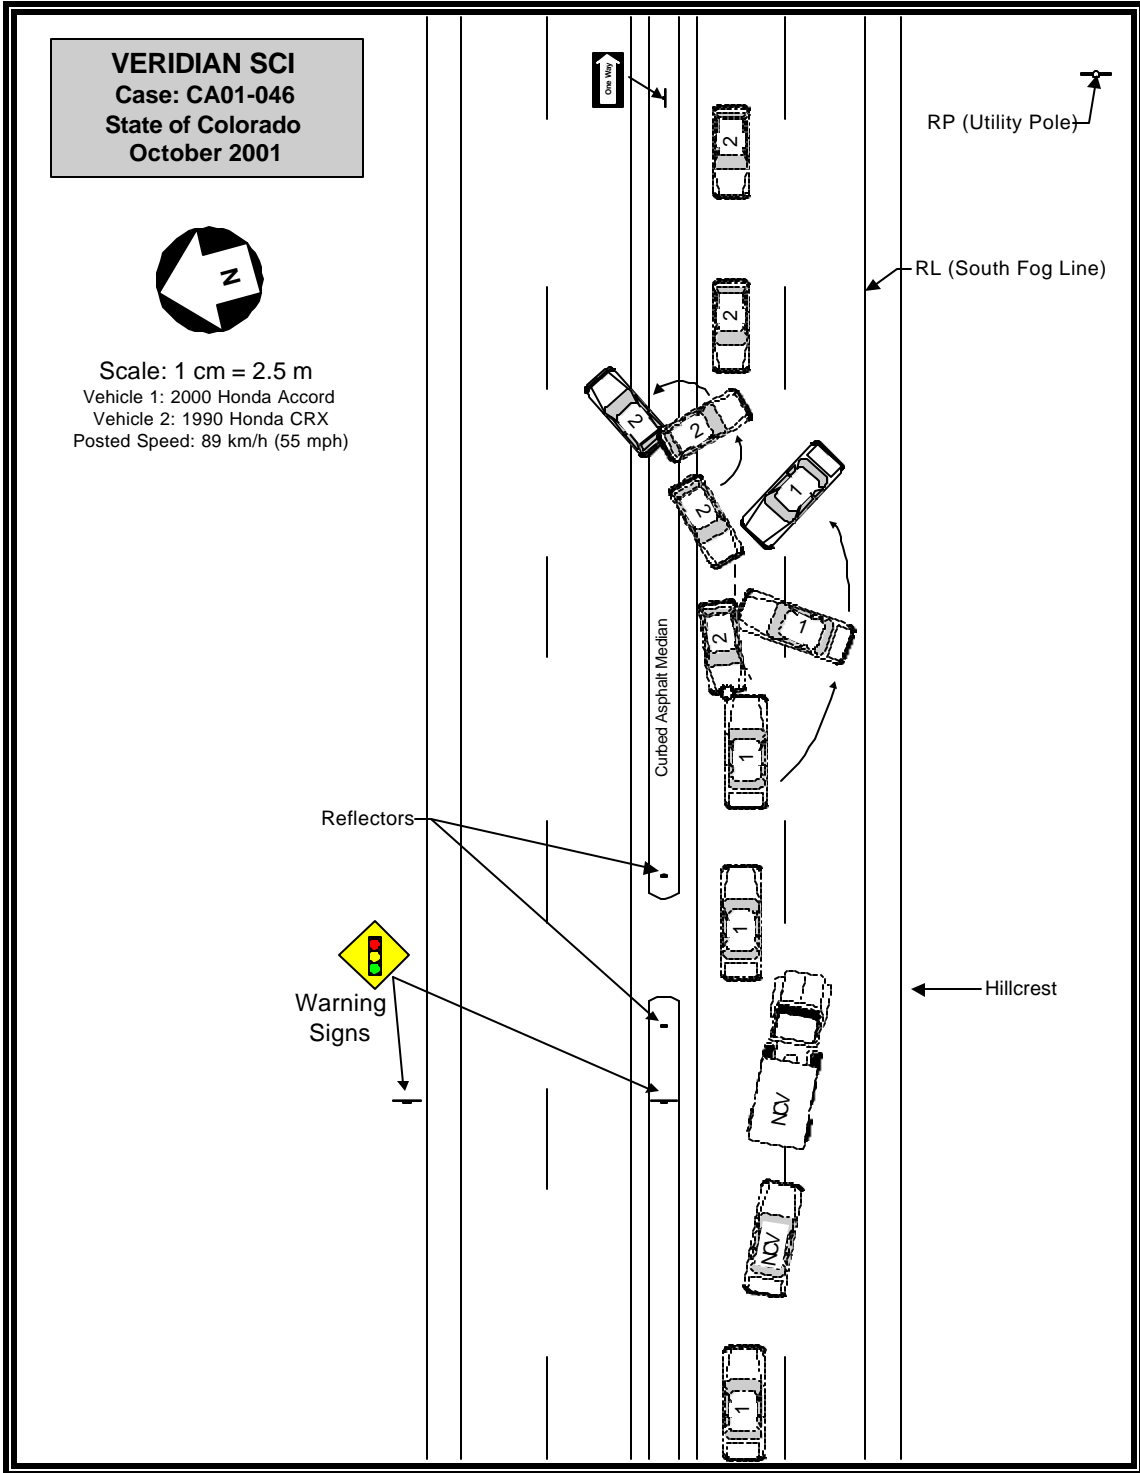
Figure 21. Scene schematic

The 2000 Honda Accord impacted the 1990 Honda CRX in an offset head-on configuration. The directions of force were in the 12 o'clock sectors for both vehicles. Based on police-documented impact and final rest positions, the trajectory algorithm of the WinSMASH program computed impact speeds of 63.5 km/h (39.5 mph) for the Accord and 94.9 km/h (59.0 mph) for the CRX, respectively. The damage algorithm of the WinSMASH program computed total velocity changes of 23.0 km/h (14.3 mph) for the Accord and 35.0 km/h (21.7 mph) for the CRX. The longitudinal and latitudinal components for the Accord were -23.0 km/h (-14.3 mph) and 0.0 km/h, respectively.
