**VERIDIAN REMOTE ADVANCED OCCUPANT PROTECTION SYSTEM
INVESTIGATION
SCI TECHNICAL SUMMARY REPORT**

NASS/SCI COMBO CASE NO. 02-43-212E

VEHICLE – 2002 BMW 325i

CRASH DATE – SEPTEMBER 2002

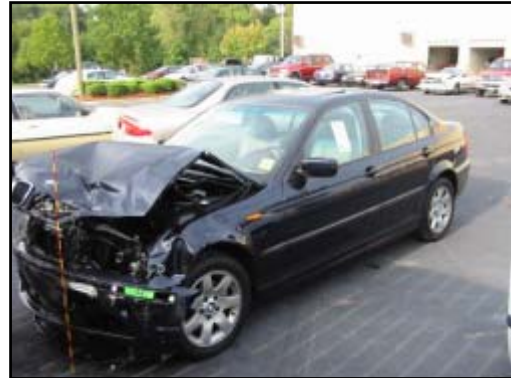
Figure 1. 2002 BMW 325i

was occupied by a restrained 37-year-old female driver, a 25-year-old female front right occupant, a 19-month-old male in the rear left, and a 23-year-old female in the rear right. The BMW 325i (**Figure 1**) was involved in a moderate severity intersection crash with a 1995 Nissan 240SX. The front of the 2002 BMW impacted the left side of the 1995 Nissan. The impact with the 1995 Nissan was sufficient to actuate the driver's and front right passenger's safety belt buckle pretensioners and deploy both stages of the frontal air bags. The driver sustained a superior thoracic spine strain. The front right occupant sustained a right facial contusion, right facial abrasion, central chest contusion and a minor closed head injury. The rear left occupant was reported as restrained in a child safety seat (CSS) and was not injured. The CSS was not inspected by the NASS researcher. The driver and two adult passengers were transported to a hospital for treatment. The child occupant was reportedly not injured or transported. The rear right occupant sustained police reported "B" type injuries and was transported to a hospital for treatment; however, no medical records have been received. The driver of the Nissan sustained police reported "B" type injuries and was transported to a local hospital for treatment. The driver of the Nissan's injuries consisted of a right lower extremity contusion, cervical spine strain, left side pelvis fracture, anterior displaced pelvis fracture, left side one rib fracture, and a posterior sacroiliac fracture. The front right occupant of the Nissan was police reported as not injured.

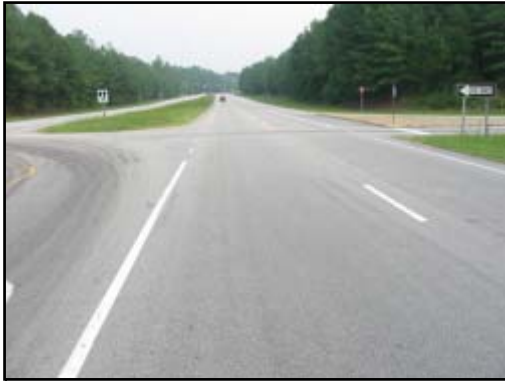
Figure 2. BMW's approach to the intersection.

The 37-year-old female driver of the 2002 BMW 325i was operating the vehicle northbound in the left through lane on approach to the intersection (**Figure 2**). A 25-year-old female front right occupant, a 19-month-old male in the rear left, and a 23-year-old female in the rear right also occupied the 2002 BMW 325i. The driver of the 1995 Nissan was operating the vehicle westbound on approach to the intersection (**Figure 3**). The

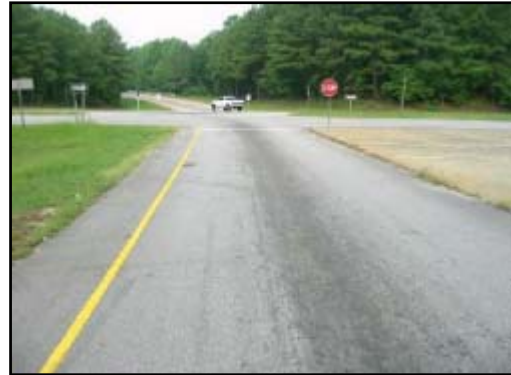
Figure 3. Nissan's approach to the intersection.

driver of the Nissan failed to detect the BMW and accelerated forward directly into the path of the BMW. It was unknown if the driver of the Nissan came to a complete stop before entering the intersection. There was no physical evidence at the crash site. The police reported travel speed for the BMW was 72 km/h (45 mph) and 16 km/h (10 mph) for the Nissan. The NASS scene schematic is included as **Figure 15** of this report.

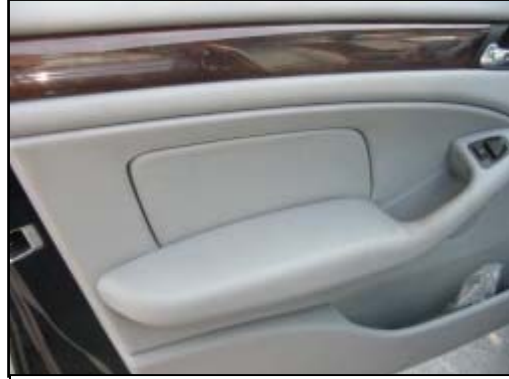
Figure 13. Front left door panel mounted side air bag.

The 2002 BMW 325i was equipped with door panel mounted side impact air bags for the driver and front right positions (**Figure 13**). The BMW was also equipped with a Head Protection System (HPS). This system included tubular shaped air bags that were mounted in the left and right roof side rails. The vehicle sustained a frontal impact, therefore the side air bag system did not deploy in this crash.
