**REMOTE ADVANCED OCCUPANT PROTECTION SYSTEM INVESTIGATION
SCI TECHNICAL SUMMARY REPORT**

NASS/SCI COMBO CASE NO. 02-47-111C

SUBJECT VEHICLE – 2003 FORD CROWN VICTORIA

CRASH DATE – SEPTEMBER 2002

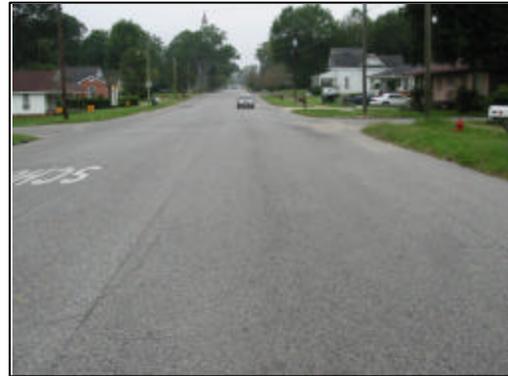
Figure 2. Westbound approach for the Crown Victoria

The 63-year-old male driver of the Ford Crown Victoria was operating the vehicle westbound on approach to the four-leg intersection (**Figure 2**) at a police-reported speed of approximately 32 km/h (20 mph). A 22-year-old male driver of the 2000 Dodge Intrepid was operating the vehicle northbound at a high rate of speed on approach to the four-leg intersection. Police estimated the speed of the Intrepid to be 97 km/h (60 mph). The driver of the Intrepid disregarded the stop sign and proceeded into the intersection across the path of the Crown Victoria. The driver of the Crown Victoria did not attempt any avoidance maneuvers prior to the crash.
