Child Safety Seat Combination Investigation / Vehicle to Vehicle  
Dynamic Science, Inc. / Case Number: 2002-76-097A  
2001 Chevrolet Cavalier / 1992 Pontiac Bonneville  
Arizona  
November, 2002

1. Report No. 2002-76-097A	2. Government Accession No.		3. Recipient Catalog No.	
4. Title and Subtitle Child Safety Seat Combination Investigation			5. Report Date November 7, 2003

**Dynamic Science, Inc.**  
**Accident Investigation**  
**Case Number: 2002-76-097A**

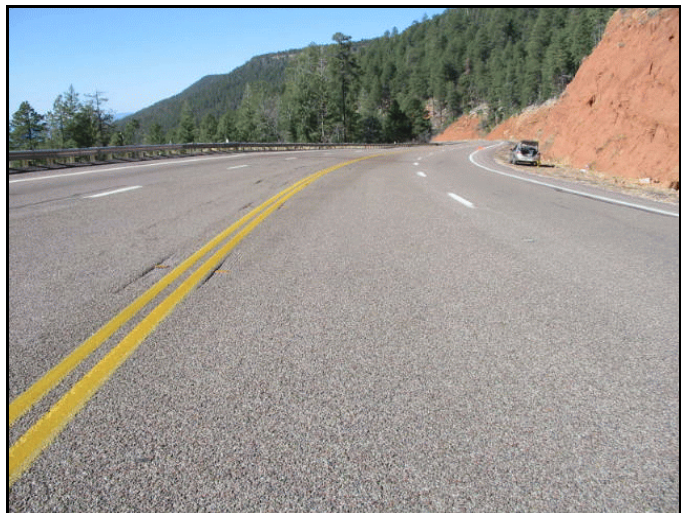
**Figure 1.** Approach to area of impact, case vehicle. Westbound.

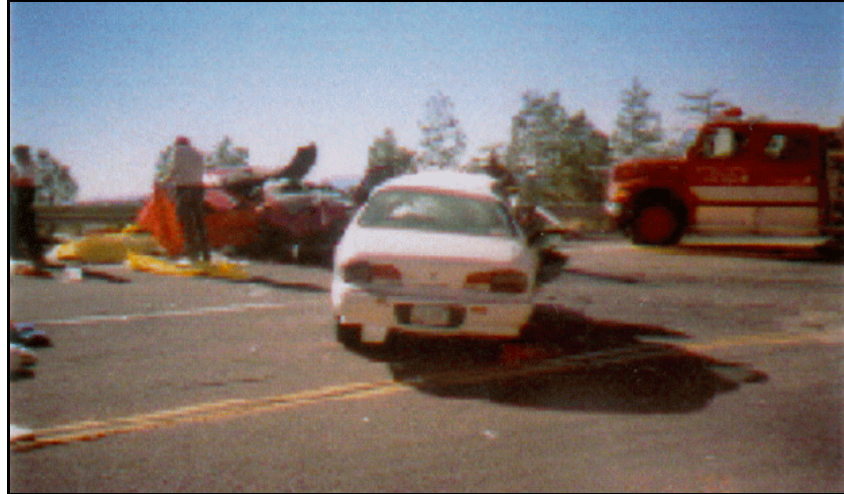
The Chevrolet was traveling westbound along the right hand curved roadway at a police reported travel speed of 97 km/h (60 mph). The Pontiac was traveling eastbound at a police reported speed of 97 km/h (60 mph). The Chevrolet crossed the center line into the path of case the Pontiac. The driver of the Pontiac braked and steered to the right but was unable to avoid the crash. The front of the Chevrolet (01FDEW5) struck the front of the Pontiac (12FDEW5) in a head-on configuration. After impact, the Chevrolet rotated counterclockwise; the Pontiac rotated clockwise. The Chevrolet came to rest on top of the southern guardrail facing north. The Pontiac came to rest facing south in the second eastbound travel lane. The Pontiac sustained a minor engine compartment fire.

**Figure 2.** Final rest

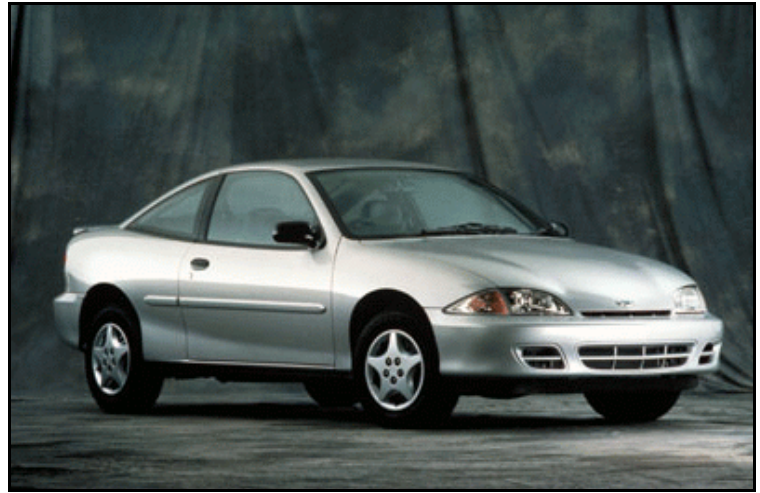
**Figure 9.** Exemplar view, 2001 Chevrolet Cavalier

The Chevrolet sustained 82 cm (32 in) of direct contact to the front end beginning at the right front bumper corner. The residual crush measured along the bumper was as follows: C1=33 cm (13 in), C2=71 cm (28 in), C3=88 cm (35 in), C4=101 cm (40 in), C5=117 cm (46 in), C6=124 cm (49 in). The maximum crush was located at the right bumper corner. The principle direction of force was within the 1 o'clock sector and was an estimated 20 degrees. The damaged components include the bumper fascia and reinforcement bar, hood, grille, and right side. There was impact force related damage to the windshield and the front right side glass was disintegrated. There was intrusion of the A pillar, instrument panel, and toe pan on the right side. The maximum intrusion was 65 cm (26 in) to the A pillar. There was intrusion of the rear seat back and instrument panel on the left side. The maximum intrusion was 15 cm (6 in) from the seat back.

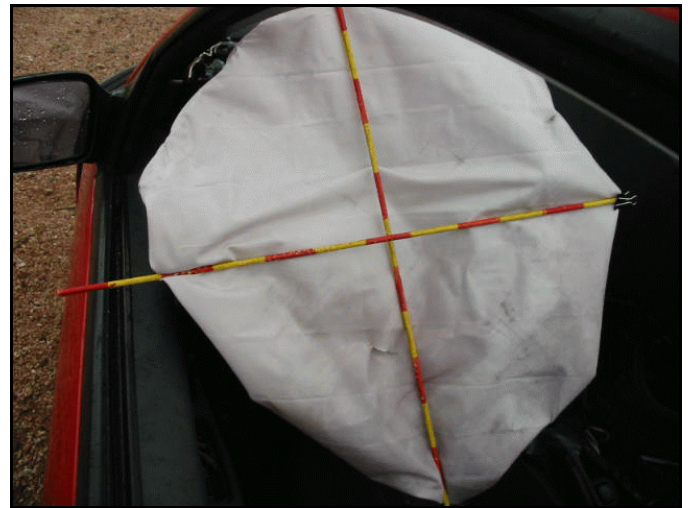
**Figure 10.** Driver's air bag

The Chevrolet Cavalier was equipped with redesigned driver and front right passenger air bags that deployed as a result of the crash. The driver air bag module was located in the center hub of the steering wheel and had an “I” configuration cover. The cover measured 20.0 cm (7.9 in) wide by 10 cm (3.9 in) high. The diameter of the deployed air bag was 60.0 cm (23.6 in). The air bag did not have any tethers. There were two vent ports at the 11 and 1 o’clock, respectively. There was no evidence of contact nor damage to the air bag and the air bag module cover. The vehicle was equipped with a tilt steering wheel column. There was no steering rim deformation nor any steering column compression.

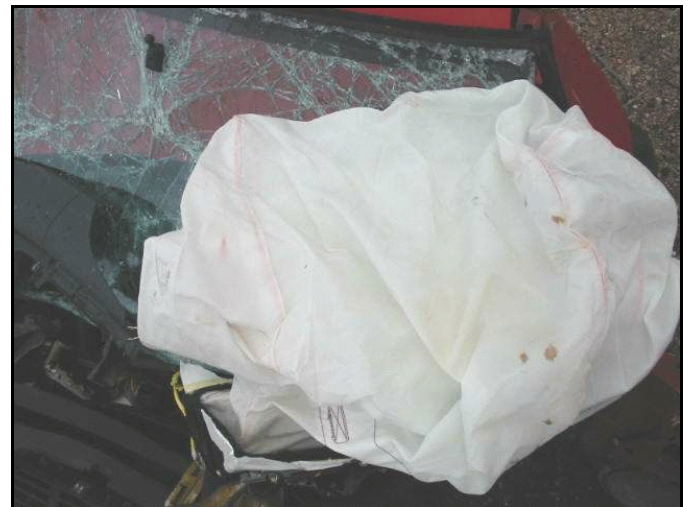
**Figure 11.** Front right passenger's air bag

The front right passenger air bag was a top mount design located in the right aspect of the instrument panel. The single air bag module cover measured 33.0 cm (12.9 in) wide by 20.0 cm (7.9 in) high. The deployed air bag measured 72.0 cm (28.3 in) wide by 60.0 cm (23.6 in) high. There were no vent ports or and two tethers. There was no evidence of contact or damage to the air bag and the air bag module cover.

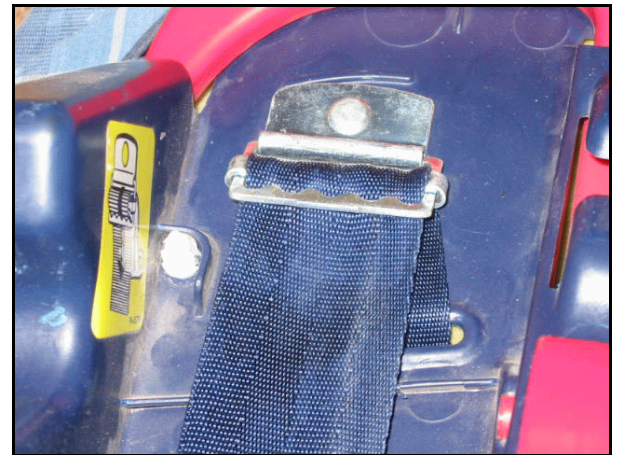
The rear right seat was occupied by an 11-month old male (66 cm/26 in, 11 kg/25 lbs) seated in a Graco Snugride (Model 8457 MV) ISS that was being used in a rear facing fashion. The seat was anchored to the vehicle using the available lap and shoulder belt. A locking clip was used with the lap and shoulder belt, but was used incorrectly (located on the webbing on the outboard side of the child seat opposite of the latch plate). The CSS was equipped with a 3-point harness. The harness straps were in the top slots, which would be appropriate for a child at the upper weight/height limit. The NASS investigator indicated that the seat harness had...”failed due to age and the harness free end not double back through the locking D ring on the back of the seat.” This does not appear to be the case. Figure 16 shows the harness properly inserted into the harness tightener. The harness clip, however, was placed in a position that would have been well below the child’s armpit level. The carrying handle was in the reclined position. It was not designed with a top tether or LATCH. The seat was manufactured on August 10, 2000. According to the manufacturer, the maximum weight capacity for this seat was 9 kg (20 lbs). The child was 1.8 kg (5 lbs) heavier than the recommended weight. The left carrier handle broke off during the crash due to contact with the front right seat back.

**Figure 16.** Harness and harness tightener

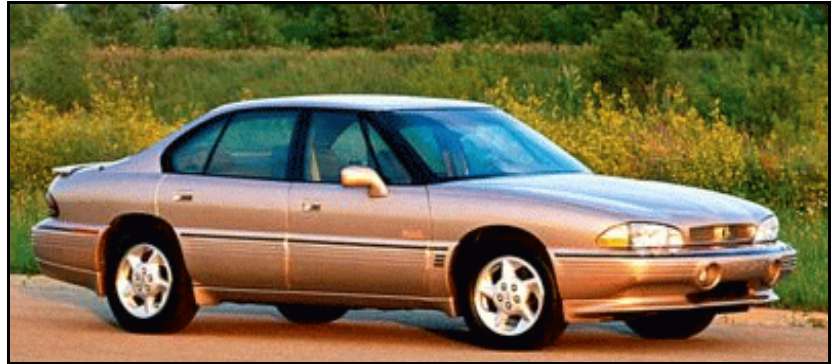
**Figure 18.** Exemplar view of 1992 Pontiac Bonneville

The Pontiac sustained 130 cm (51 in) of direct contact that extended across the entire frontal end width of the vehicle. The residual crush measured along the bumper was as follows: C1=24 cm (9 in), C2=59 cm (23 in), C3=89 cm (35 in), C4=99 cm (39 in), C5=91 cm (36 in), C6=116 cm (47 in). The maximum crush was located at C6. The principle direction of force was within the 12 o'clock sector and was an estimated 350 degrees. The damaged components include the bumper fascia and reinforcement bar, hood, and grille. There was impact force related damage to the windshield and the left front side glass was disintegrated. The right front and right rear doors were jammed shut. There was intrusion of the A pillar, toe pan, windshield header, and B pillar on the right side. The maximum intrusion was to the right instrument panel.

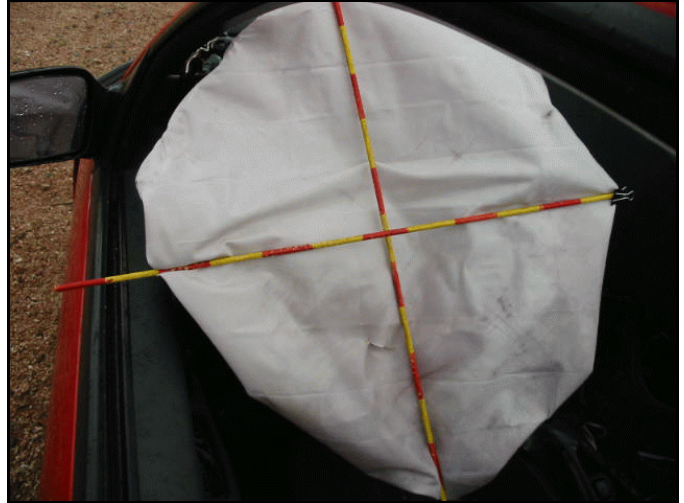
**Figure 19.** Driver's air bag

The 22-year-old female driver (168 cm/66 in, 54 kg/119 lbs) was seated in a normal, upright fashion. She was wearing the available lap and shoulder belt. The fabric covered bucket with folding back was adjusted to the forward most track position. At impact, the driver pitched forward and to the right and loaded the lap and shoulder system—causing the shoulder, abdomen, and bilateral hip contusions/abrasions. The driver's face engaged the deployed air bag—causing the forehead contusion/abrasion and a concussion. The driver was able to exit the vehicle on her own. She was transported by ambulance to a local hospital where she was treated and released.

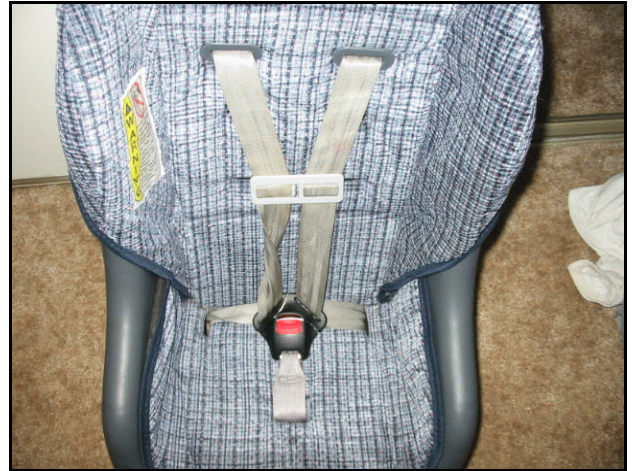
**Figure 20.** Front, CSS

The 2-year-old female (84 cm/33 in, 14 kg/31 lbs) rear left seat occupant was seated in a forward facing Cosco Touriva CSS. The convertible seat was anchored to the fabric covered bench seat with the lap and shoulder belt. A locking clip was available, but was used incorrectly; the clip was installed on the lap and shoulder belt on the outboard side of the seat—opposite the seat belt latch plate. The child seat was tethered to the tether anchorage on the rear deck. At impact, this occupant responded to the 1 o'clock direction of force by moving forward and to the right. She pitched forward and loaded the convertible seat harness—causing the abrasion/contusion to her upper shoulder near the neck, the contusion to the left shoulder, and the contusion to the center of the chest. She also sustained an abrasion to the left eyelid. The NASS team attributed this injury to the convertible seat itself, but its actual origin is not known.

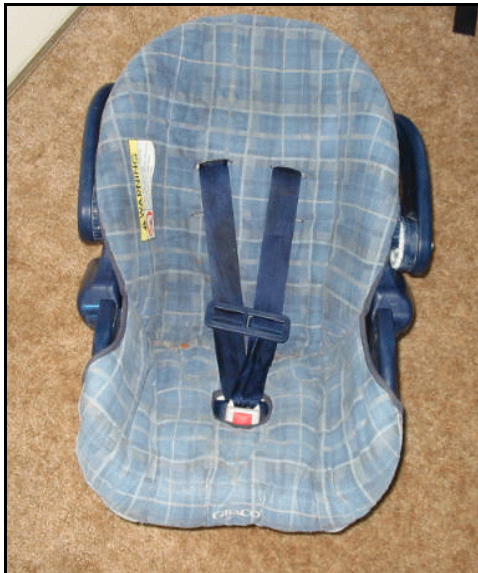
**Figure 25.** Graco ISS

The 11-month old male (66 cm/26 in, 11 kg/24 lbs) rear right seat occupant was seated in a Graco Snugride seat (Model 8457 MV) ISS that was being used in a rear facing position. The infant seat was anchored to the fabric covered bench seat using the available lap and shoulder belt. A locking clip was used with the lap and shoulder belt, but was used incorrectly (located on the webbing on the outboard side of the child seat opposite of the latch plate). The front right seat had been adjusted to the rear most track position and the seat back slightly reclined—placing the seat back as close to the child seat as physically possible. The infant seat was, by design, reclined in approximately a 45 degree angle towards the front of the vehicle. The seat was equipped with a 3-point harness. The harness straps were in the top slots, which would be appropriate for a child at the upper weight/height limit. The investigator indicated that the seat harness had...”failed due to age and the harness free end not double back through the locking D ring on the back of the seat.” This does not appear to be the case. The harness clip, however, was placed in a position that would have been well below the child’s armpit level. At impact, the child seat pitched forward and the child seat back rotated downward—engaging the rear of the right front seat. The rear seat back intruded forward 15 cm (6 in) further reducing the available distance between the front and rear seat backs. The child’s head pitched toward the front and to the right of the vehicle and engaged the left side of the infant seat back (when facing rearward)—causing the skull fracture and brain injuries. The initial impact was functionally between the infant seat back and the back of the right front seat.

Noncompliance: This recall involves infant car seats, Model Numbers 7493G9, 7493RS, 7497HL, 7497SY, 7499LK, 7499N2, 841101, 841102, 841103, 841203, 8412T02, 8457D5, 8457DVB, 8457F3, 8457GP, 8457IND, 8457MA, **8457MV**, 8457RG, 8457TMJ, 8457TMP, 8457YL, 8458A5, 8458AE, 8458B7, 8458D8, 8458FKB, 8458HE, 8458HH, 8458KY, 8458N5, 8459VL, 8460LV, 8462HAV, 8462JAM, 8471UVB, 8472BLW, 8472BRN, 8472CYP, 8472GMP, 8472MAD, 8472YL, 8474HAB, 8474MEL, 8476VIN, 8477HAV, 8477JAM, 8477NGS, 8478SAR. Affected model numbers may also begin with the letter "A." These seats may be missing components on the base or the carrier shell. The components are 1 or 2 metal hooks and their retainer pins on the base, or the mating "U" shaped bars on the carrier shell that are used to attach the carrier to the base. If the hooks, pins, or "U" bars are missing, the carrier may not be securely attached to the base. In the event of a sudden stop or crash, the carrier could detach from the base, possibly resulting in serious injury or death to the seat occupant.

Remedy: Graco will provide a replacement seat or base free of charge. The manufacturer has reported that owner notification began March 19, 2002. Owners who do not receive the free replacement seat or base within a reasonable time should contact Graco Century at 1-800-345-4109. [NHTSA Recall No. 02E014]
