# INDIANA UNIVERSITY

### ON-SITE CHILD AIR BAG-RELATED SERIOUS INJURY INVESTIGATION

CASE NUMBER - IN-02-003  
LOCATION - OHIO  
VEHICLE - 1993 DODGE INTREPID ES  
CRASH DATE - July 2002

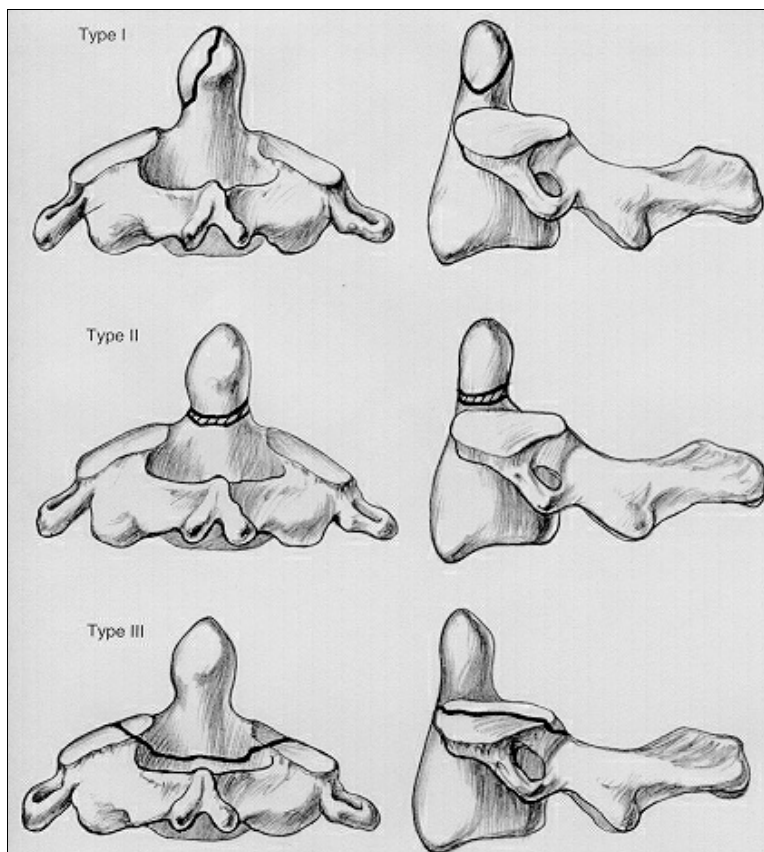
**CLASSIFICATION: Odontoid Fractures** -- Anderson and D'Alonzo based their classification of odontoid fractures on the location of the fracture (see Figure). **Hangman's Fractures** - Bucholz described hangman's fractures as stable or unstable injuries on the basis of the amount of C<sub>2</sub>-C<sub>3</sub> discoligament injury associated with the fracture. Stable hangman's fractures are minimally displaced and the C<sub>2</sub>-C<sub>3</sub> disc is intact. In unstable hangman's fractures, the C<sub>2</sub>-C<sub>3</sub> disc is disrupted, resulting in C<sub>2</sub>-C<sub>3</sub> vertebral body subluxation. A rare third type of hangman's fracture was identified by Levine and Edwards. This injury consists of fracture of the pars interarticularis and dislocation of the C<sub>2</sub>-C<sub>3</sub> facet joints.

**Figure 24:** Anderson and D'Alonzo classification of odontoid fractures.  
 Type I: rare, stable avulsion fractures of the tip of the dens  
 Type II: unstable transverse fractures in the cortical bone of the waist of the dens  
 Type III: unstable fractures in the cancellous bone of the body of C<sub>2</sub>
