On-scene Investigation / Vehicle to Vehicle  
Dynamic Science, Inc. / Case Number: DS02004  
2002 Jaguar X type 3.0  
California  
February, 2002

1. Report No. <b>DS02004</b>	2. Government Accession No.	3. Recipient Catalog No.	
4. Title and Subtitle <b>In-Depth Accident Investigation</b>		5. Report Date

**Dynamic Science, Inc.**  
**Accident Investigation**  
**Case Number: DS02004**

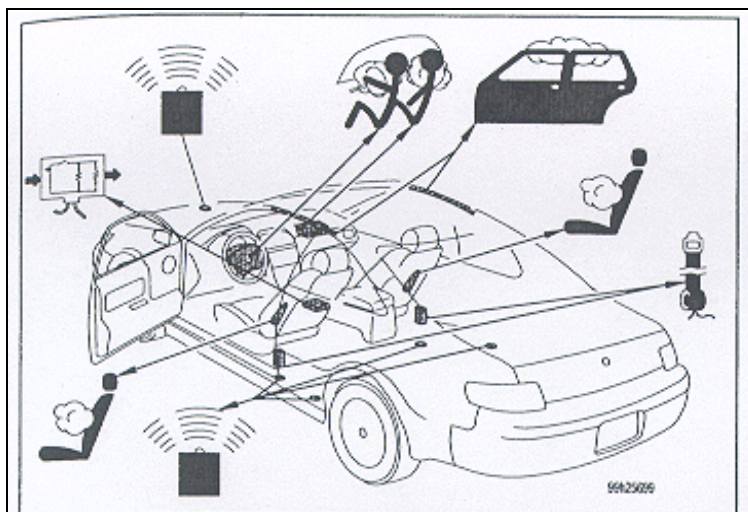
Fig. 02-3: Identifying Air Bag Components (X Type)

There were no air bag deployments. This is likely due to the long crash pulse (an extended delta T) caused by the relatively soft rear structure of the struck Honda vehicle. It should be noted that the Jaguar is 31% heavier than the Honda (1558 to 1078 kg, 3434 to 2374 lbs).

The front outboard seats were equipped with seat belt pretensioners. The driver's seat belt pretensioner fired as a result of the crash. The front right passenger's pretensioner did not fire.
