ON-SITE ADVANCED OCCUPANT PROTECTION SYSTEM INVESTIGATION

CASE NUMBER - IN-02-008
LOCATION - TEXAS
VEHICLE - 2003 TOYOTA COROLLA CE
CRASH DATE - September 2002

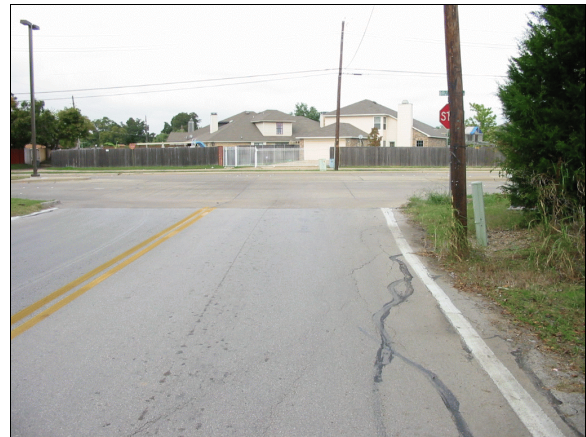
Figure 1: Case vehicle's northward travel path approaching Tee intersection (case photo #01)

Pre-Crash: The case vehicle had been traveling north and came to a stop, heading north at the **STOP** sign (**Figure 1** above). The case vehicle entered the intersection, intending to turn left and proceed westward. The Chevrolet pickup was traveling east in the center through lane and intended to proceed straight ahead (**Figure 2** above). The case vehicle's driver made no avoidance maneuvers prior to the crash. The crash occurred in the center through lane of the eastbound roadway, within the "Tee" the intersection of the two trafficways.

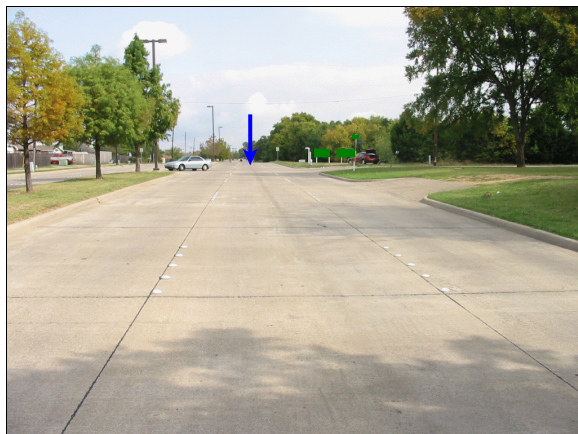
Figure 2: Chevrolet's eastward travel path in center through lane; Note: arrow marks approximate point of impact with case vehicle (case photo #09)

The other vehicle's city roadway was straight and level at the area of impact (**Figure 2** above). The pavement was concrete, and the width of the center eastbound travel lane was 3.4 meters (11.2 feet). The shoulders were not improved (i.e., grass), but the roadway was bordered by barrier curbs. The north side of the eastbound road had a barrier curb protecting the 4.1 meter (13.5 feet) wide unprotected, tree-lined, grassy median. No pavement markings were present on the roadway; however, the through lanes were divided by a series of white raised pavement markers. The estimated coefficient of friction was 0.70. There were no visible traffic controls in the immediate area of the crash. The statutory speed limit was 64 km.p.h. (40 m.p.h.). No regulatory speed limit sign was posted near the crash site.

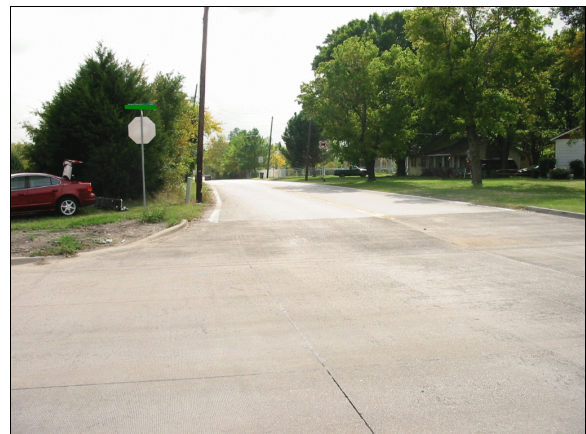
Figure 3: Southward view of case vehicle's northbound pre-crash path into Tee intersection; Note: downgrade on approach path (case photo #08)

The case vehicle's city roadway was straight and level (i.e., actual slope was slightly negative to the north) at the area of impact (**Figure 3** above). The pavement was bituminous, but traveled, and the width of the case vehicle's northbound travel lane was 4.7 meters (15.4 feet) and the southbound lane was 4.6 meters (15.1 feet). The shoulders were not improved (i.e., grass) on either the north or south sides of the roadway. Pavement markings consisted of a double solid yellow centerline for both north and southbound traffic. In addition, solid white edge lines were present. The estimated coefficient of friction was 0.75. Traffic controls consisted of a **STOP** sign (Manual on Uniform Traffic Control Devices, R1-1) located on the southeast quadrant of the intersection. The statutory speed limit was 56 km.p.h. (35 m.p.h.). No regulatory speed limit sign was posted near the crash site.

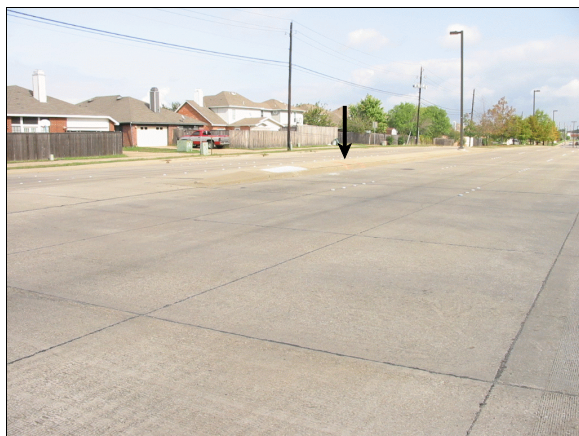
fender (**Figure 4** above) side slapped the Chevrolet, most likely in its left front fender. The force from the initial impact caused the case vehicle to move in an east-northeasterly direction into a raised, paved median while continuing to rotate counterclockwise (**Figure 6**). The case vehicle came to rest on the median heading southeastward, straddling the east and westbound roadways (**Figure 7**).

Figure 6: Northeasterly view from approximate point of impact with Chevrolet showing case vehicle's post-crash trajectory across eastbound lanes and into (arrow) raised paved median (case photo #04)

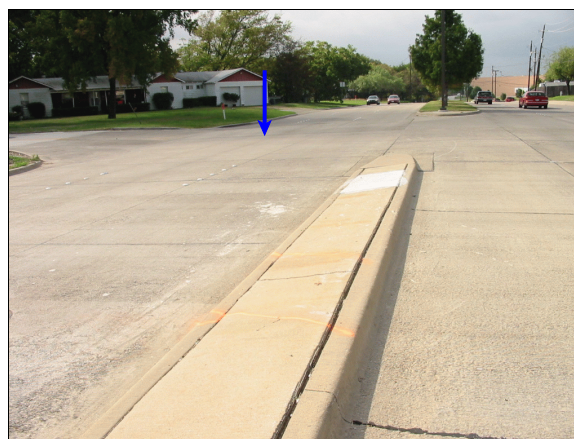
Figure 7: Southwesterly view from beyond case vehicle's obliquely oriented, final rest position atop raised paved median; Note: arrow marks approximate point of impact (case photo #06)
