On Site Child Safety Seat Investigation / Vehicle to Vehicle  
Dynamic Science, Inc. / Case Number: DS02008  
2002 Volvo V70 AWD Cross Country station wagon  
Washington  
May, 2002

1. Report No. <b>DS02008</b>		2. Government Accession No.		3. Recipient Catalog No.	
4. Title and Subtitle <b>On Site Child Safety Seat Investigation</b>				5. Report Date <b>September 3, 2003</b>

**Dynamic Science, Inc.**  
**Accident Investigation**  
**Case Number: DS02008**

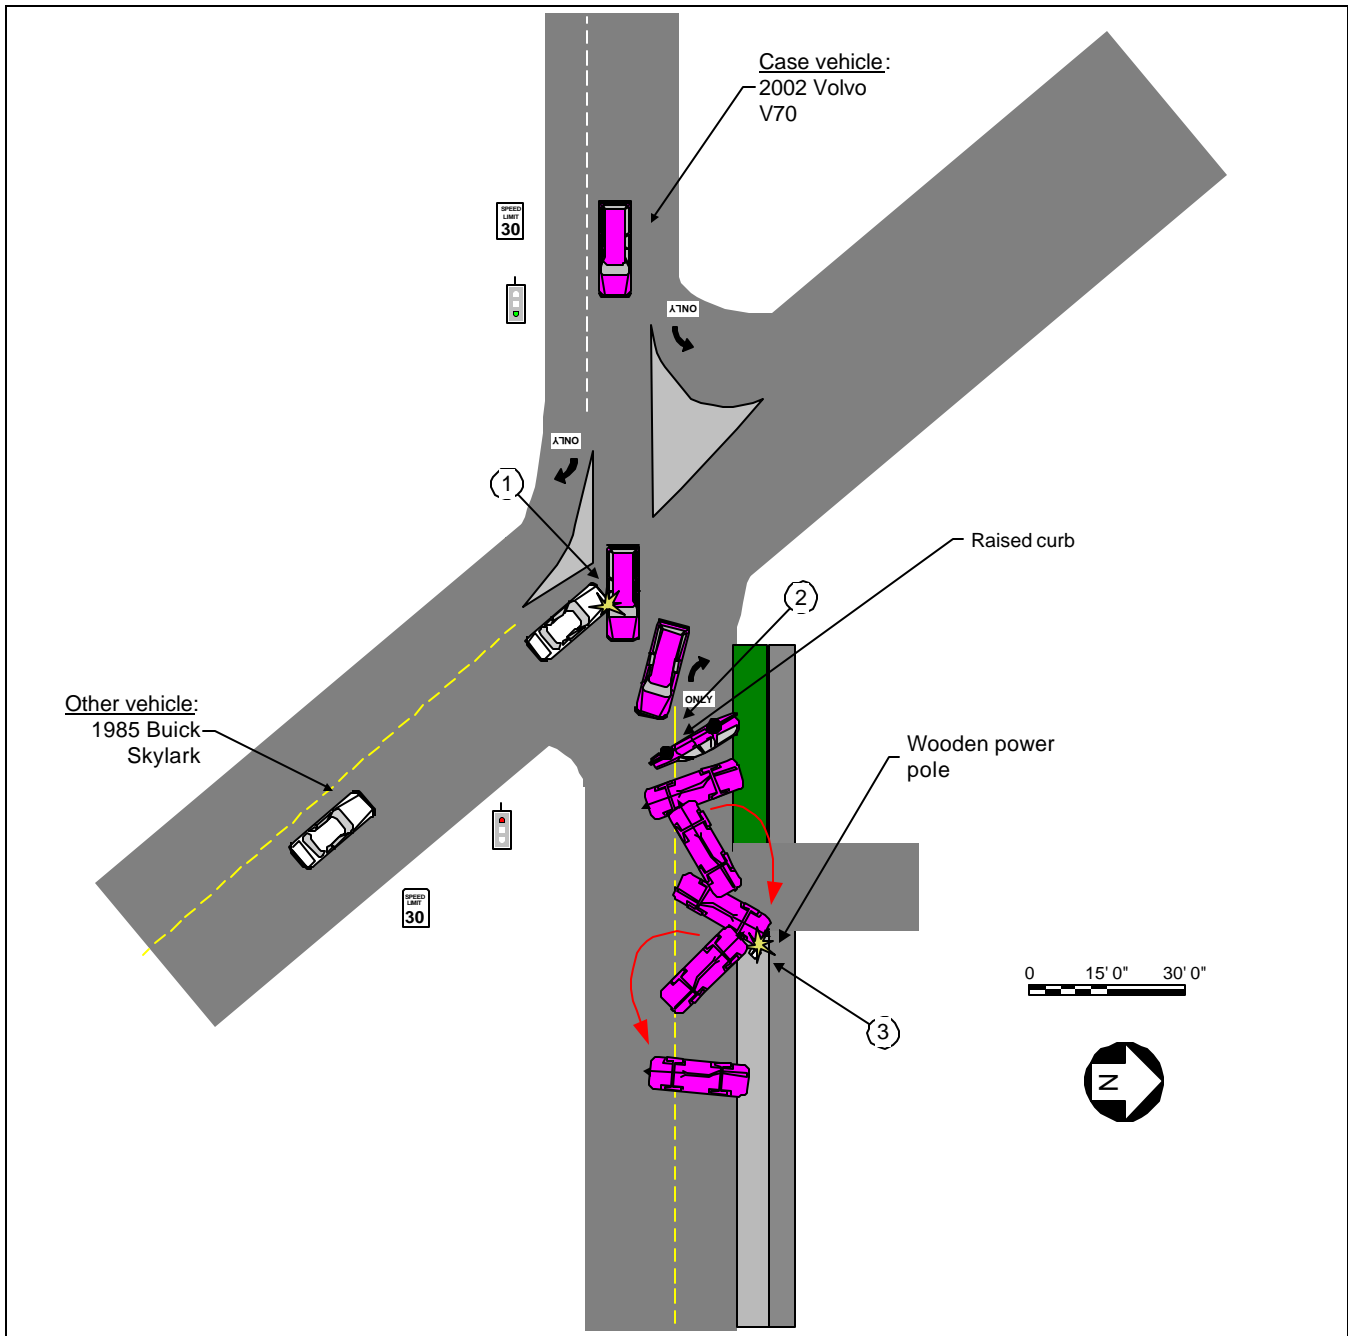
Figure 5. Scene diagram

The front of the other vehicle struck the right side of the case vehicle (01RZEW2). The total velocity change calculated by the missing vehicle algorithm of WinSmash was 14.0 km/h (8.7 mph). The longitudinal and lateral components were -10.7 km/h (-6.7 mph) and -9.0 km/h (-5.6 mph)<sup>1</sup>, respectively. The case vehicle began a clockwise rotation. The front left tire engaged a yellow colored raised curb in the eastern leg of the intersection. This tripped the vehicle and it began a roll onto its left side. The vehicle continued rolling over and went onto its roof (00TDDO2). While overturning, the vehicle was also rotating in a clockwise direction. The vehicle continued northeast until the left side (while upside down) contacted a wooden power pole (00LFEE3). This impact redirected the vehicle into a counterclockwise rotation and came to rest on its roof facing south. The other vehicle rotated clockwise after impact and came to rest in the intersection.
