**VERIDIAN ON-SITE AMBULANCE CRASH INVESTIGATION
SCI TECHNICAL SUMMARY REPORT**

VERIDIAN CASE NO. CA02-009

VEHICLE - 2000 FORD E-350 TYPE III AMBULANCE

CRASH DATE - MARCH 2002

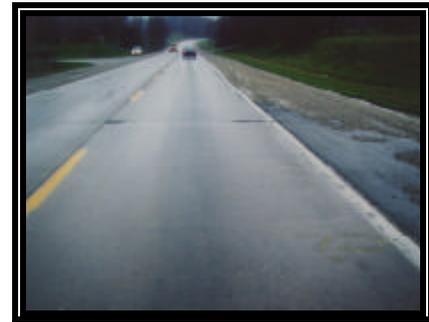
Figure 2. Westbound approach for the ambulance

The driver was operating the ambulance westbound on the two-lane U.S. route in a non-emergency mode (**Figure 2**). The emergency warning devices were not in operation. The driver stated that the low-beam headlights were in use and there were no distractions within the ambulance. The driver said that he exited a right curve that was located approximately 1.6 km (1.0 miles) east of the crash site and did not detect any headlights from any approaching vehicles. He stated that he noted the speedometer read 89 km/h (55 mph) as the ambulance entered the curve. He subsequently detected headlights approaching from the opposite direction and realized that the ambulance had crossed the centerline. The ambulance driver steered right in an attempt to avoid the collision. A witness following behind the ambulance stated that he did not see any brake lights illuminate on the ambulance as it crossed the centerline.

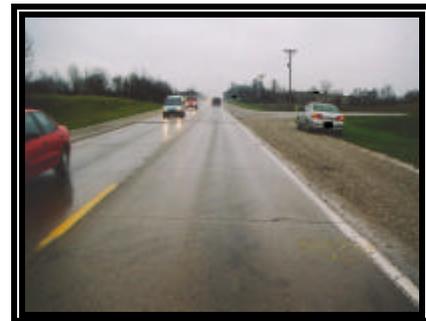
Figure 3. Eastbound approach for the Mitsubishi Eclipse

A 17-year-old male was operating the 1995 Mitsubishi Eclipse eastbound on the U.S. roadway (**Figure 3**). The driver detected the ambulance encroaching into the eastbound lane and braked and steered left in an attempt to avoid the collision. A right front tire mark that measured 8.8 m (28.9') was present in the Mitsubishi's pre-crash trajectory. The mark began in the center of the eastbound lane, curved slightly toward the centerline, and ended at the point of impact.

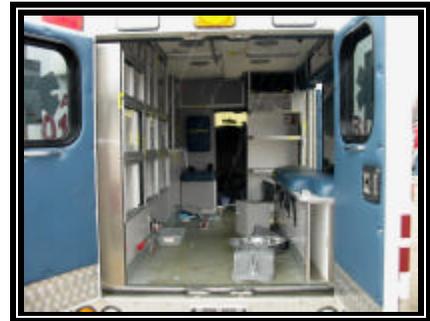
Figure 7. View of patient compartment interior

The interior of the patient compartment (**Figure 7**) was configured with six halogen dome lights, one incandescent bar light, and one stepwell light that was activated with the side door. The interior was also configured with a heater/air conditioner, three-speed ventilation fan, and a static vent located over the side entry door. A non-padded 163 cm (64") long stainless steel assist rail was located on the ceiling above the ambulance cot area and 25 cm (10") assist rails were located on each entry door and on the forward right aspect of the patient compartment. Most of the interior cabinetry consisted of sliding 0.5 cm (0.2") thick plexiglass doors configured with full-length aluminum pull handles. Each cabinet with plexiglass doors was configured with a 3.2 cm (1.3") wide aluminum trim picture frame with 45 degree angles at the corners. Three columns and three rows of cabinets with plexiglass doors were located along the left wall on the center and rear aspect and measured 41.9 cm (16.5") in depth. The entire cluster of cabinets on the left wall of the ambulance measured 165 cm (65") in width and 118 cm (47") in height. Additional cabinets with plexiglass doors were located over the work space area on the forward aspect of the left wall and over the bench seat on the right wall. The specific cabinet locations are illustrated in the ambulance interior schematic in **Appendix B**.

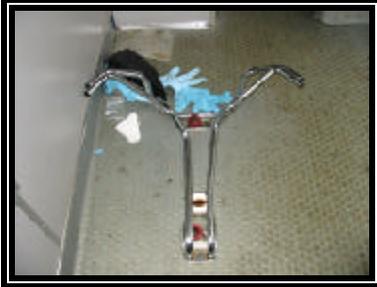
Figure 8. Front “antler” bracket

A Stryker Model cot fastener system was installed in the ambulance. The fastening system consisted of a front “antler” bracket mounted to the left aspect of the floor (**Figure 8**) that secured the front wheels of the cot and a rear spring-loaded fastener rail mounted on the lower left wall (**Figure 9**) that fastened directly to the cot frame. The ambulance cot was a Stryker Model 6091 EZ-PRO 2 aluminum cot (**Figure 10**). The cot was rated for a maximum weight of 228 kg (500 lb). The ambulance cot measured 210.8 cm (83.0") in length and 58.4 cm (23.0") in width. It was configured with three sets of harness straps for the chest, hips, and legs and was also configured with a four-point shoulder harness restraint. The articulated backrest elevated to a maximum of 75 degrees from horizontal.

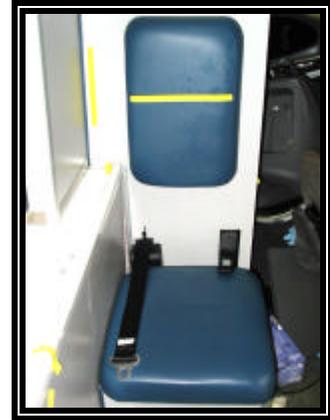
Figure 23. Attendant's seat lap belt

The patient compartment seating areas were configured with manual lap belts with ALR's and sewn latch plates. Tags sewn on the webbing indicated that model number was: BBLP1164, the part number was: 209SHP, and date of manufacture was April 2000. The retractor and buckle assemblies were vertically mounted on the wall behind each seating position (**Figure 23**). The lower anchor bolts for the retractor and buckle assemblies were mounted approximately 2.5 cm (1.0") above the base of the seats and approximately 5.1 cm (2.0") below the height of the seat cushions. The webbing pull-out measured approximately 127 cm (50") for each belt. The buckle assemblies were mounted with plastic sleeves that measured 15.2 cm (6.0") in height above the anchor bolts. The buckles and webbing extended 15.2 cm (6.0") above the top aspect of the sleeves.

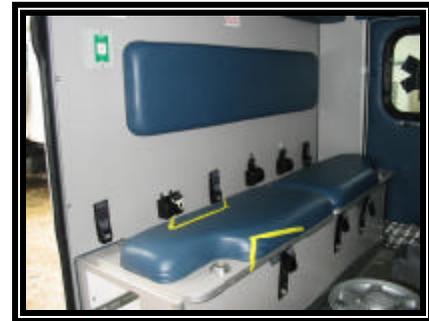
Figure 24. View of lap belts on the right side bench seat

The distance between the center of the retractor assembly and center of the buckle assembly was 26.4 cm (10.4") on the rear-facing attendant's seat. The distance between the retractor assemblies and center of the buckle assemblies on the right side bench seat measured 30.5 cm (12.0") for each of the three seating positions (**Figure 24**). In addition, three buckle assemblies were mounted on the inboard face of the bench and centered vertically between the floor and the cushions to facilitate the restraint of a stretcher on the bench seat. Plastic sleeves that measured 18.7 cm (7.4") in height were mounted with a single bolt on the bottom aspects, and the webbing and buckles extended 10.8 cm (4.3") above the sleeves. The forward-most buckle was located 55.2 cm (21.8") rear of the forward edge of the bench seat, and the remaining two buckle assemblies were spaced 49.5 cm (19.5") and 31.1 cm (12.3") apart, respectively.

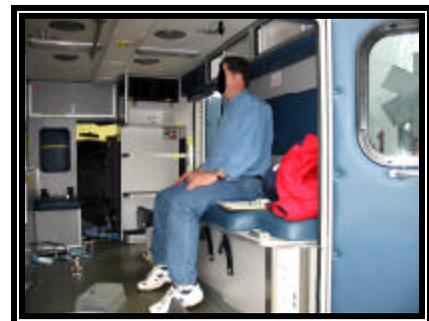
Figure 27. Photograph depicting pre-crash position of the PCP

The 37-year-old PCP was seated on the right side bench seat in the center position (**Figure 27**). A Lifepack 10 defibrillator unit was restrained vertically on the forward aspect of the bench seat to his right, and an unrestrained soft-sided medical supply bag was on the seat to his left. Prior to the impact, he had been restrained by the lap belt on the bench seat. He got up to adjust the HVAC controls on the left side of the patient compartment. He returned to the seat, but never re-engaged the lap belt. At impact, he initiated a lateral trajectory to his right toward the front of the patient compartment. He loaded the defibrillator as he moved across the bench seat which resulted in a right lumbar area contusion. The medical supplies/instruments in the right outboard pocket of his cargo pants caused abrasions and scuff marks on the vinyl seat cushion and the compression against his upper leg resulted in a right lateral thigh abrasion and contusion.

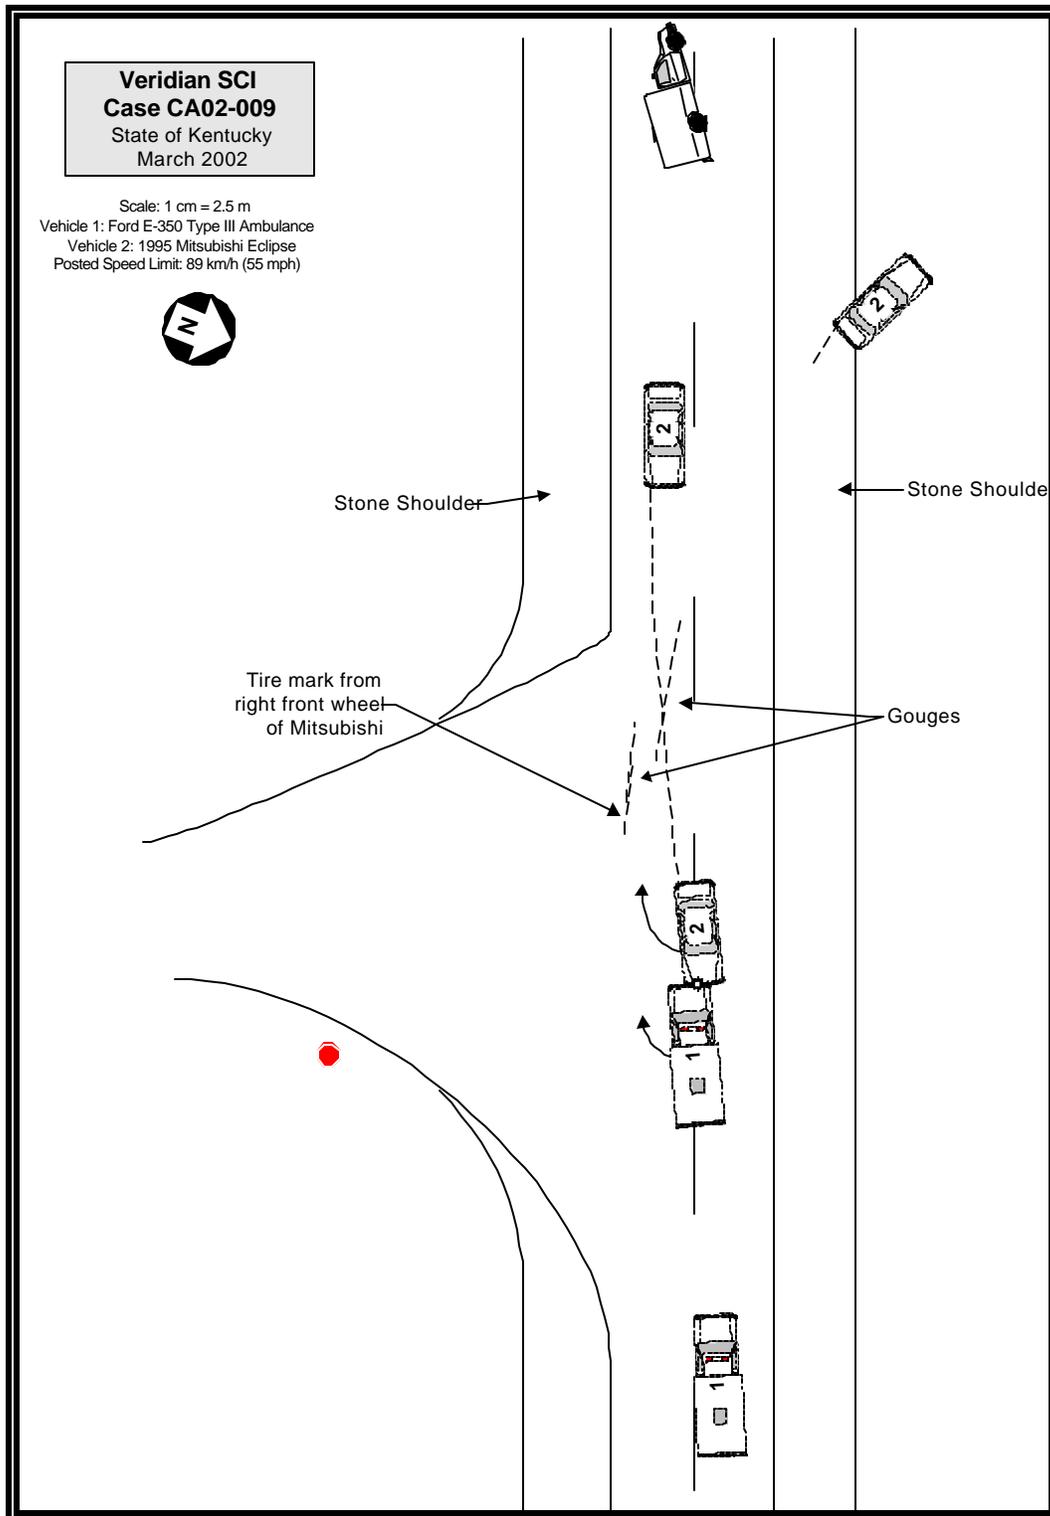
Figure 32. Scene schematic

This two-vehicle crash occurred during the nighttime hours on a two-lane U.S. route. At the time of the crash, it was dark with no roadway illumination. The driver of the ambulance stated that the temperature was approximately 4 degrees Celsius (40 degrees Fahrenheit) and the weather was clear and windy. The concrete roadway surface was dry. The east/west two-lane roadway was straight and consisted of one travel lane in each direction separated by a dashed yellow centerline and bordered by gravel shoulders. The U.S. route had an approximate three percent negative westbound grade that began at a hillcrest 395 m (1295') east of the scene. At the crash site, a two-lane local roadway intersected the U.S. route in a T-configuration on the south side. A stop sign was located on the southeast corner for traffic turning onto the U.S. route. The posted speed limit for the roadway was 89 km/h (55 mph). The scene schematic is included as **Figure 32**.
