Office of Defect Investigations Potential Fail-to-Deploy Investigation / Vehicle to Object
Dynamic Science, Inc. / Case Number: DS02011
2001 GMC Yukon XL 2WD Four Door Sport Utility Vehicle
California
June, 2002

Dynamic Science, Inc.
Crash Investigation
Case Number: DS02-011

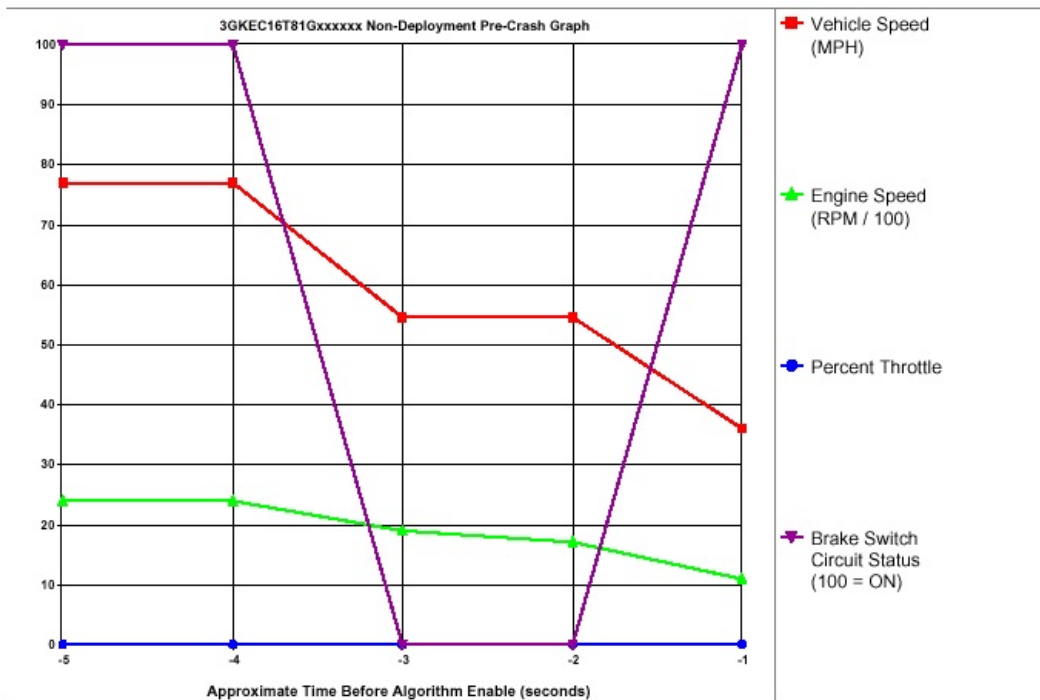
| Maximum SDM Recorded Velocity Change (MPH) | -4.06 |
| Algorithm Enable to Maximum SDM Recorded Velocity Change (msec) | 77.5 |

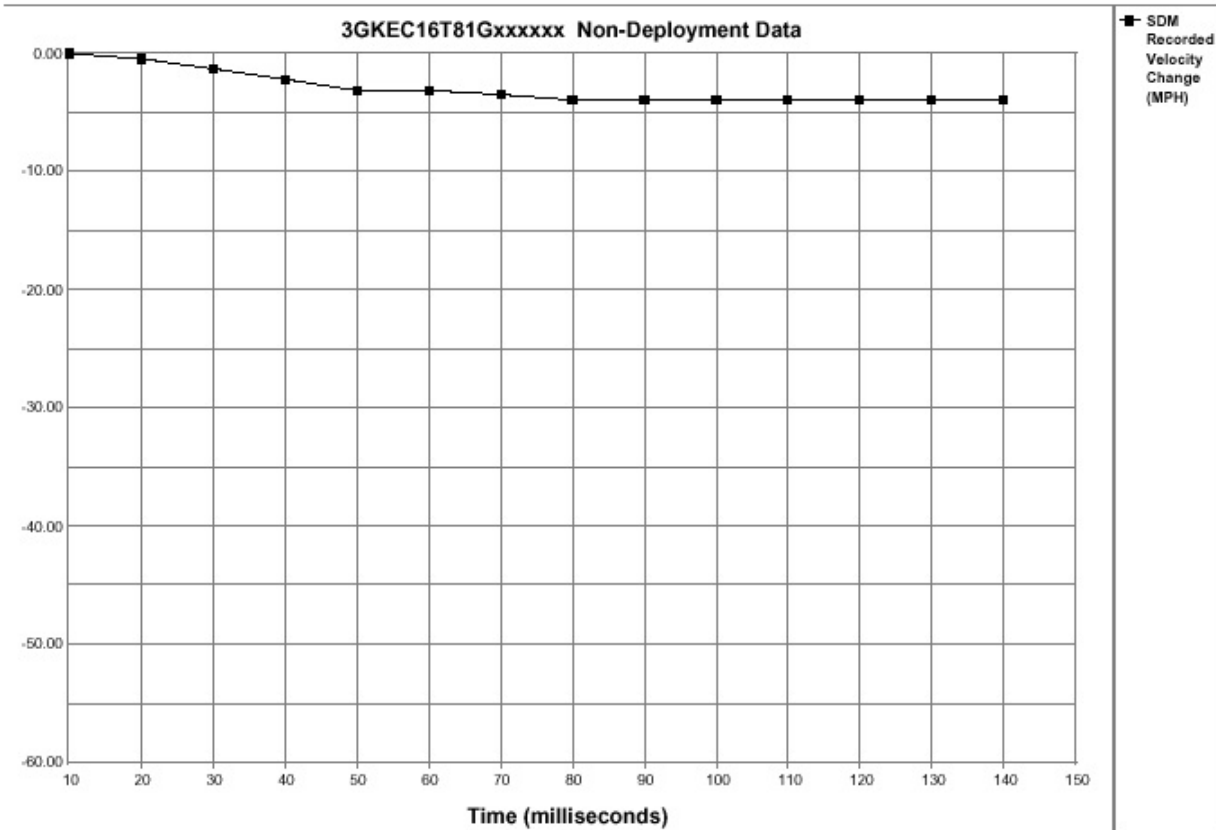
ATTACHMENT 2 - Vetronix Output Report (Cont...)

| Time (milliseconds) | 10 | 20 | 30 | 40 | 50 | 60 | 70 | 80 | 90 | 100 | 110 | 120 | 130 | 140 | 150 |
|---|---|---|---|---|---|---|---|---|---|---|---|---|---|---|---|
| SDM Recorded Velocity Change | 0.00 | -0.44 | -1.32 | -2.19 | -3.07 | -3.07 | -3.51 | -3.95 | -3.95 | -3.95 | -3.95 | -3.95 | -3.95 | -3.95 | N/A |
