**ON-SITE AIR BAG RELATED ADULT DRIVER FATALITY INVESTIGATION  
SCI TECHNICAL SUMMARY REPORT**

**VERIDIAN CASE NO. CA02-016**

**VEHICLE - 1996 FORD F-150 PICKUP TRUCK**

**CRASH DATE - JUNE 2001**

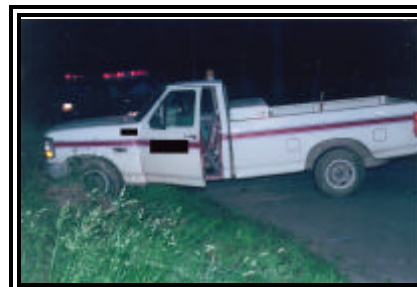
**Figure 1. On-scene photograph of the 1996 Ford F-150 pickup truck**

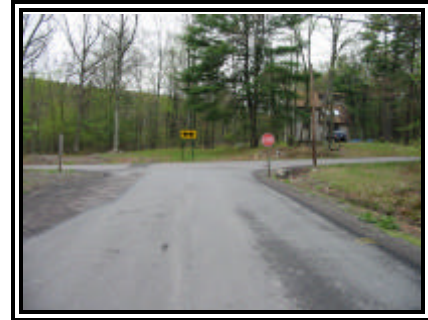
This crash occurred during the nighttime hours in June 2001 at a T-intersection of two rural roadways (**Figure 2**). At the time of the crash, there were no adverse weather conditions and the asphalt roadway was dry. The unmarked north/south roadway consisted of one travel lane in each direction that were bordered by gravel shoulders. The roadway was straight and had a 2 percent negative southbound grade. The unmarked east/west roadway consisted of one travel lane in each direction and was bordered by gravel shoulders. A dirt embankment was present on the south side of the roadway opposite the mouth of the intersection and was offset to the west aspect. The embankment consisted of moderately packed dirt and rocks and was located 2.1 m (6.9') from the south road edge. It measured 8.6 m (28.2') in width and 110 cm (43") in height. The slope of the embankment was approximately 50 degrees from vertical, front-to-rear. The east/west roadway was straight at the intersection and had a 3 percent positive westbound grade. The roadway curved to the left west of the intersection. Shallow drainage ditches were present on both sides of the east/west roadway and on the west side of the north/south roadway. Traffic control at the intersection consisted of a stop sign on the northwest corner for southbound traffic. A yellow warning sign with opposing arrows was present on the south roadside for southbound traffic, but it appeared to have been installed after the crash. The posted speed limit for the east/west roadway was 48 km/h (30 mph) and there was no posted speed limit for the north/south roadway. The roadside environment consisted of various trees and wooded areas with private driveways and residential properties. There was no roadway illumination. The scene schematic is included as **Figure 10** of this report.

**Figure 2. View of T-intersection looking south**
