ON-SITE SIDE IMPACT OCCUPANT PROTECTION INVESTIGATION

VEHICLE: 1999 AUDI A6

CASE NO: CA02-023

CRASH DATE: JUNE 2002

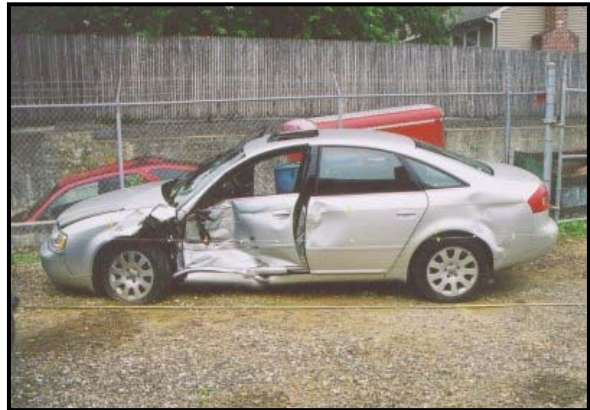
This investigation focused on the side impact occupant protection of a 1999 Audi A6, **Figure 1**, involved in a left side impact with a 2001 Chevrolet Tahoe police unit. The Audi was equipped with a redesigned driver air bag, a dual-stage front right passenger air bag, and seat mounted side impact air bags for the front occupants. The left side impact air bag deployed as a result of an angular crash configuration. The Chevrolet was equipped with a SRS that consisted of frontal air bags for the driver and front passenger and side impact air bags mounted in the front seat backs. The air bags in the Chevrolet did not deploy in the below threshold crash. The male driver of the Audi suffered a nasal fracture and other minor injuries as a result of the impact. The driver of the Chevrolet had a complaint of chest pain. Both drivers were transported to a local hospital, treated and released.

Figure 1: Left side view of the Audi.

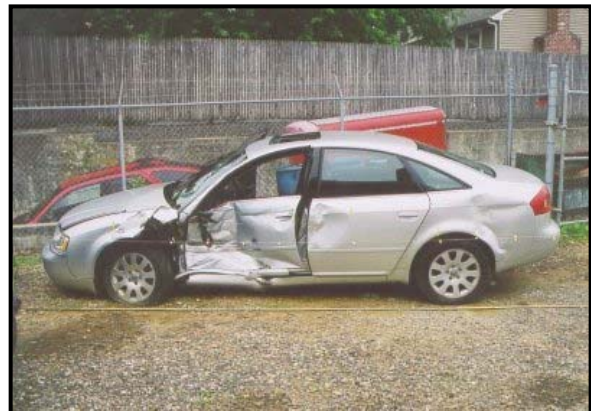
The 1999 Audi A6, **Figure 3**, was identified by the Vehicle Identification Number (VIN): WAUBA24B4XN (production sequence deleted). The 4-door sedan was equipped with a 2.8 liter/V6 engine linked to a 5-speed automatic transmission. The manual restraint system consisted of 3-point lap and shoulder belts for the five seat positions. The manual restraints for the front occupants were equipped with retractor pretensioners. The vehicle was equipped with a Supplemental Restraint System (SRS) that consisted of a redesigned driver air bag, a dual-stage front right passenger air bag, and seat mounted side impact air bags for the front occupant positions. The odometer read 62,722 km (38,795 miles) at the time of the inspection. The Audi was equipped with Michelin MXV4 P205/55R16 tires on OEM alloy wheels. The manufacturer’s recommended tire pressure was 221 kpa (32 psi). The specific measured tire data was as follows:

Figure 3: Front view of the Audi A6.

Tire	Measured Pressure	Tread Depth	Restricted	Damage
LF	0 kpa	5.6 mm (7/32)	No	Sidewall cut/ Debeaded
LR	213.8 kpa (31.0 psi)	6.4 mm (8/32)	No	None
RF	196.5 kpa (28.5 psi)	6.5 mm (7/32)	No	None
RR	200.0 kpa (29.0 psi)	4.8 mm (6/32)	No	None

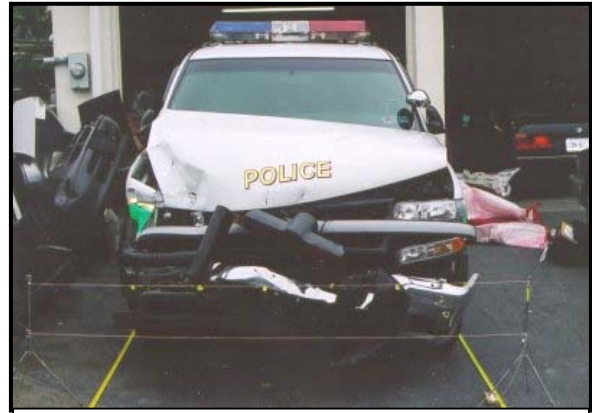
The 2001 Chevrolet Tahoe, **Figure 4**, was identified by the Vehicle Identification Number (VIN): 1GNEC13V61J (production sequence deleted). The 4-door, 4x2 sport utility vehicle was configured as a police unit and was equipped with an aftermarket push bumper mounted to the OEM front bumper and forward frame. The power train consisted of a 4.8 liter/V8 engine linked to a 4-speed automatic transmission. The manual restraint system consisted of continuous loop 3-point lap and shoulder belts with sliding latch plates for the four outboard positions. The restraints for the front seated occupants were integrated into the front seat backs. The center rear position was lap belt equipped. The Supplemental Restraint System (SRS) consisted of redesigned air bags for the driver and front right passenger and seat mounted side impact air bags for the front seat occupants. The date of vehicle manufacture was March 2001. The electronic odometer could not be accessed at the time of the inspection due to the lack of electrical power. The Tahoe was equipped with Goodyear Conquest P245/75R16 tires on OEM alloy wheels. The manufacturer’s recommended tire pressure was 241 kpa (35 psi). The specific measured tire data was as follows:

Figure 4: Front view of the Chevrolet Tahoe.

Tire	Measured Pressure	Tread Depth	Restricted	Damage
LF	231.0 kpa (34.5 psi)	7.9 mm (10/32)	No	None
LR	231.0 kpa (34.5 psi)	6.4 mm (8/32)	No	None
RF	231.0 kpa (33.5 psi)	8.7 mm (11/32)	Yes	None
RR	231.0 kpa (33.0 psi)	5.6 mm (7/32)	No	None

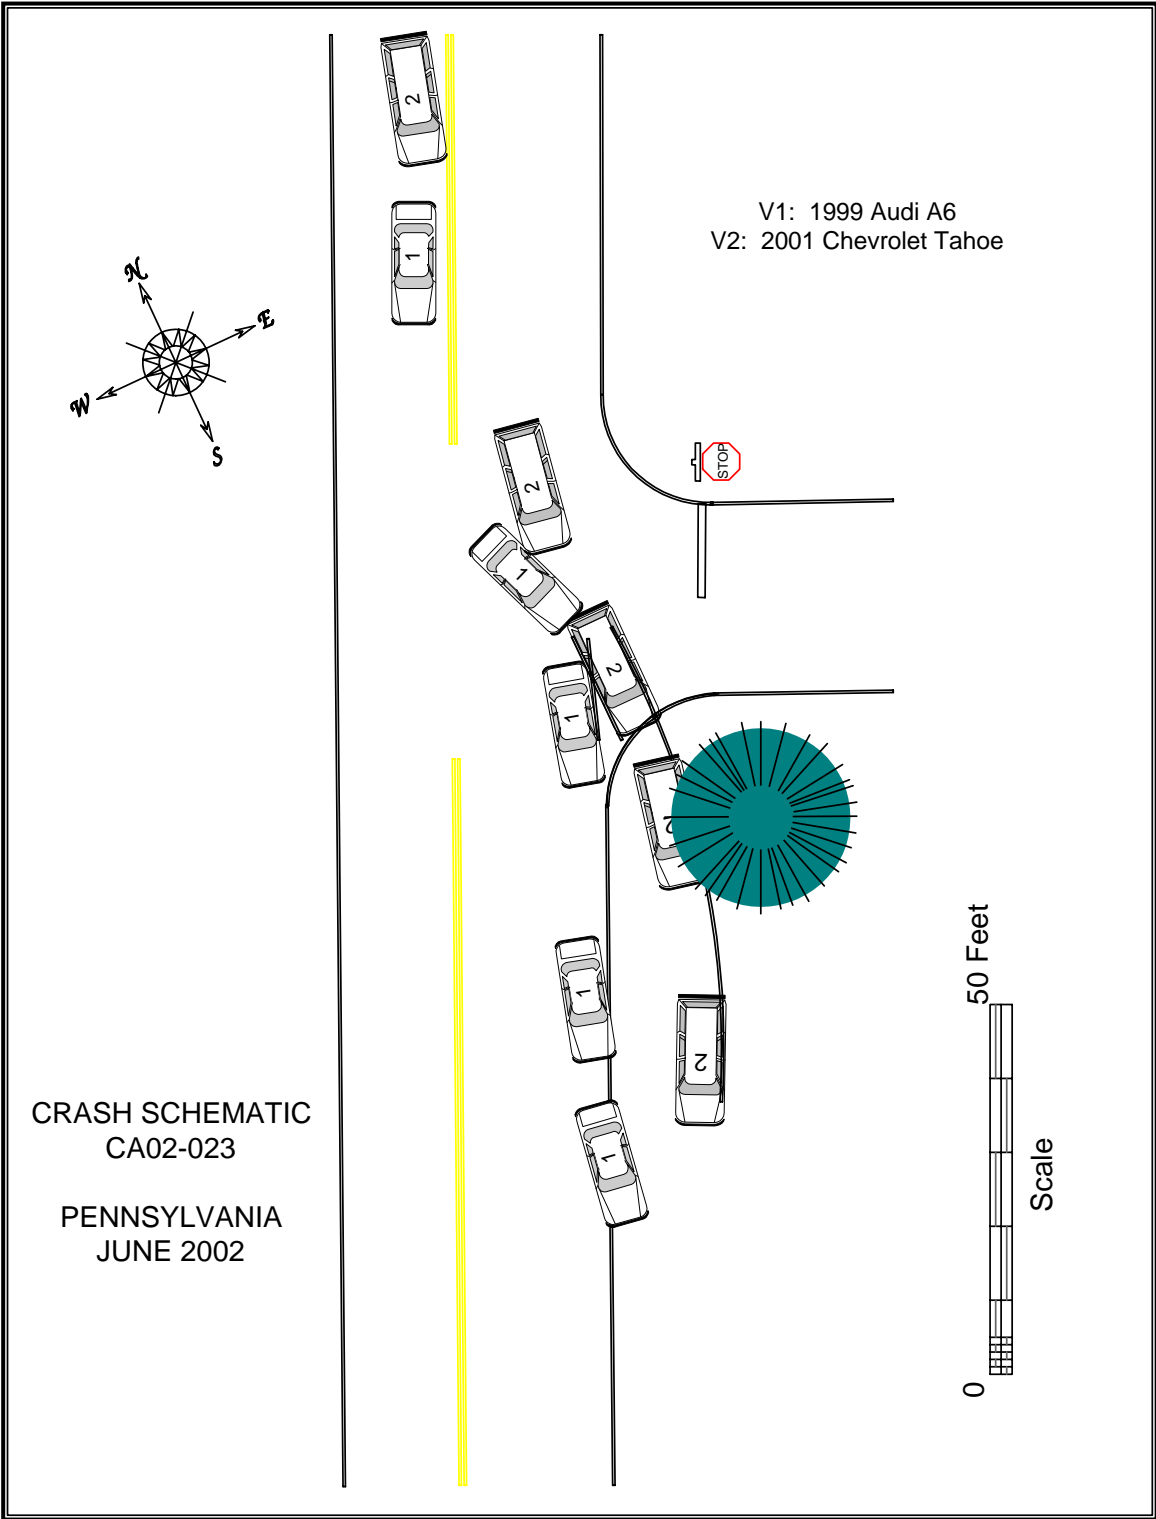
Figure 13: Crash Schematic

The crash occurred with the front right aspect of the Chevrolet impacting the left side plane of the Audi in a 12/7 o'clock impact configuration. The force of the impact deployed the left side occupant protection of the Audi. The Chevrolet's engagement with the Audi began on the mid-aspect of the Audi's left front door and continued forward into the area of the left A-pillar. The impact of the Chevrolet forward of the Audi's center of gravity caused the Audi to rotate clockwise to a southerly heading. The vehicles contacted a second time in a side-slap configuration. The area of initial impact was identified by the initiation of a pavement rim gouge documented during the SCI scene inspection. The rim gouge was attributed to the left front wheel of the Audi.

The Chevrolet Tahoe traveled through the mouth of the intersection and ran off the road to the southeast. The Chevrolet came to rest in the yard of a private residence facing southward approximately 20 m (65 ft) from the point of impact. The Audi continued south southeastward, mounted the curb and came to rest approximately 21 m (70 ft) from the point of impact, in-close proximity to the Chevrolet. Inspection of the crash scene identified post-crash tires marks attributed to both vehicles and identified their respective trajectories to final rest. **Figure 13**, Page 11, is a schematic of the crash sequence.
